4.0 Foreshore Seawalls

4.1 Background

4.2 Project Scope

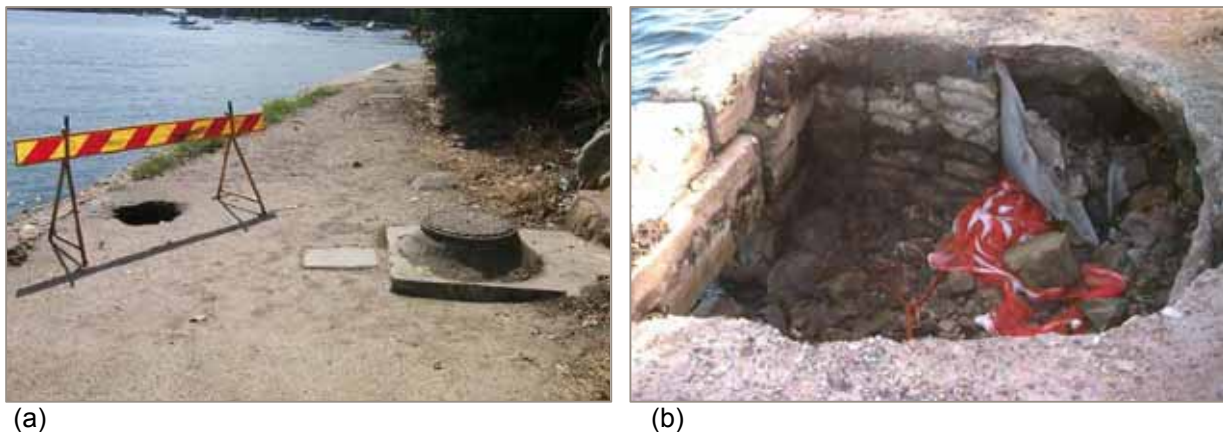
All seawalls and coastal revetments must be designed with appropriate filter layers to retain fine sediments on the landward side of the seawall and provide adequate drainage. Loss of fine sediments from behind the wall results in the development of sinkholes (Figure 4-10a) and the ultimate collapse of the seawall or revetment can occur when filter layers are not incorporated (Figure 4-10b). Inadequate drainage also leads to the build up of excessive pore water pressure behind the wall, which may result in lateral movement and compromise structural integrity.

Figure 4-10. (a) relatively small sink hole with larger cavity underneath (b) sudden collapse of unsupported pathway (North Sydney Council 2002)

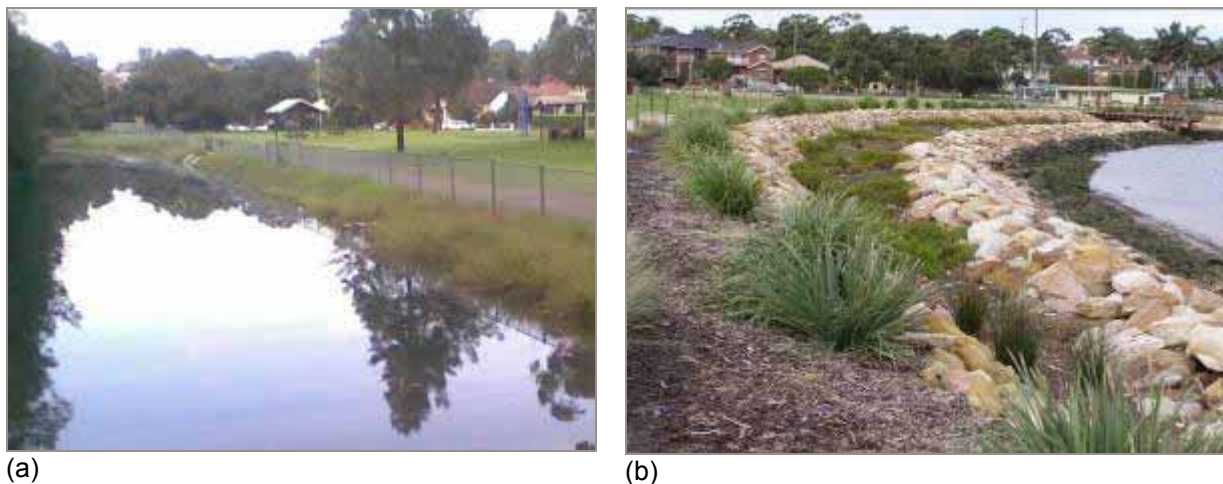
Overtopping of seawalls and coastal revetments occurs due to inadequate crest height (Figure 4-11a). Overtopping, due to the combined influence of large tides, wave run up and storm surge can result in a loss of fines or a build up of excessive pore water pressure in the soil behind the wall. Conversely, some seawalls are designed to facilitate overtopping at various tidal ranges to provide habitat for intertidal biota (Figure 4-11b).

Figure 4-11. (a) King tide overtopping crest, Hawthorne Canal, Ashfield LGA (b) Seawall design that allows overtopping of high tides to inundate saltmarsh vegetation Claydon Reserve, Kogarah LGA

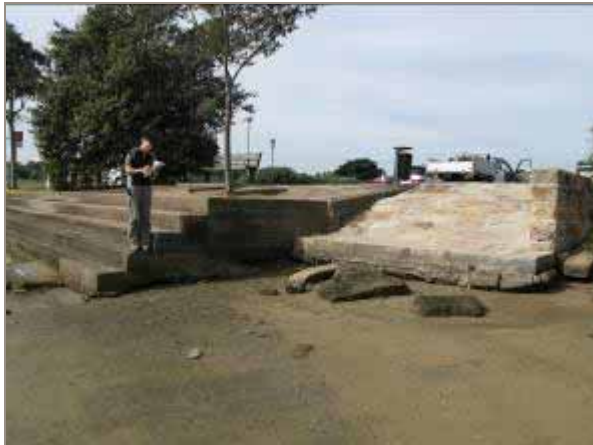
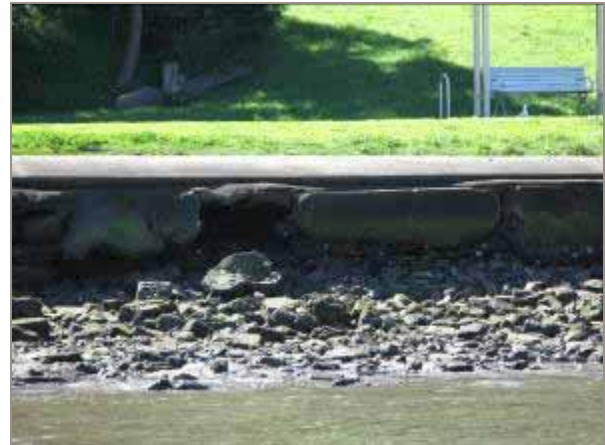
The foundations of seawalls and coastal revetments often incorporate toe protection to prevent scouring and undermining. Toe scour occurs due to currents from wind and vessel-induced waves. Where inadequate toe protection is provided, scour can lead to undermining of the wall (Figure 4-12a). In the case of block seawalls, undermining can result in individual block failures reducing the structural capacity of the seawall (Figure 4-12b). For rubble revetments, if the toe armour mass is insufficiently sized to resist currents, individual units may become dislodged exposing the material beneath the revetment, altering the structure profile and causing instabilities in the armour units above.

Figure 4-12. (a) Undermining of seawall stairs and wall at Rodd Point, Canada Bay LGA (b) Individual block failure upstream of John Whitton Bridge, Ryde LGA

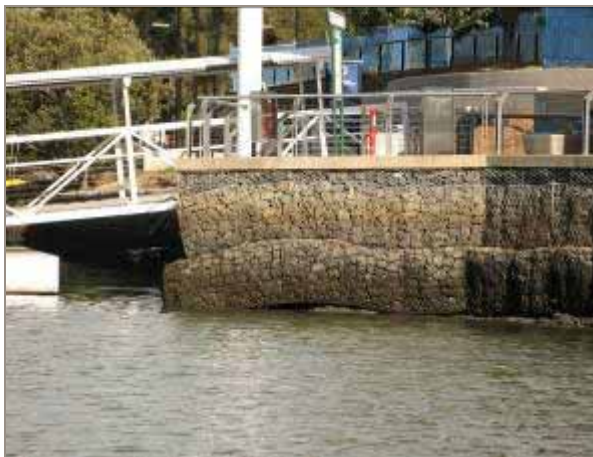
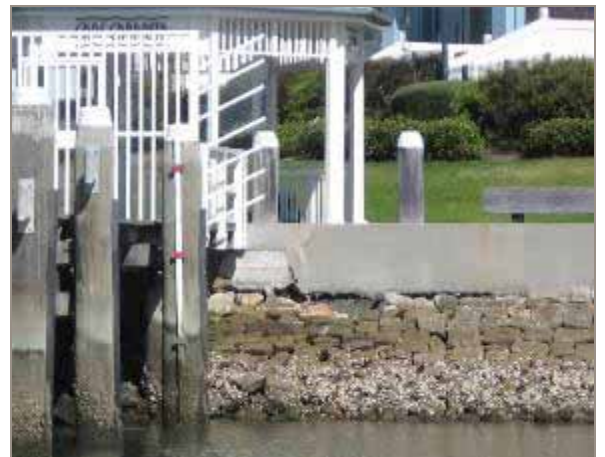
Differential settlement may occur if the structure is located on unconsolidated sediments and has inadequate foundations. Settlement can cause grout and concrete to crack and individual seawall units to move relative to each other, compromising the integrity of the structure.

Figure 4-13. (a) Movement of gabion wall units in Parramatta LGA (b) Relatively new seawall treatment showing differential settlement

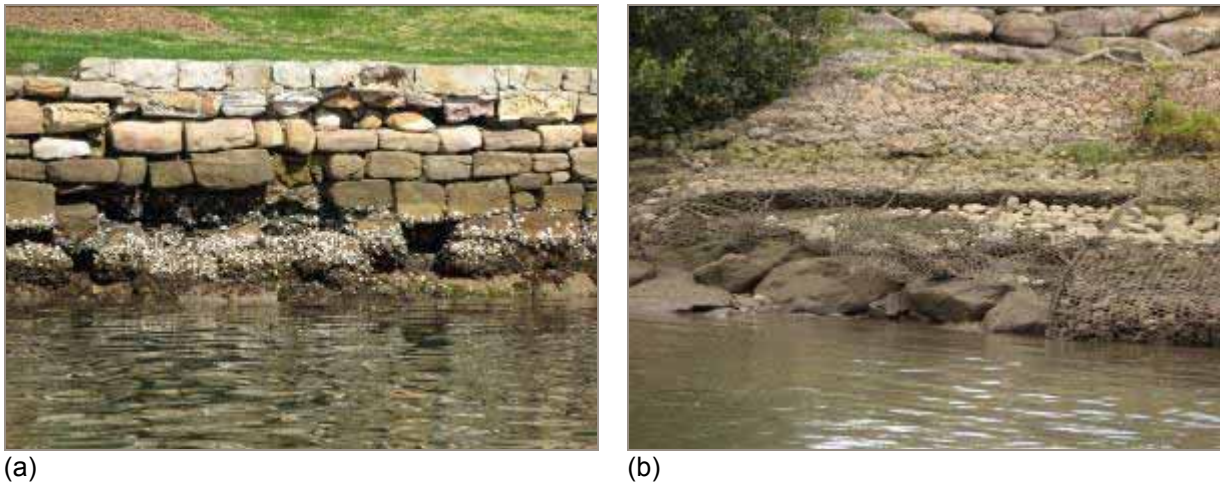
- Sandstone and concrete weathers over time (Figure 4-14a).
- Where revetment armour material has been inadequately specified or has been installed in an ad-hoc manner, local wind-generated waves, currents or waves may displace the units.
- The wire mesh that forms gabion units corrodes over time leading to a loss of gabion fill material and ultimately failure of the structure (Figure 4-14b).

Figure 4-14. (a) Weathered sandstone blocks adjacent newly developed residential area in Canada Bay LGA (b) Loss of materials from gabion mesh units on the River in Parramatta LGA

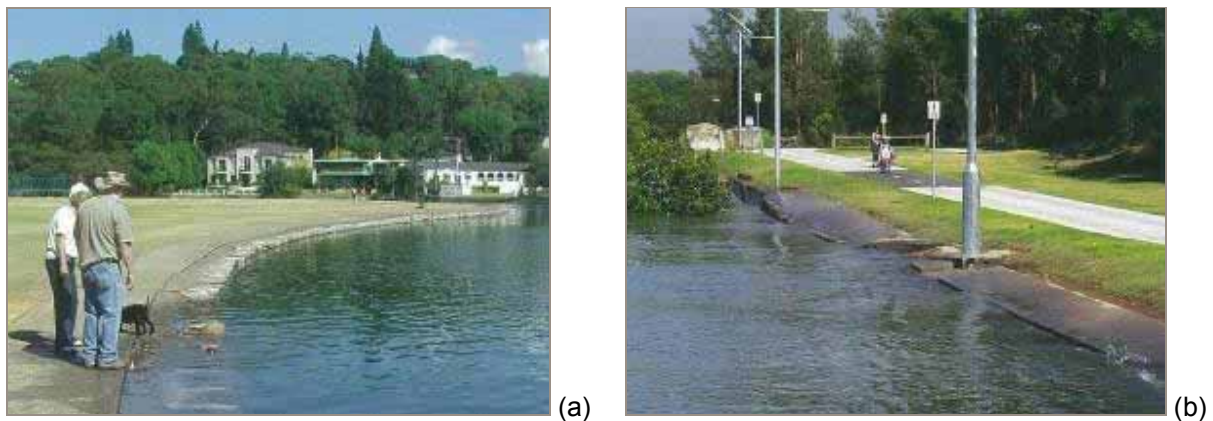
DECCW facilitated a photographic record (January 2009) of the tide throughout NSW. Photographs taken at Tarban Creek in Hunters Hill (HUN_S11, Figure 4-15a) and Meadowbank in Ryde (RYD_S23, Figure 4-15b) indicated the vulnerability of low crested seawalls to overtopping with elevated water levels.

Figure 4-15. King tide event at Tarban Creek in Hunters Hill, HUN_S11 (a) and Meadowbank in Ryde, RYD_S23 (b) (Watson and Frazer, 2009)
