6.0 Foreshore Recreational Assets and Facilities

6.3 Condition Assessment

PARRAMATTA RIVER ESTUARY PROCESSES STUDY
FORESHORE RECREATIONAL FACILITIES & RESERVES

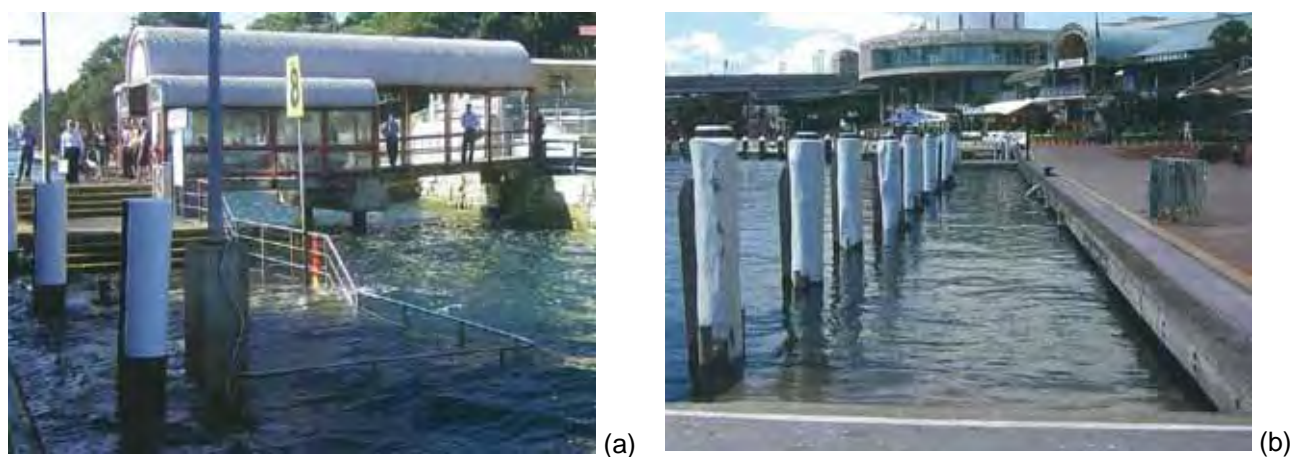
DECCW facilitated a photographic record of the tide throughout NSW (January 2009). Photographs taken at Darling St Ferry Wharf in Balmain (Figure 6-9a) and Darling Harbour (Figure 6-9b), indicated the vulnerability of fixed facilities to inundation at high tide levels.

Figure 6-9 Inundation of the Darling Street ferry wharf, Balmain (a) and a Darling Harbour timber landing facility (b) (Watson and Frazer 2009)

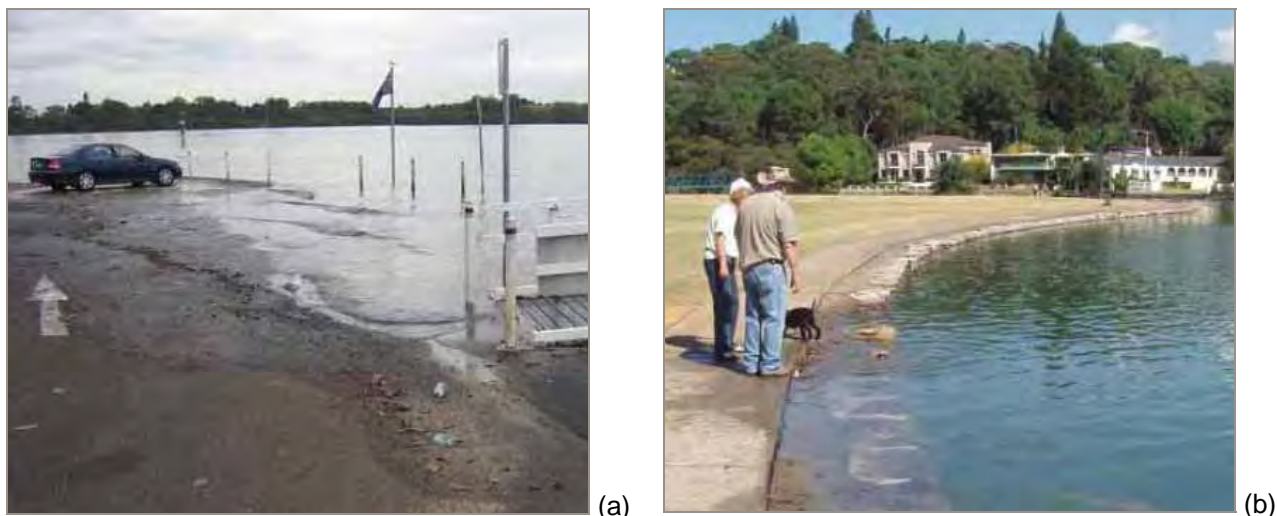
Cardno Lawson and Treloar (2008) identified the potential loss of foreshore space due to predicted sea level rise as a major concern for several LGAs. This is largely due to foreshore open spaces forming the majority of the available open space for recreation within some LGAs in the study area. Already a number of foreshore parks are inundated during spring high tides, for example: Kissing Point Park (Figure 6.10a) and Riverglade Reserve (Figure 6.10b).

Figure 6-10 (a) Inundation of car park at Kissing Point Park, and (b) Riverglade Reserve, Tarban Creek (Watson and Frazer 2009)
