Leichhardt LGA

9.2 Leichhardt

Seawall Inspection Record - LEI_S08

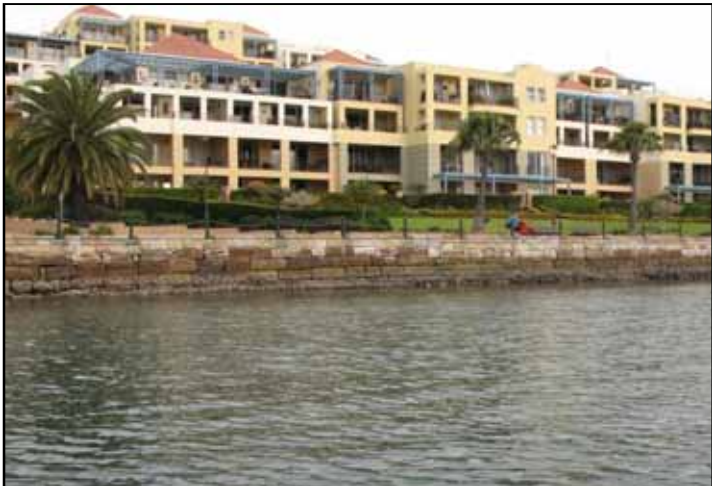
Photo 1

Exposed old sandstone blocks along bottom of wall are slumping. Concrete capping is showing signs of surface weathering and has in many places begun to crack and has fallen away from the old sandstone wall. Major undermining is present at discrete locations.

Northern part of wall showing slumping of old sandstone blocks and new blocks along crest.

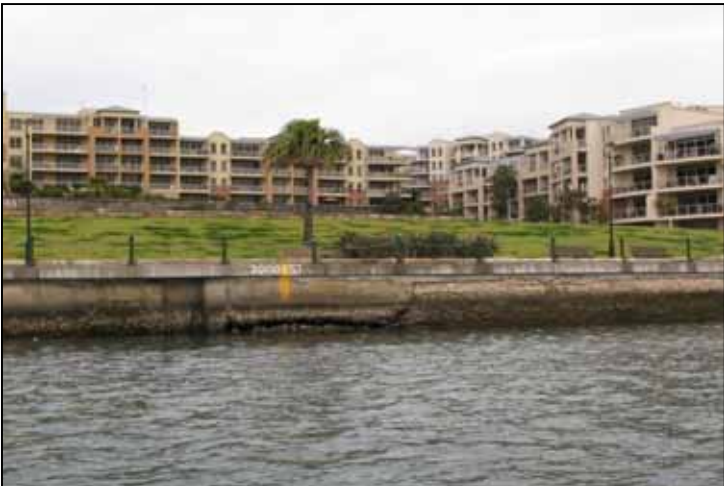
Photo 2

Undermining of seawall and concrete capping of wall face and crest.

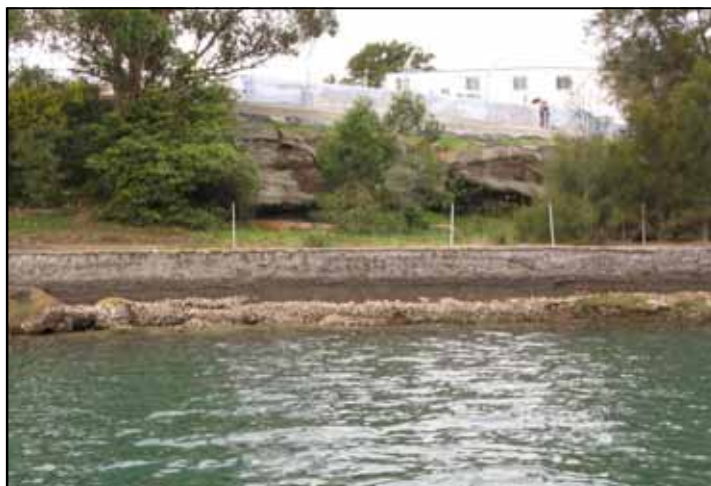
Photo 1

Concrete has been lost from the vertical face of the wall. The concrete is showing signs of severe surface weathering with aggregates visible. Major horizontal and vertical cracks are also present. The safety fence has significantly corroded and has collapsed in some places.

View of NE extent of wall showing weathering and cracking of concrete. No safety fence present.

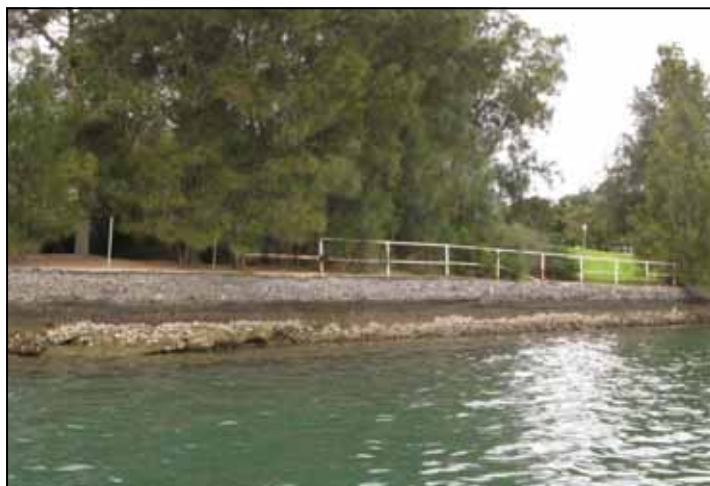
Photo 2

SW extent of seawall showing concrete cracking and failure of safety fence.

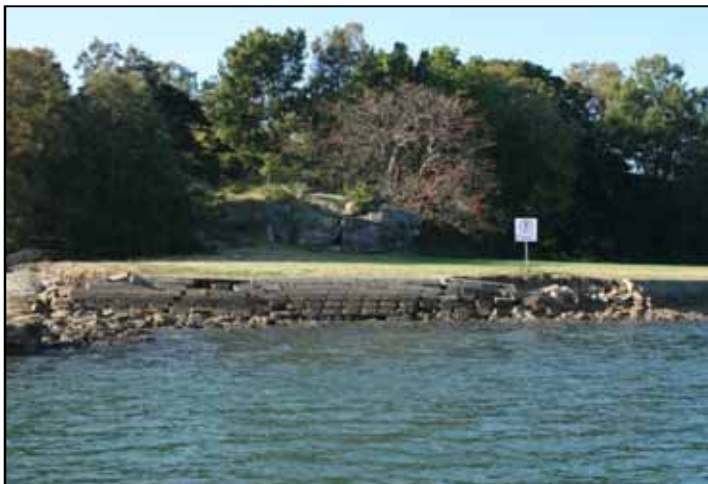
The structure has failed at its northern extent with a large cavity present behind the wall. The rest of the revetment is slumping and is undermined at the toe particularly at the southern extent.

Failure of revetment at northern extent.

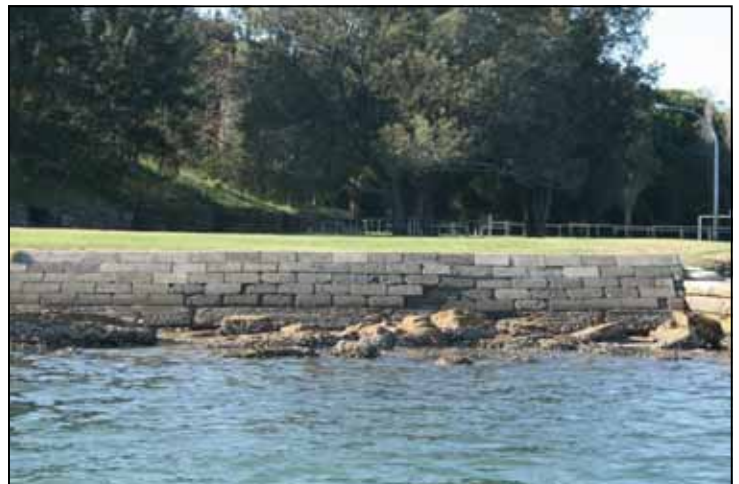
Photo 2

Slumping and movement of blocks at southern extent.

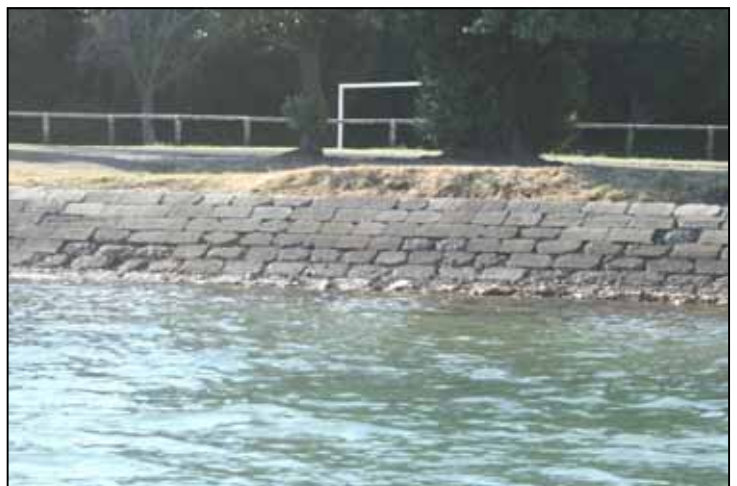
Photo 2

Surface weathering with aggregate exposed and slumping due to loss of fine material was observed. Sinkholes and erosion of earth behind structure was observed indicating inundation and/or exposure to wash during periods of elevated water levels.

Surface weathering and slumping of concrete blocks and erosion of earth beyond crest.

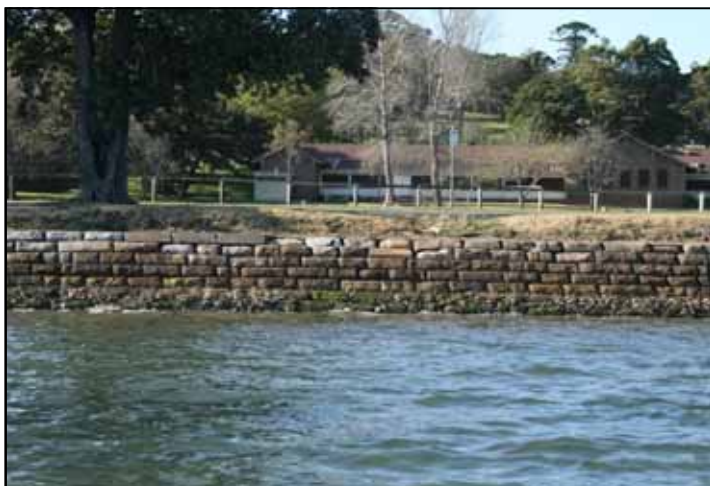
Photo 1

Typical view of revetment showing surface weathering, slumping and erosion of earth beyond crest.

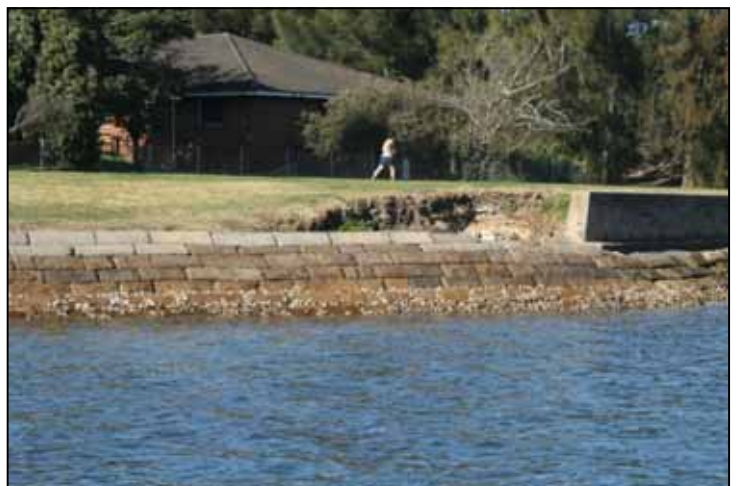
Photo 2

The revetment has failed at its southern extent where it joins LEI_S15 with a large cavity present behind the wall. Surface weathering of sandstone blocks & slumping due to loss of fine material was also observed. Sinkholes & erosion of earth behind structure indicates inundation and/or exposure to wash during periods of elevated water levels.

Failure of structure at southern extent.

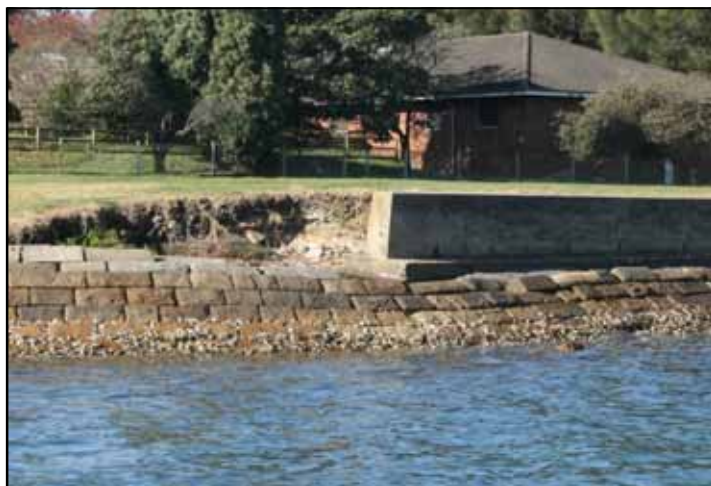
Photo 1

The structure has failed at its northern extent where it meets seawall LEI_S14. The rest of the structure, surface weathering of sandstone blocks & slumping due to loss of fine material was observed. The concrete retaining wall is leaning towards the water in some places with minor cracking observed.

Failure of structure at northern extent.

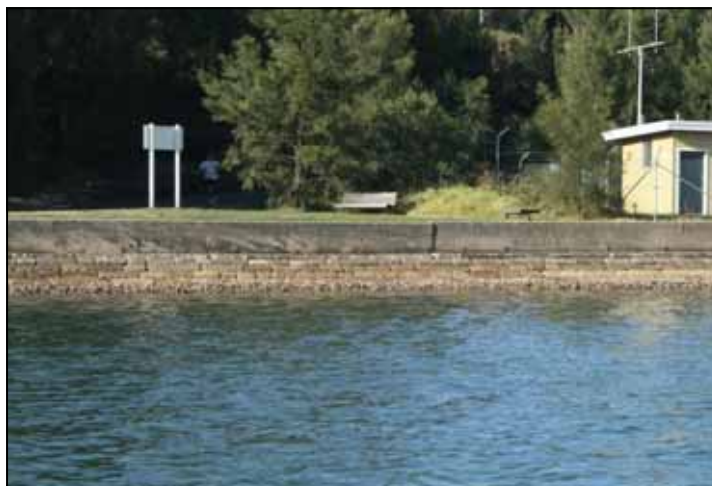
Photo 2

Typical view of structure showing weathering and slumping of sandstone blocks and leaning concrete retaining wall.

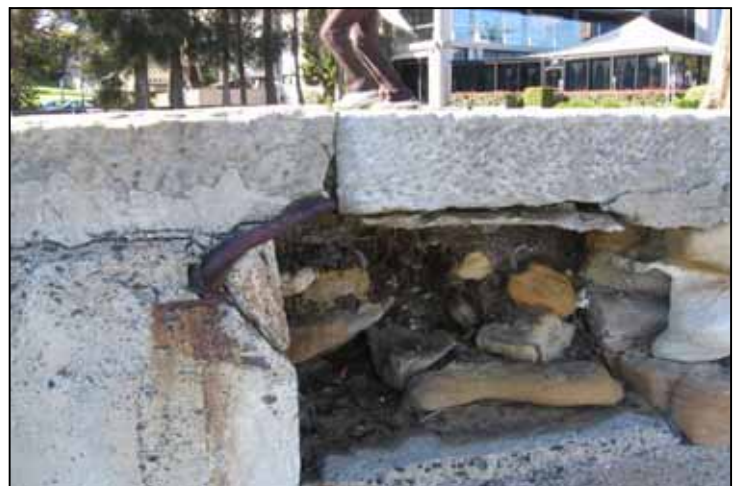
Photo 2

Loss of grout from both sloping and vertical sections. Block failures and sever undermining of adjacent footpath are also present. The newer vertical sandstone blocks have began to weather indicating that a low-grade sandstone may have been used. The old concrete footpath between the two sandstone section is cracking in many places.

Block failure of newer vertical sandstone wall beneath footpath.

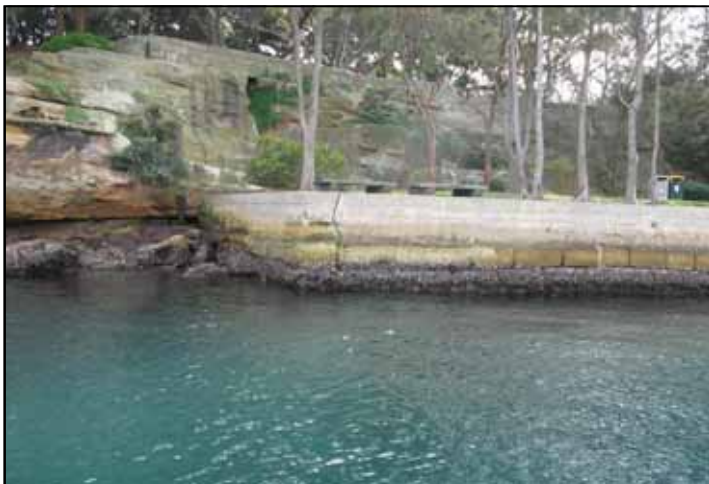
Photo 1

Large crack at SW corner extending from crest to toe. Large sinkhole behind seawall crest at NE corner.
Surface weathering of sandstone blocks and concrete capping with aggregate exposed also observed.

Block failure at SW corner

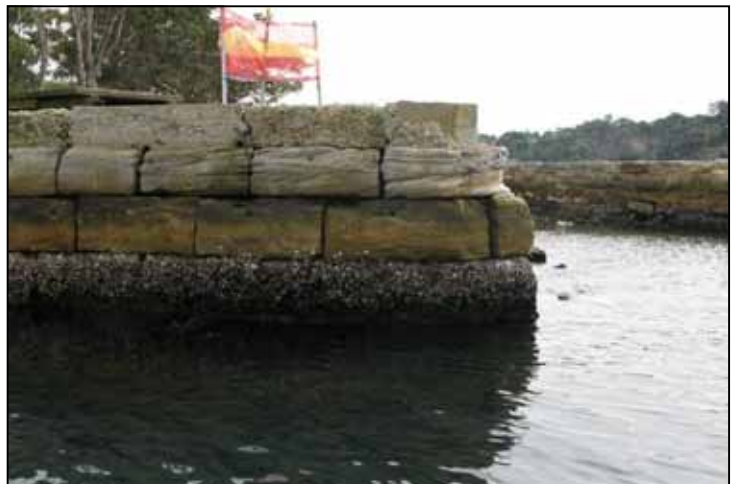
Photo 2

NE corner, temporary safety fence installed beyond crest to prevent public access to sinkhole.

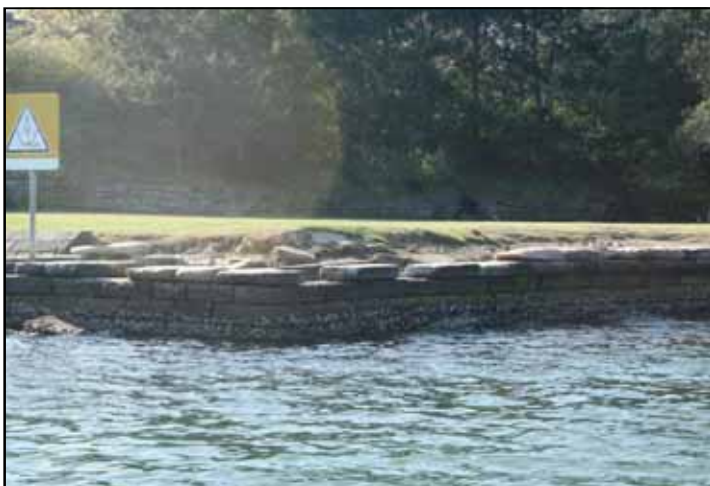
The structure has failed at its northern and southern extents with the blocks that make up the crest dislodged and erosion of material from behind. The rest of the revetment is slumping and is undermined at the toe.

Failure of seawall at northern extent.

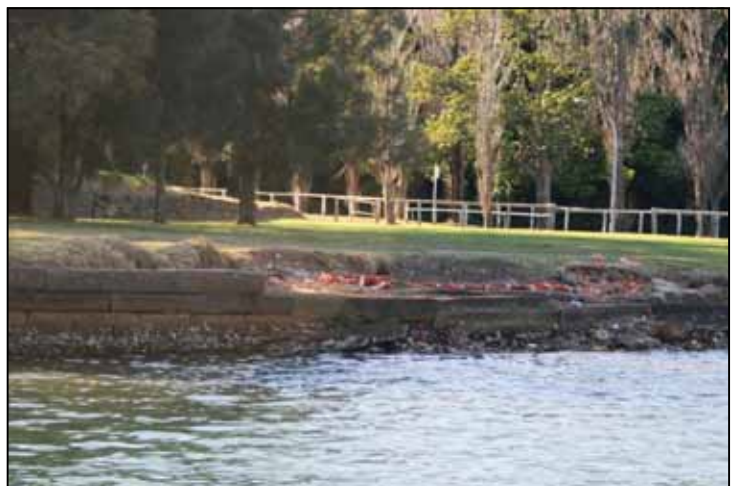
Photo 2

Failure of seawall at southern extent.

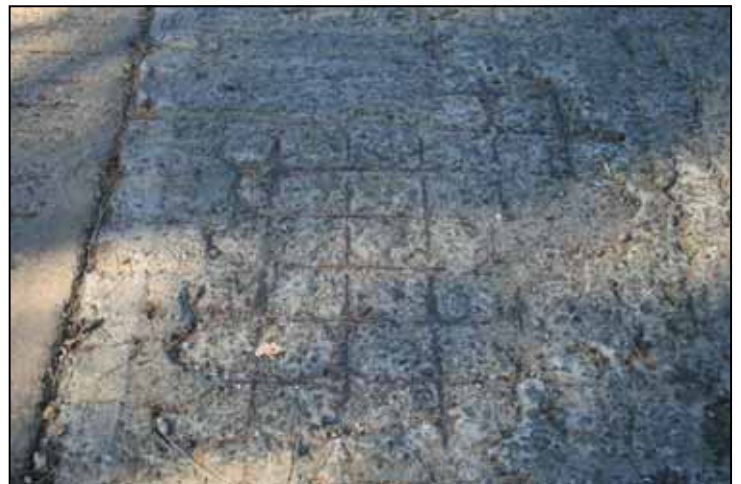
Photo 2

Concrete that forms ramp is cracked and weathered with aggregates and steel reinforcement exposed.

Weathering of concrete with aggregate and reinforcement exposed.

Asset Name	Recommendation	Priority
LEI_F10	Concrete that forms ramp is cracked and weathered with aggregates and steel reinforcement exposed. The boat ramp requires modification to extend the toe beyond low tide level. If this does not occur it is recommended that the boat ramp be decommissioned.	1
LEI_F01	Stairs on land have collapsed and require replacement. It is recommended that a more detailed investigation be undertaken to determine the extent of deterioration of the timber components that form the structure.	2
LEI_F02	Sea stairs are fouled making access to the water difficult. Access should be formalised or restricted to ameliorate the hazard observed. Provision of formalised dinghy storage is also recommended.	3
LEI_F03	Formal dinghy storage is provided however some dinghies are informally tethered at the site. It is recommended that dinghies are either relocated and ad-hoc structures removed or formal dinghy storage and launching facilities are installed.	4

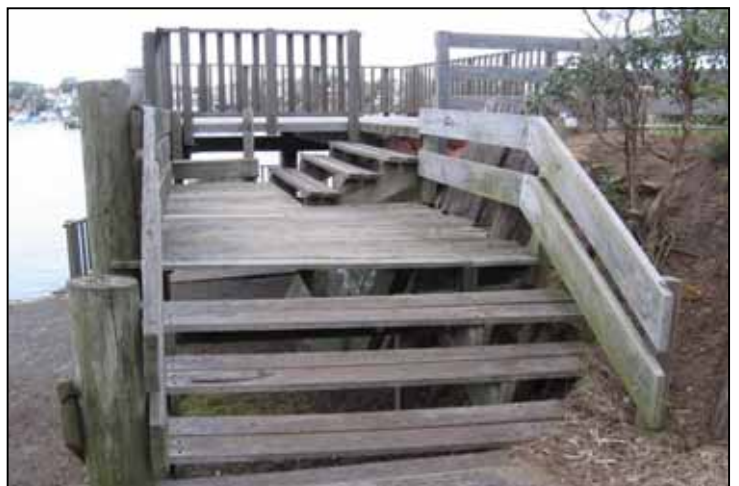
Photo 2

Stairs on land have collapsed and require replacement. The rest of the structure including timber piles is in a good condition

Collapsed stairs are a hazard for pedestrians. Structure is supported by vertical sandstone seawall (LEI_S01).

Collapsed stairs.

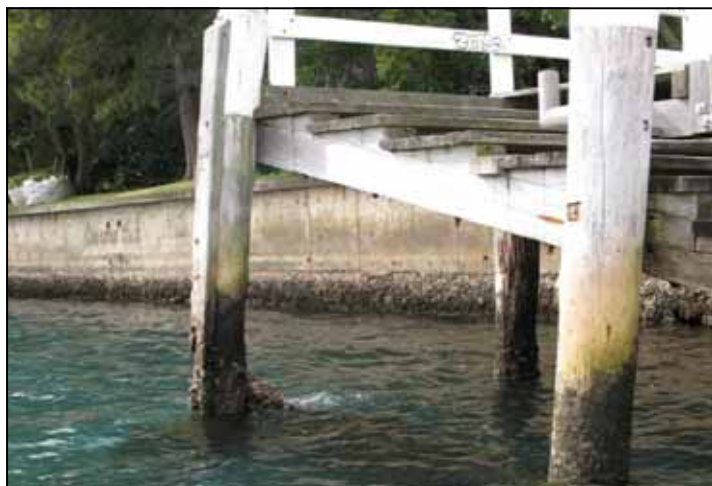
Photo 2

Generally good. Timber piles are thinning and are off vertical. Grout is missing from blocks beneath wharf and are slumping. Sandstone has also weathered creating voids. Some maintenance has been carried out to the south of the wharf with sandstone blocks replaced and grout added. Concrete section to the north is in good condition.

Timber sea stairs and pile. Vertical concrete seawall is also shown in background

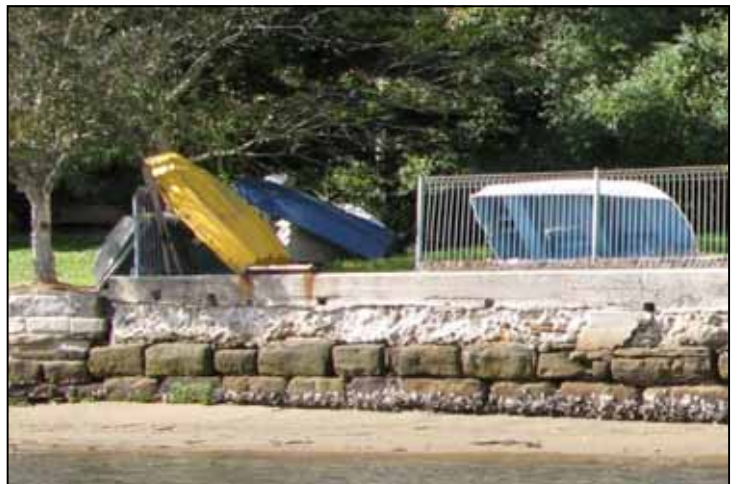
Photo 2

Dinghies tethered to steel fence.

LEI_F06	Formalised dinghy storage and water access required	5
LEI_F07	Formalised dinghy storage required	6

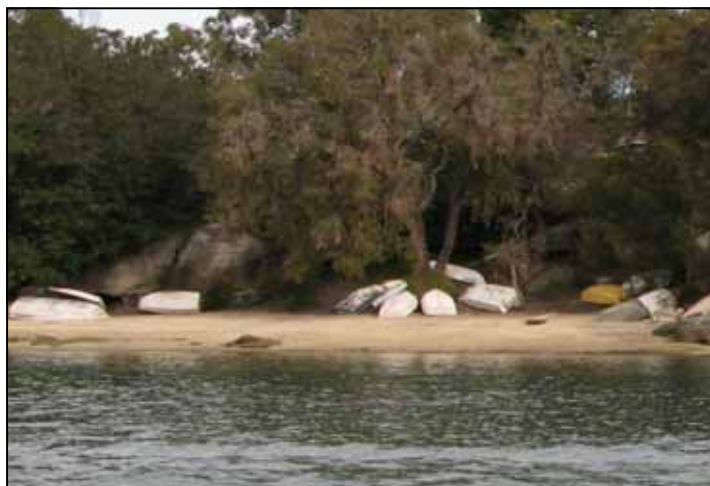
Photo 2

Dinghies tethered to trees on shoreline.
