Ashfield LGA

9.3 Ashfield LGA

Seawall Inspection Record - ASH_S03

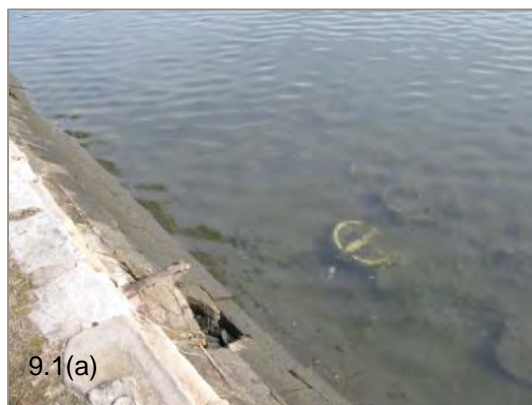
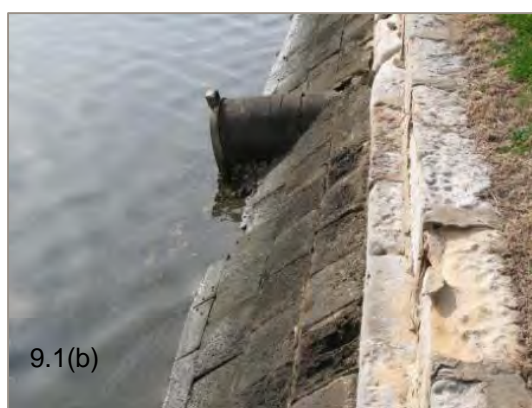
Forty seven stormwater outlets were identified which discharge directly to Hawthorne Canal, Dobroyd Canal, Iron Cove Bay or the river. The sub-catchments which drain to at least six of these outlets should be investigated to determine whether gross pollution control is required. Three outlets are located in Dobroyd Canal (Dobroyd_Canal_005; Dobroyd_Canal_010; and Dobroyd_Canal_013) and three in Hawthorne Canal (Hawthorne_Canal_015; Hawthorne_Canal_022; Hawthorne_Canal_029). Two stormwater outlets in Iron Cove Bay require maintenance repairs (Iron_Cove_040 and Iron_Cove_041). All stormwater outlets are illustrated in Figure 9-2.

- Ashfield Council in conjunction with Sydney Water, Leichhardt and City of Canada Bay Councils should undertake a critical review of existing stormwater management practices to determine:
 - The efficacy of maintenance regimes of existing GPTs, and
 - Where additional gross pollutant trapping is required. This should include a review of current street sweeping activities in catchment areas draining to Iron Cove Bay – given that the dominant gross pollutant evident is leaf litter (refer Section 7.4.5.1).
- Update existing stormwater drainage GIS layer to include stormwater outlets located in seawall sections ASH_S02 and S03; and
- Repair stormwater outlets located in seawall section ASH_S03 (photos: 9.1(a) and (b)).

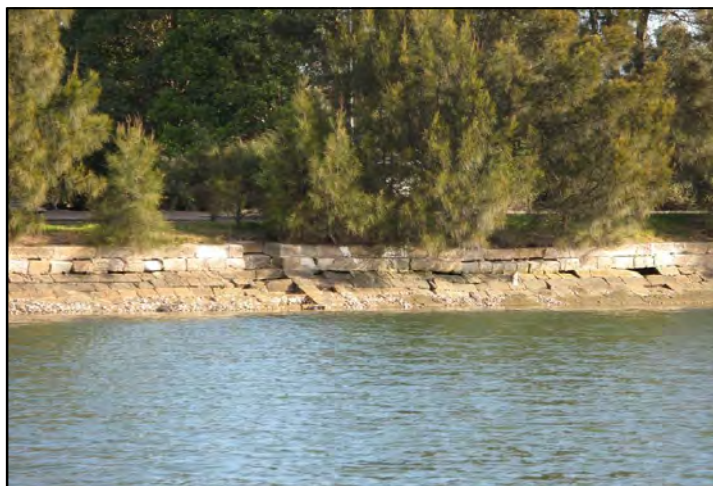
Photo 1

Sandstone seawall is missing grout, slumping and showing signs of weathering on both the sloping and vertical sections. Numerous local block failures were observed. Sea stairs are in good condition, cracking of the stormwater outlets was observed.

Typical view of revetment with block failures, slumping, weathering and loss of grout evident.

- Continue to monitor ASH_S03 for any decrease in structural stability – data collected for all seawalls including referenced site photographs are provided in the project GIS database and should be used as a reference benchmark for ongoing monitoring;
- Eventual repair and / or replacement to include intertidal habitat function such as artificial reef habitat.

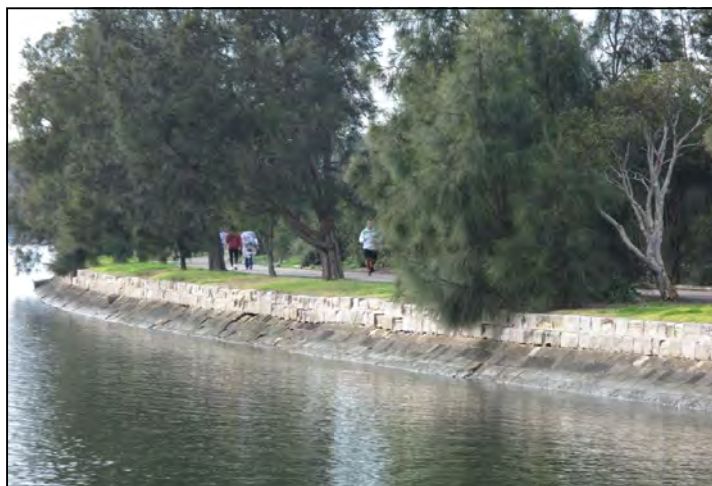
Photo 2

SW section of revetment showing weathering and slumping of sandstone blocks.

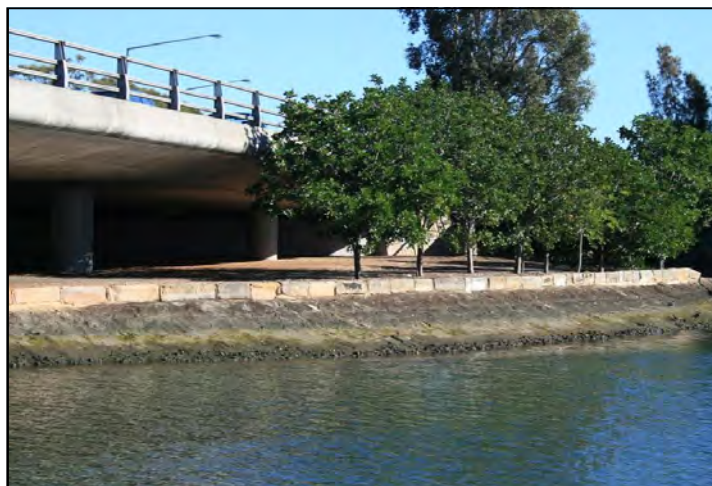
Photo 1

Generally good condition. Shotcrete is showing signs of weathering. Minor weathering and loss of grout of new sandstone blocks at crest.

Typical section of revetment.

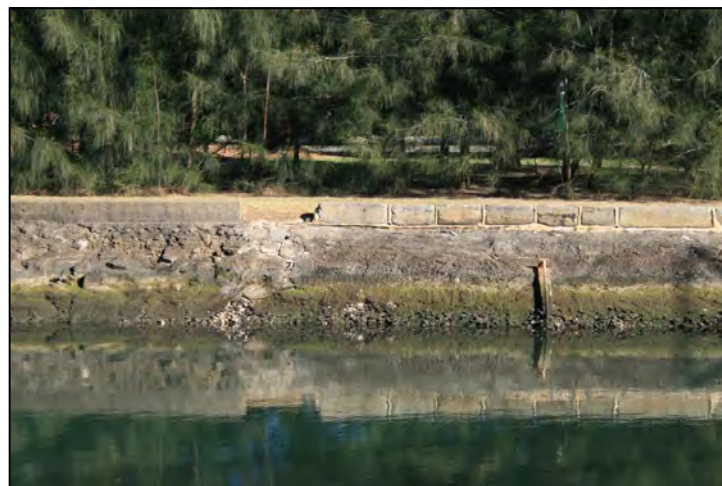
Photo 2

Transition of revetment into Hawthorne Canal.

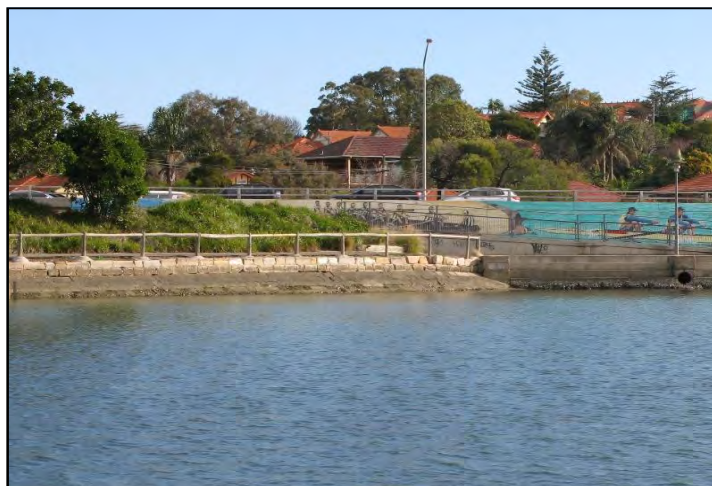
Photo 1

Sandstone seawall is missing grout, slumping and showing signs of weathering on both the sloping and vertical sections. Both sets of sea stairs are in good condition.

Sloping and vertical sandstone blocks and concrete sea stairs sections of the seawall.

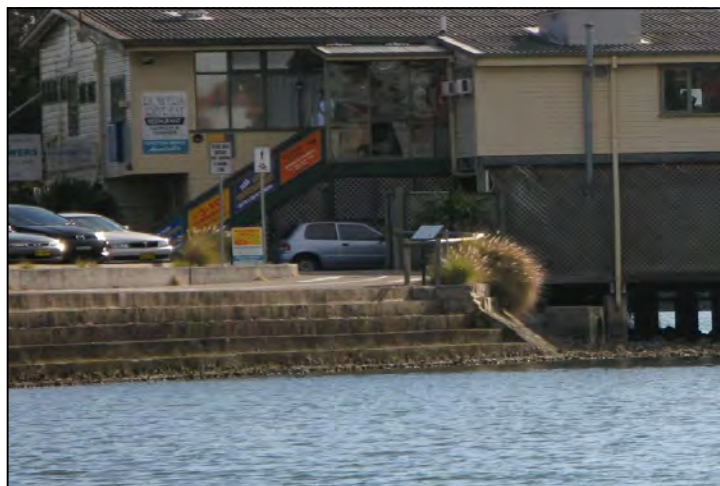
Photo 2

Sandstone sea stairs adjacent to the UTS Rowing Club house.
