City of Canada Bay LGA

9.4 City of Canada Bay

The City of Canada Bay LGA contains 16.2 km of seawalls of which 75 discrete sections of seawall were assessed (Table 9-15). Assessment details and management recommendations for high priority seawall sections are provided in Table 9-15 and Appendix 3.

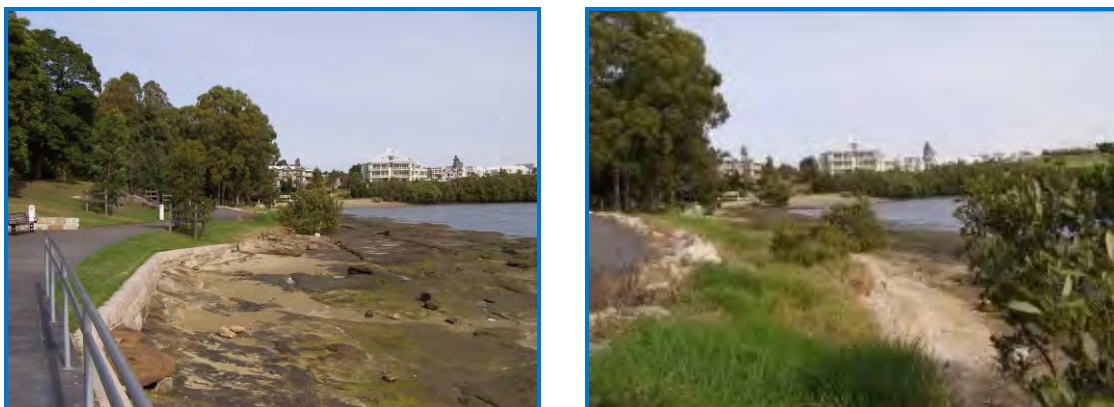
Above (left and right): Terrestrial weed control required in saltmarsh adjacent pathway

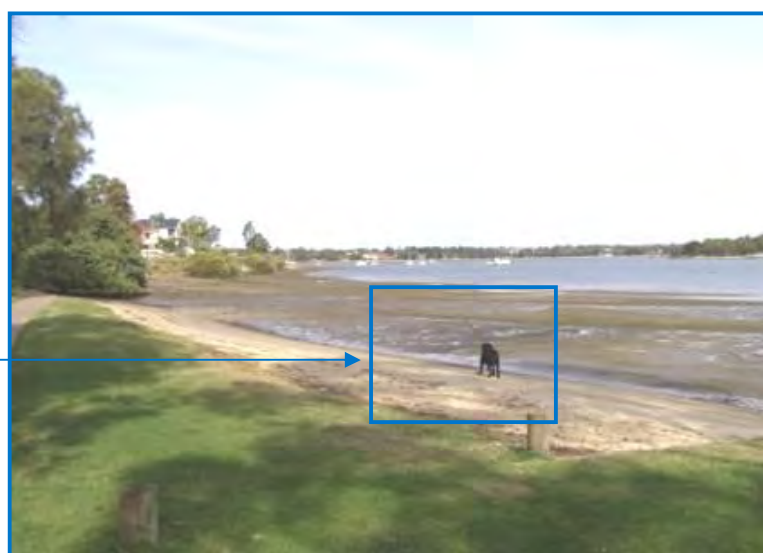
Unaccompanied and unleashed dog eyeing off wader birds foraging on mudflat (Hen & Chicken Bay)

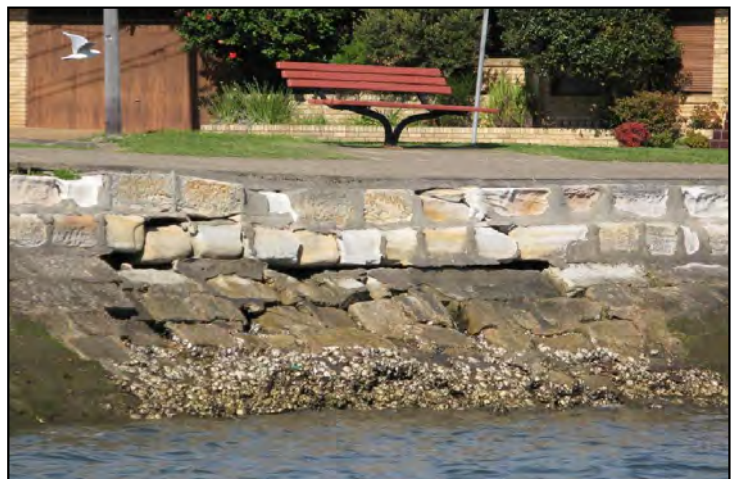
Photo 2

Failure of revetment beneath public footpath.

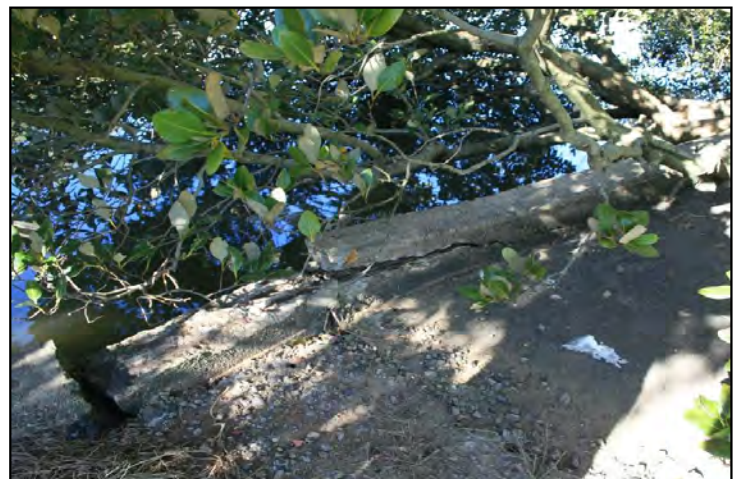
Photo 2

Failure at northern extent of structure.

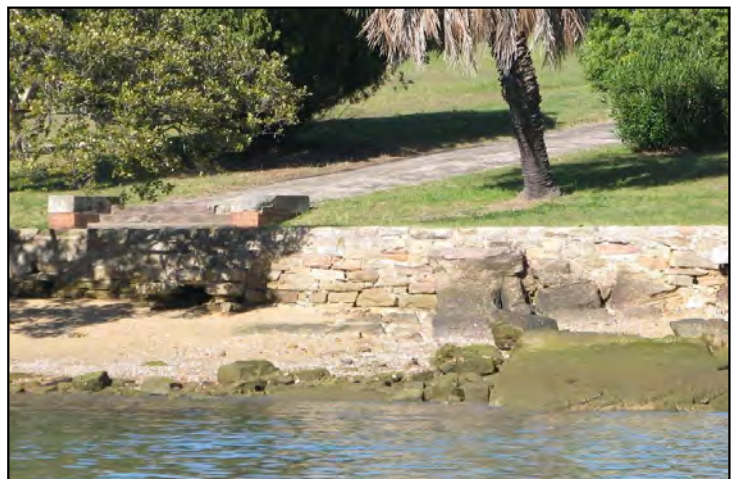
Photo 2

Grout missing from lower blocks of wall.

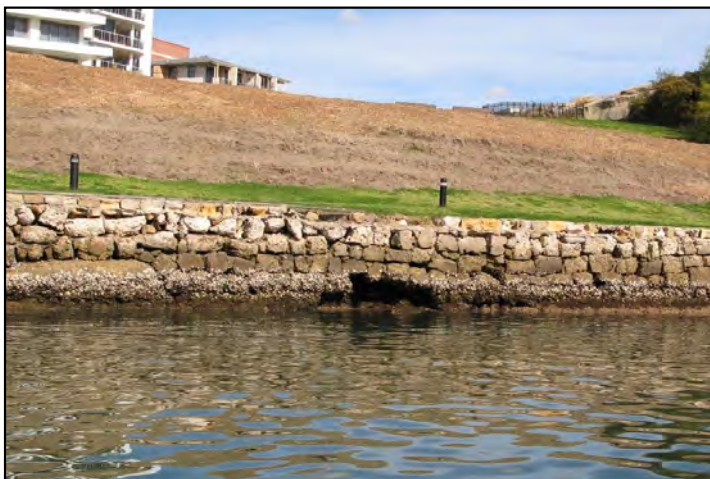
Photo 1

Typical view of wall showing block failure at toe, absence of grout, voids and weathering of blocks

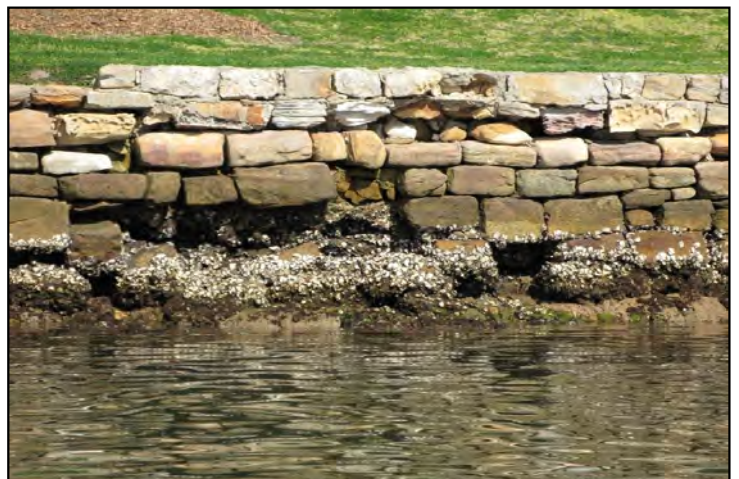
Photo 2

Block failure at toe beneath footpath.

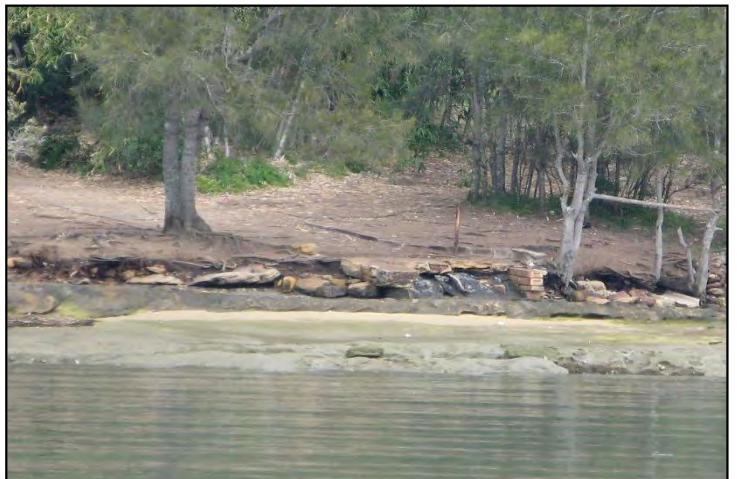
Photo 2

Erosion scarp at northern extent of wall where blocks are missing.

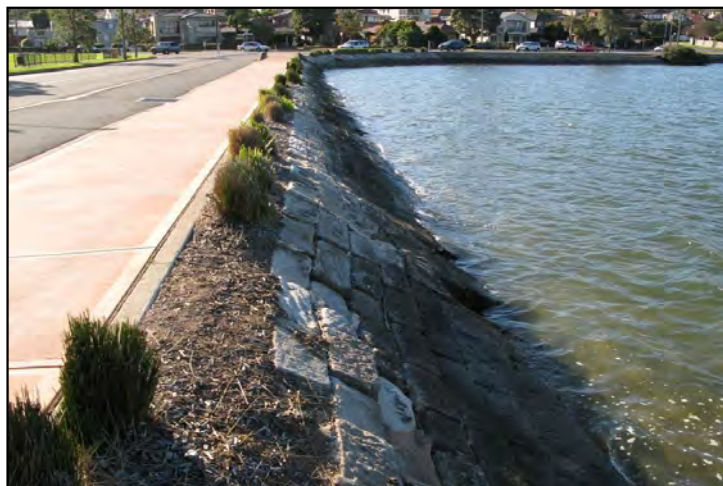
Photo 1

Typical section revetment showing slumping and loss of grout from blocks.

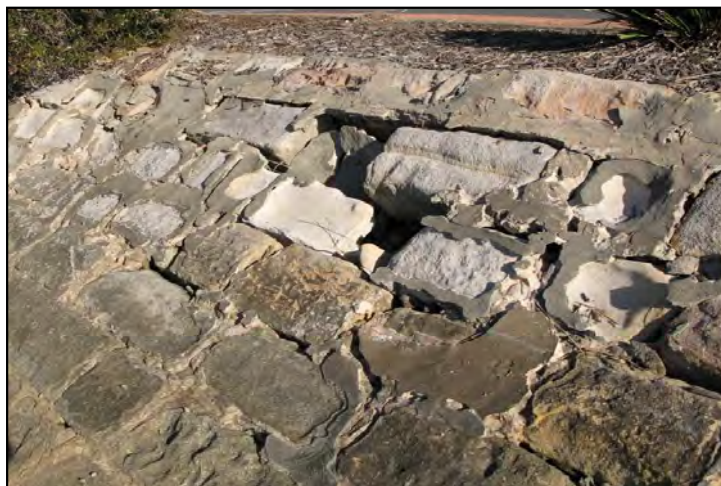
Photo 2

Block failure of wall due to loss of material from behind.

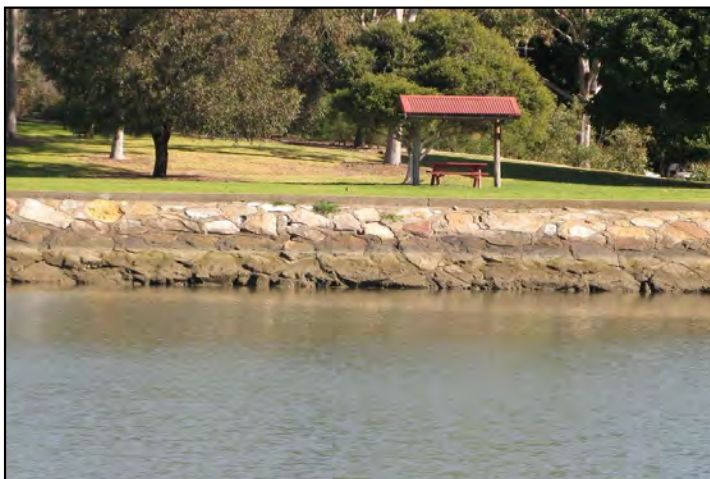
Photo 1

Typical section of revetment showing minor weathering of blocks and loss of grout.

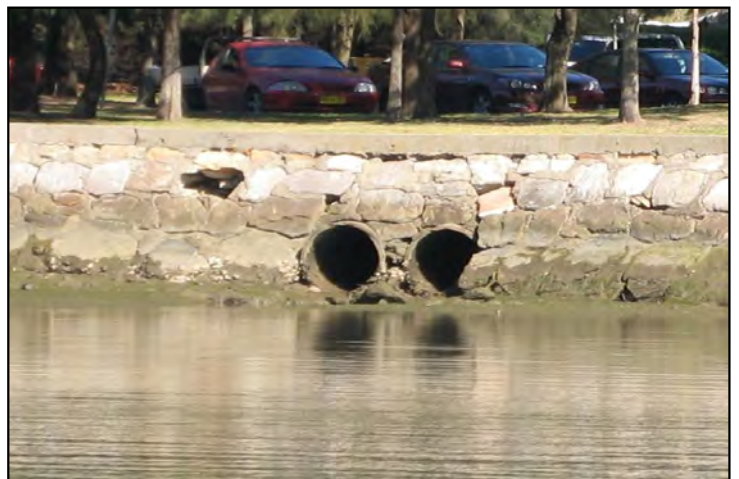
Photo 2

Failure and loss of grout adjacent to storm water outlet.

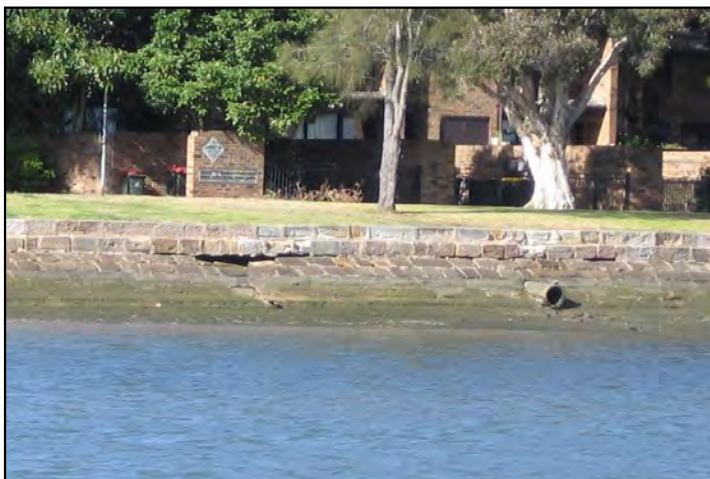
Photo 1

Typical section of revetment showing failure and weathering of blocks.

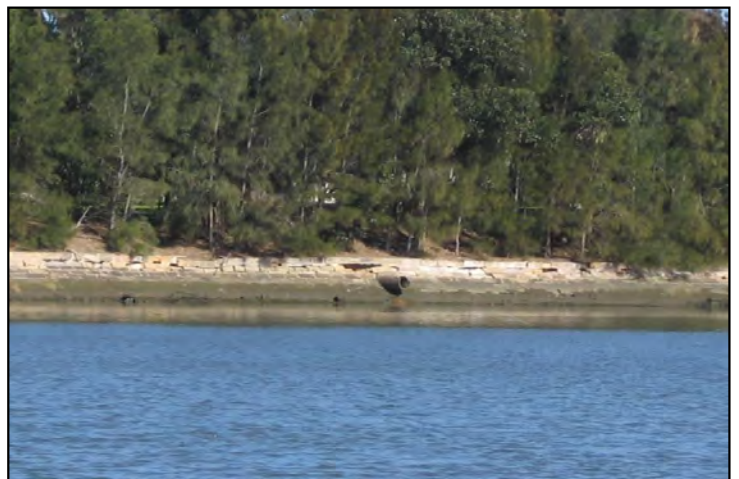
Photo 2

Western section of revetment showing failure, weathering of blocks and Casuarina stand atop crest.

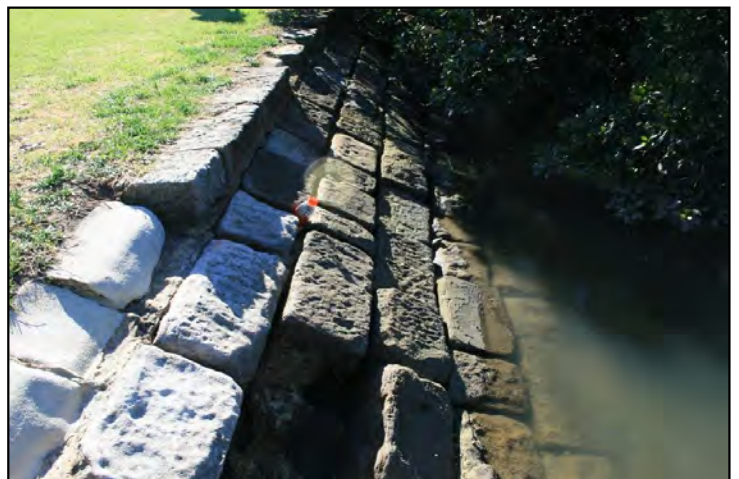
Photo 2

Block failure on structure slope.

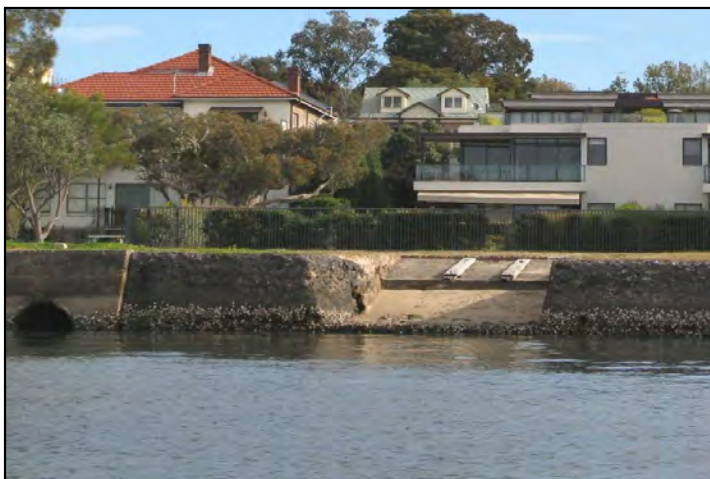
Photo 1

Typical view of seawall showing old boat ramp and storm water outlet.

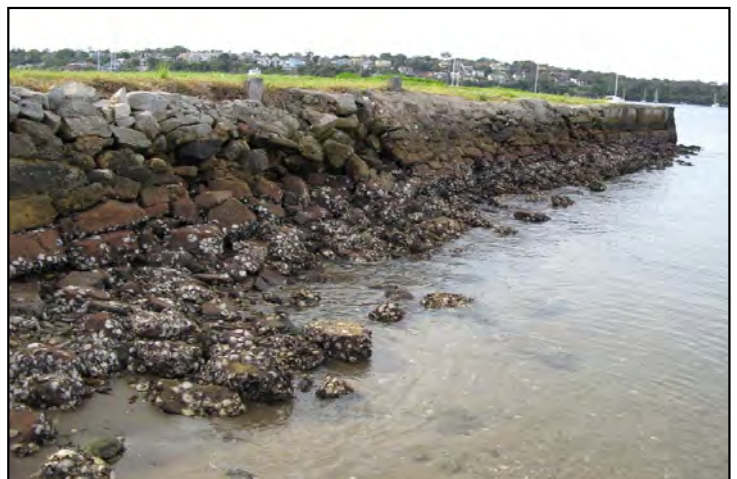
Photo 2

Sandstone block section of seawall showing failure.

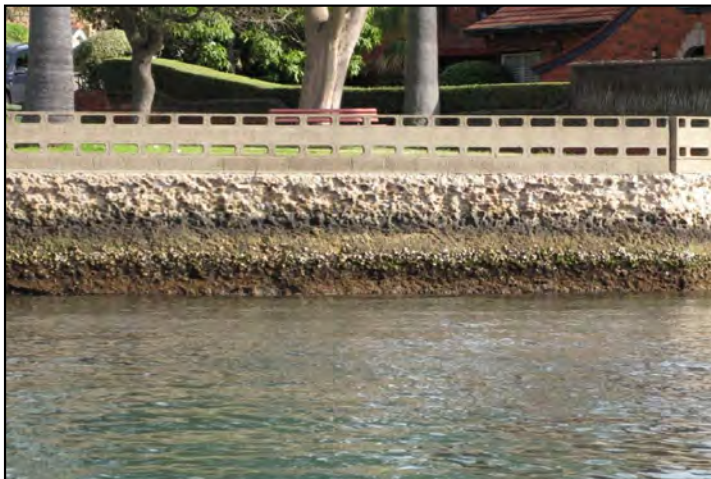
Photo 1

Typical section of seawall showing extent of concrete weathering.

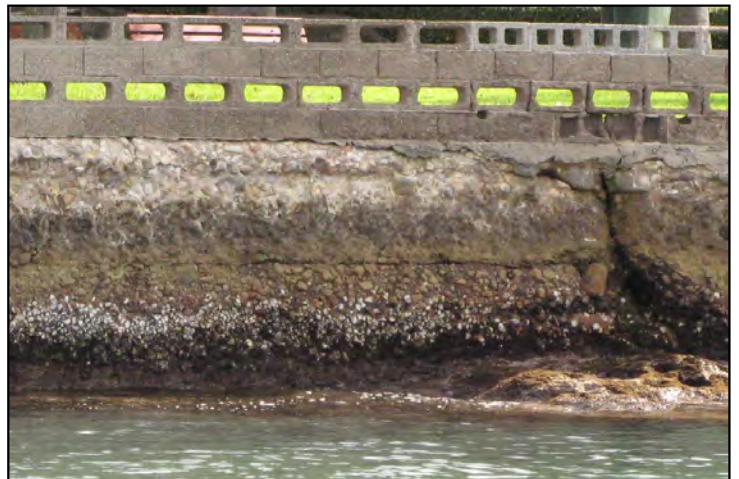
Photo 2

Cracking of concrete and mortar connecting cinder blocks to wall crest.

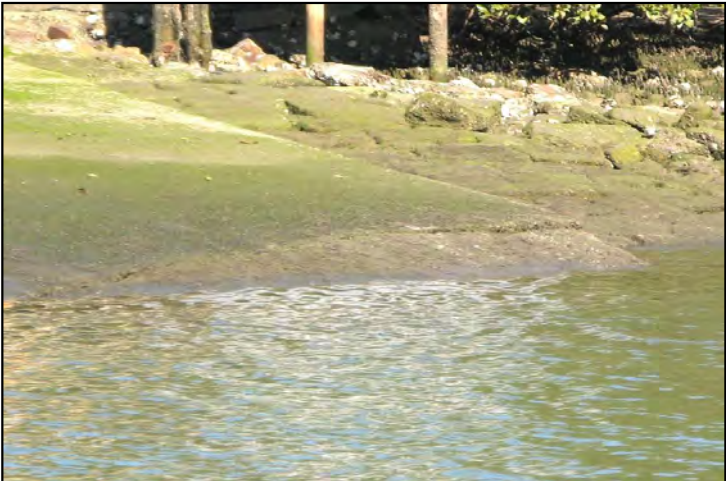
Asset Name	Description
CAN_F28	Concrete, single lane boat ramp and nearby informal trailer parking is available. Small sandstone block seawalls are located on either side of the boat ramp. The concrete has cracked and failed at the western corner of the ramp. The rest of the ramp is in good condition with minor weathering and fouling observed.
CAN_F10	<p>Informal dinghy storage along sandy/rocky shoreline with vessels tethered to connections in cliff. No formal storage structure present. Vessels are tethered to cliff and are resting on tyres. Vessels are launched/retrieved via adjacent sandy/rocky shoreline. This would be difficult at high tide.</p> <p>It is recommended that dinghies are either relocated or formal dinghy storage and launching facilities are installed.</p>

Photo 2
Failure at western corner of boat ramp.
