# Sydney Olympic Park

## 9.6 Sydney Olympic Park

# Seawall Inspection Record

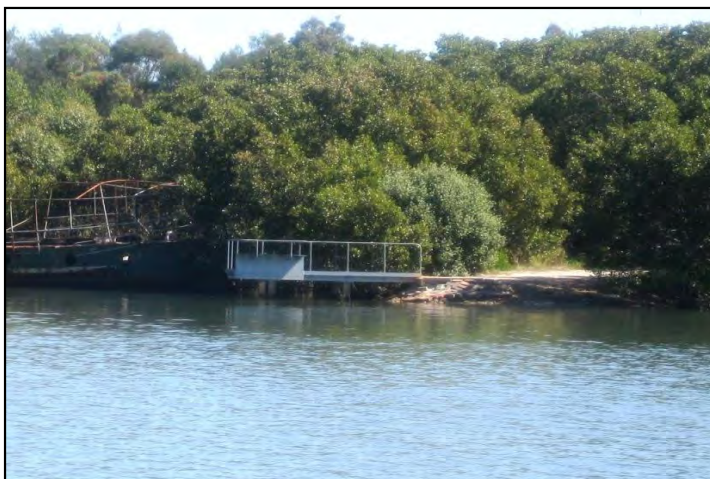
Photo 1

View of concrete block revetment and lookout structure.

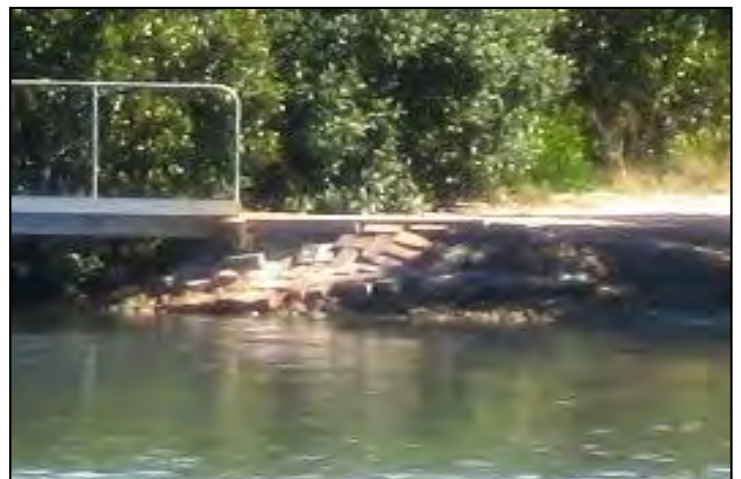
Photo 2

Blocks that form the revetment have collapsed due to a loss of fine sediments.

Collapse of blocks that form revetment.

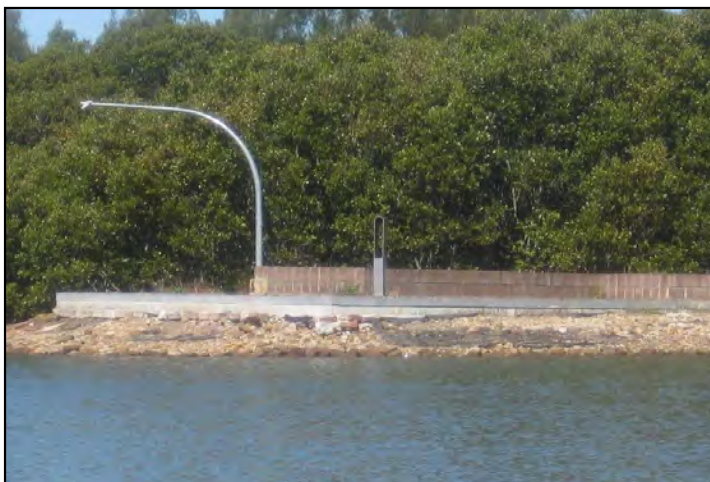
Photo 1

View of revetment and lookout structure.

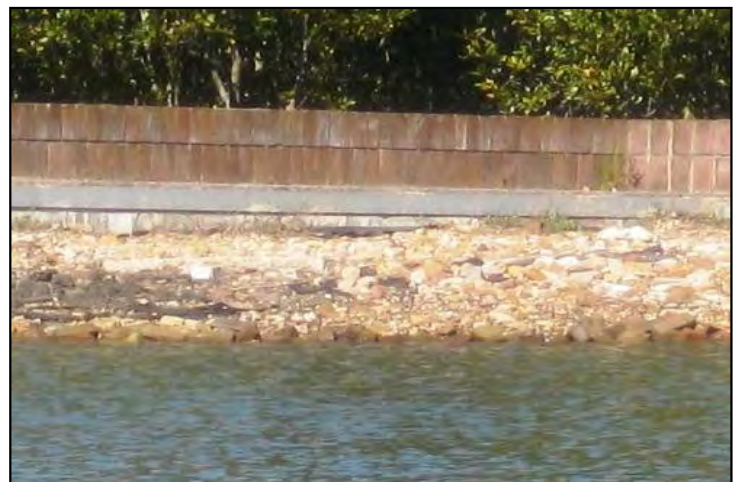
Photo 2

Blocks that form the revetment have collapsed and soil beneath is exposed. The concrete slab has been undermined.

Failure of blocks exposing soil and undermining concrete slab on crest.

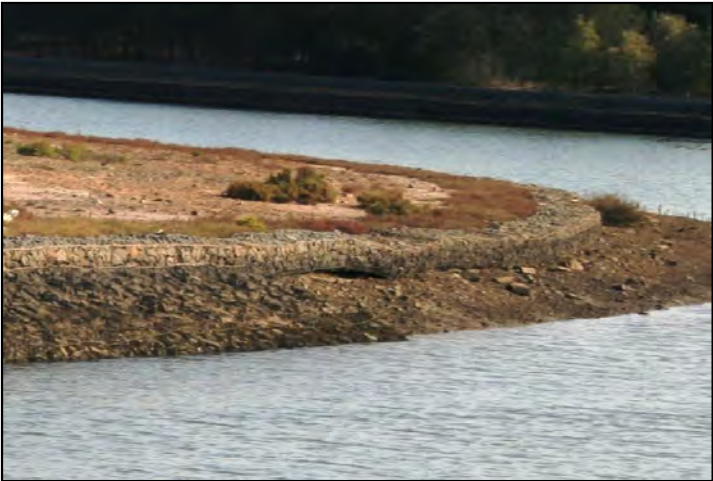
Condition Assessment:  
Where the gabion matt is not present, the slope is eroding and the gabion basket crest has been undermined.

Photo 1  
View of structure with erosion of slope and undermining of crest shown.

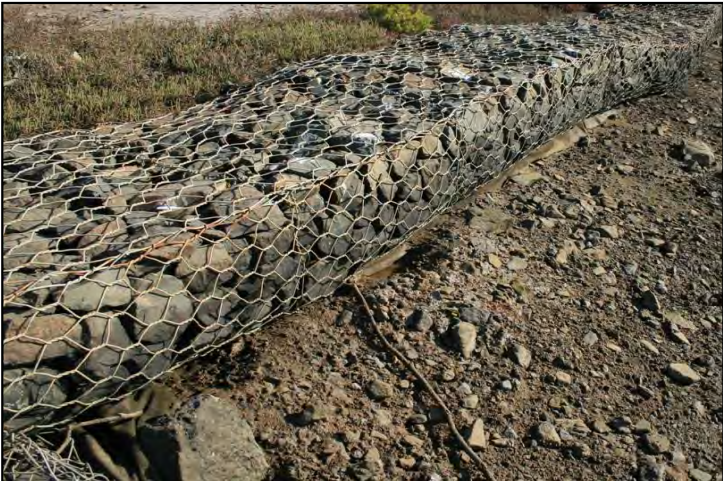
Photo 2  
Undermining of crest.

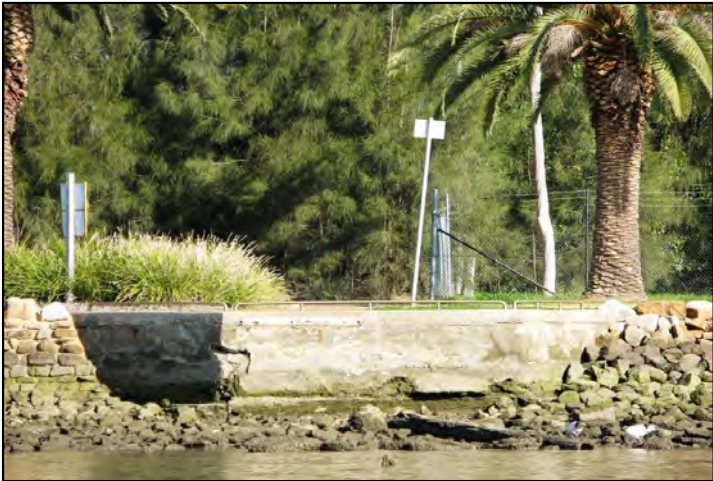
Photo 1

View of facility.

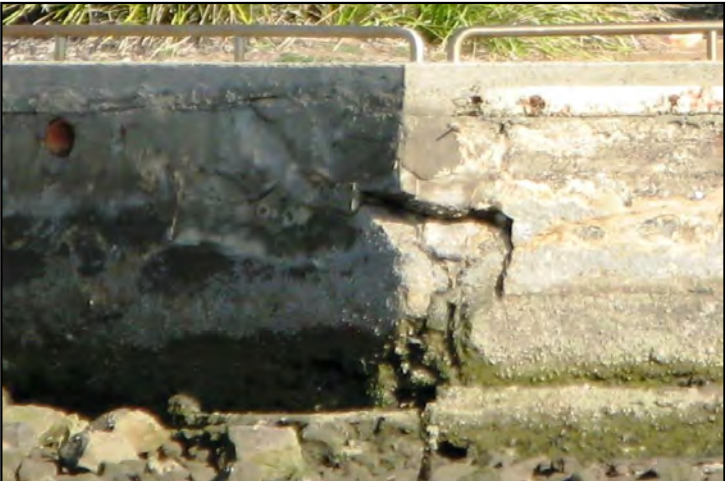
Photo 2

Surface weathering and cracking was observed.

Cracking and weathering of concrete.

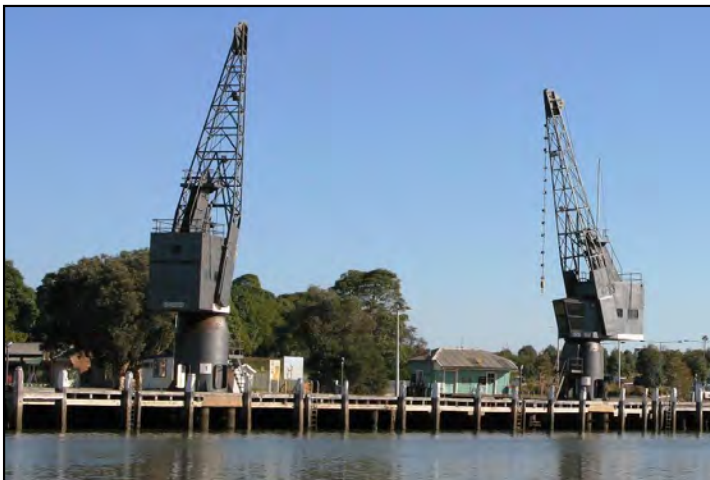
## Photo 1

Timber piles, decking and beams are showing signs of deterioration. The concrete slabs and steel piles that support the crane are corroding.

View of facility.

It is recommended that a more detailed investigation be undertaken to determine the extent of deterioration of the timber piles. The defects in the decking noted should be replaced and public access reinstated.

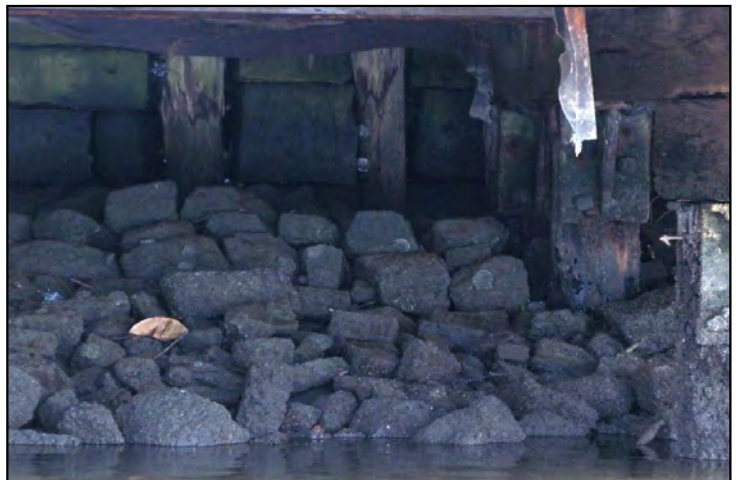
## Photo 2

Timber piles, sandstone block seawall and rubble revetment beneath structure deck.
