Auburn LGA

9.7 Auburn

Appendix 6: Field Assessment Sheets for Priority Sites

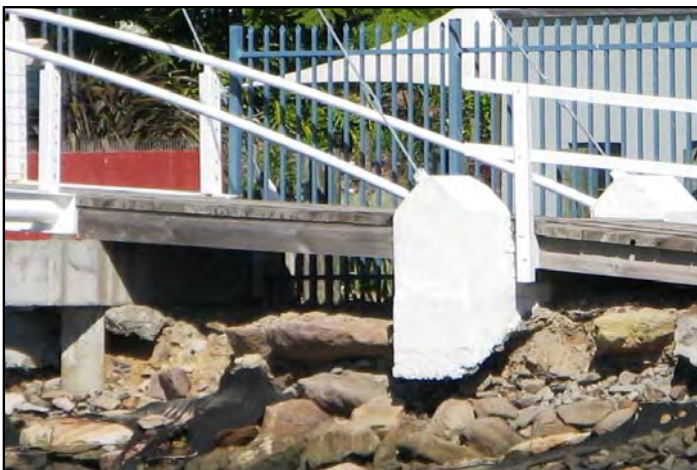
Photo 1

Material has been lost from slope exposing soil/fill beneath. It appears a support of the footbridge has been undermined.

Apparent undermining of footbridge support.

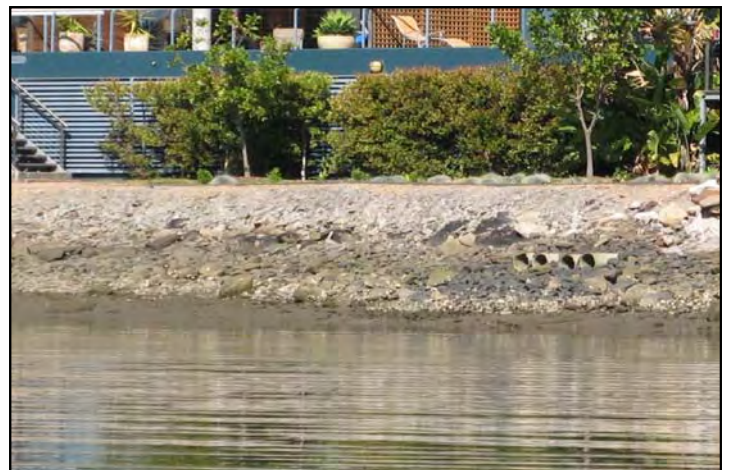
Photo 2

Loss of material from slope at eastern extent of revetment exposing soil/fill beneath

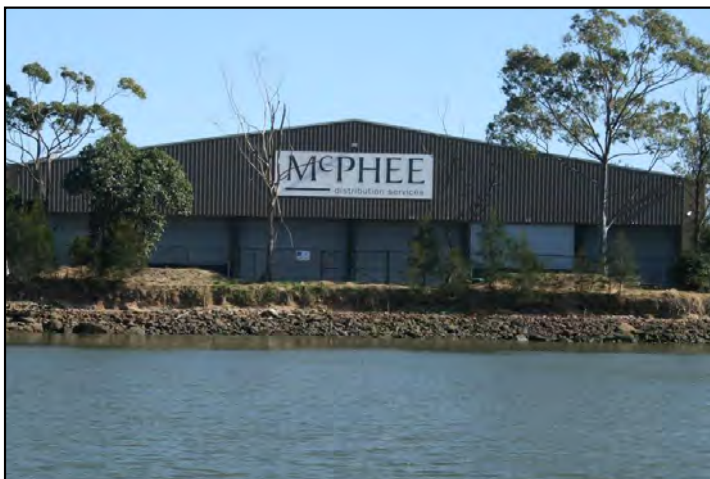
Photo 1

Typical section of revetment.

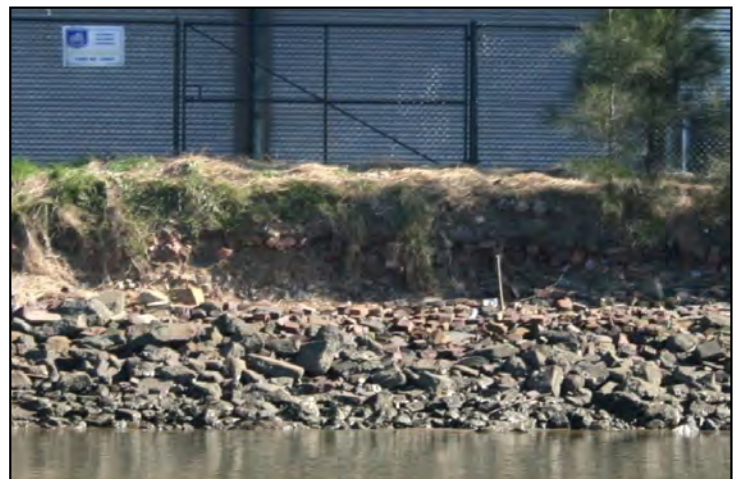
Photo 2

The rubble that forms the revetment has become dislodged and is strewn across the toe. There is also a large erosion scarp behind the structure indicating inundation during periods of elevated water levels.

Loss of rubble material and large erosion scarp at the crest.

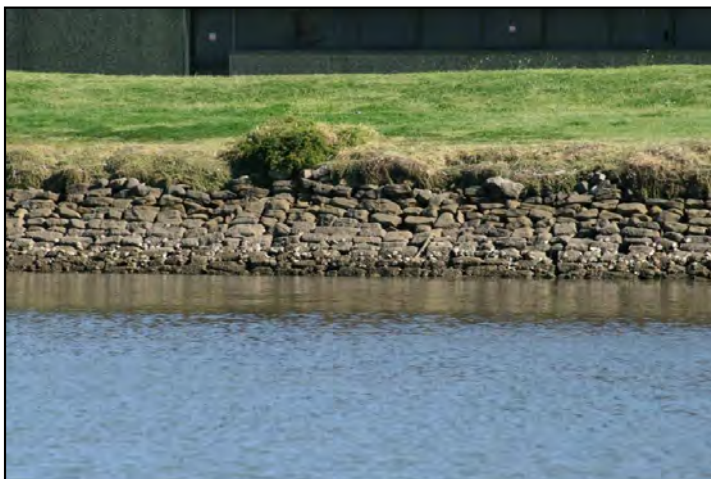
Photo 1

Typical section of revetment.

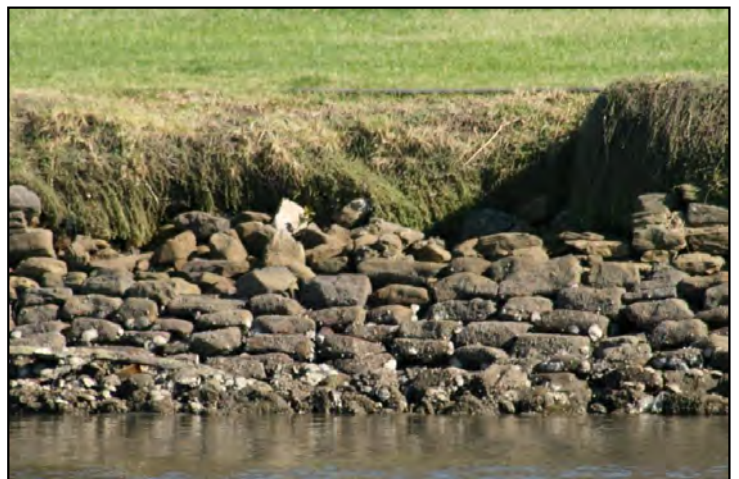
Photo 2

The blocks that forms the revetment are slumping and have become dislodged due to a loss of fine material from behind. There is also a large erosion scarp behind the structure indicating inundation during periods of elevated water levels.

Slumping of revetment and erosion of bank behind.

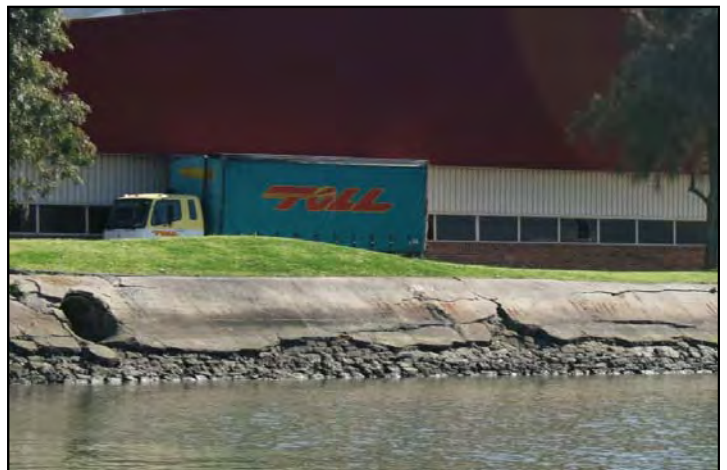
Photo 2

The concrete capping has cracked and failed along the lower section of the wall. The older blocks that forms the revetment are slumping.

Cracked and failed concrete capping with older sandstone block revetment visible.

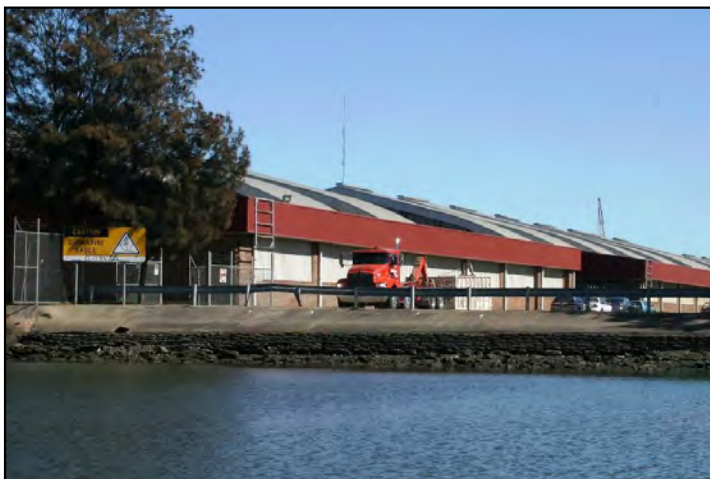
Photo 1

Typical section of revetment.

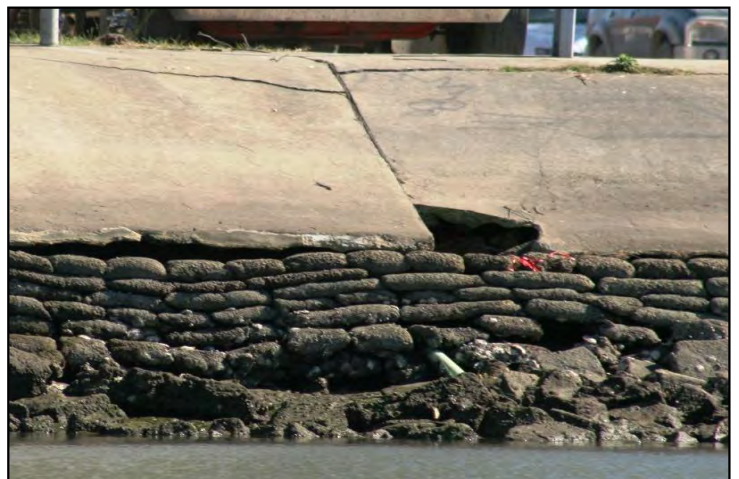
Photo 2

The sloping concrete crest has cracked and failed in places with large voids observed. The blocks that form the toe of the structure are slumping.

Cracked and failed concrete crest with voids present and slumping of concrete blocks.

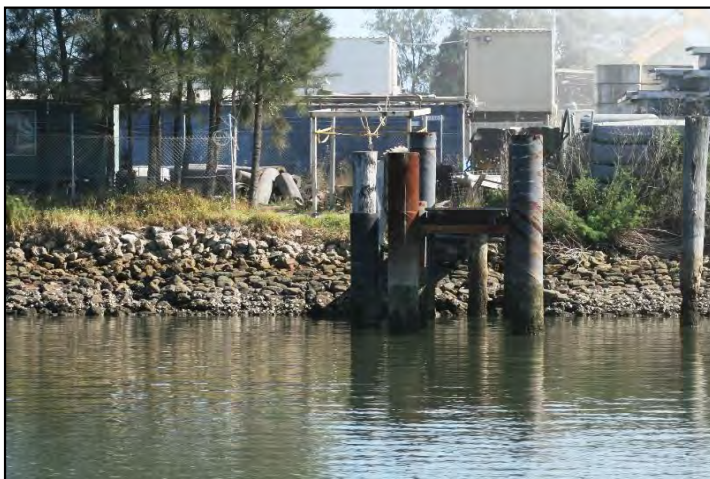
Photo 1

Typical section of revetment with abandoned facility shown.

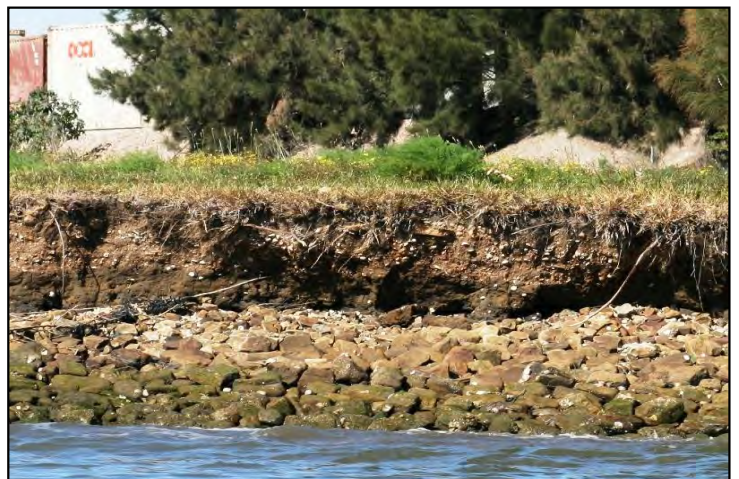
Photo 2

The revetment has failed with material lost from the crest and strewn across the muddy flat in front. A large erosion scarp is present at the crest which increases on the Parramatta River side where it is exposed to ferry wash.

Erosion scarp where material has been lost due to exposure to ferry wash.

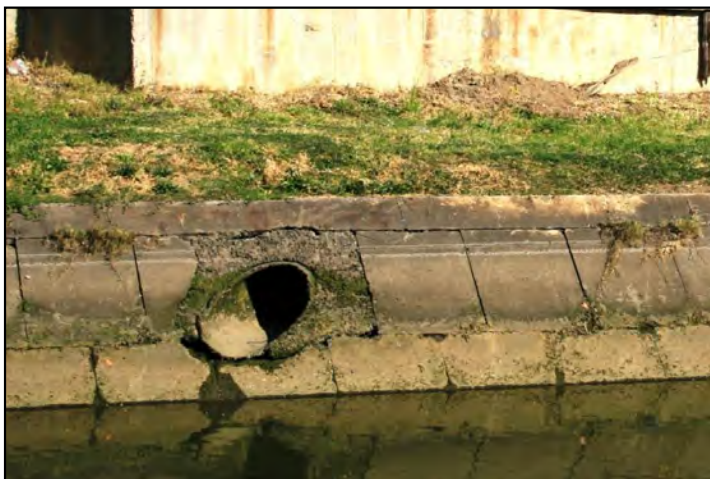
Cracking between concrete panels.

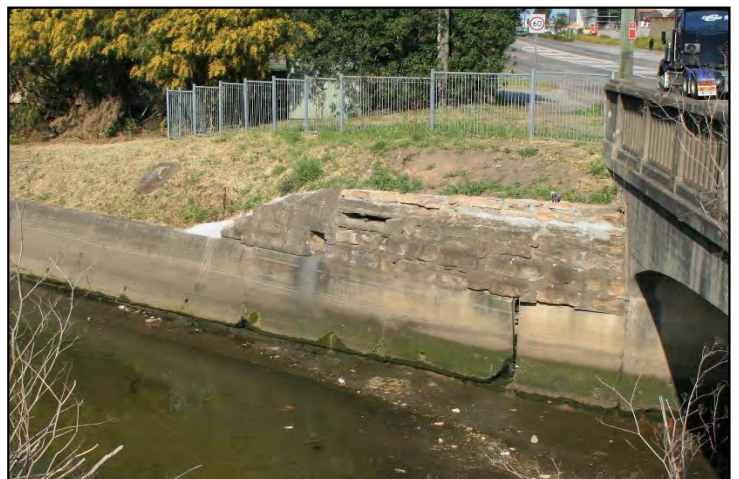
Photo 2

Minor cracking and weathering of concrete observed. Cracks are particularly evident between concrete panels.
The wall is cracking beneath the eastern abutment of Parramatta Road.

Cracks beneath eastern abutment of Parramatta Road.

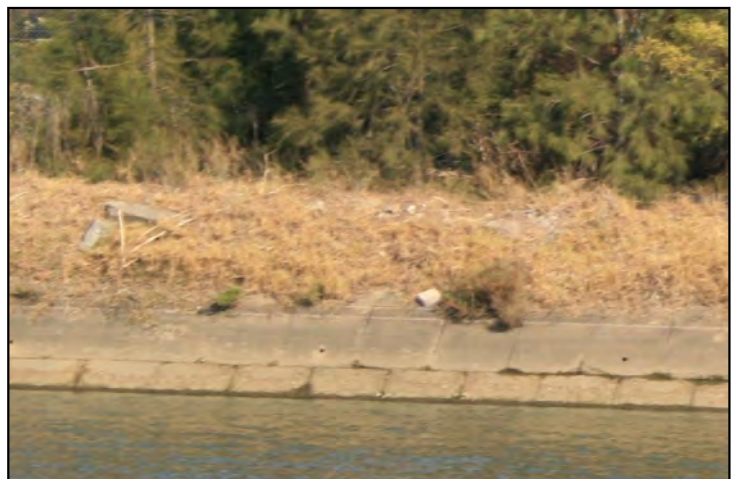
Photo 2

Minor cracking and weathering of concrete observed. Cracks are particularly evident between concrete panels.

Cracks between concrete panels that form canal bank.

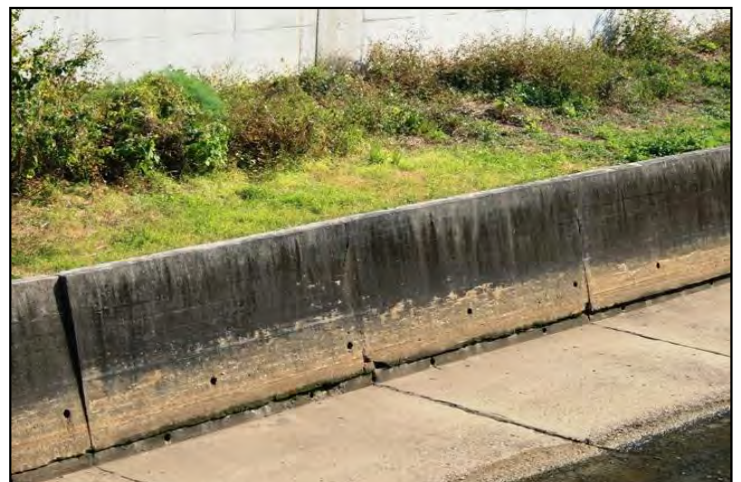
Photo 2

Minor cracking and weathering of concrete observed. Cracks are particularly evident between concrete panels.

Condition worsens to the south.

Cracking and weathering of vertical concrete wall between panels.

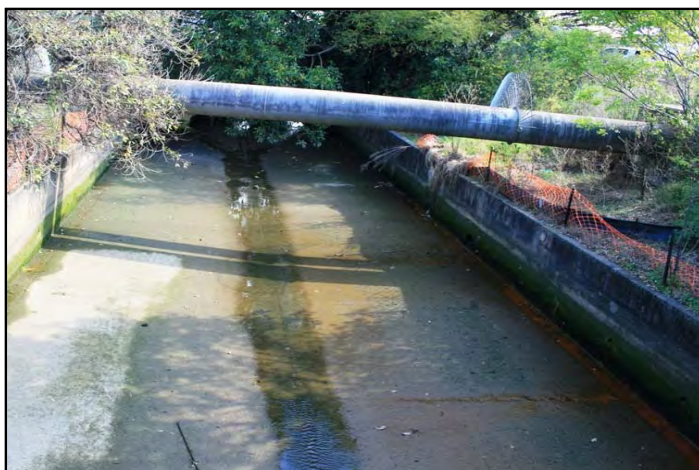
Photo 1

Typical view of concrete canal.

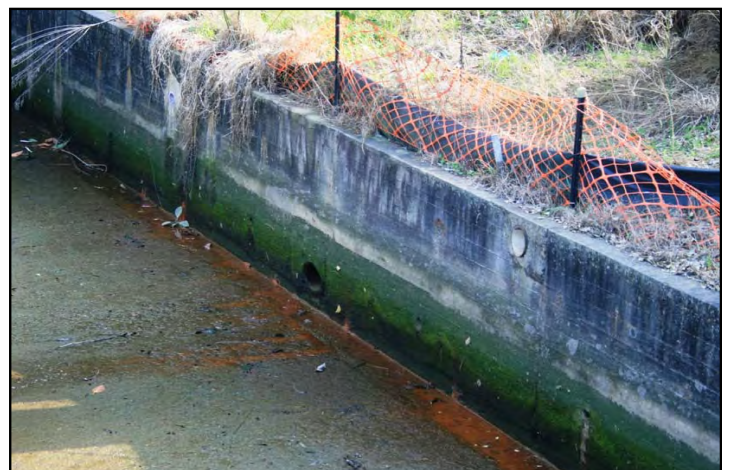
Photo 2

Minor cracking and weathering of concrete observed. Cracks are particularly evident between concrete panels.
Condition worsens to the south.

Minor cracking and weathering of vertical concrete wall.

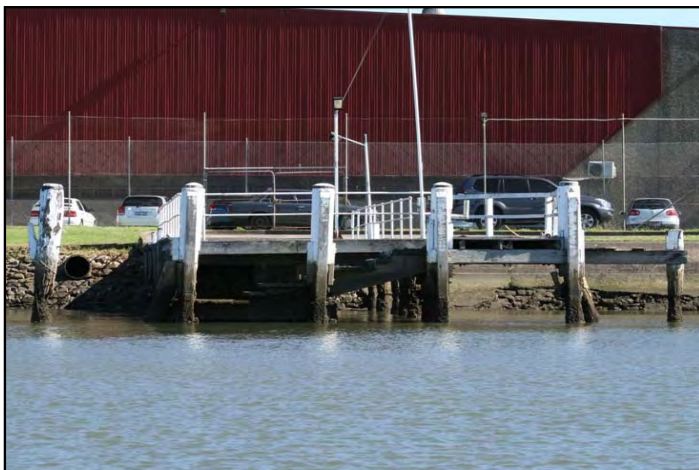
View of facility.

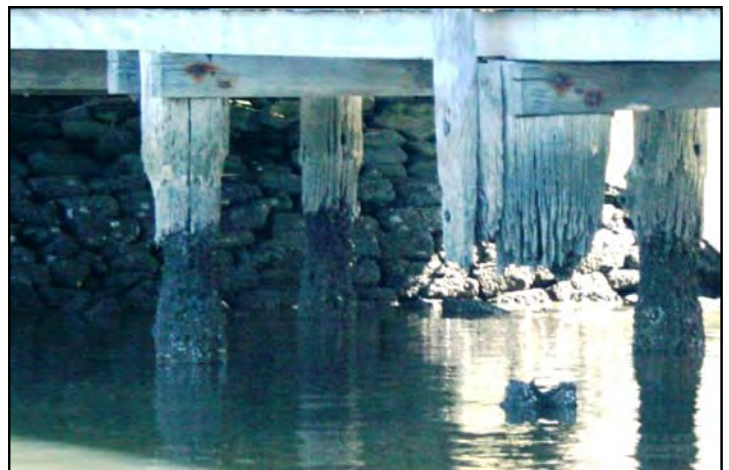
The piles have failed and the structure may collapse if no action is taken.

Failed timber piles.

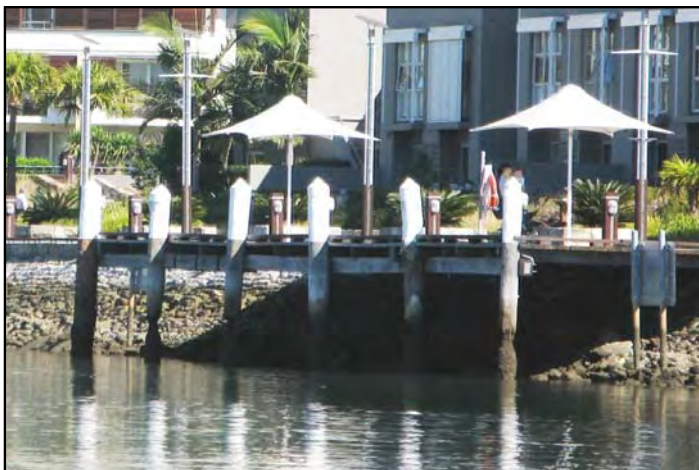
Photo 1

View of facility.

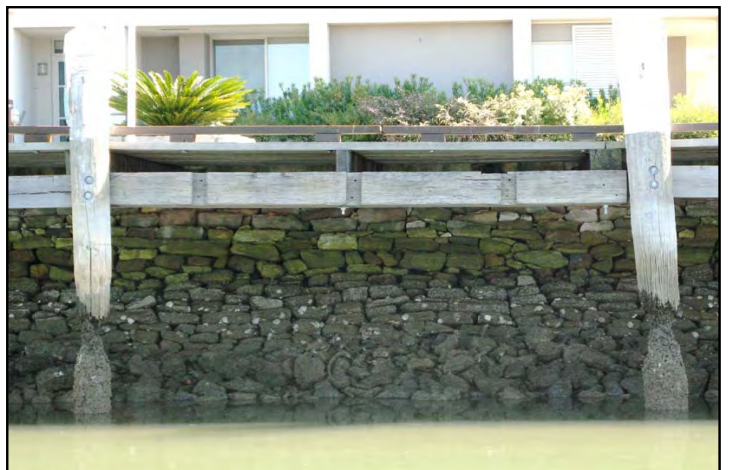
Photo 2

Apart from the new pile at the southern end of the structure, all timber piles have failed at the water line. Other timber components are showing signs of deterioration.

The piles have failed and the structure may collapse if no action is taken. Umbrellas and adjacent residential development mean structure is well utilised by the public. The structure edge is well defined by timber rail.

Failure of timber piles at the water line.

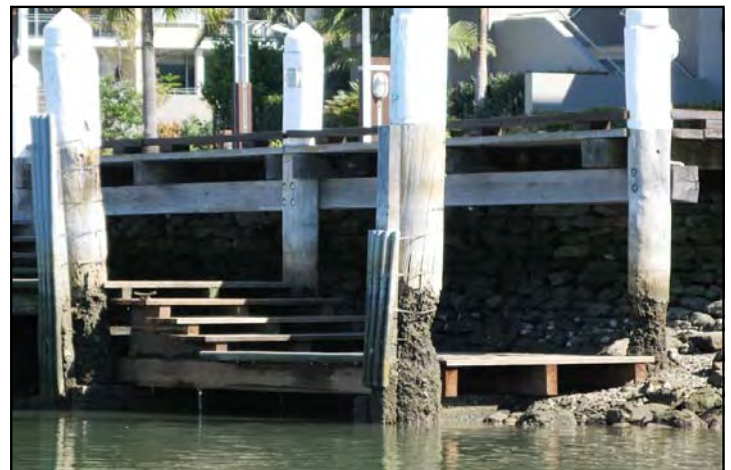
Photo 2

Timber piles are severely deteriorated at the water line. Other timber components are showing signs of deterioration. A number of timber stairs have been replaced.

The piles are in poor condition and may fail if not replaced. Access to structure from the water is difficult at low tide. Umbrellas and adjacent residential development mean structure is well utilised by the public. The structure edge is well defined by timber rail.

Severe deterioration of timber piles at the water line.

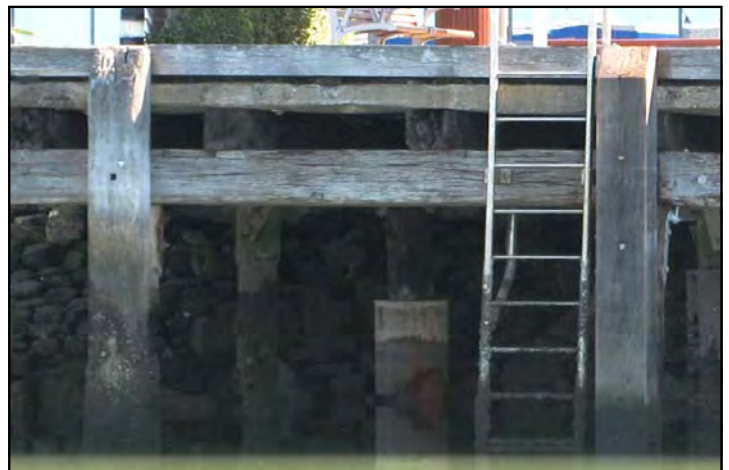
Photo 2

Timber piles and other components are showing signs of deterioration.

Although not as urgent as the two other facilities at this location (AUB_F03 & AUB_F04), the piles are in poor condition and may fail if not replaced. Umbrellas and adjacent residential development mean structure is well utilised by the public. The structure edge is not defined.

Deterioration of timber piles and other components.

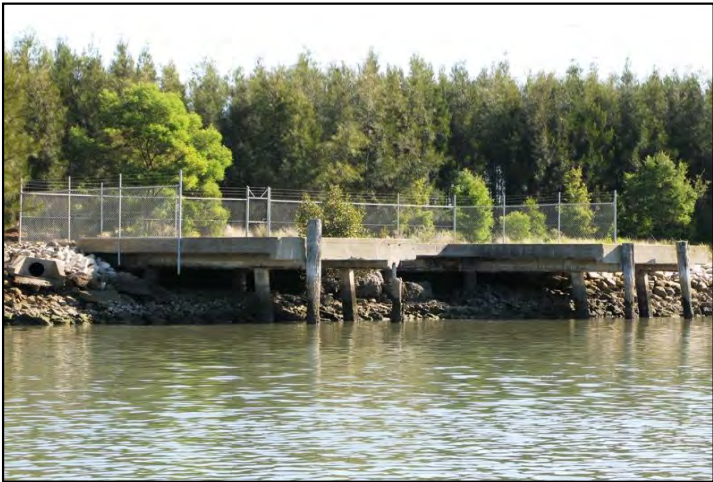
Photo 1
View of facility.

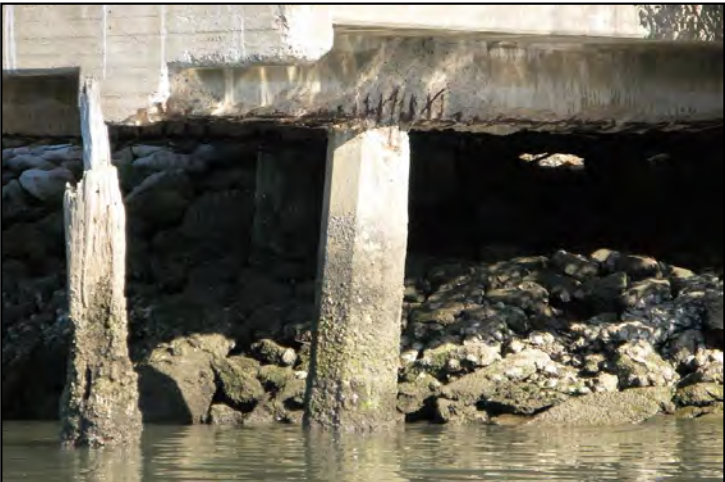
Condition Assessment:
The structure appears condemned/abandoned with severe corrosion of concrete beams beneath landing exposing reinforcement.

Photo 2
Corrosion of concrete beam exposing reinforcement.

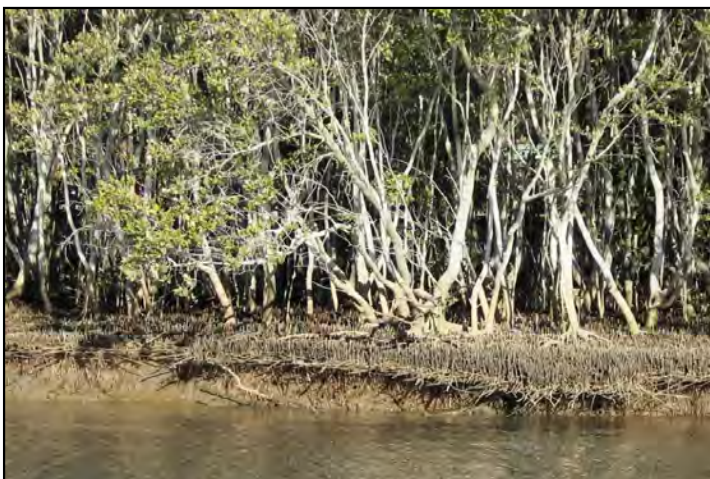
Photo 1

Erosion observed with undermining and loss of fine material from pneumatophores due to exposure to vessel wash. The condition of the shoreline improves upstream of the confluence in the Duck River.

Loss of fine material and undermining of mangroves.

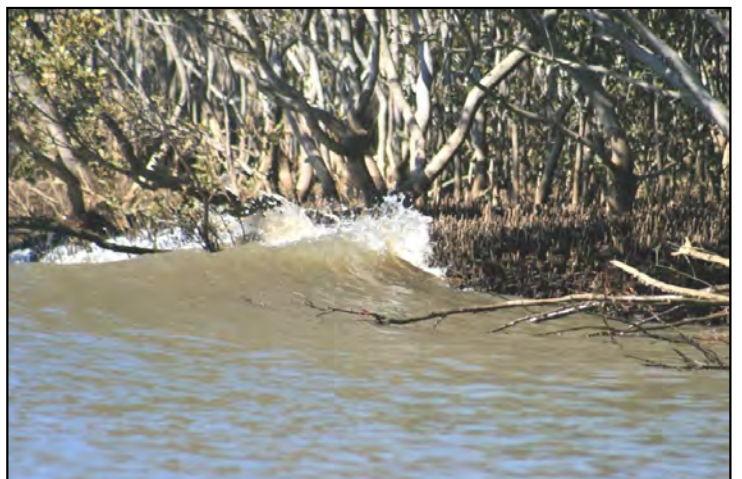
Photo 2

Ferry wash at Duck and Parramatta Rivers confluence.
