Hunters Hill LGA

9.8 Hunters Hill

Seawall Inspection Record - HUN_S01

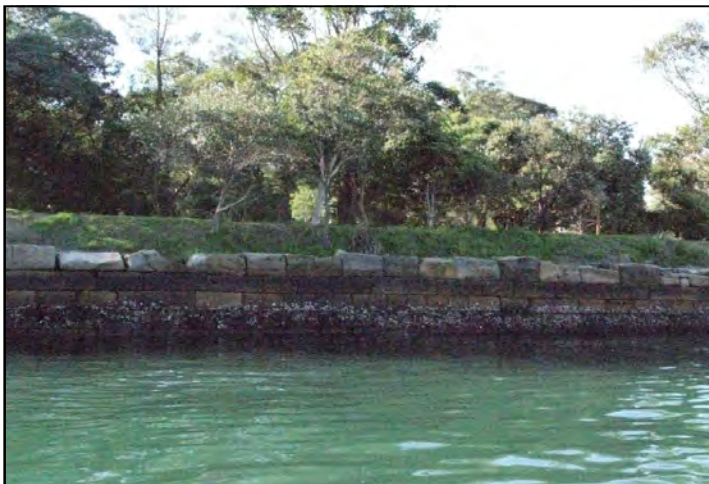
Numerous block failures of the crest were observed with blocks fallen into water below. Surface weathering of the sandstone blocks and sinkholes behind structure crest were also observed.

Typical section of seawall showing failure of blocks at crest, surface weathering and loss of grout material.

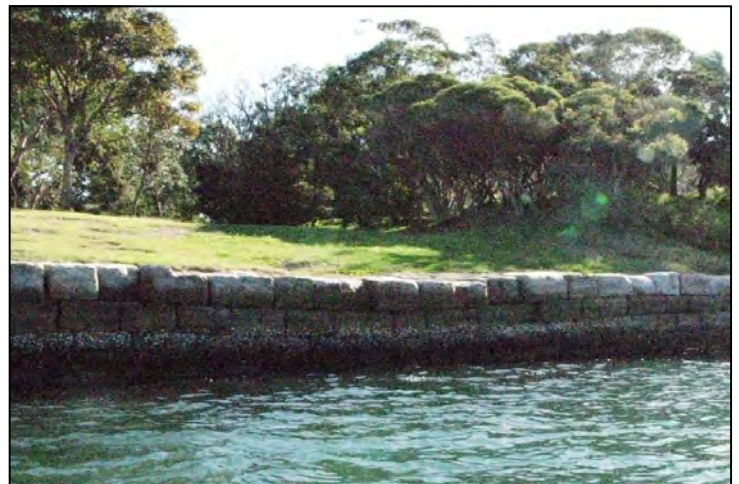
Photo 2

Slumping of sandstone blocks.

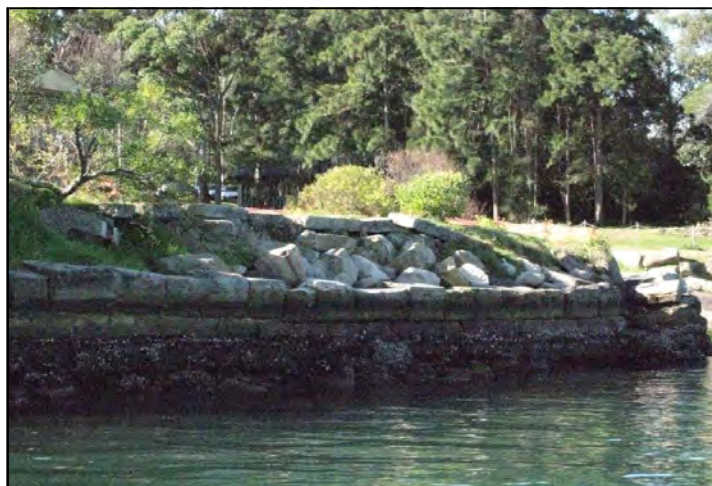
Photo 1

Numerous block failures of the crest were observed with blocks fallen into water below.
Surface weathering of the sandstone blocks and sinkholes behind structure crest were also observed. Western section is in better condition.

Typical section of seawall showing failure of blocks at crest, surface weathering and loss of grout material.

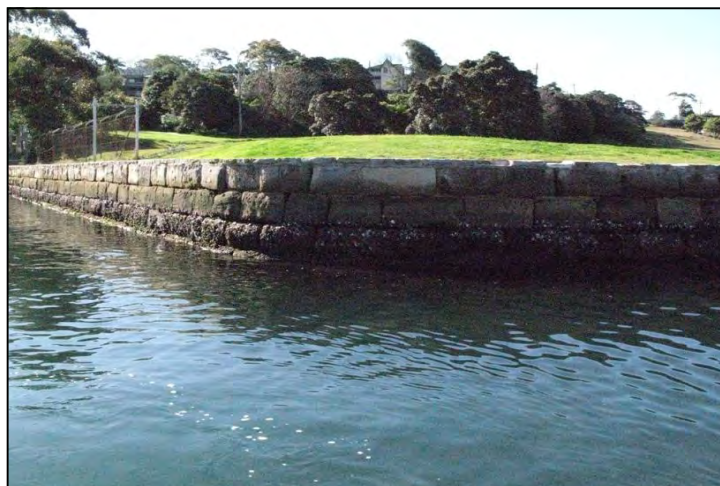
Photo 2

Western section of the seawall leading to boat ramp is in better condition than the rest of the structure

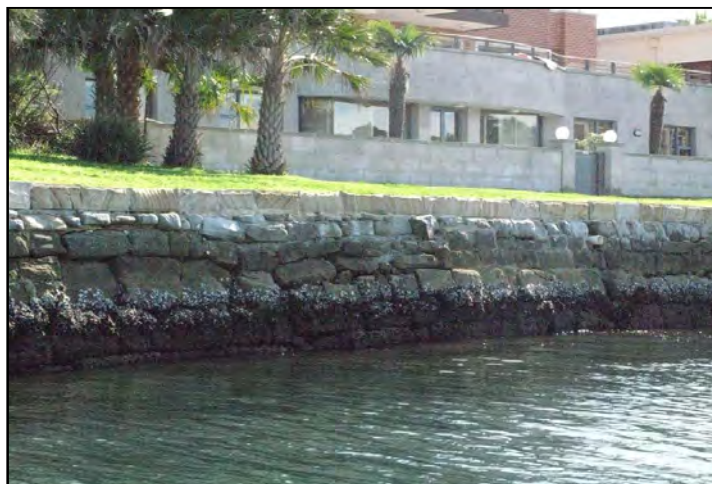
Photo 1
Typical view of seawall.

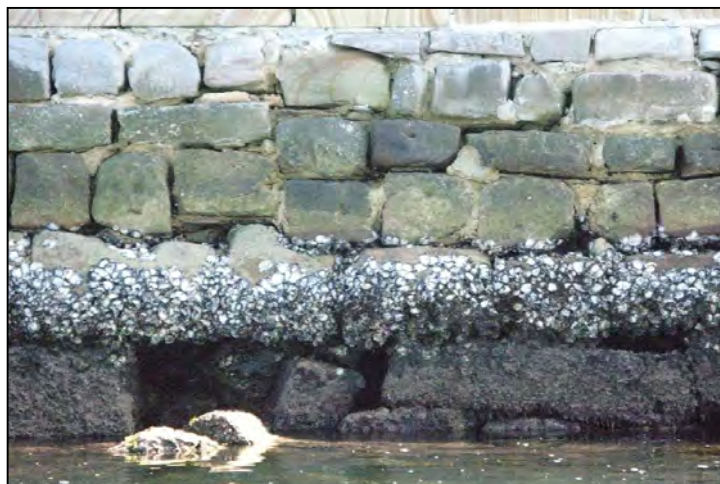
Condition Assessment (Slope, Crest, Toe, Backfill):	Excellent	<input type="checkbox"/>
<u>Grout is missing from the lower blocks with extensive slumping and cavities observed. A number of localised block failures at the seawall toe were also observed. The newer, top layer is in good condition with grouting present.</u>	Good	<input type="checkbox"/>
	Poor	<input checked="" type="checkbox"/>
	Failed	<input type="checkbox"/>

Photo 2
Block failure at toe and loss of grout and clumping of lower, older sandstone blocks.

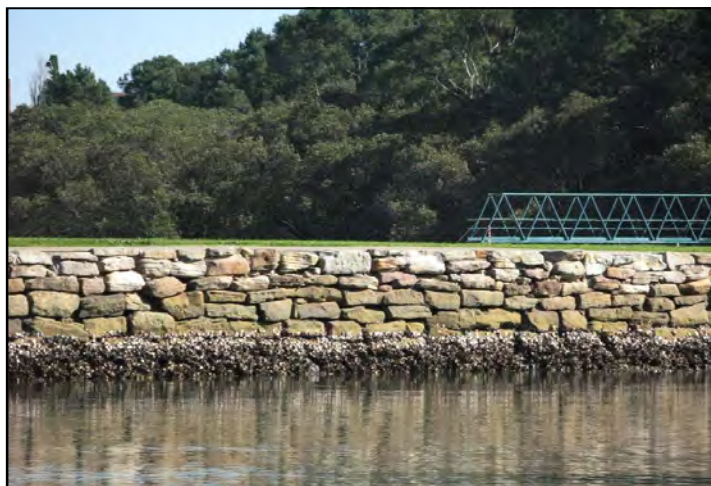
Photo 1

Majority of grout material has been lost from the structure leading to loss of fines from behind and slumping of both the vertical face of the wall and the concrete footpath beyond. Significant weathering of the sandstone blocks was also observed.

Typical view of structure showing loss of grout and slumping of sandstone blocks.

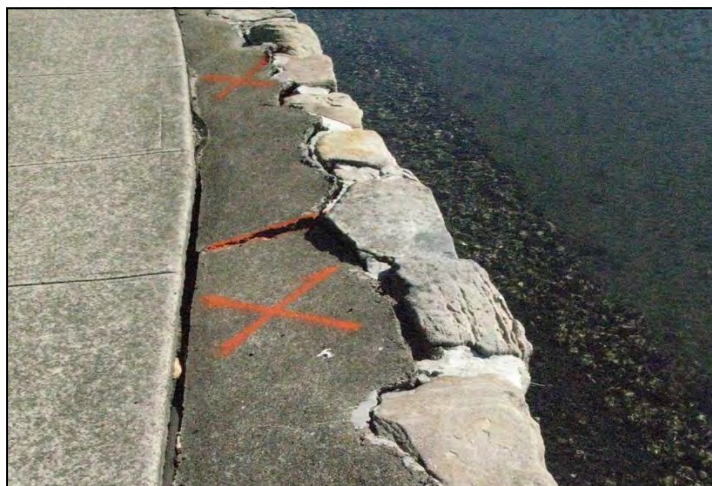
Photo 2

The footpath beyond the wall crest is cracking and many defects were marked with crosses at location (WP 206 327942, 6254391).

Slumping and cracking of public footpath with marked defects shown.

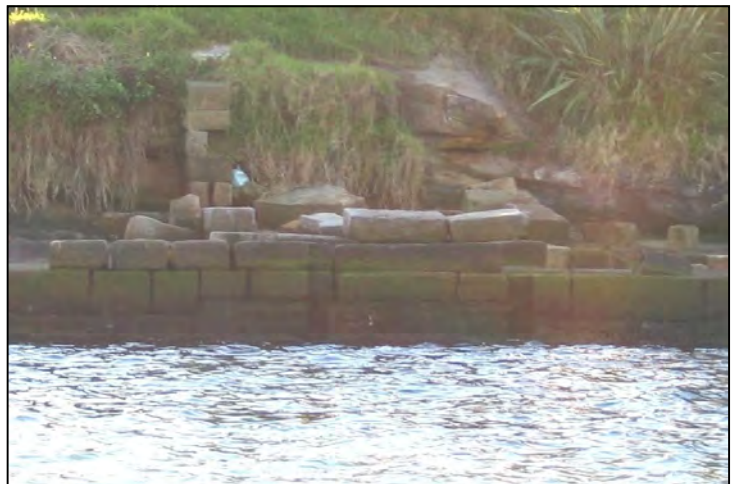
Photo 2

Loss of grout, weathering and failure of sandstone blocks.

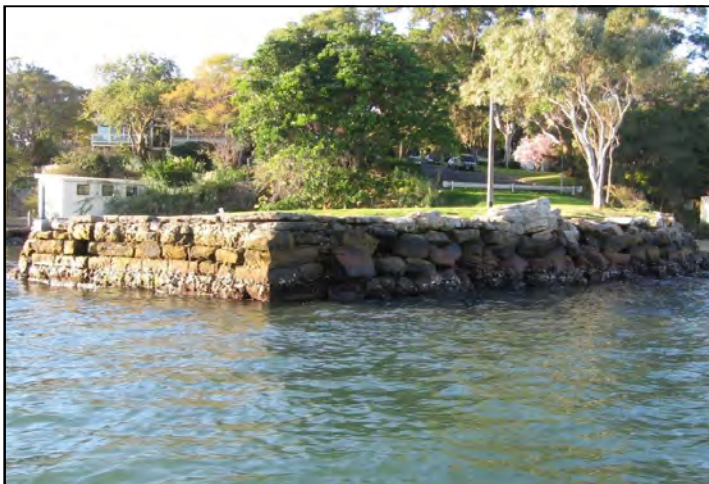
Photo 1

Vertical sandstone block wall that forms front face of structure is missing grout material, a number of block failures were also observed. The revetments on each side of the structure are slumping due to a loss of fine material from behind. Large sinkholes and cracking of concrete capping at crest further confirm the loss of fine material.

Eastern view of structure. Block failures on front vertical face is shown.

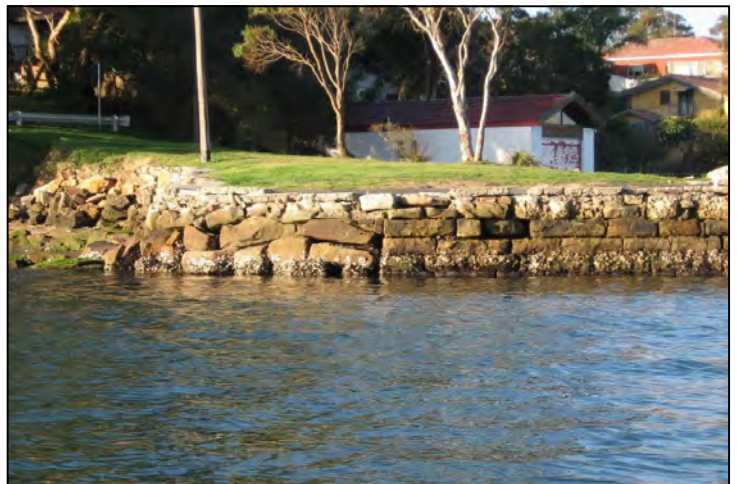
Photo 2

Western section of structure showing extent of slumping of revetment component.

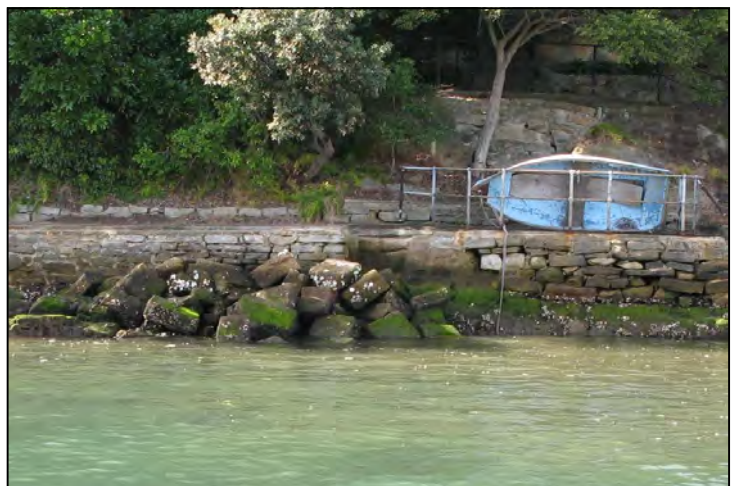
Photo 2

Sandstone seawall has failed in some locations with blocks strewn across bedrock. At other location all grout is missing with surface weathering and large cavities evident while grout has been replaced at discrete locations long the wall. Steel safety fence is corroding. Timber piles are showing signs of deterioration.

Block failure of seawall.

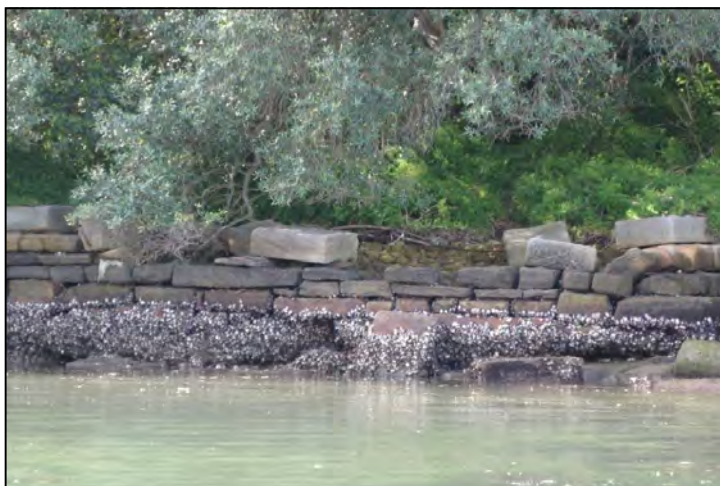
Photo 2

Numerous blocks have collapsed and fallen into water below. No grouting was observed. Surface weathering and slumping also evident.

Block failure of seawall.

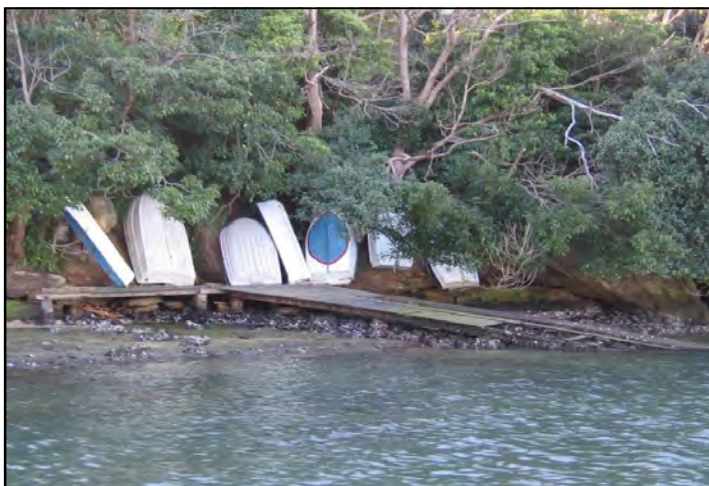
Timber ramp has partly collapsed and is severely deteriorated. Landing has also deteriorated. No formal dinghy storage structure was observed.

View of dinghy storage area showing deterioration of timber ramp.

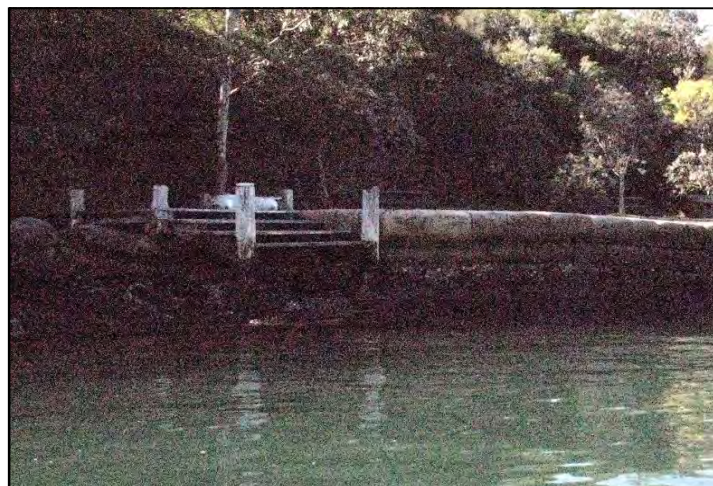
Photo 1

View of structure and adjacent seawall (HUN_S03).

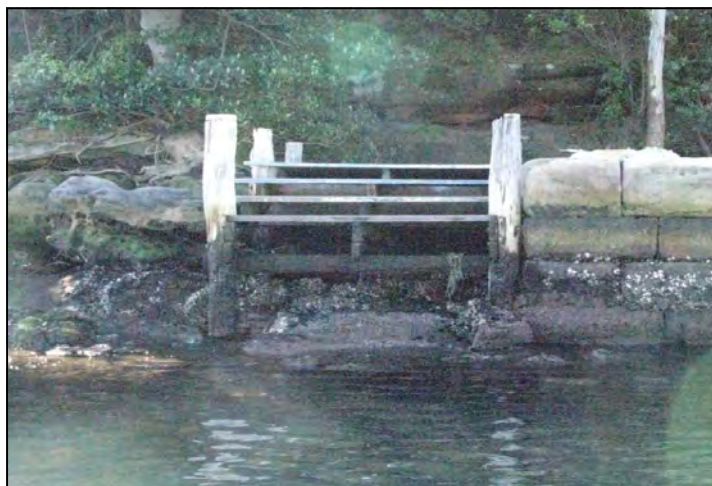
Photo 2

Deterioration of timber landing, stairs and piles was observed. Steel connections are corroding.

View of structure showing deterioration of timber piles.
