9.9 Ryde

9.9.3 Seawalls

Seawall Inspection Record - RYD_S23

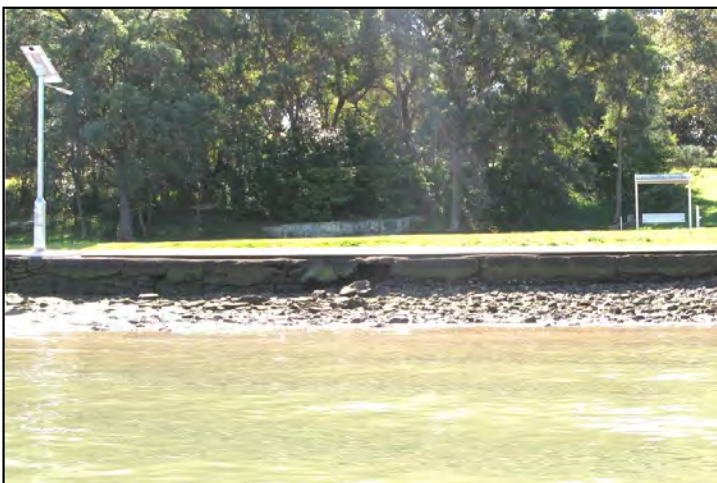
Photo 1

Grout not present, voids and localised block failures were observed. Concrete capping on crest and face has cracked and failed.

Typical view of structure showing block and concrete capping failure.

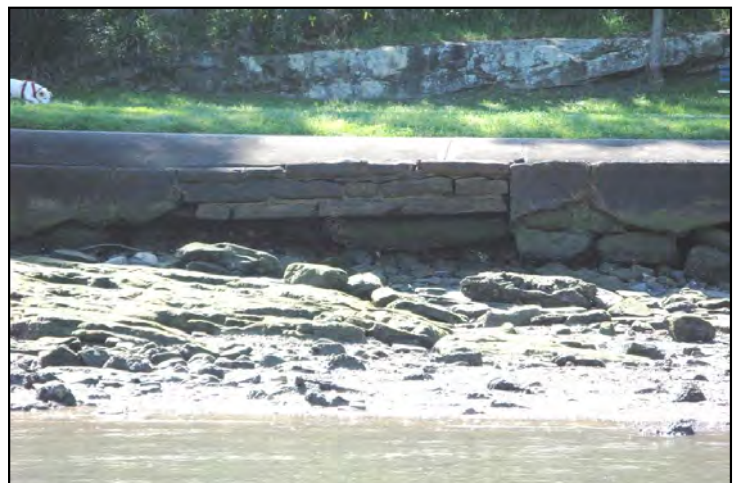
Photo 2

Block failure beneath at toe.

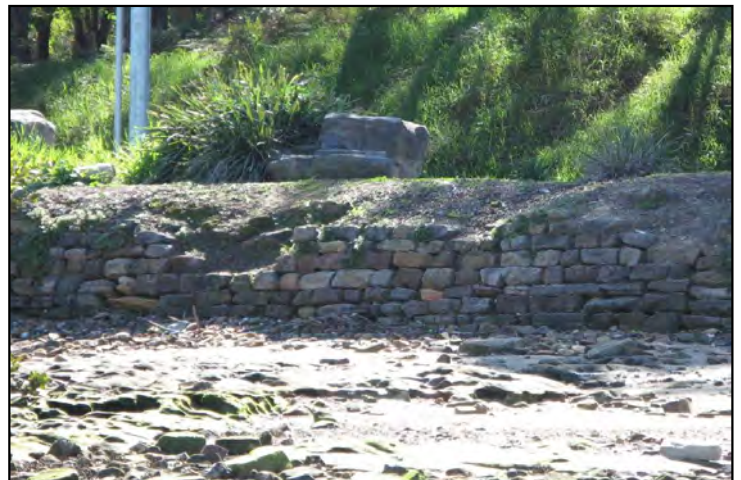
Photo 2

Significant slumping, block failures at the crest and weathering of sandstone blocks was observed along the length of the structure. Vegetation is also growing out of the wall.

Block failures and slumping of wall.

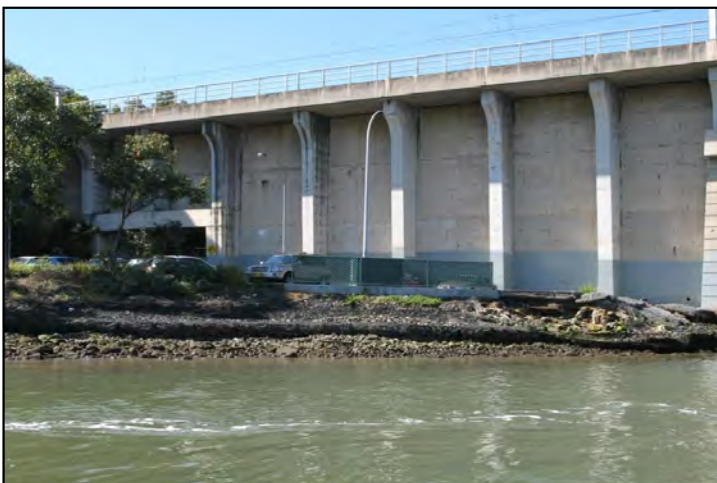
Photo 1

View of structure.

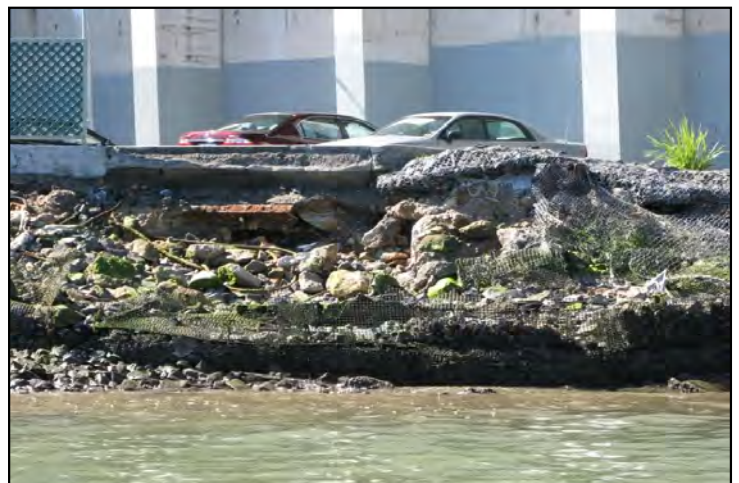
Photo 2

The section adjacent to the bridge abutment has failed and all material has been lost from the baskets. The rest of the structure is slumping.

The structure supports a public carpark and walkway which has been undermined by the failure adjacent to the bridge abutment.

Failure of structure adjacent to John Whitton Bridge.

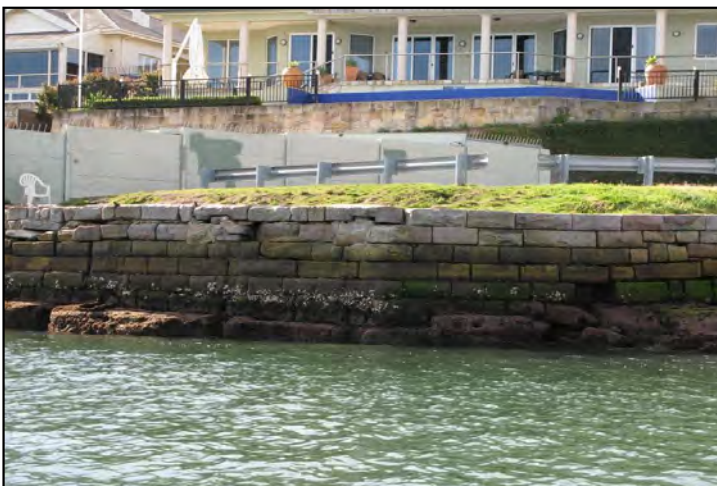
Photo 1

Typical view of wall.

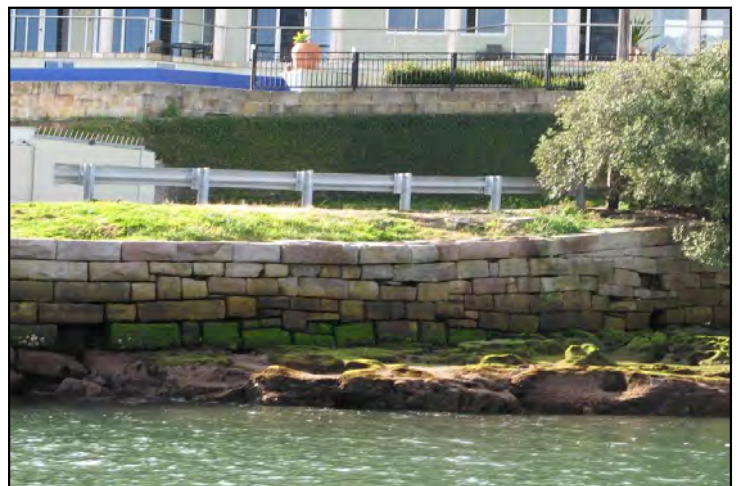
Photo 2

A number of block failures were observed along the length of the wall. Additionally, no grout is present between the blocks, sinkholes are present at the crest and surface weathering of the blocks has taken place.

Block failures along wall.

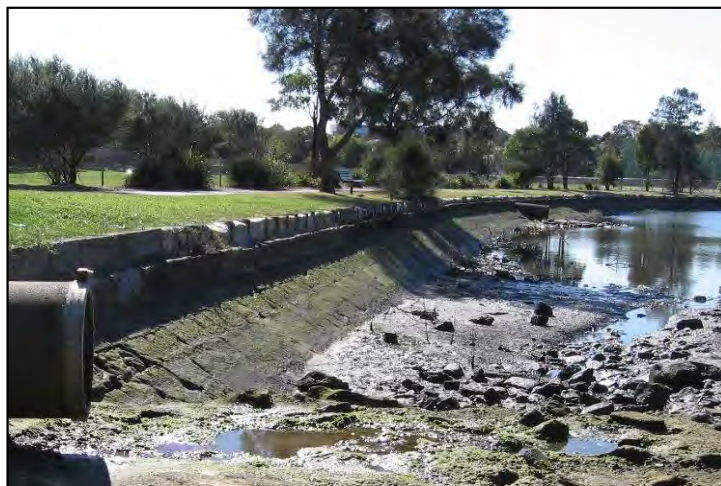
Photo 1

Typical view of seawall.

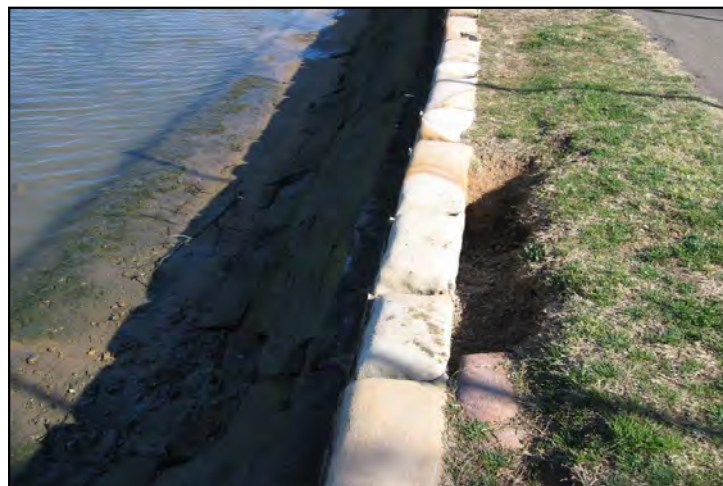
Photo 2

Severe weathering, slumping and loss of grout from between sandstone blocks was observed. A number of sinkholes are present behind the crest indicating a loss of fine material.

Weathering of sandstone blocks at crest and sinkhole behind wall.

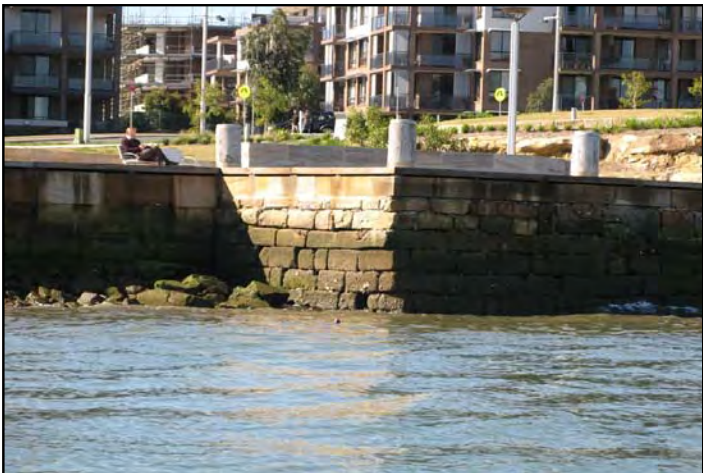
Photo 1
Typical section of wall showing older blocks along toe and newer blocks at crest.

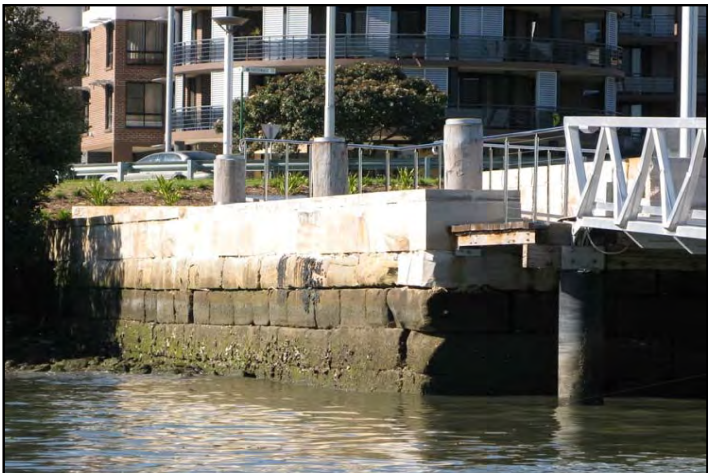
Condition Assessment (Slope, Crest, Toe, Backfill):
Single block failures were observed along the older, lower section of the wall. The lower section is also slumping and grout material is missing from between the blocks. The newer blocks that form the crest are in excellent condition.

Photo 2
Block failures beneath the connection of the public wharf.

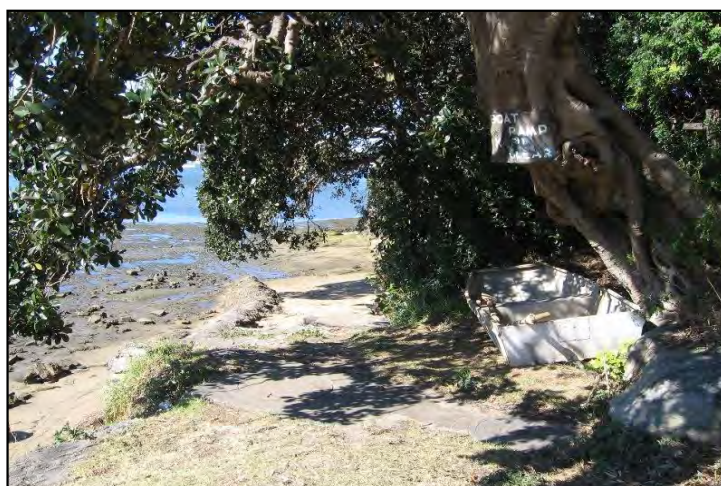
Photo 1

View of ad-hoc boat ramp and informal dingy storage.

Priority	Asset Name	Asset Description
1	RYD_F08	<p>There is no formal structure for dinghy storage and dinghies are launched via the ad-hoc boat ramp which is failing.</p> <p>It is recommended that dinghies are either relocated and ad-hoc structures removed or formal dinghy storage and launching facilities are installed.</p>
2	RYD_F05	<p>The concrete stairs are in a poor condition with cracks present and undermining at the lowest point. The rocky foreshore, accessible via the stairs, is steep and mossy with deep water in front. Members of the public were fishing from the rocks and climbing along the shoreline during the inspection.</p> <p>It is recommended that public access is prevented. The site provides an opportunity for a new lookout structure to be installed.</p>
3	RYD_F16	<p>The timber slats on the jetty are loose and deteriorating as is the timber rail. The timber slats on the gangway are also loose and deteriorating. The edges of the concrete that makes up the floating pontoon are severely corroded with reinforcement visible. The structure is exposed to ferry wash making berthing and mooring difficult.</p> <p>A new facility should be designed and installed to replace the existing facility.</p>

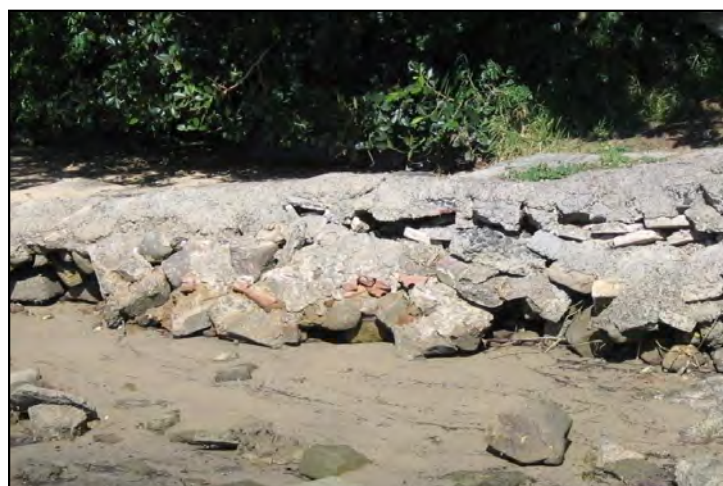
Photo 2

The boat ramp is not constructed to typical engineering standards. The toe has been undermined and the sides of the ramp are failing with aggregate material strewn along adjacent sandy shoreline. There is no formal structure for dingy storage.

Undermining at the toe and failure along the side of the ad-hoc boat ramp.

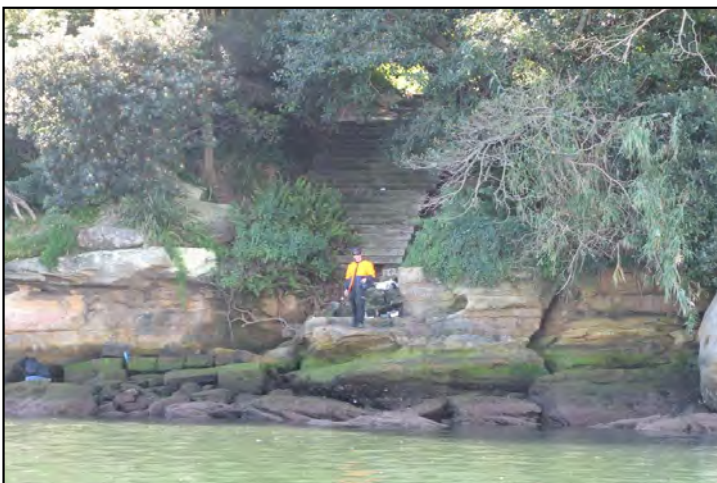
Photo 1

Concrete stairs and rocky shoreline with members of the public fishing and climbing on rocks.

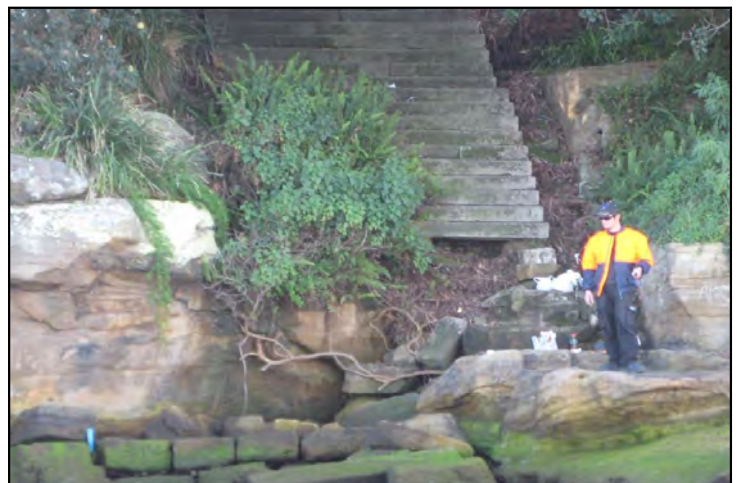
Photo 2

The concrete stairs are in a poor conditions with cracks present and undermining at the lowest point.

Undermining of concrete stairs.

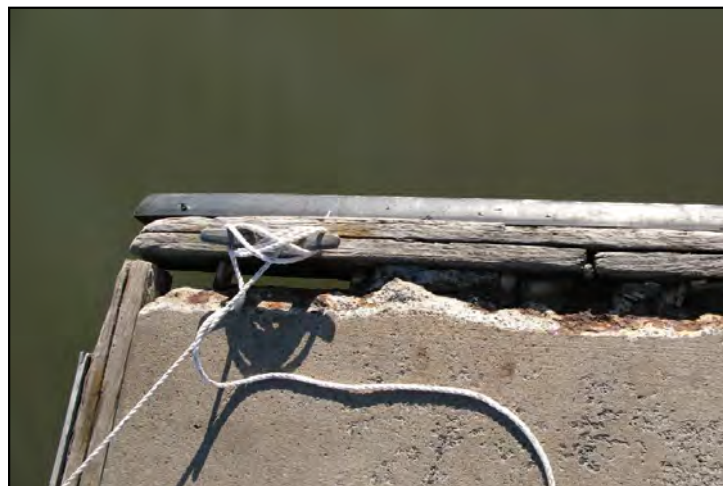
Photo 2

The timber slats on the jetty are loose and deteriorating as is the timber rail. The timber slats on the gangway are also loose and deteriorating. The edges of the concrete that makes up the floating pontoon are severely corroded with reinforcement visible.

Corrosion of concrete which forms floating pontoon.

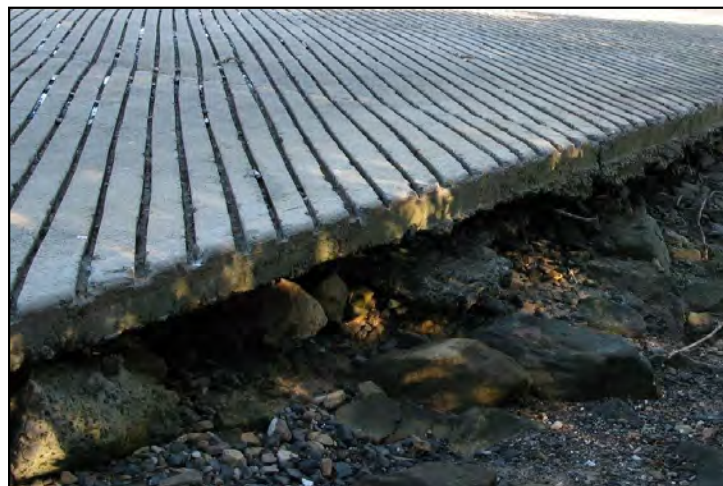
Photo 2

The concrete ramp is cracking and aggregate is exposed. The western side of the structure has been undermined.

Undermining of structure on the western side.

4	RYD_F17	<p>The concrete ramp is cracking and aggregate is exposed. The western side of the structure has been undermined. Members of the public commented that the toe of the structure finished abruptly and cars often get stuck. There is also a number of sandstone boulders present in the water beyond the structure and the area is exposed to vessel wash making launching and retrieval difficult.</p> <p>A new facility should be designed and installed to replace the existing facility.</p>
5	RYD_F03	<p>Informal dinghy storage with dinghies tethered to steel safety rail associated with adjacent Sydney Water pumping station. Steel safety rail associated with Sydney Water pumping station is showing signs of corrosion and the concrete slab it sits upon has been undermined. No formal access to water, dinghies must be launched via mossy bedrock.</p> <p>It is recommended that dinghies are either relocated or formal dinghy storage and launching facilities are installed.</p>

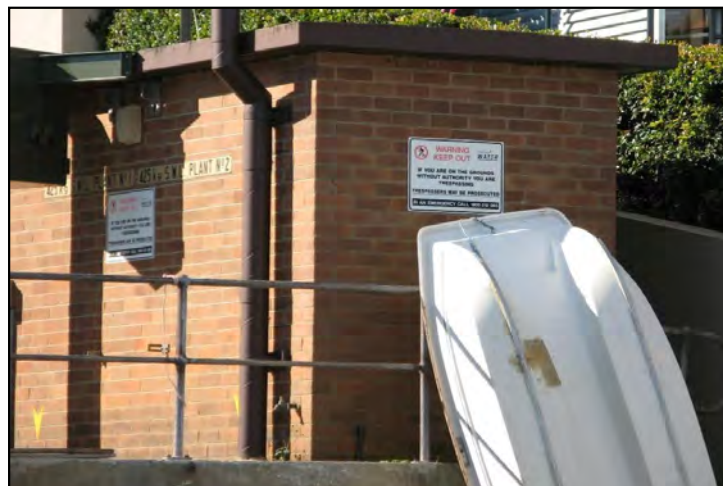
Photo 2

Dinghy tethered to steel safety rail.

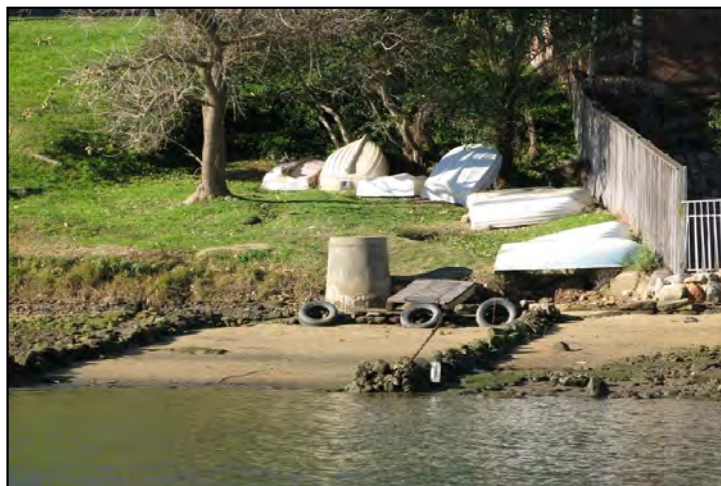
Photo 1

View of informal dinghy storage facility and ad-hoc structures along shoreline.

Priority	Asset Name	Asset Description
6	RYD_F07	<p>Informal dinghy storage within public reserve with dinghies tethered to private timber paling fence and trees. Ad-hoc groynes with timber poles to mark their ends have been constructed with small sandstone rocks to define the launch area. A timber ramp and rubber tires have also been placed at the shore for launching and berthing,</p> <p>It is recommended that dinghies formal dinghy storage and launching facilities are installed.</p>

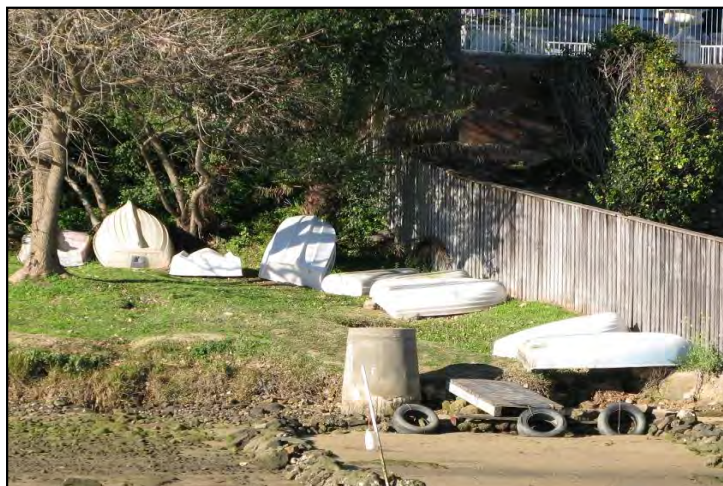
Photo 2

Dinghies tethered to trees and timber fence.

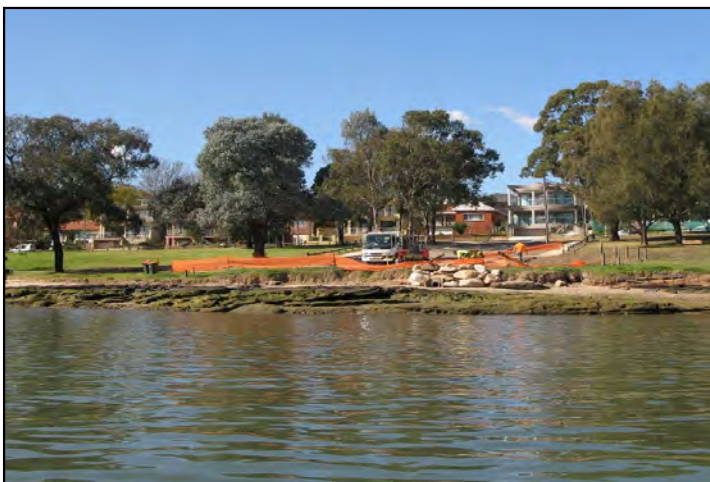
Photo 1

View of erosion scarp behind rocky shoreline.

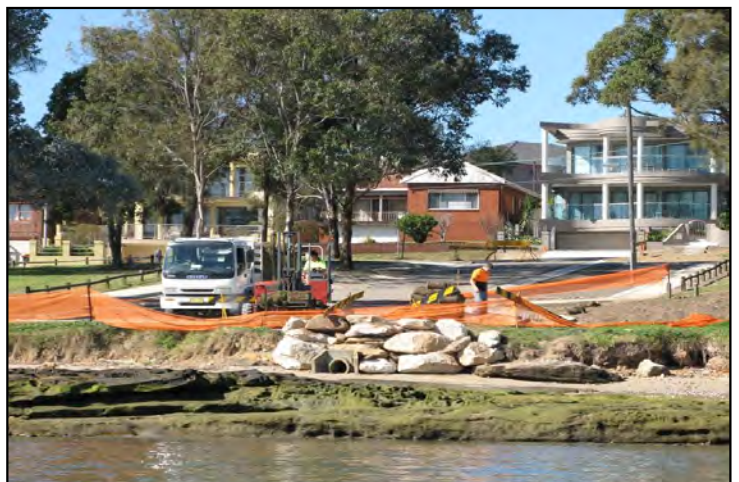
Photo 2

Large sandstone blocks placed along erosion scarp encompassing
a new storm water culvert.

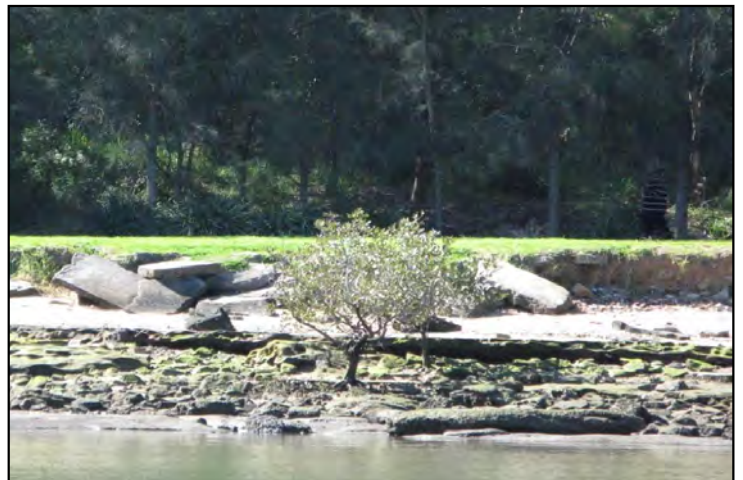
Photo 2

Erosion scarp with concrete building waste.

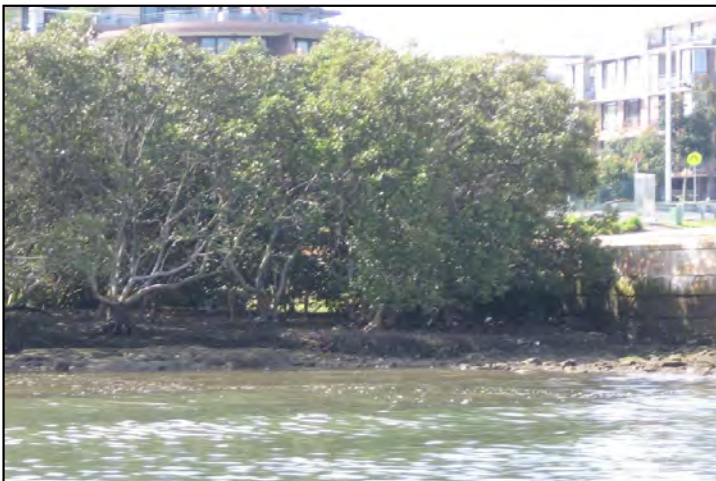
Photo 1

Mangroves adjacent to Seawall RYD_NS11.

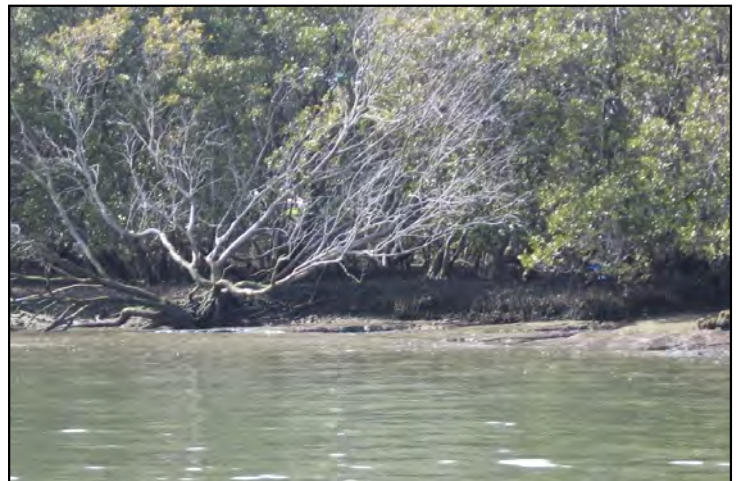
Photo 2

Collapsed mangrove.

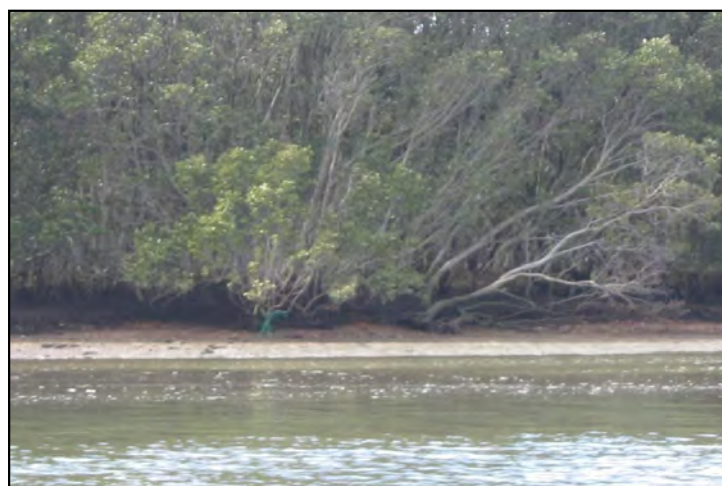
Photo 2

Undermining and collapsing of mangroves.

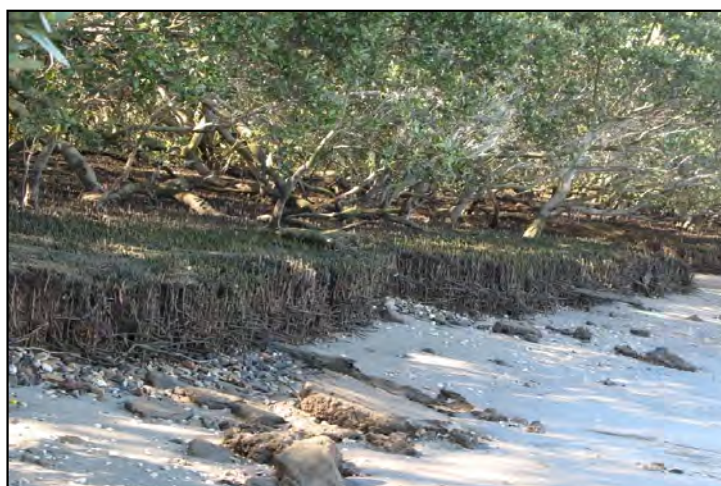
Photo 1

Loss of fine material from pneumatophores.

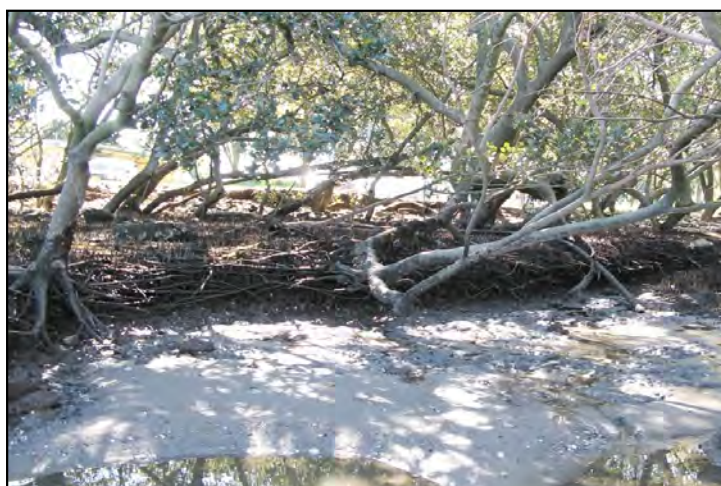
Photo 2

Mangroves collapsing due to undermining.
