Parramatta LGA

9.10 Parramatta LGA

Seawall Inspection Record - PAR_S16

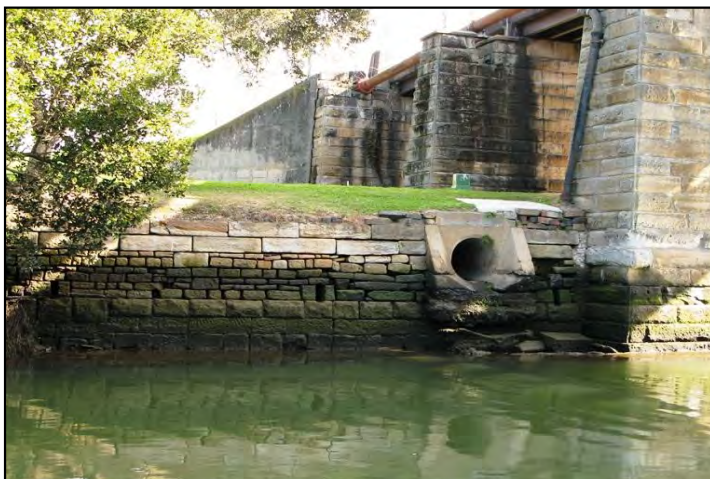
Photo 1

Localised wall failures at the toe and crest were observed. In general, grout is absent from blocks which are slumping. Some section of the wall have been repaired with grout installed between sandstone blocks.

View of western extent of structure adjacent to the Macarthur Street Bridge Southern Abutment.

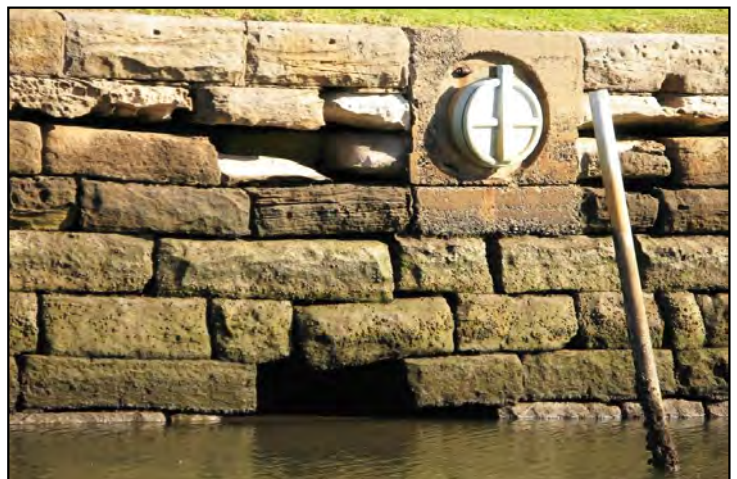
Photo 2

Block failure at the toe.

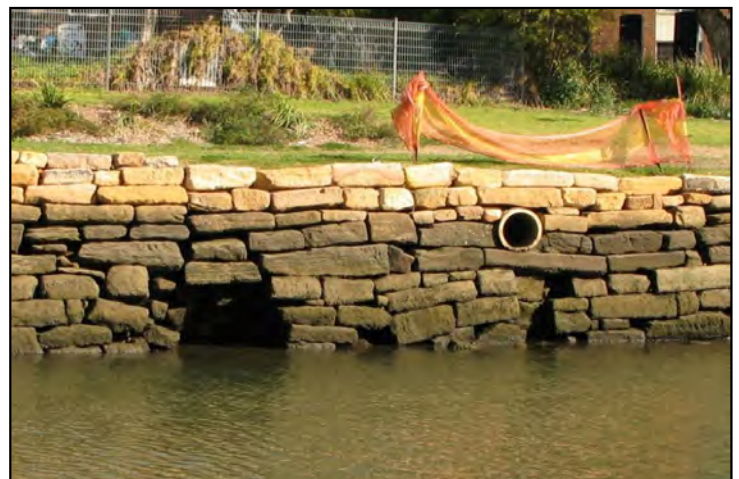
Photo 2

Localised wall failures at the toe and crest were observed. The blocks are also slumping and weathered.

Block failure at the toe.

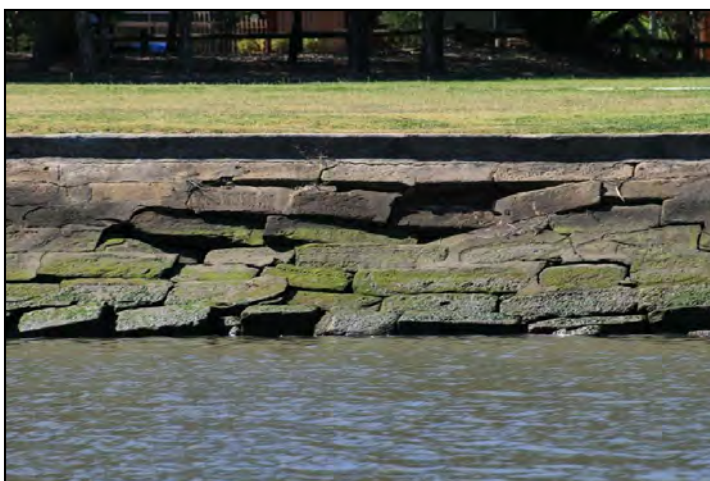
Photo 1

The revetment is failing at discrete locations which correspond to the absence of mangroves exposing the structure to vessel wash. In general, the structure is ungrouted, slumping and the sandstone blocks are weathered. Mangroves that are present in front of the revetment have been undermined leading to failure.

Block failure of revetment.

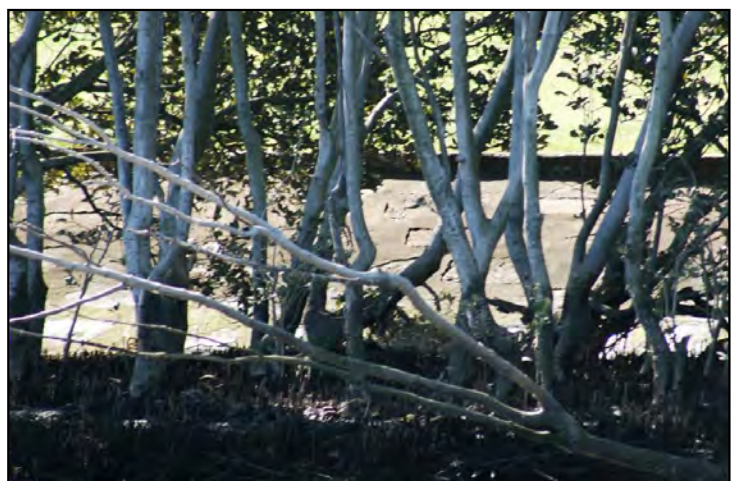
Photo 2

Collapsed mangrove in front of revetment.

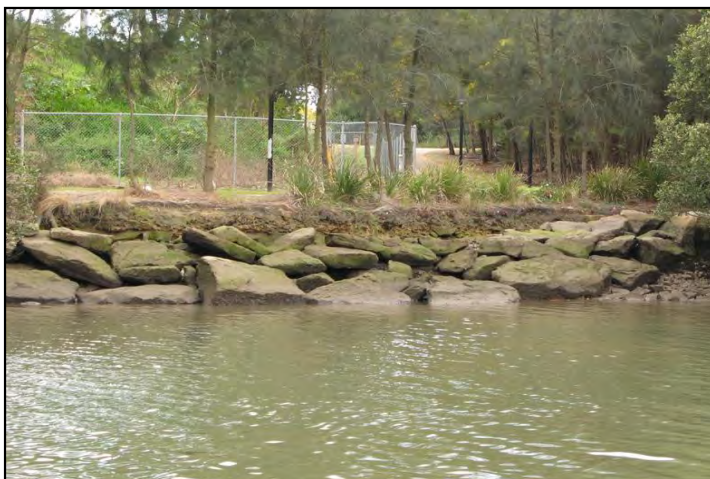
Photo 1

The revetment has not been constructed to typical engineering standards with no underlayers evident. The structure crest level is inadequate with an erosion scarp present beyond due to vessel wash exposure. A number of the gabion baskets that form the storm water outlet structure at the western extent have failed with all material lost.

Eastern extent of structure with erosion scarp beyond crest shown.

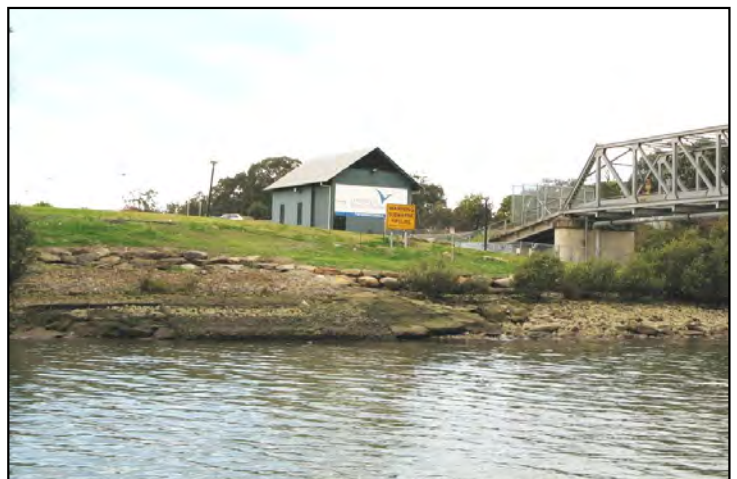
Photo 2

The storm water outlet structure may fail if no maintenance is undertaken. The informal public footpath would be inundated during periods of elevated water levels and would be overtopped by vessel wash.

Western extent of structure with gabion basket storm water outlet shown.

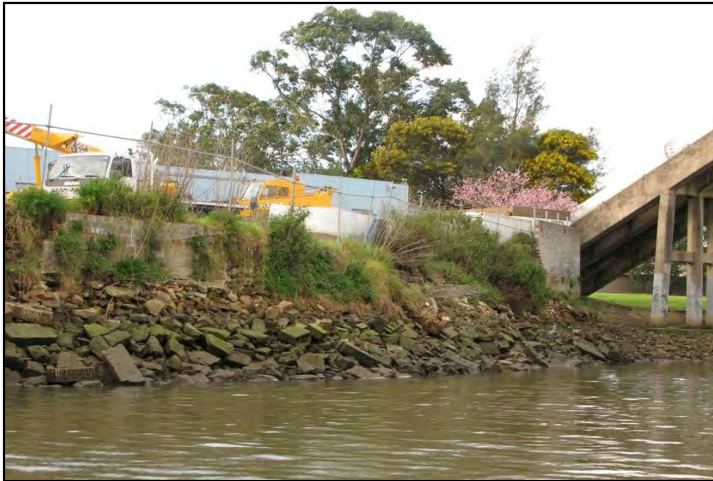
Condition Assessment (Slope, Crest, Toe, Backfill):
The revetment has not been constructed to typical engineering detail. The brick wall at the back of the structure has collapsed with bricks strewn across the revetment slope.

Photo 1
View of ad-hoc rubble revetment.

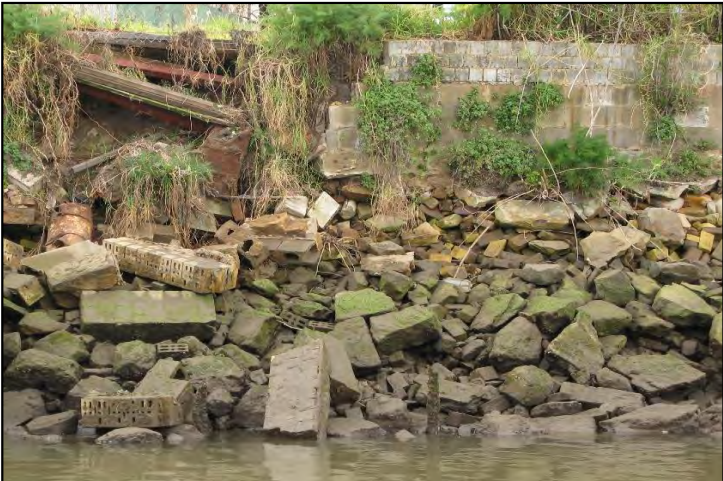
Photo 2
Failure of brick wall at back of revetment.

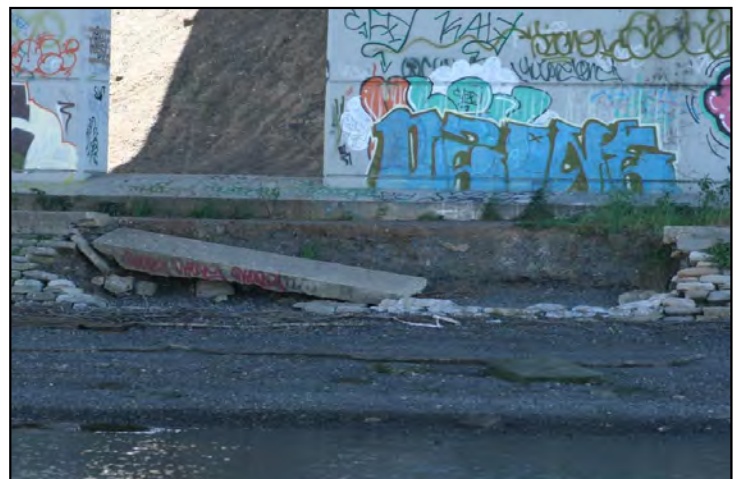
Photo 2

The structure has failed with a large section of sandstone blocks missing. The concrete crest has collapsed onto the sandy bank below. Gabions baskets are present to the east (PAR_S03) and west (PAR_S05) and have probably been installed to replace other section of failed wall.

Failed section of wall.

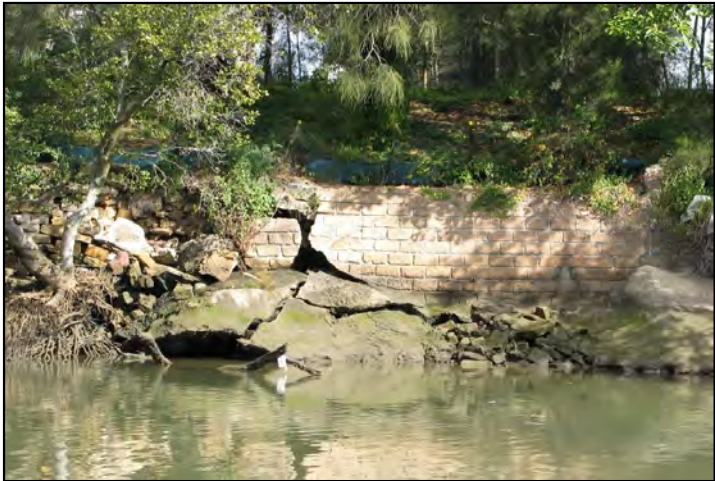
Condition Assessment (Slope, Crest, Toe, Backfill):
The majority of the wall has failed due to undermining. The new section of wall at the western extent has also failed. Mangroves that are in front of the wall have been undermined and have collapsed into the water.
Excellent ☐
Good ☐
Poor ☐
Failed ☒

Photo 1
Failure of new section of brick seawall at north western extent.

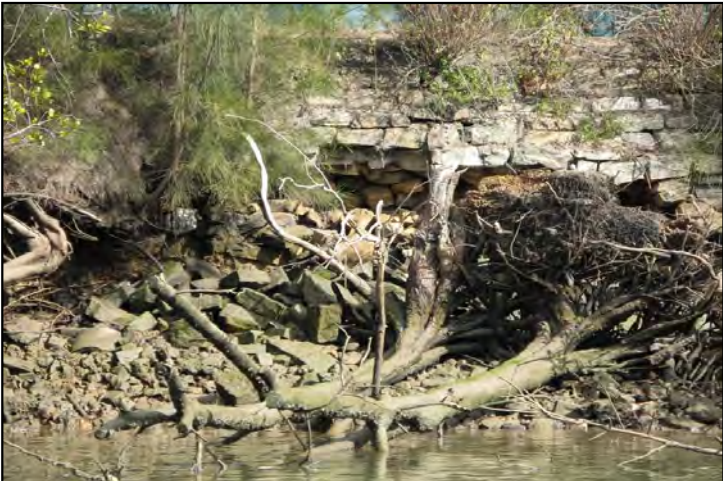
Photo 2
Typical section of wall showing sandstone block wall failure and collapse of mangrove.

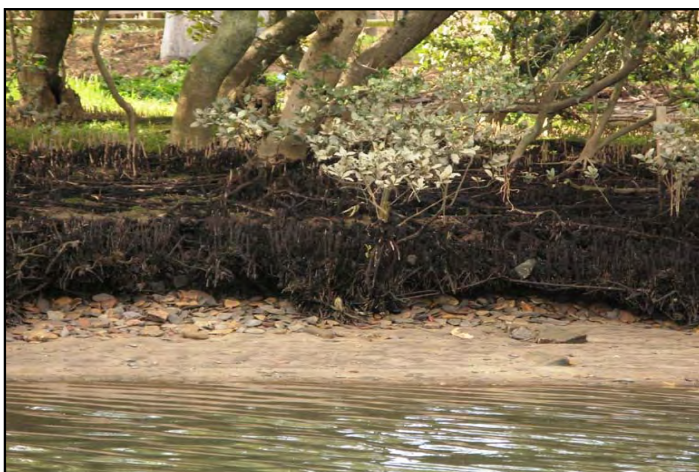
Photo 1

Erosion observed with undermining and loss of fine material from pneumatophores due to exposure to vessel wash.
A number of mangroves have collapsed into the water. The A-Jacks units are in good condition with no displacement observed.

Undermining and loss of fine material from pneumatophores.

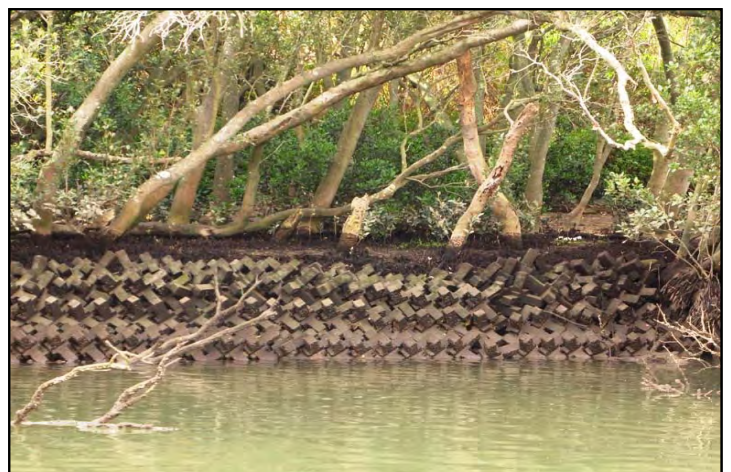
Photo 2

A-Jacks armour units installed along the shoreline.

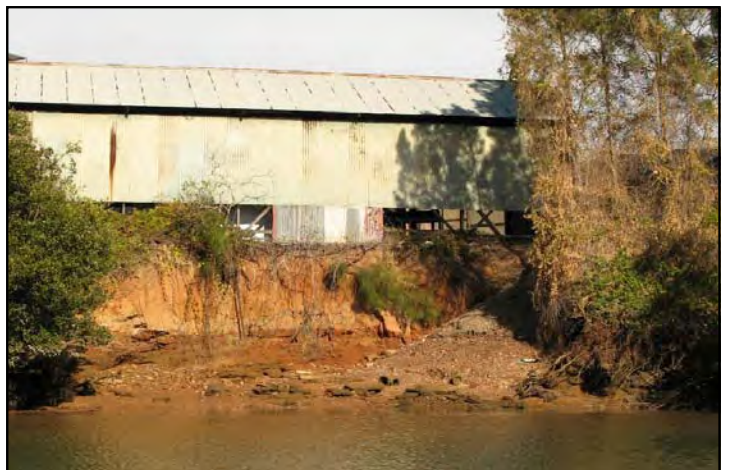
Photo 2

Loss of fine material from pneumatophores due to exposure to vessel wash observed. A section without mangroves has collapsed with a large, >2m, erosion scarp present. Fill material has been dumped to the side of the failure in an attempt to impede erosion.

Collapse of exposed bank in front of private industrial building.

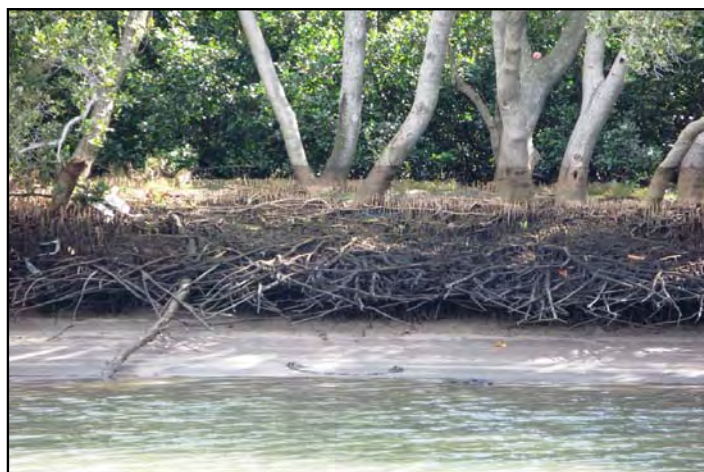
Photo 1

Erosion observed with undermining and loss of fine material from pneumatophores due to exposure to vessel wash.
 The steel fence has failed and the surrounding earthen bank is severely eroded.

Loss of fine material and undermining of pneumatophores.

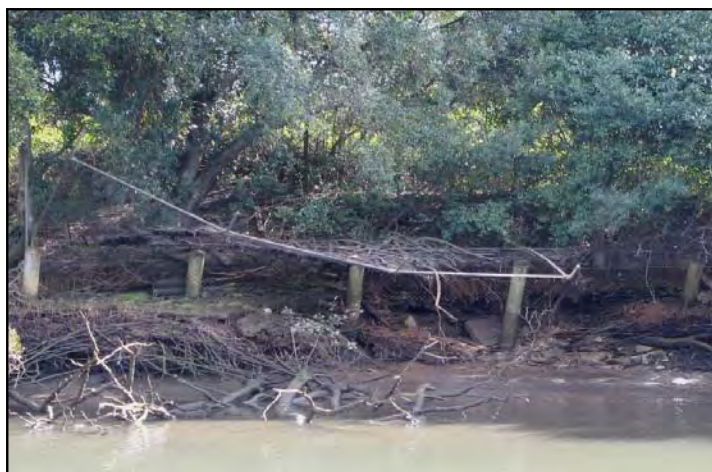
Photo 2

Failure of fence and bank.

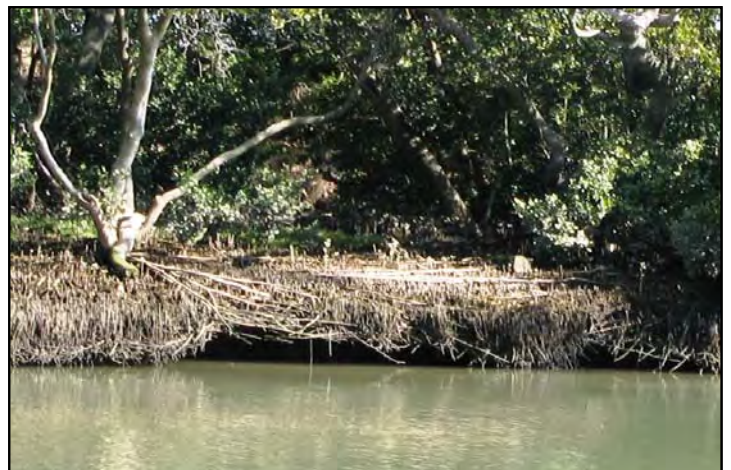
Photo 2

Erosion observed with undermining and loss of fine material from pneumatophores due to exposure to vessel wash.

Undermining of pneumatophores.

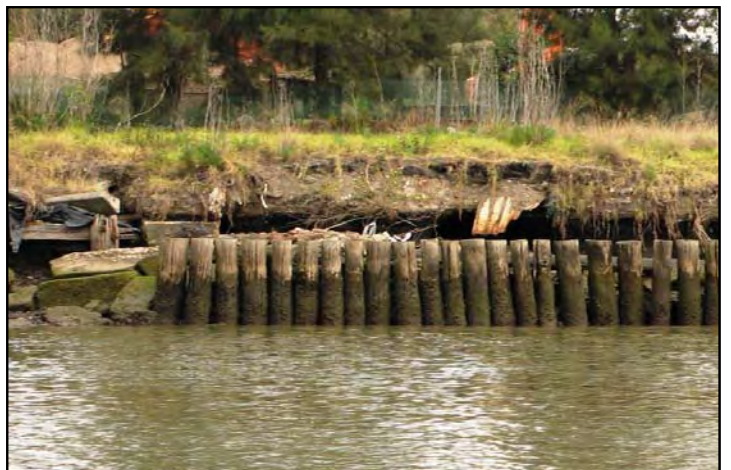
Photo 2

Erosion observed with undermining and loss of fine material from pneumatophores due to exposure to vessel wash. The abandoned timber pile wharves and concrete stack have been undermined.

Abandoned timber pile facility with large erosion scarp behind.

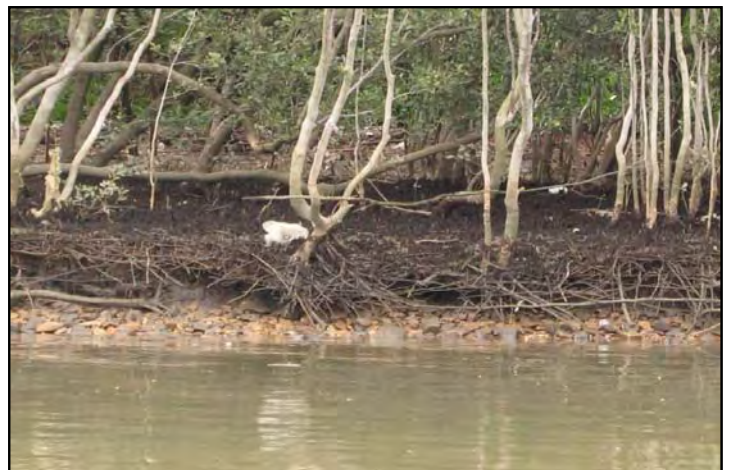
Photo 2

Erosion observed with undermining and loss of fine material from pneumatophores due to exposure to vessel wash.

Undermining of pneumatophores.

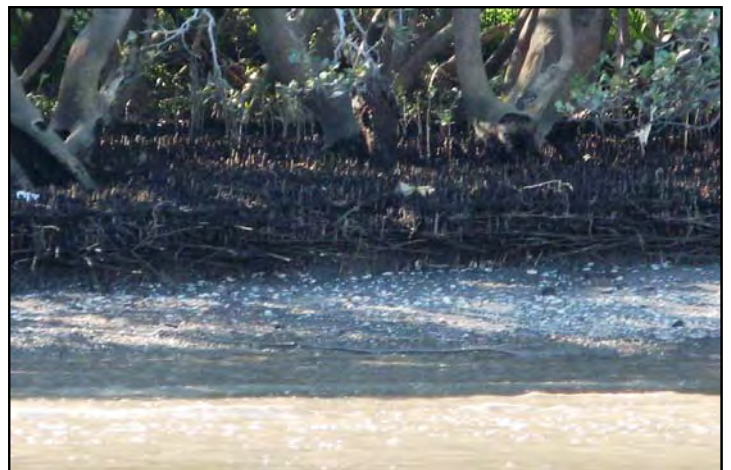
Photo 2

Erosion observed with undermining and loss of fine material from pneumatophores due to exposure to vessel wash.
A number of mangroves have collapsed into the water.

Undermining and loss of fine material from pneumatophores.

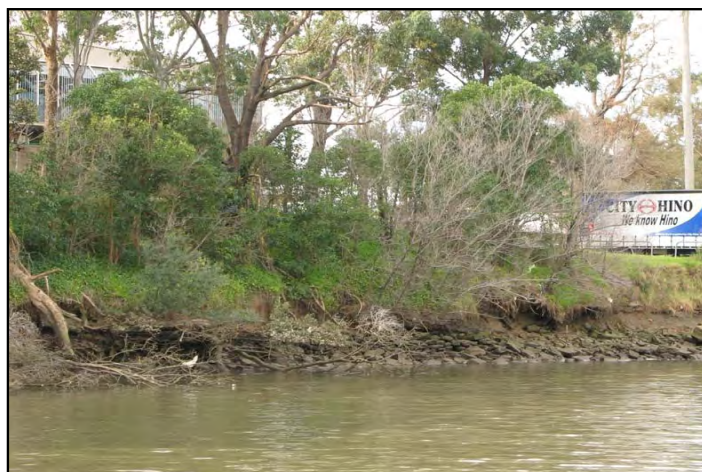
Photo 1

View of foreshore showing erosion scarp at waterline.

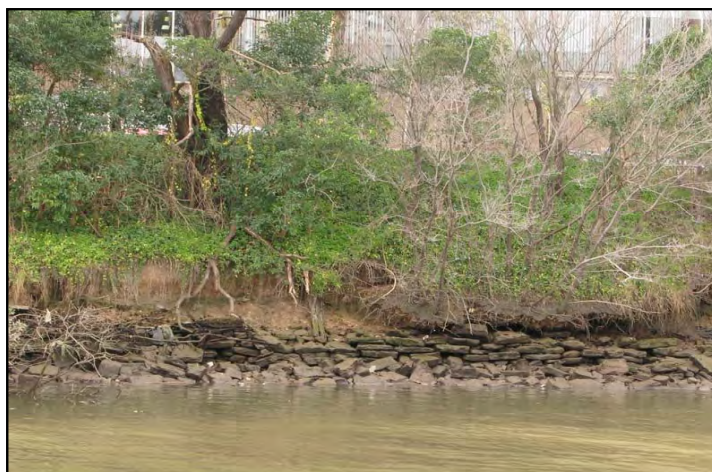
Photo 2

Undermining of slope with erosion scarp shown.

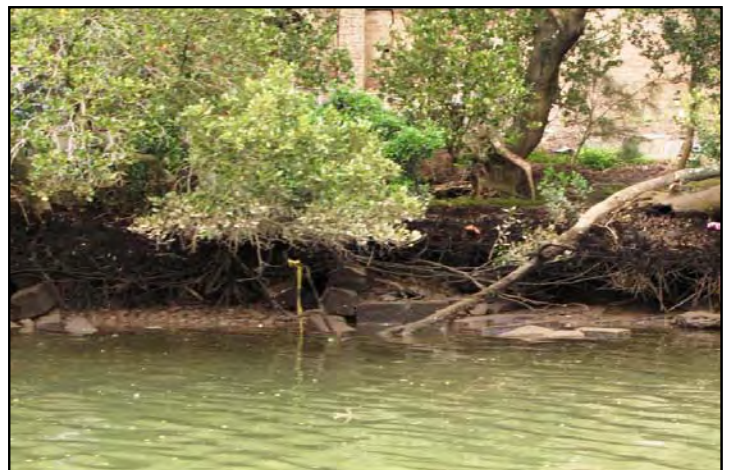
Photo 2

Undermining of pneumatophores.

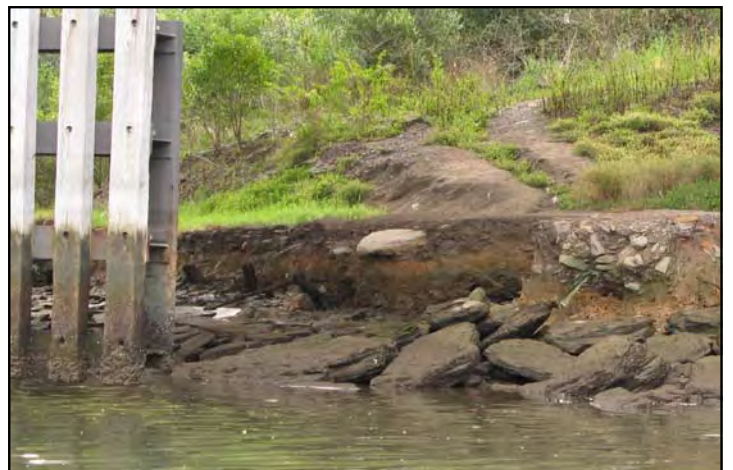
Photo 2

Erosion scarp behind timber fenders directly under James Ruse Drive.

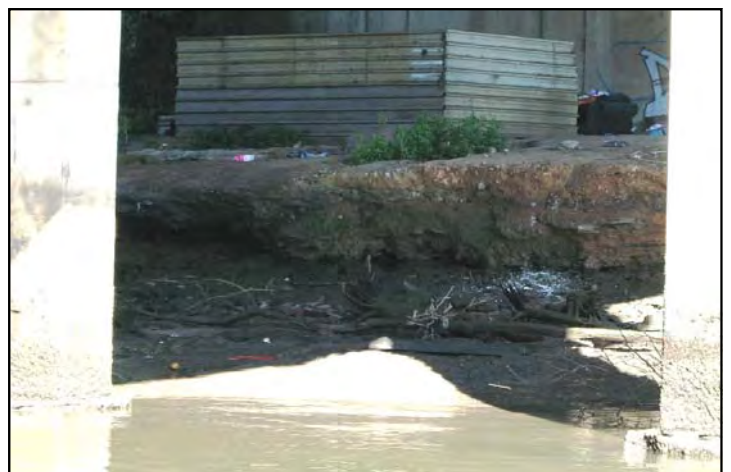
Photo 2

The large erosion scarp at the foreshore.

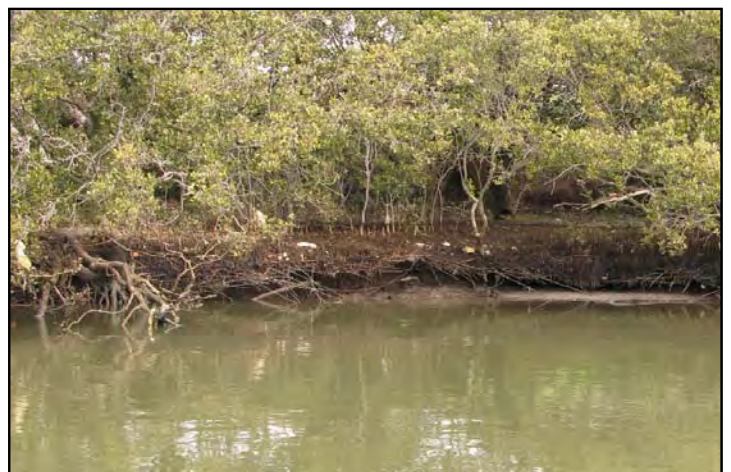
Photo 2

Loss of fine material and undermining of mangroves.

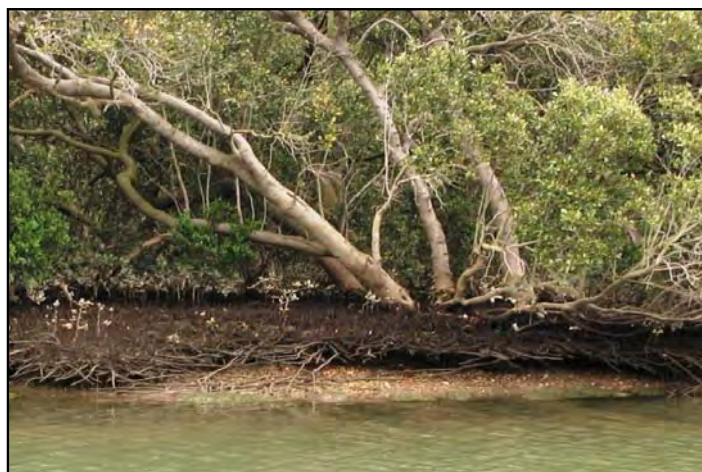
Photo 1

Loss of fine material and undermining of mangroves at confluence.

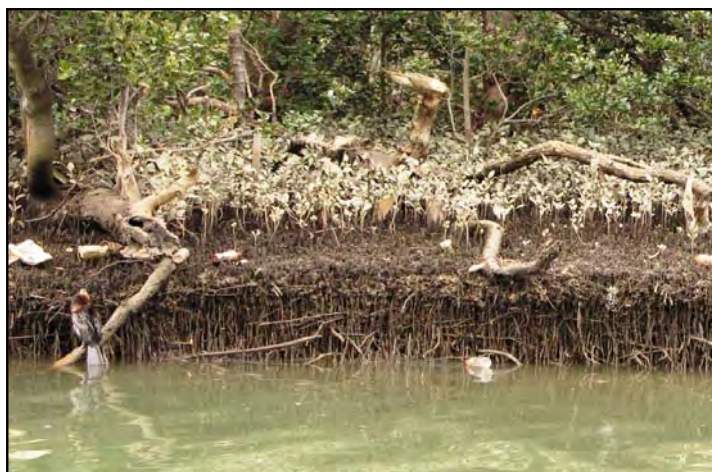
Photo 2

Loss of fine material from pneumatophores upstream of confluence in the Duck River.

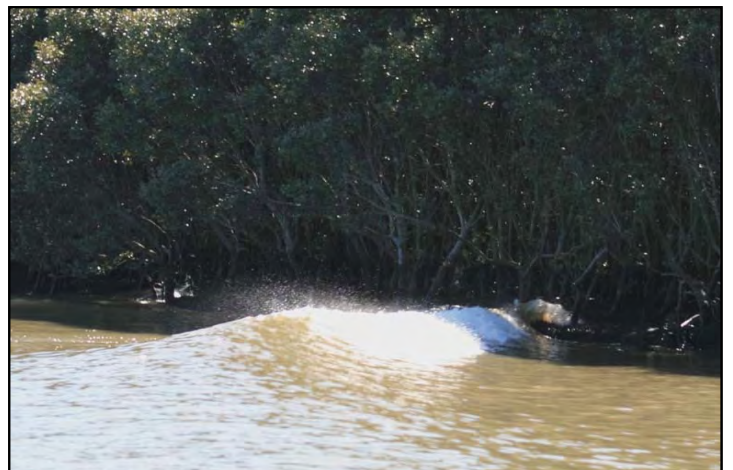
Photo 2

Vessel wash at foreshore.

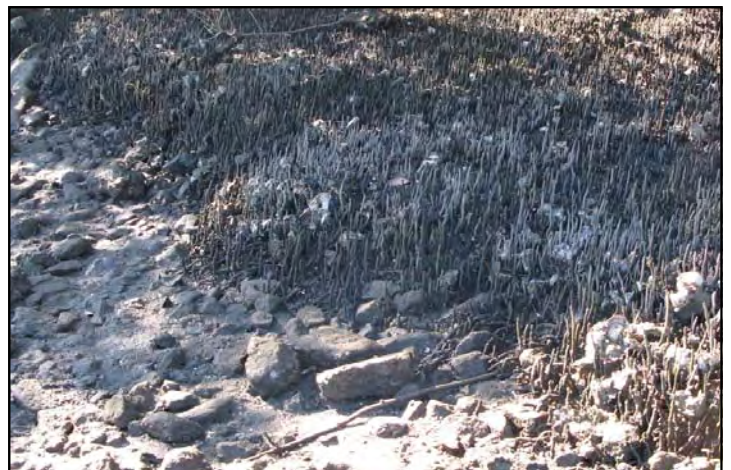
Photo 2

Loss of fine material from pneumatophores.
