9.11 Sydney Water

9.11.2 Canals

Appendix 10: Field Assessment Sheets for Priority Sites

Canal Inspection Record - POW_E01

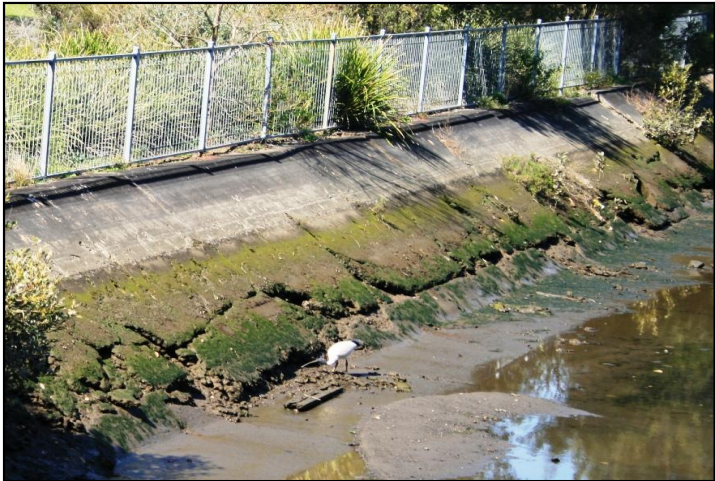
Condition Assessment:
The concrete panels that form the canal sides have cracked and along their lower half. The bed is also cracking.
Sinkholes are present behind the structure crest. The conditions improves to the south.

Photo 1
Cracking and loss of concrete where sloping side meets bed.

- Ongoing monitoring of the structural condition of canal walls in poor condition (DOB_E03, HAS_E07, HAS_E08, HAS_W05, POW_W02 BPW_W02); Investigate sinkholes present behind the wall indicating a loss of material from behind (HAW_W01, HAW_E01)

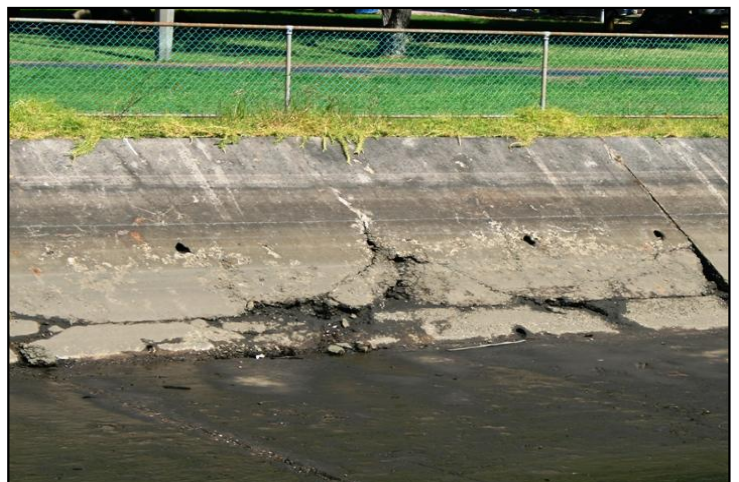
Photo 2

The canal sides are cracking between the concrete panels. The concrete that forms both the sides and the bed is also weathered with aggregates visible.

Cracking and weathering of concrete.

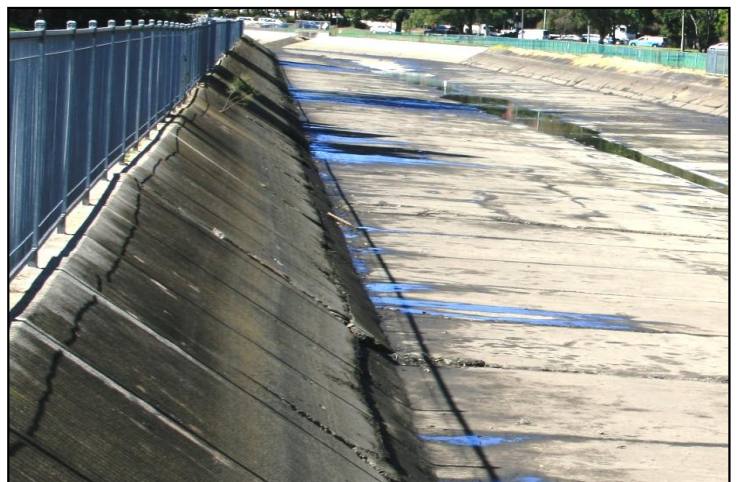
Photo 2

The canal is cracking between the concrete panels. The concrete that forms both the sides and the bed is also weathered with aggregates visible.

Cracking and weathering of concrete.

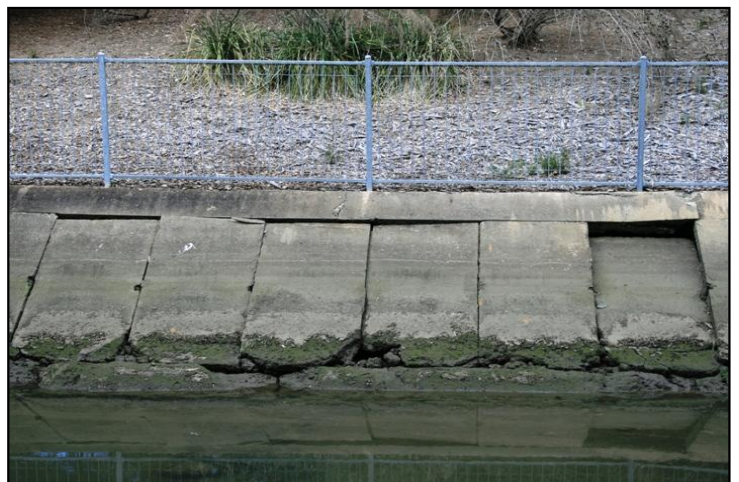
Photo 2

Concrete panels are cracked and weathered. Many have collapsed backwards due to a loss of fines from behind the wall. The concrete bed has corroded with aggregates visible.

Collapsed concrete panels.

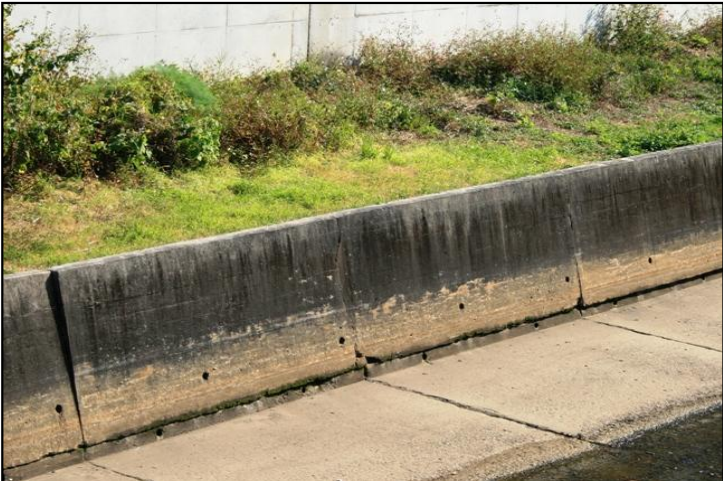
Condition Assessment:
Minor cracking and weathering of concrete observed. Cracks are particularly evident between concrete panels.
Condition worsens to the south.

Photo 2
Cracking and weathering of vertical concrete wall between panels.
