Canal Inspection Record

- POW\_E01

LocalityPowells Creek East Bank, Concord West

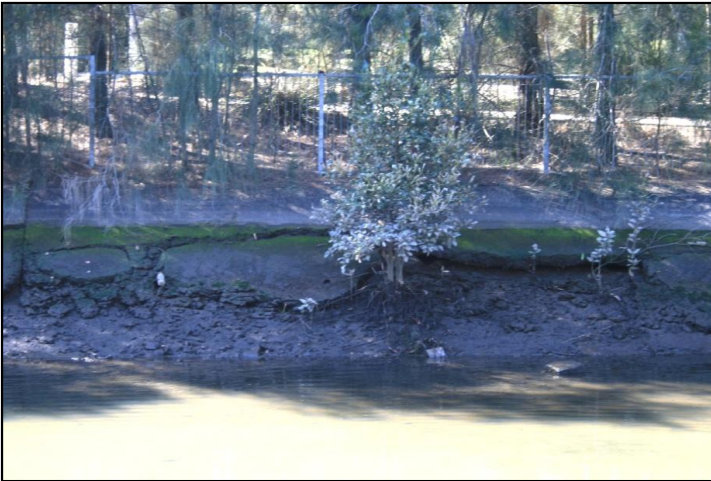
Photo 1

The concrete panels that form the canal sides have cracked and failed along their lower half. The bed has also failed. Sinkholes are present behind the structure crest. The conditions improves to the south.

Typical condition of northern section of canal showing failure of sloping concrete wall.

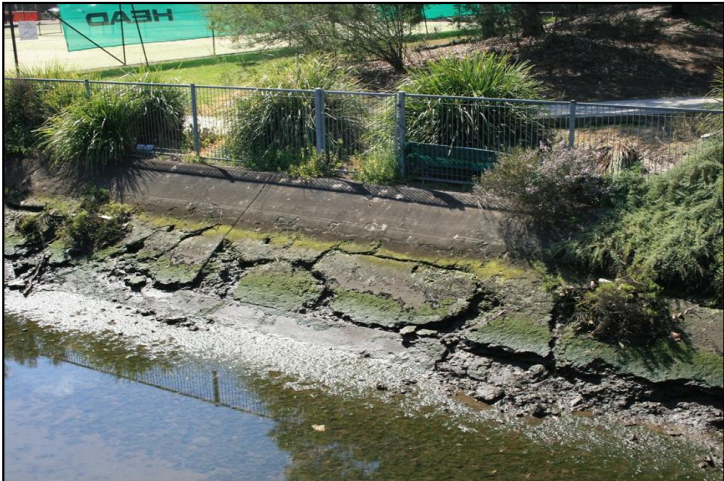
Photo 2

Typical section of southern section of canal showing cracking of canal wall.

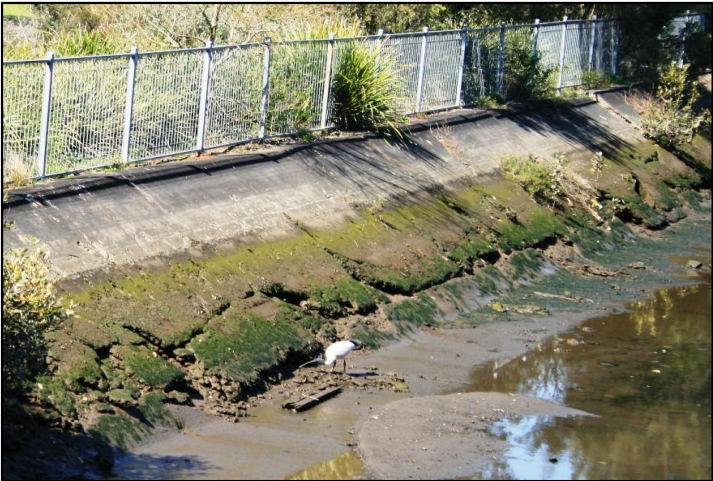
Photo 1

The concrete panels that form the canal sides have cracked and along their lower half. The bed is also cracking.

Cracking and loss of concrete where sloping side meets bed.

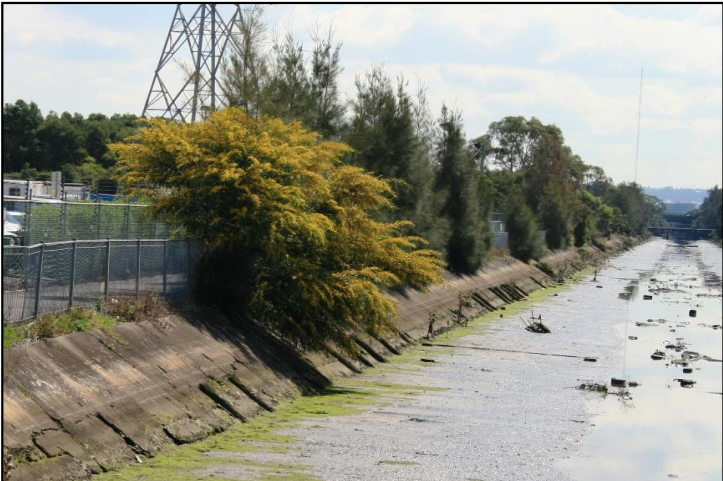
Photo 2

Southern section of canal. Condition is better than at northern section.

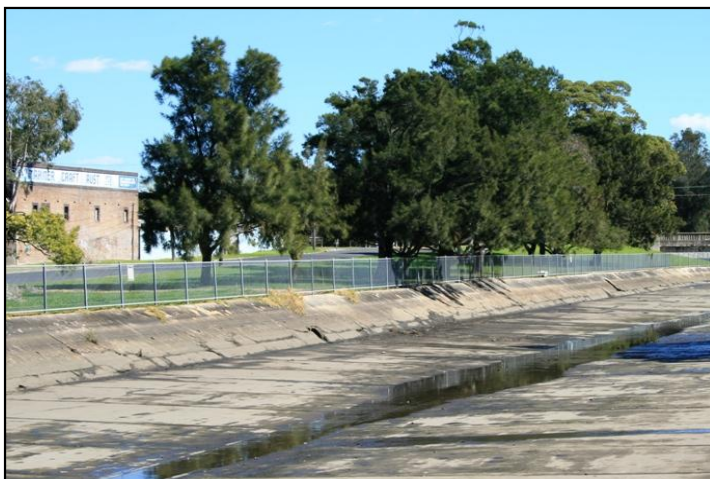
Photo 1

View of canal.

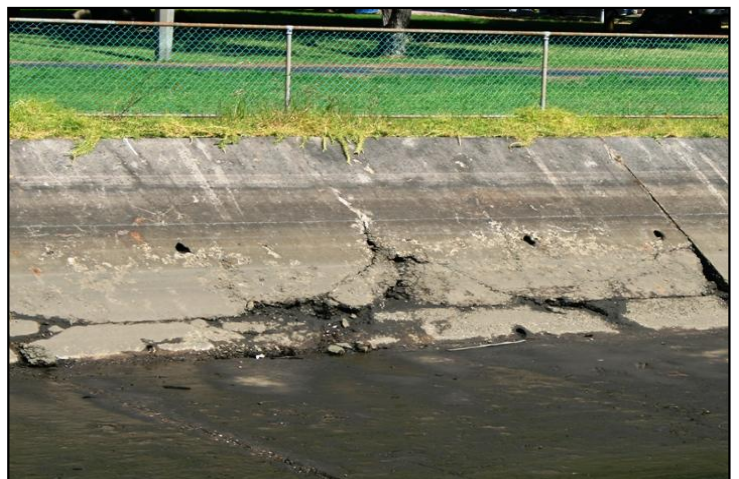
Photo 2

The canal sides are cracking between the concrete panels. The concrete that forms both the sides and the bed is also weathered with aggregates visible.

Cracking and weathering of concrete.

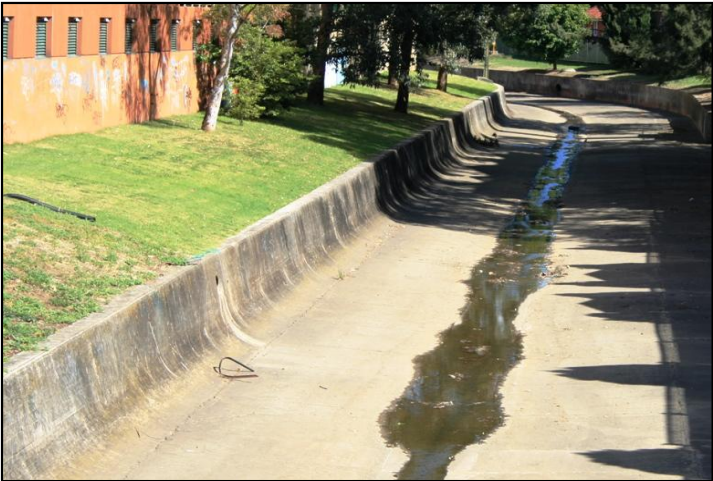
Photo 1  
View of southern western extent of canal.

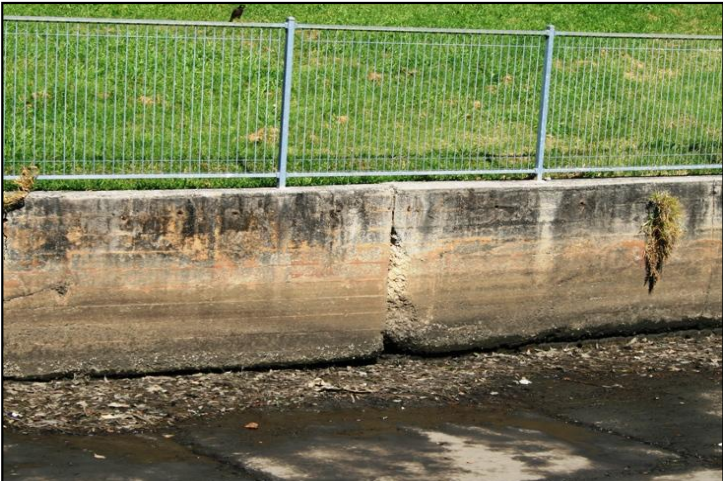
Condition Assessment:  
The canal wall is cracking between the concrete panels and also between the panels and the bed. The concrete that forms both the sides and the bed is also weathered with aggregates visible. The condition of the canal improves to the south east.

Photo 2  
Cracking and weathering of concrete between sides and bed at north eastern extent.

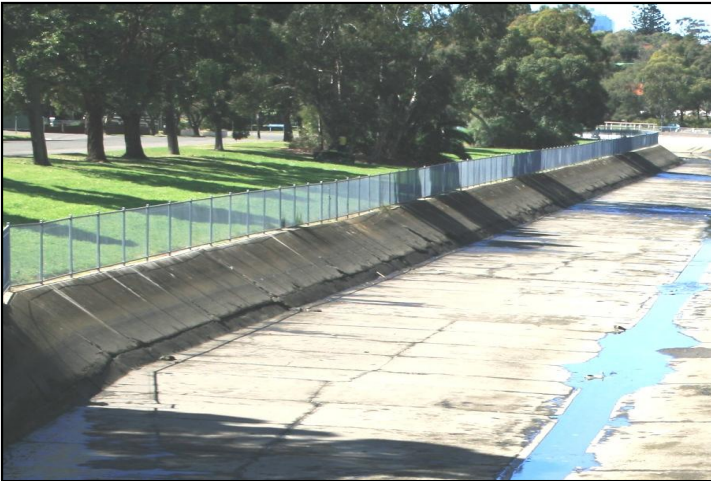
Photo 1

View of canal.

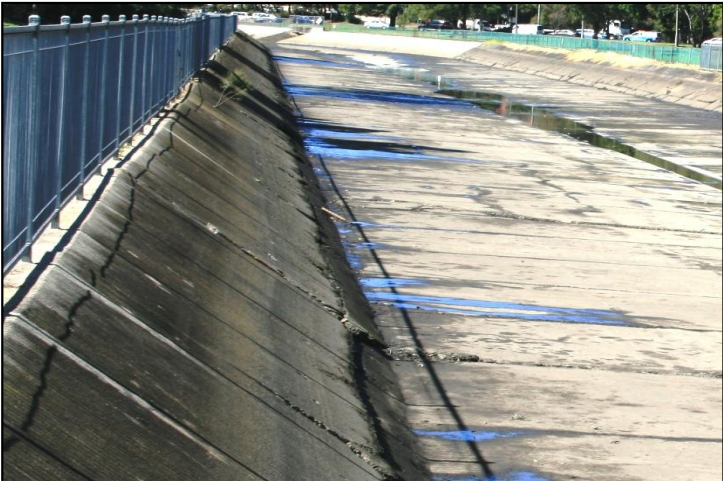
Photo 2

The canal is cracking between the concrete panels. The concrete that forms both the sides and the bed is also weathered with aggregates visible.

Cracking and weathering of concrete.

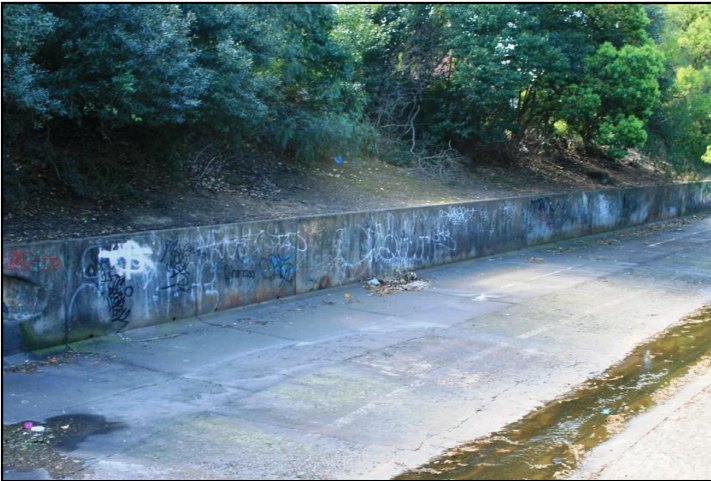
Photo 1  
View of southern western extent of canal.

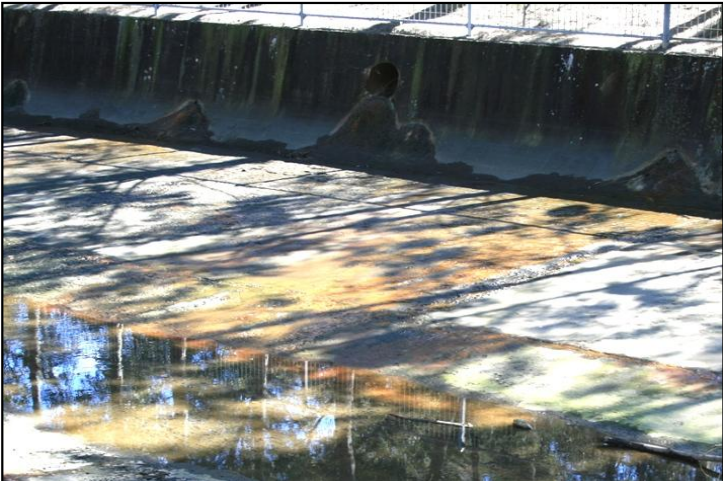
Condition Assessment:  
The canal wall is cracking between the concrete panels and also between the panels and the bed. The concrete that forms both the sides and the bed is also weathered with aggregates visible. Leachate is present from the wall.  
The condition of the canal improves to the south east.

Photo 2  
Corrosion of concrete with leachate shown.

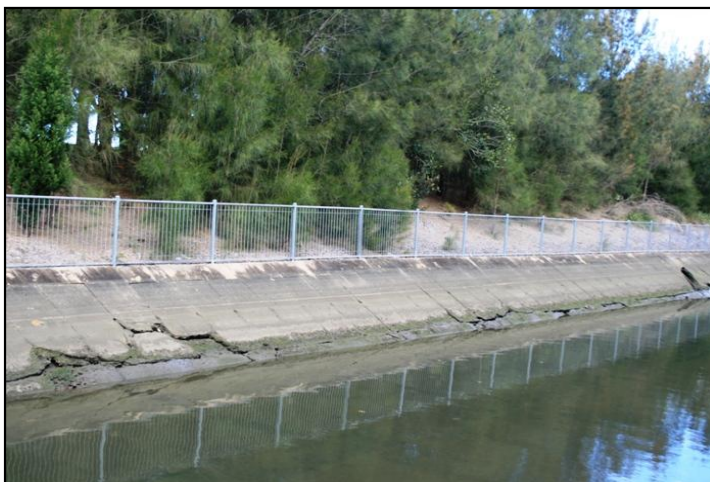
## Photo 1

Typical view of structure.

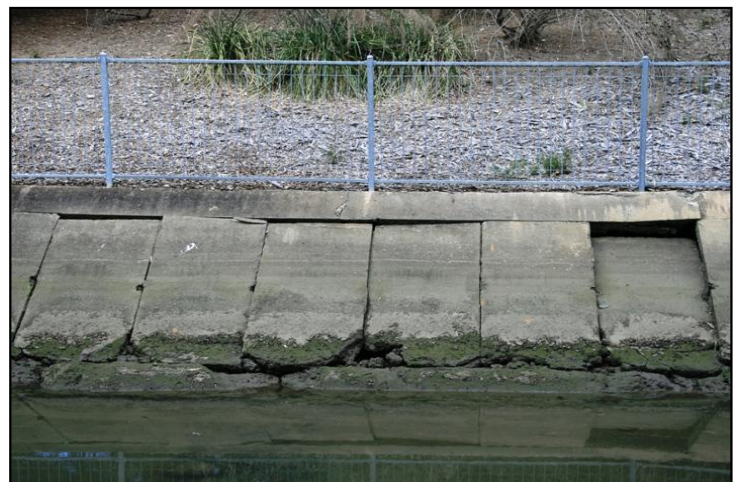
## Photo 2

Concrete panels are cracked and weathered. Many have collapsed backwards due to a loss of fines from behind the wall. The concrete bed has corroded with aggregates visible.

Collapsed concrete panels.

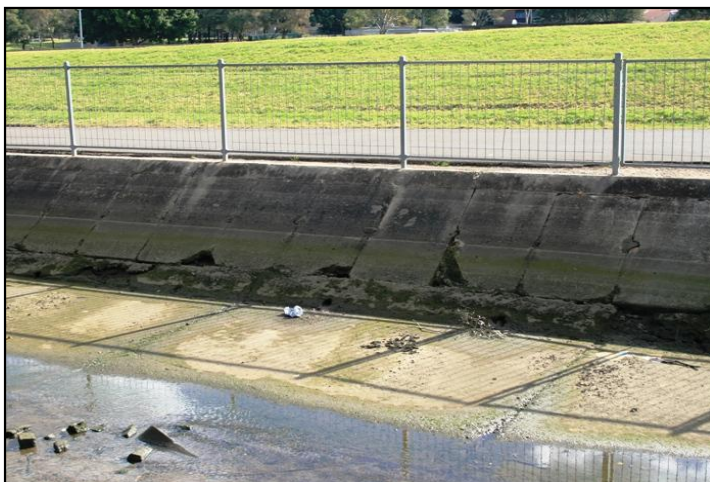
## Photo 1

Typical view of structure.

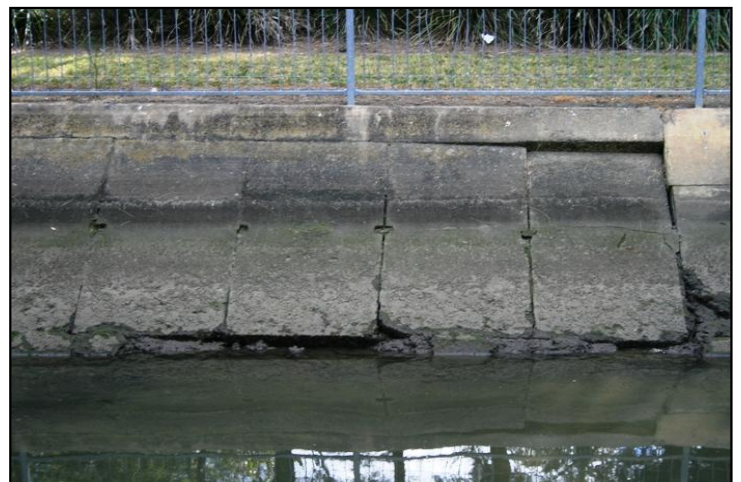
## Photo 2

Concrete panels are cracked and weathered. Many have collapsed backwards due to a loss of fines from behind the wall. The concrete bed has corroded with aggregates visible.

Collapsed concrete panels.

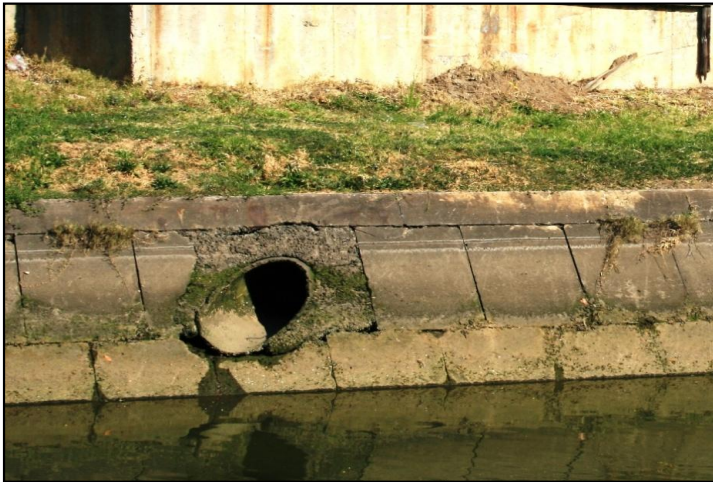
Condition Assessment:  
Minor cracking and weathering of concrete observed. Cracks are particularly evident between concrete panels.  
The wall is cracking beneath the eastern abutment of Parramatta Road.

Photo 1  
Cracking between concrete panels.

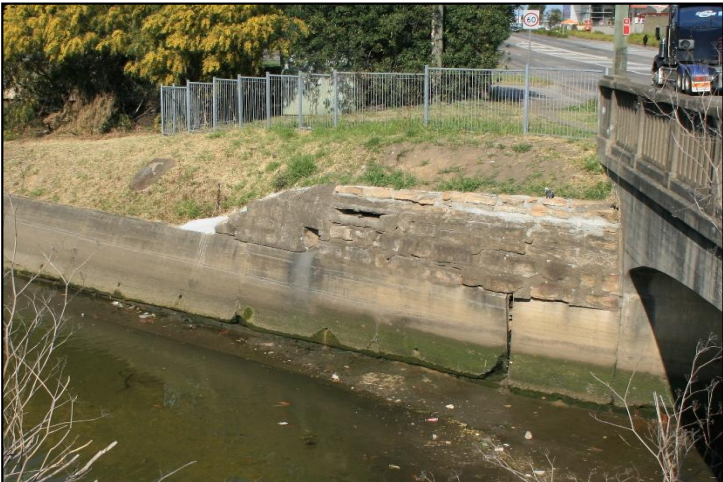
Assets:  
The bank supports abutments for two road bridges and is cracking beneath one.

Photo 2  
Cracks beneath eastern abutment of Parramatta Road.

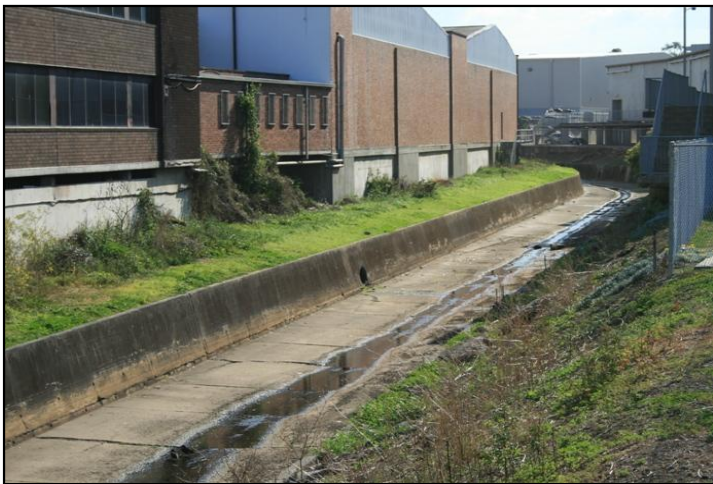
Photo 1  
Typical view of concrete canal.

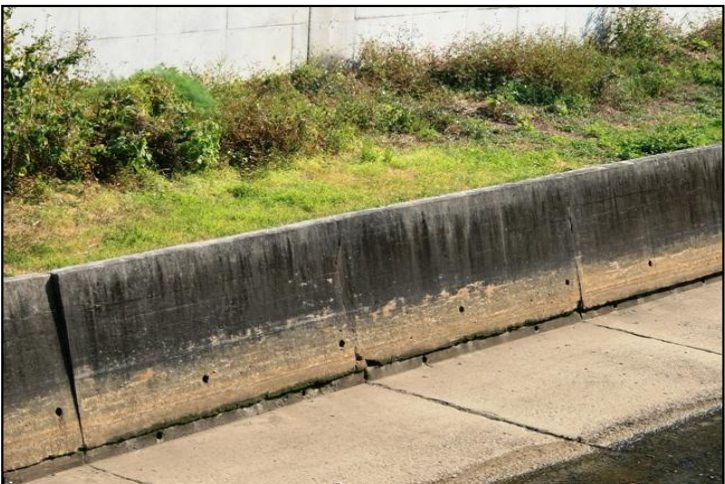
Condition Assessment:  
Minor cracking and weathering of concrete observed. Cracks are particularly evident between concrete panels.  
Condition worsens to the south.

Photo 2  
Cracking and weathering of vertical concrete wall between panels.

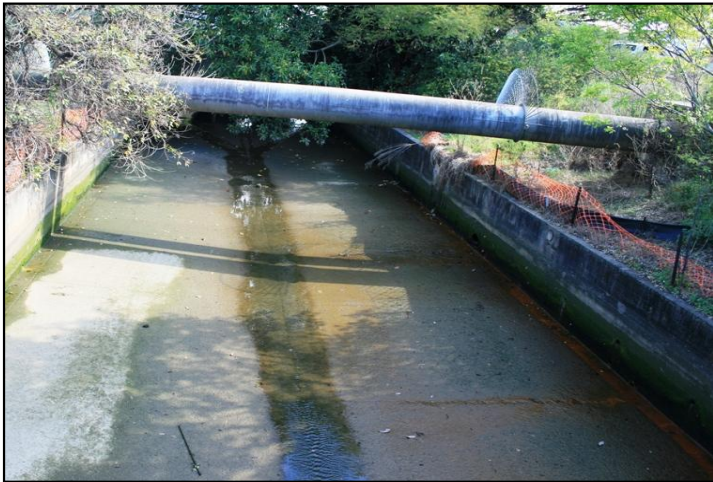
Photo 1

Typical view of concrete canal.

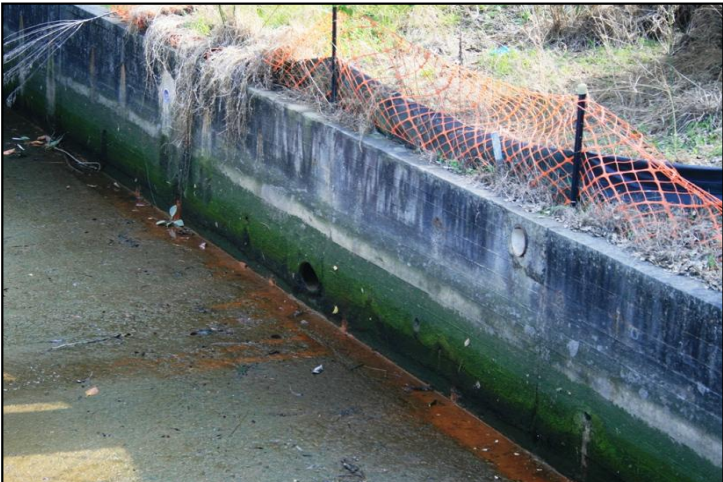
Photo 2

Minor cracking and weathering of concrete observed. Cracks are particularly evident between concrete panels.

Minor cracking and weathering of vertical concrete wall.
