Seawall Inspection Record - LEI_S08

Date	<u>4/08/09</u>	Locality	<u>Rozelle, Iron Cove Bay</u>	Level (AHD)	<u>0.82m</u>	LGA	<u>Leichhardt</u>
Time	<u>13:35</u>			Tide	<u>Low-Mid</u>

Seawall Inspection Record - LEI_S09

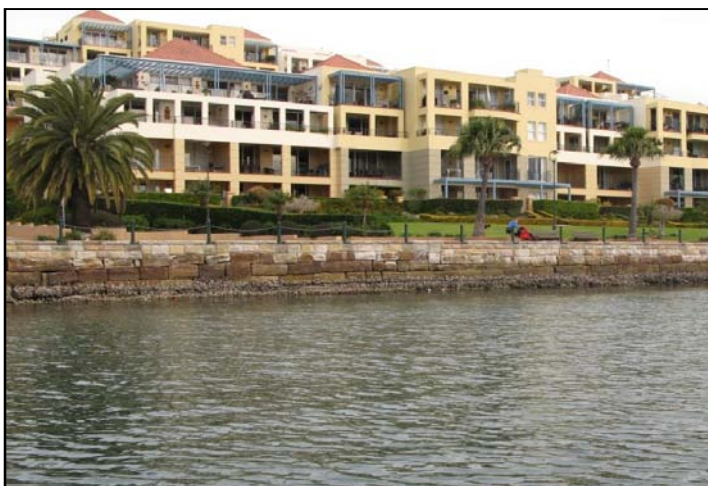
Photo 1

Exposed old sandstone blocks along bottom of wall are slumping. Concrete capping is showing signs of surface weathering and has in many places begun to crack and has fallen away from the old sandstone wall. Major undermining is present at discrete locations.

Northern part of wall showing slumping of old sandstone blocks and new blocks along crest.

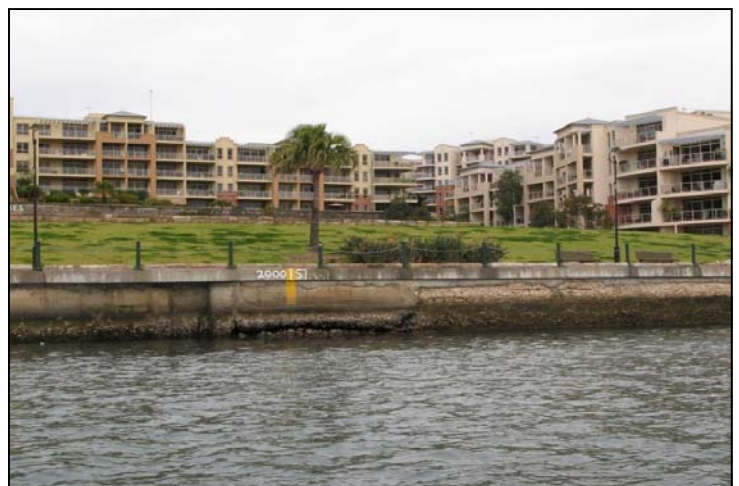
Photo 2

Undermining of seawall and concrete capping of wall face and crest.

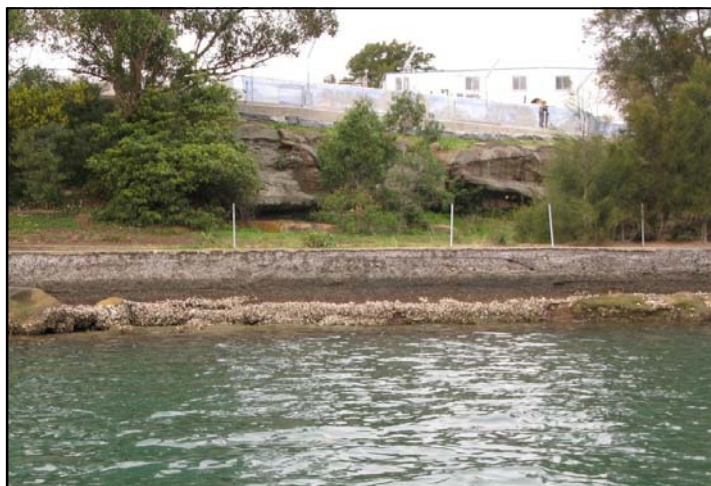
Photo 1

Concrete has been lost from the vertical face of the wall. The concrete is showing signs of severe surface weathering with aggregates visible. Major horizontal and vertical cracks are also present. The safety fence has significantly corroded and has collapsed in some places.

View of NE extent of wall showing weathering and cracking of concrete. No safety fence present.

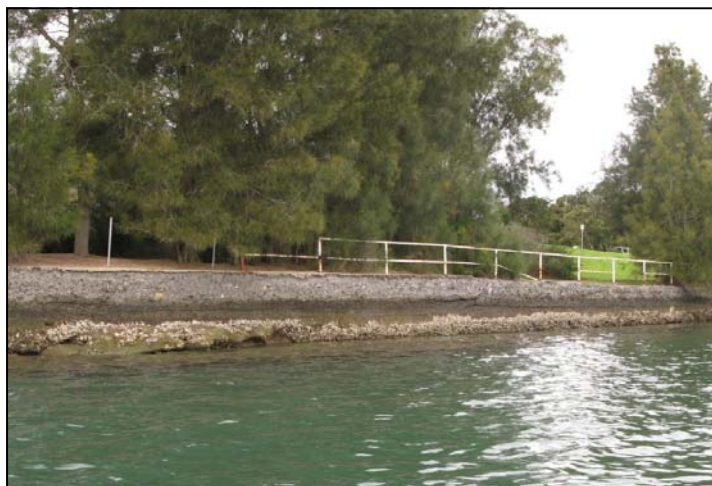
Photo 2

SW extent of seawall showing concrete cracking and failure of safety fence.

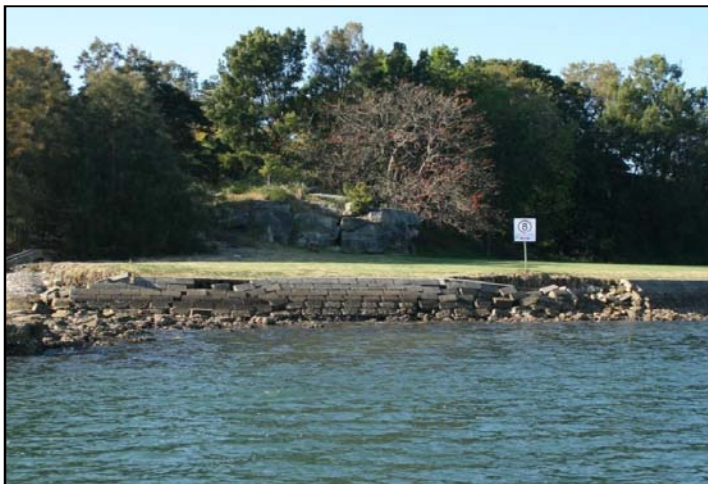
Photo 1

The structure has failed at its northern extent with a large cavity present behind the wall. The rest of the revetment is slumping and is undermined at the toe particularly at the southern extent.

Failure of revetment at northern extent.

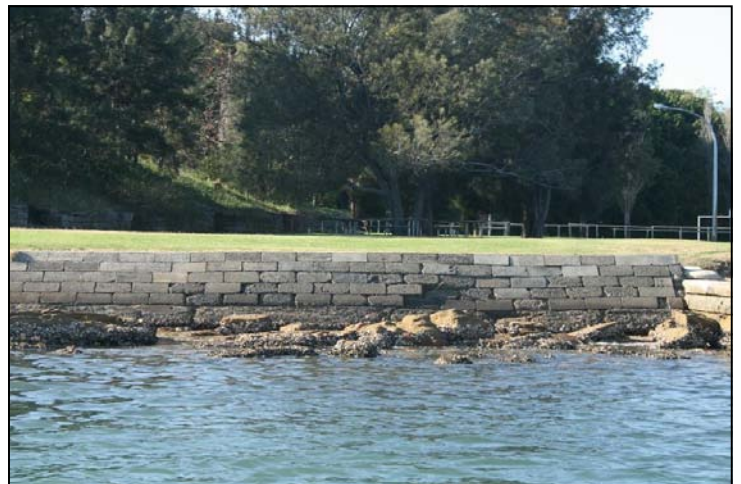
Photo 2

Slumping and movement of blocks at southern extent.

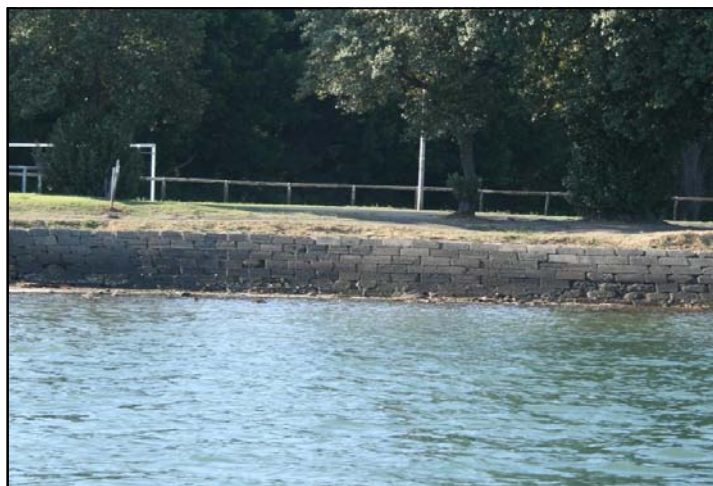
Photo 1

Typical view of revetment.

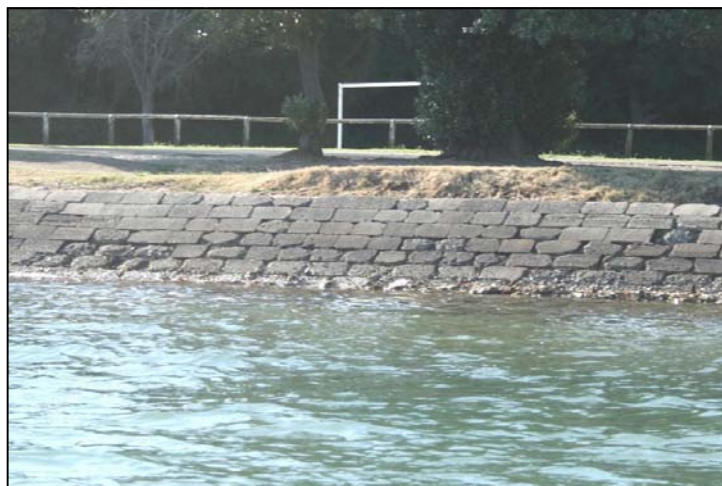
Photo 2

Surface weathering with aggregate exposed and slumping due to loss of fine material was observed. Sinkholes and erosion of earth behind structure was observed indicating inundation and/or exposure to wash during periods of elevated water levels.

Surface weathering and slumping of concrete blocks and erosion of earth beyond crest.

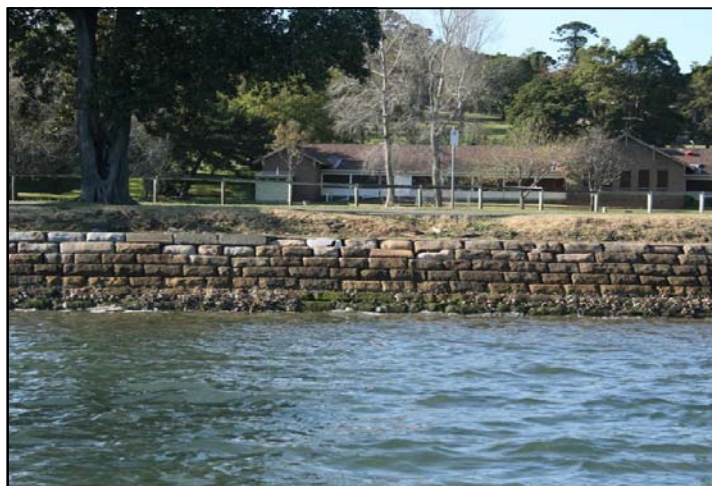
Photo 1

Typical view of revetment showing surface weathering, slumping and erosion of earth beyond crest.

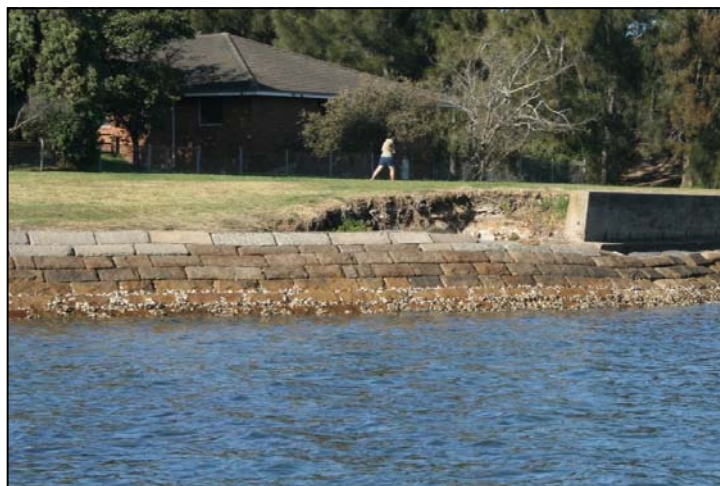
Photo 2

The revetment has failed at its southern extent where it joins LEI_S15 with a large cavity present behind the wall.
Surface weathering of sandstone blocks & slumping due to loss of fine material was also observed. Sinkholes & erosion of earth behind structure indicates inundation and/or exposure to wash during periods of elevated water levels.

Failure of structure at southern extent.

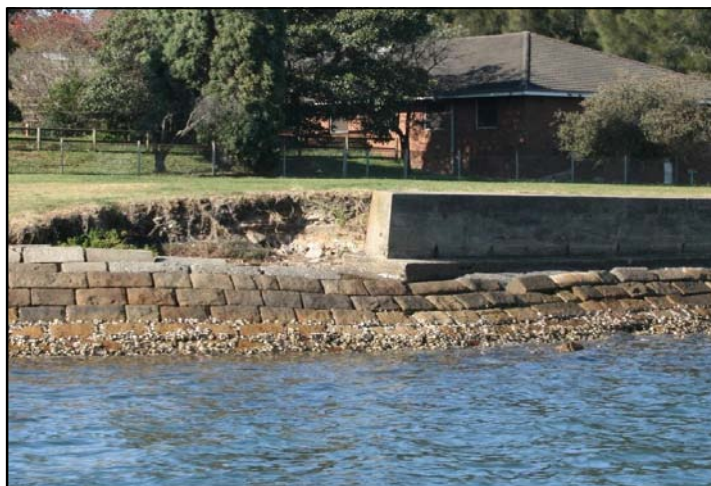
Photo 1

The structure has failed at its northern extent where it meets seawall LEI_S14. The rest of the structure, surface weathering of sandstone blocks & slumping due to loss of fine material was observed. The concrete retaining wall is leaning towards the water in some places with minor cracking observed.

Failure of structure at northern extent.

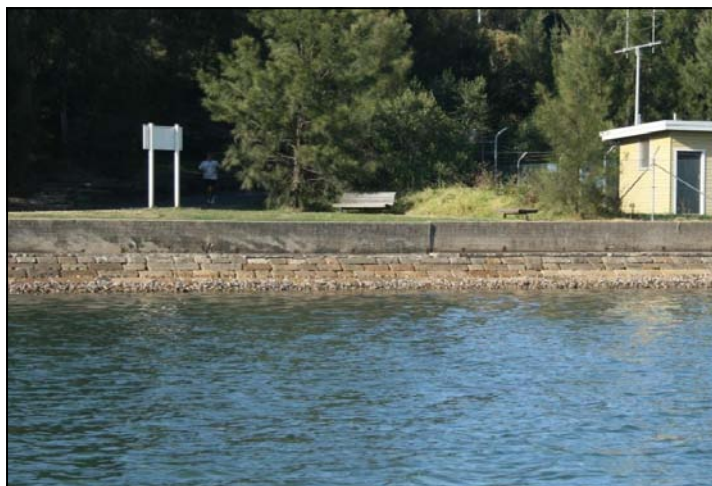
Photo 2

Typical view of structure showing weathering and slumping of sandstone blocks and leaning concrete retaining wall.

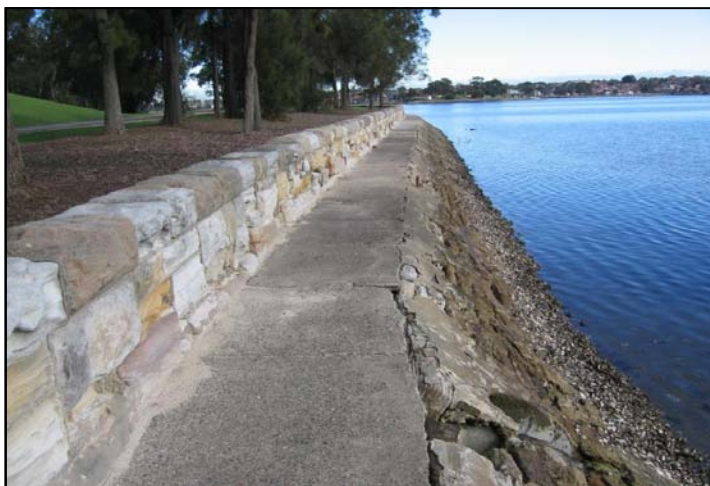
Photo 1

Typical view of revetment and wall.

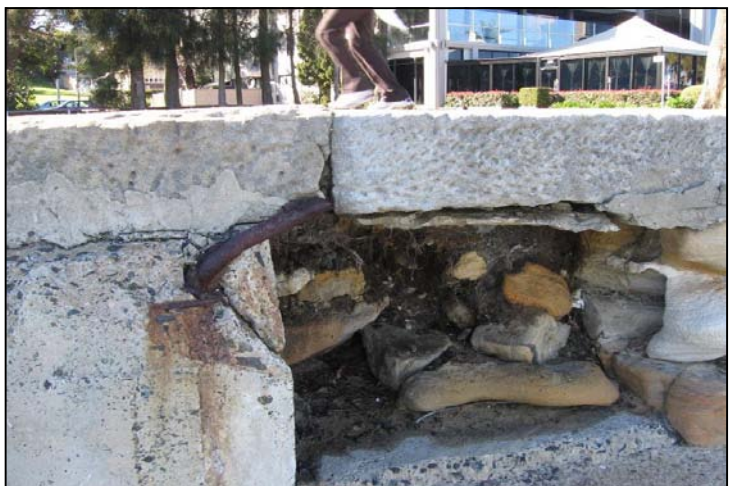
Photo 2

Loss of grout from both sloping and vertical sections. Block failures and sever undermining of adjacent footpath are also present. The newer vertical sandstone blocks have began to weather indicating that a low-grade sandstone may have been used. The old concrete footpath between the two sandstone section is cracking in many places.

Block failure of newer vertical sandstone wall beneath footpath.

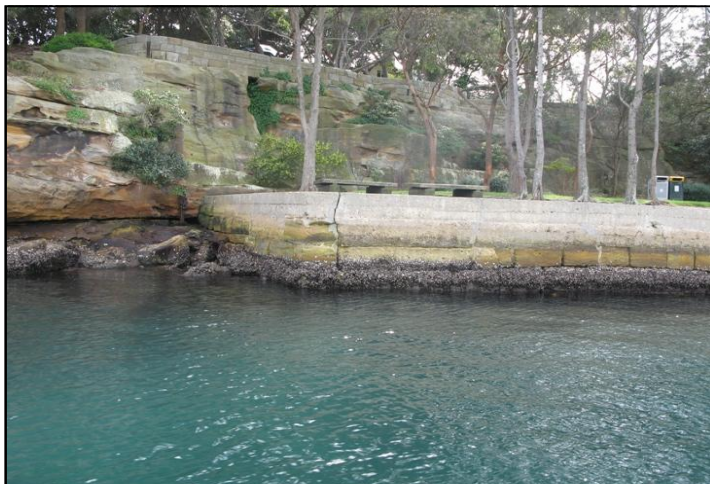
Photo 1

Large crack at SW corner extending from crest to toe. Large sinkhole behind seawall crest at NE corner.
Surface weathering of sandstone blocks and concrete capping with aggregate exposed also observed.

Block failure at SW corner

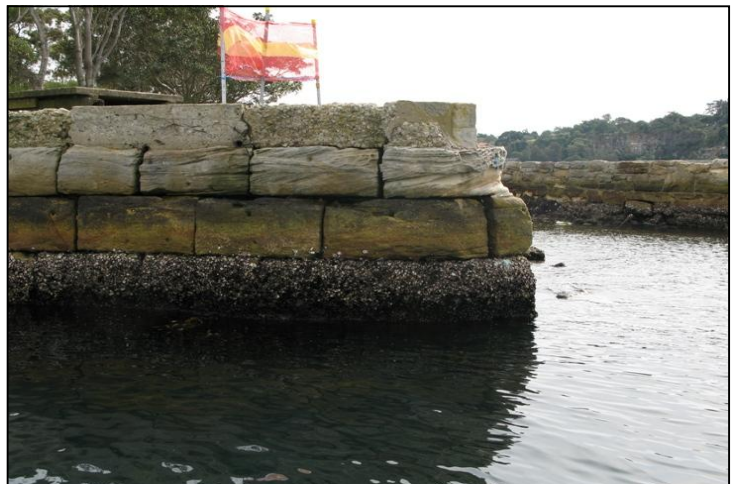
Photo 2

NE corner, temporary safety fence installed beyond crest to prevent public access to sinkhole.

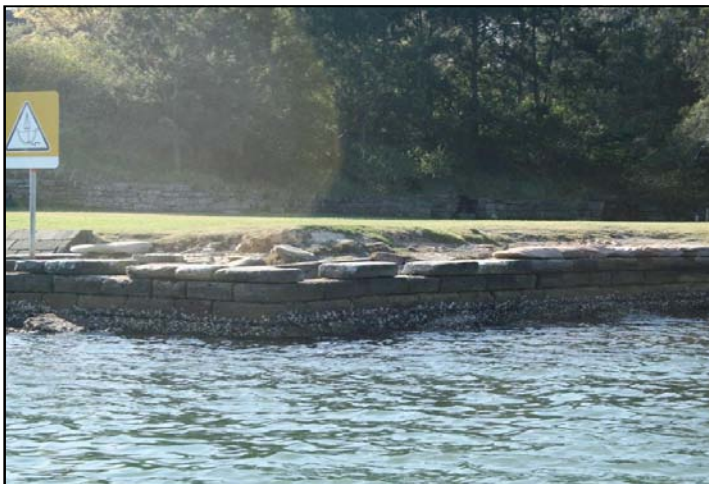
Photo 1

The structure has failed at its northern and southern extents with the blocks that make up the crest dislodged and erosion of material from behind. The rest of the revetment is slumping and is undermined at the toe.

Failure of seawall at northern extent.

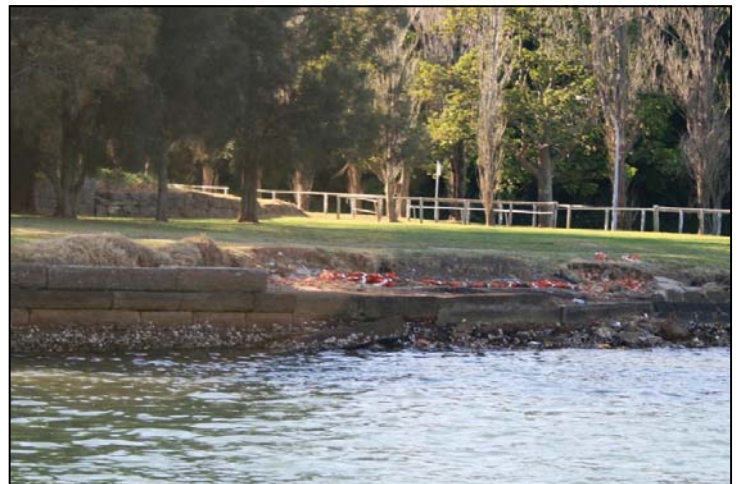
Photo 2

Failure of seawall at southern extent.

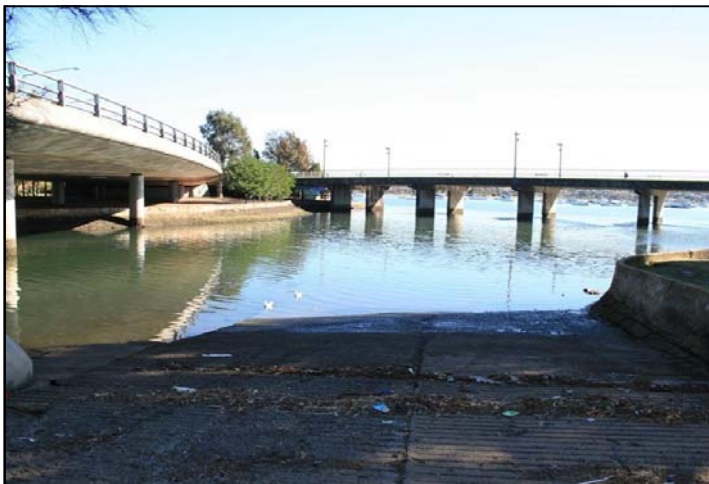
Photo 1

View of boat ramp.

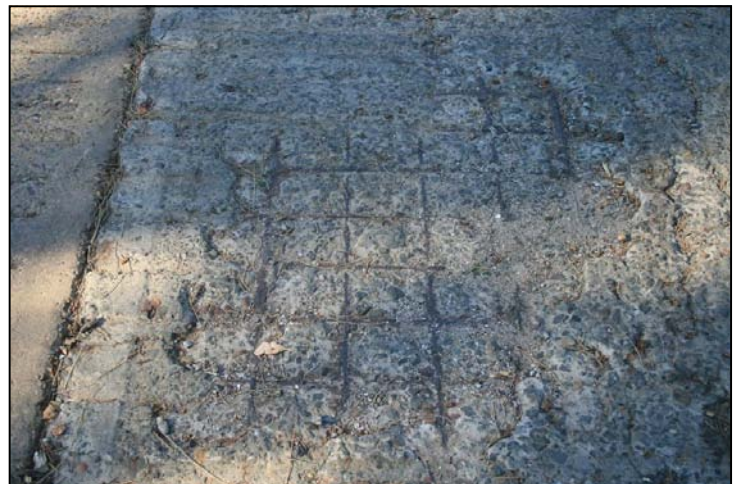
Photo 2

Concrete that forms ramp is cracked and weathered with aggregates and steel reinforcement exposed.

Weathering of concrete with aggregate and reinforcement exposed.

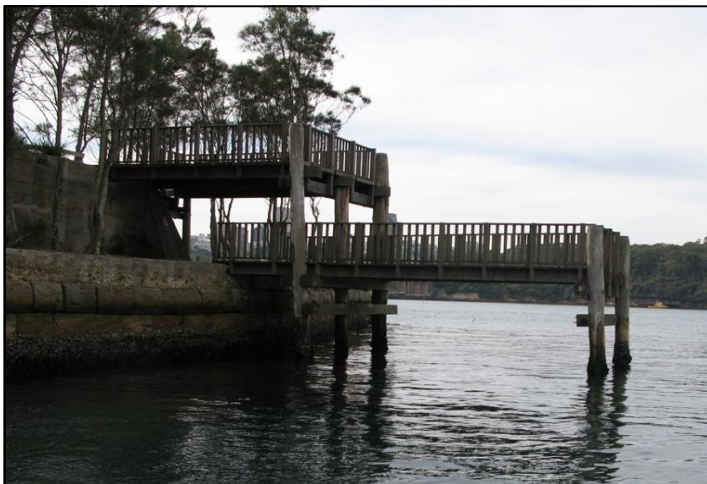
Photo 1

View of structure.

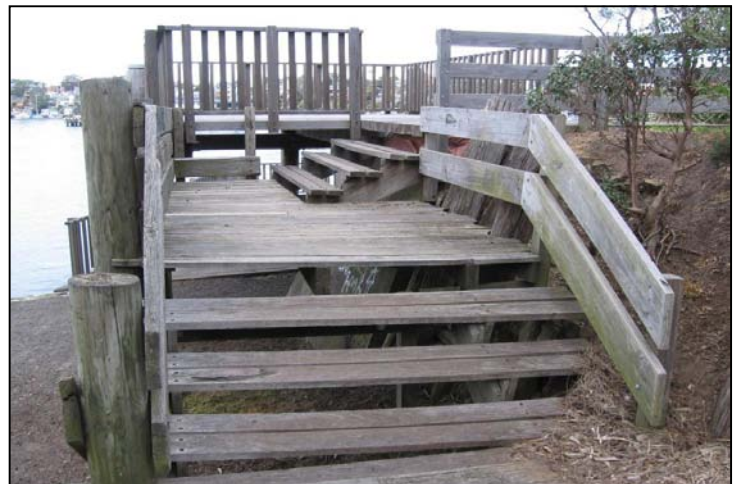
Photo 2

Condition Assessment: Stairs on land have collapsed and require replacement. The rest of the structure including timber piles is in a good condition	Excellent Good Poor Failed	<input type="checkbox"/> <input checked="" type="checkbox"/> <input type="checkbox"/> <input type="checkbox"/>
--	-------------------------------------	---

Issues:
 Collapsed stairs are a hazard for pedestrians. Structure is supported by vertical sandstone seawall (LEI_S01).

Collapsed stairs.

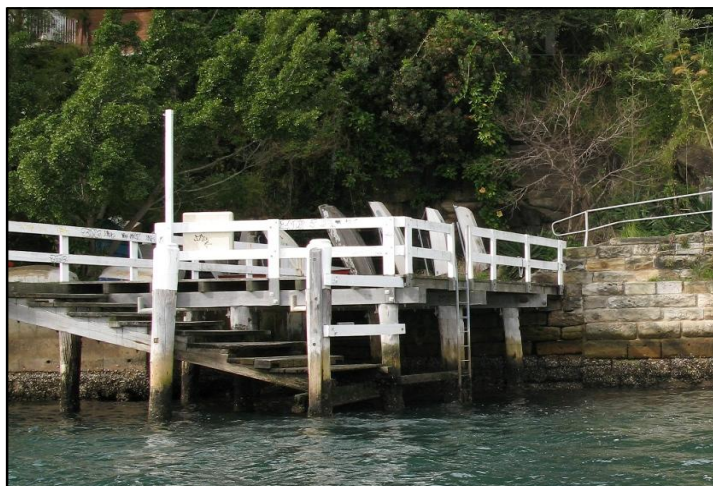
Photo 1

Timber wharf facility showing dinghy storage at public park and vertical sandstone seawall

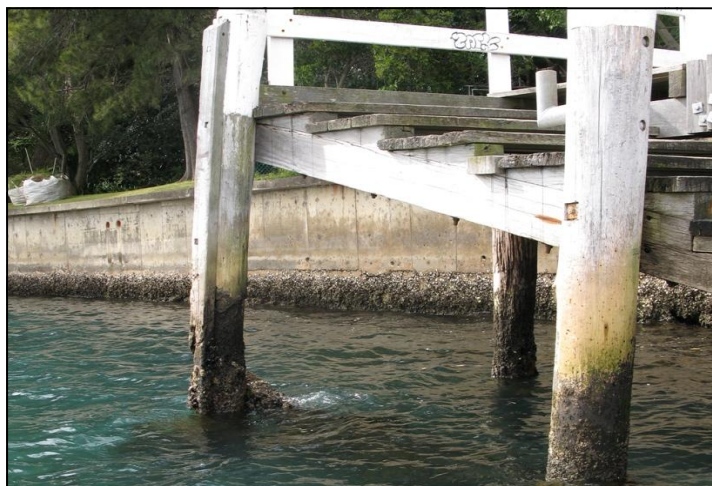
Photo 2

Generally good. Timber piles are thinning and are off vertical. Grout is missing from blocks beneath wharf and are slumping. Sandstone has also weathered creating voids. Some maintenance has been carried out to the south of the wharf with sandstone blocks replaced and grout added. Concrete section to the north is in good condition.

Timber sea stairs and pile. Vertical concrete seawall is also shown in background

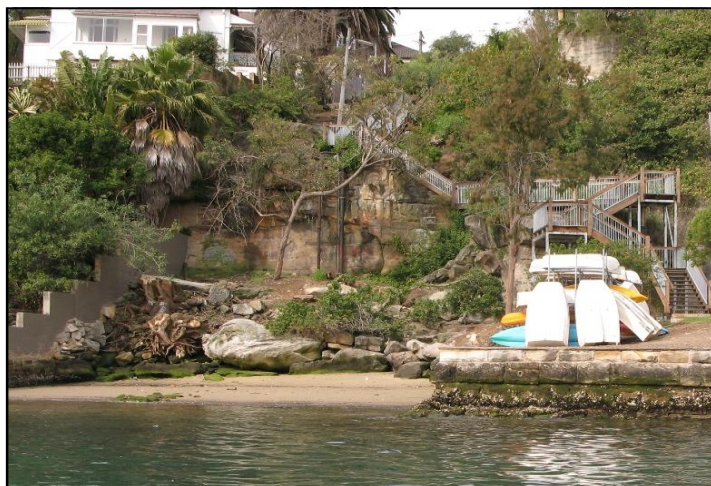
Photo 1

Storage rack and access from street. Dinghies are launched from adjacent beach

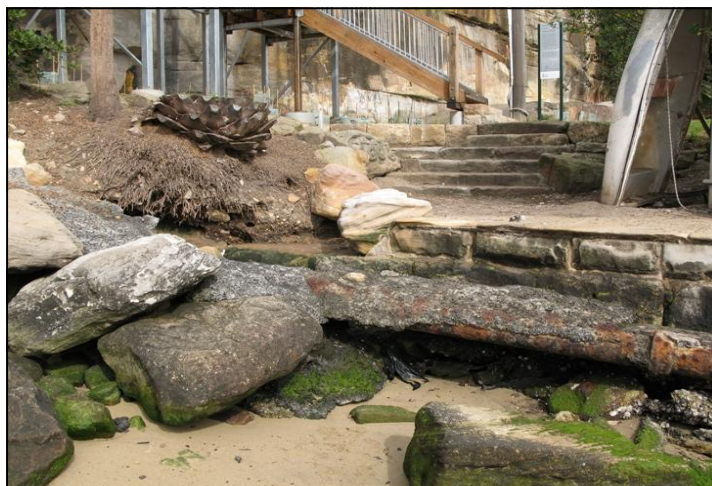
Photo 2

No formal access to beach is provided for launching dinghies. At high tide dinghies must be launched from rocks.

Access to beach

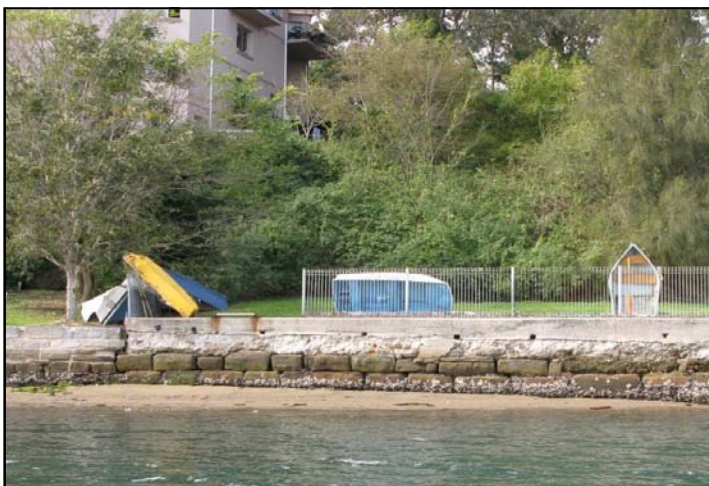
Photo 1

View of informal storage facility.

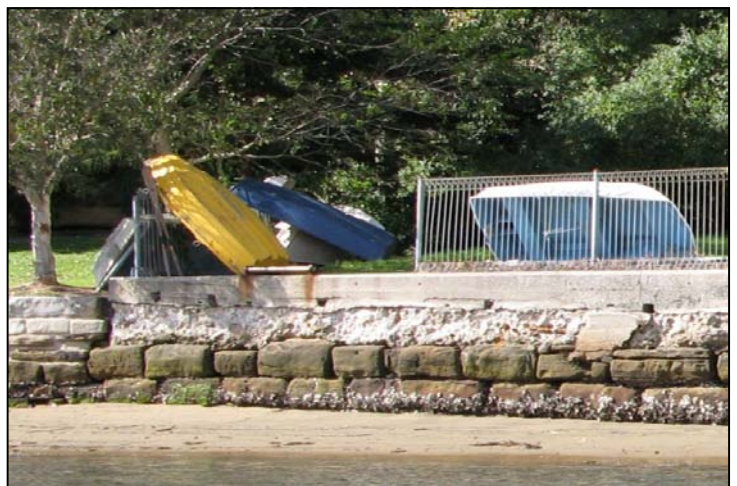
Photo 2

Dinghies tethered to steel fence.

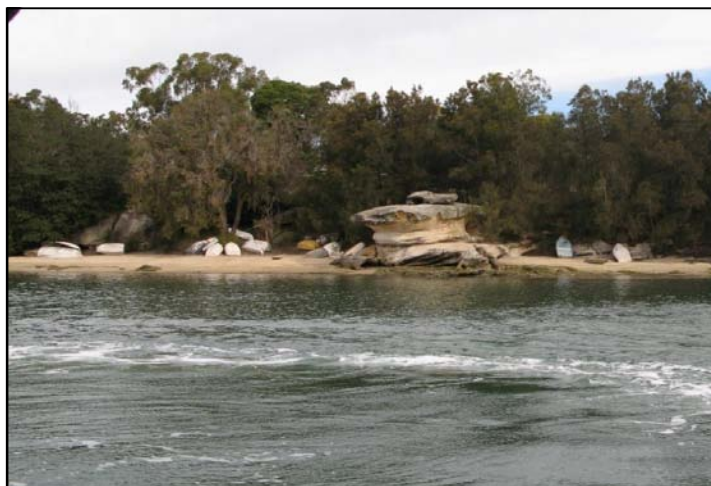
Photo 1

View of informal storage facility.

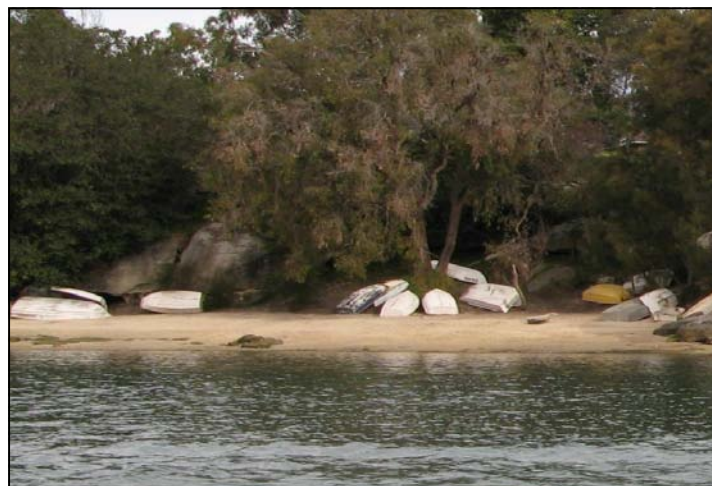
Photo 2

Dinghies tethered to trees on shoreline.
