Seawall Inspection Record - ASH_S01

Date	<u>1/09/09</u>	Locality	<u>Adjacent City West Link</u>	Level	<u>0.87m</u>	LGA	<u>Ashfield</u>
Time	<u>9:20</u>			Tide	<u>Mid</u>

Seawall Inspection Record

- ASH_S02

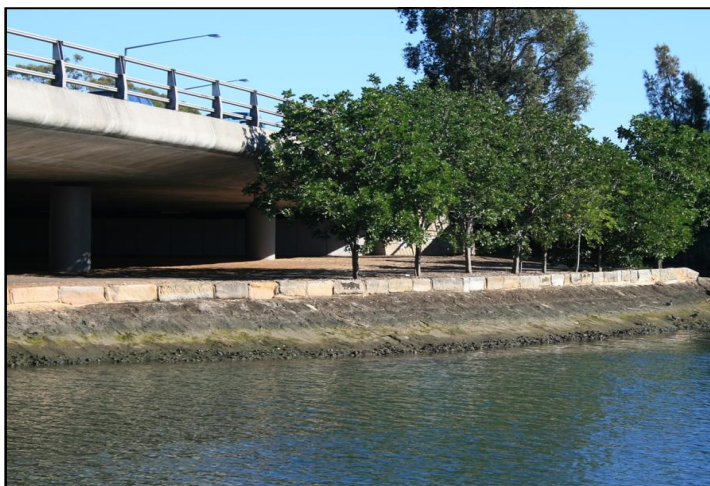
Photo 1

Generally good condition. Shotcrete is showing signs of weathering. Minor weathering and loss of grout of new sandstone blocks at crest.

Typical section of revetment.

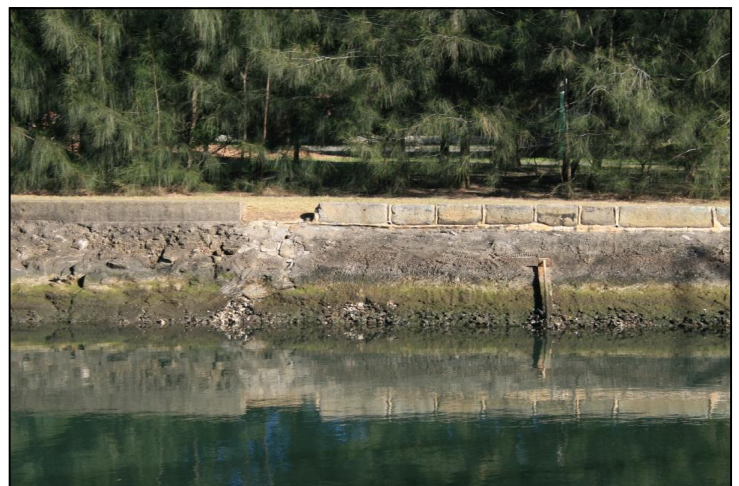
Photo 2

Transition of revetment into Hawthorne Canal.

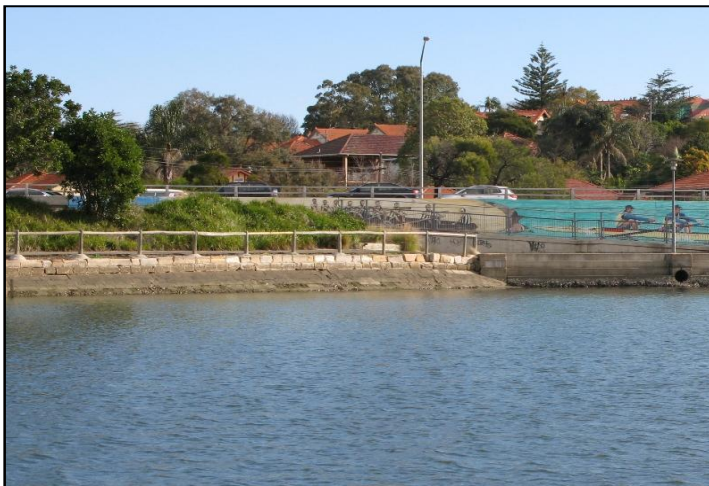
Photo 1

Sandstone seawall is missing grout, slumping and showing signs of weathering on both the sloping and vertical sections. Both sets of sea stairs are in good condition.

Sloping and vertical sandstone blocks and concrete sea stairs sections of the seawall.

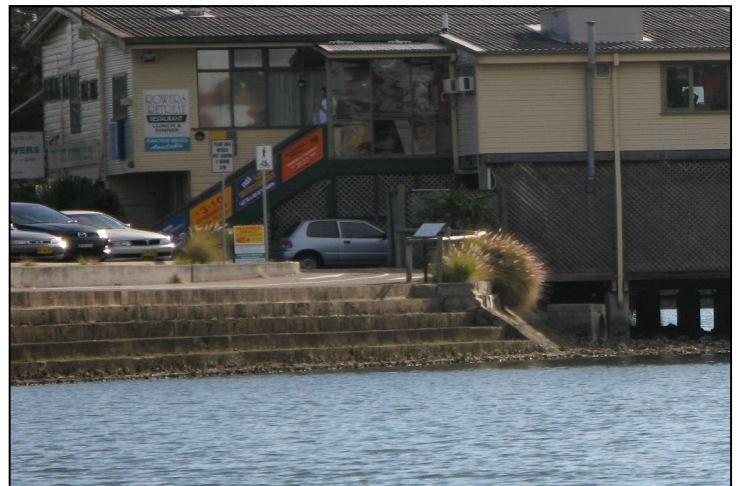
Photo 2

Sandstone sea stairs adjacent to the UTS Rowing Club house.

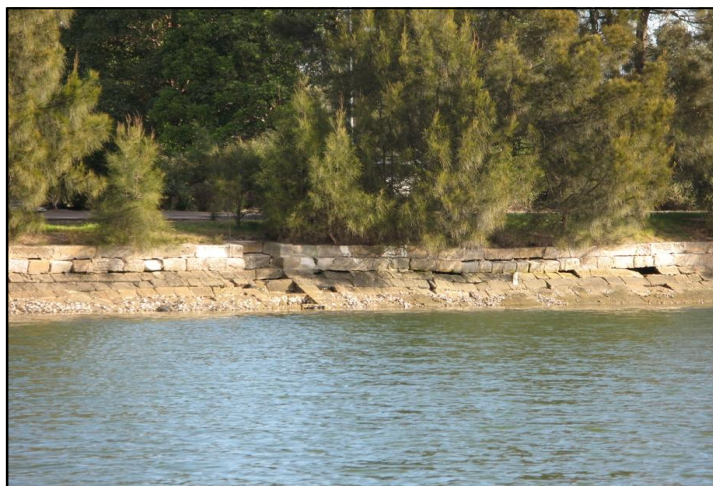
Photo 1

Sandstone seawall is missing grout, slumping and showing signs of weathering on both the sloping and vertical sections. Numerous local block failures were observed. Sea stairs are in good condition, cracking of the stormwater outlets was observed.

Typical view of revetment with block failures, slumping, weathering and loss of grout evident.

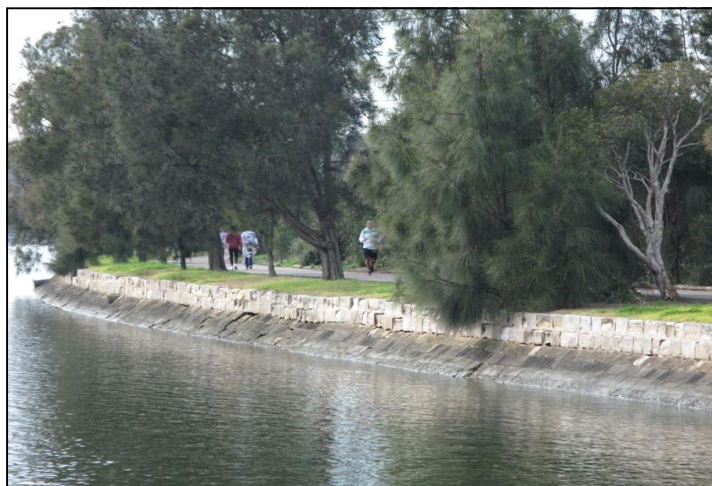
Photo 2

SW section of revetment showing weathering and slumping of sandstone blocks.
