Seawall Inspection Record - ASH_S01

| Date | <u>1/09/09</u> | Locality | <u>Adjacent City West Link</u> | Level | <u>0.87m</u> | LGA | <u>Ashfield</u> |

Seawall Inspection Record - ASH_S02

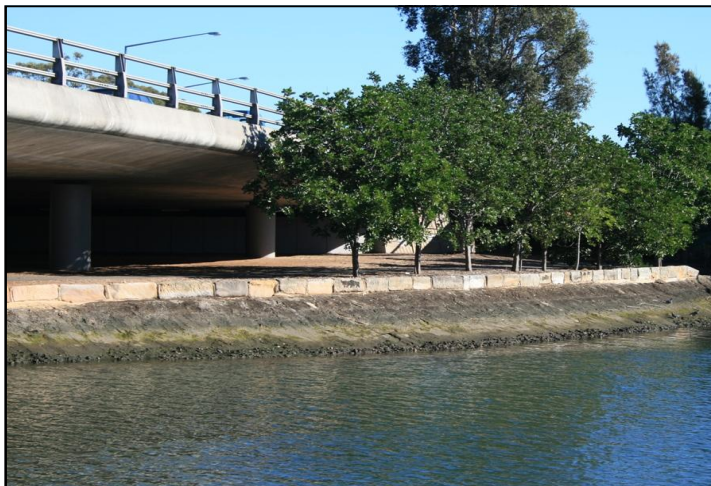
Photo 1
 Typical section of revetment.

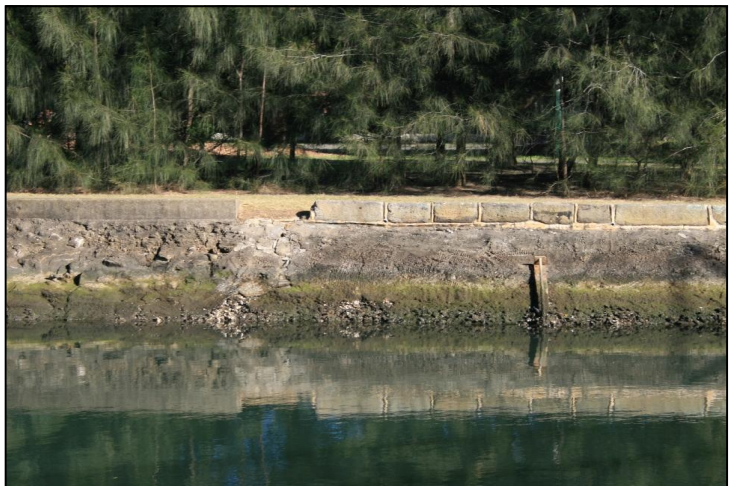
Photo 2
 Transition of revetment into Hawthorne Canal.

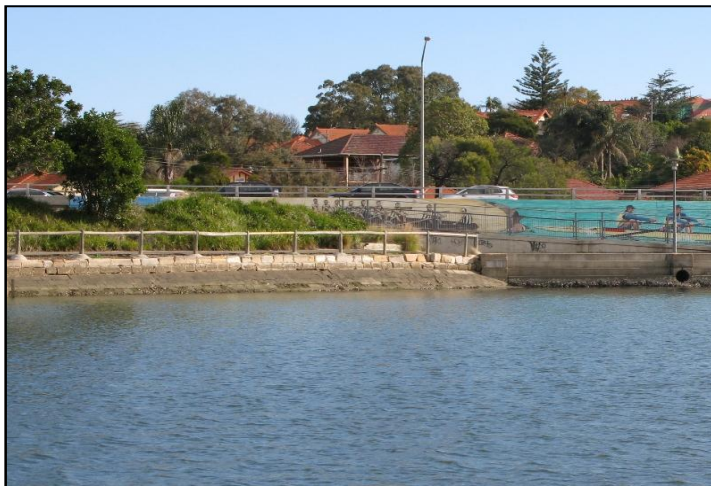
Condition Assessment (Slope, Crest, Toe, Backfill):
Sandstone seawall is missing grout, slumping and showing signs of weathering on both the sloping and vertical sections. Both sets of sea stairs are in good condition.

Photo 1
Sloping and vertical sandstone blocks and concrete sea stairs sections of the seawall.

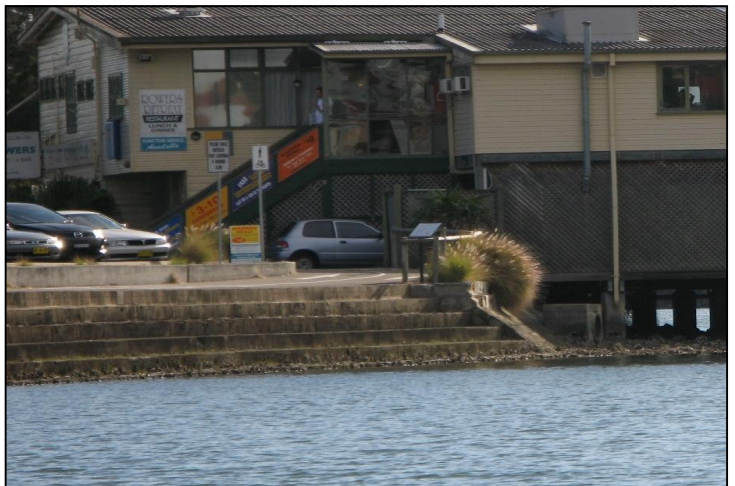
Photo 2
Sandstone sea stairs adjacent to the UTS Rowing Club house.
