Seawall Inspection Record - CAN_S60

Date	17/08/09	Locality	Mortlake Point, River South	Level	1.13m	LGA	
Time	13:17			People	Mid	Canada Bay

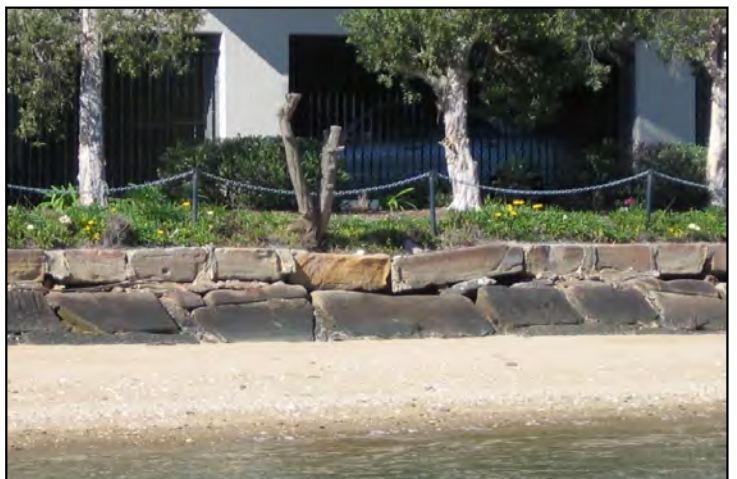
Condition Assessment (Slope, Crest, Toe, Backfill):	Excellent	<input type="checkbox"/>
The blocks that make up the slope are weathered with grout missing leaving voids indicating a loss of material from behind the structure. The vertical blocks at the crest are also weathered and missing grout material, some blocks have collapsed.	Good	<input type="checkbox"/>
	Poor	<input checked="" type="checkbox"/>
	Failed	<input type="checkbox"/>

Photo 2
Collapse of blocks at the crest at southern section of structure.

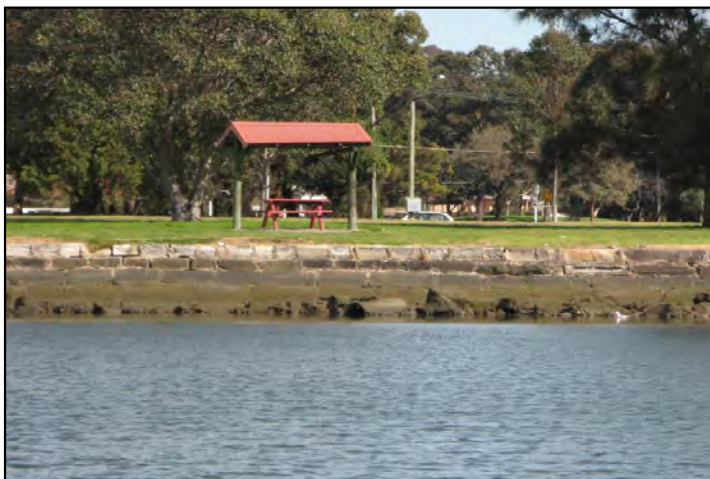
Photo 1

Typical view of revetment.

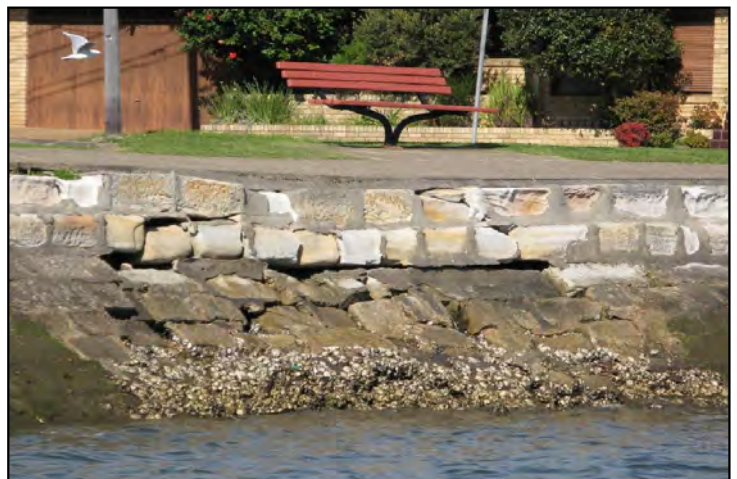
Photo 2

Numerous failures were observed where fine material has been lost from behind the revetment creating large cavities causing blocks to slump. Surface weathering, loss of grout material from blocks and sinkholes behind structure crest were also observed.

The public footpath that runs along the structure has been undermined due to the failures and subsequent loss of fines beneath and may collapse if the revetment is not repaired. The revetment also supports a retaining wall associated with the end of The Esplanade.

Failure of revetment beneath public footpath.

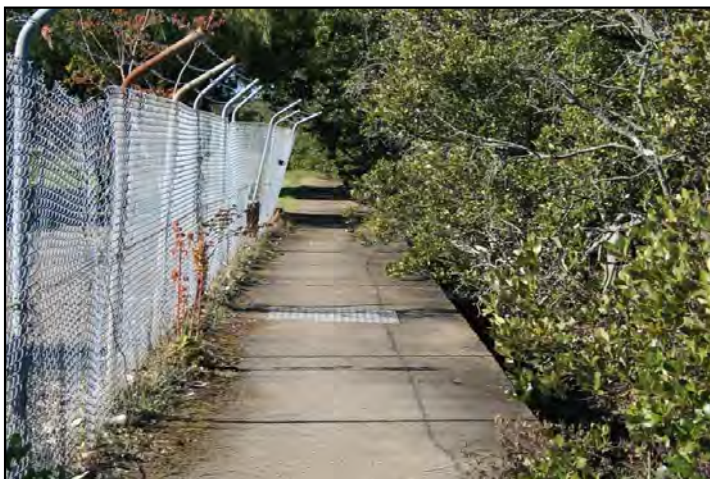
Photo 1

View of structure.

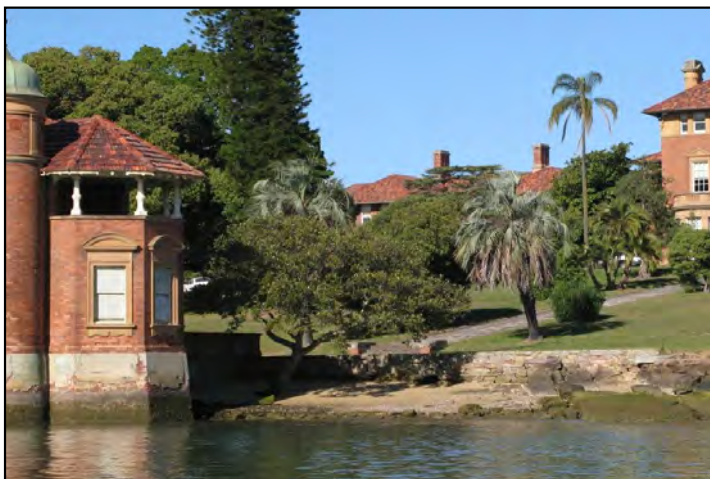
Photo 1

Small section of sandstone seawall adjacent Concord Hospital Watergate.

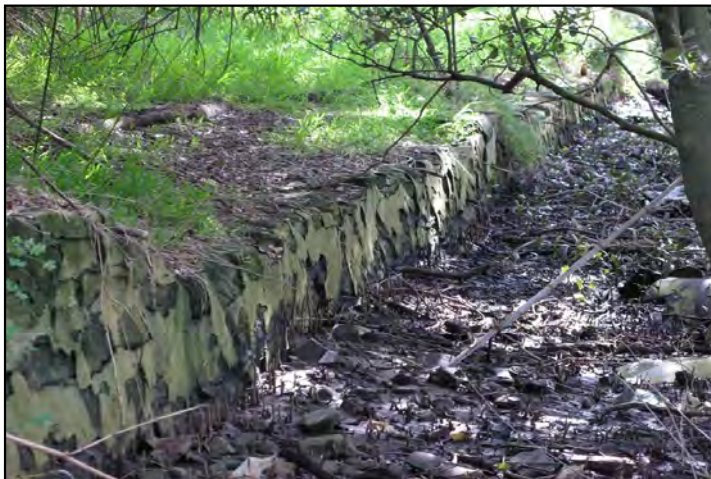
Photo 1

Southern extent of wall.

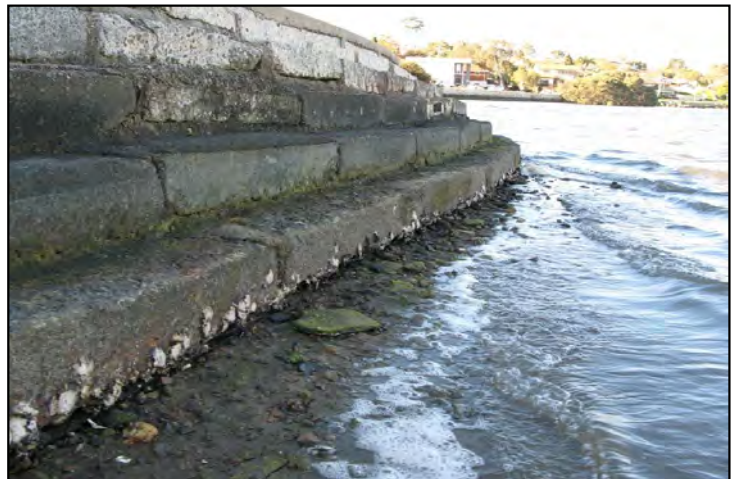
Photo 2

The structure is slumping along its entirety with undermining of the toe, severe weathering of the concrete blocks with aggregate and reinforcement visible and loss of grout observed. The public footpath is cracked in places.

Undermining of the toe and surface weathering of the concrete blocks.

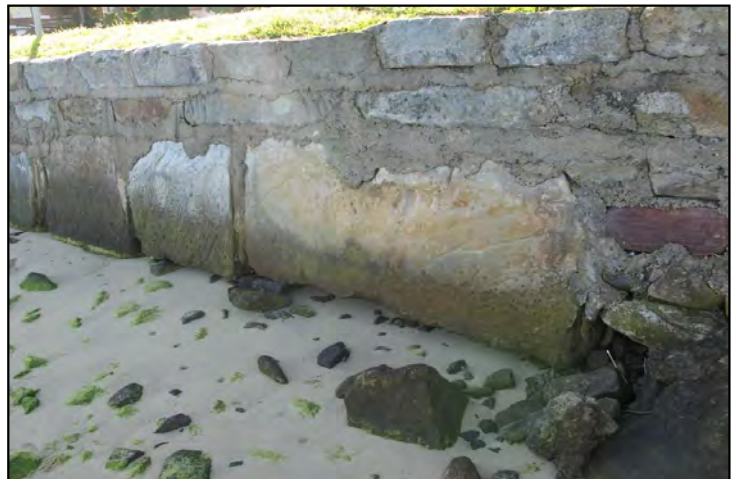
Photo 2

The western extent of the wall has failed with a large void left behind the structure. The rest of the structure is showing signs of weathering and has been undermined at the toe.

Undermining of structure at toe.

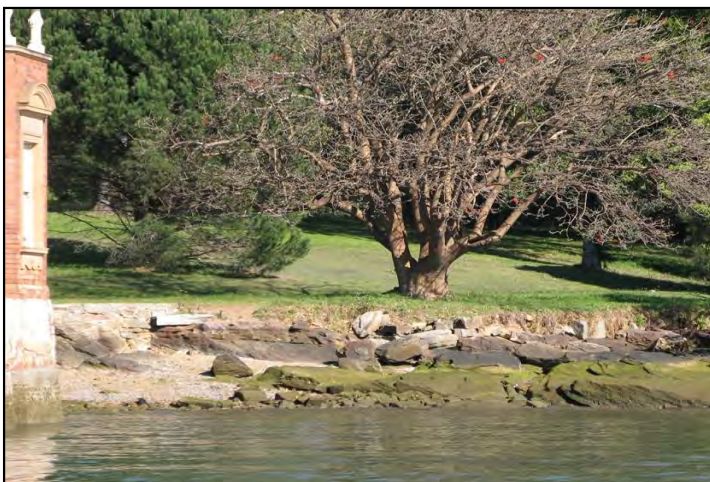
Photo 1

The open section, adjacent Concord Hospital Watergate has a large erosion scarp present. The rest of the foreshore, vegetated with mangroves, is in poor condition with fine material lost from pneumatophores.

Erosion scarp adjacent Concord Hospital Watergate.

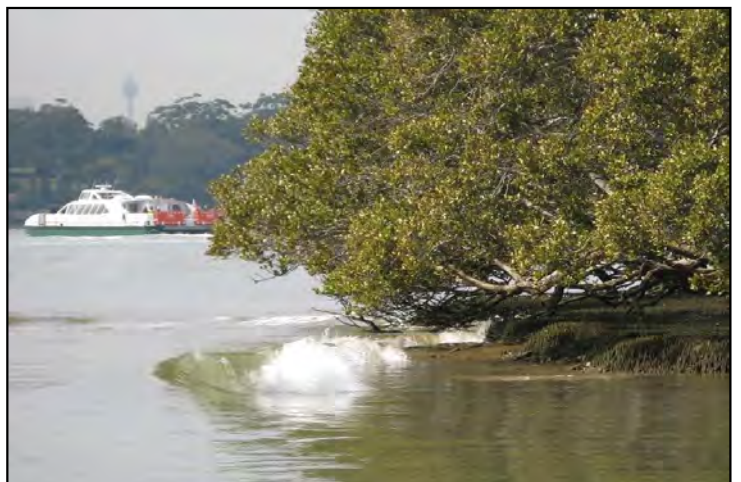
Photo 2

Ferry wash at mangrove section of foreshore with absence of fine material from pneumatophores shown.

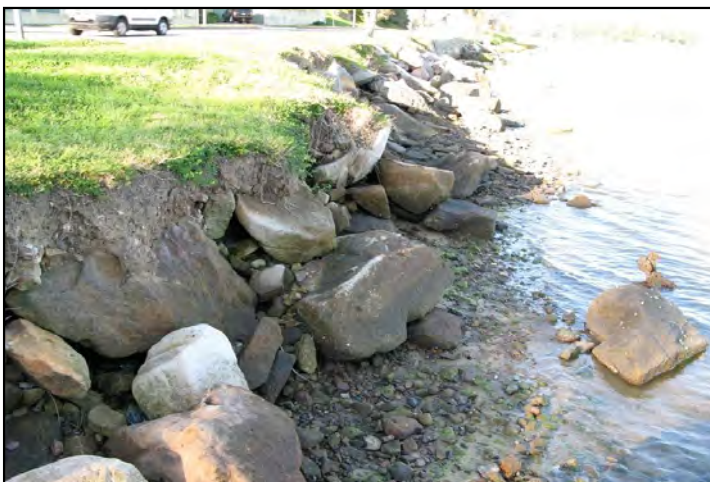
Photo 1

View shoreline showing erosion scarp and sandstone boulders at toe.

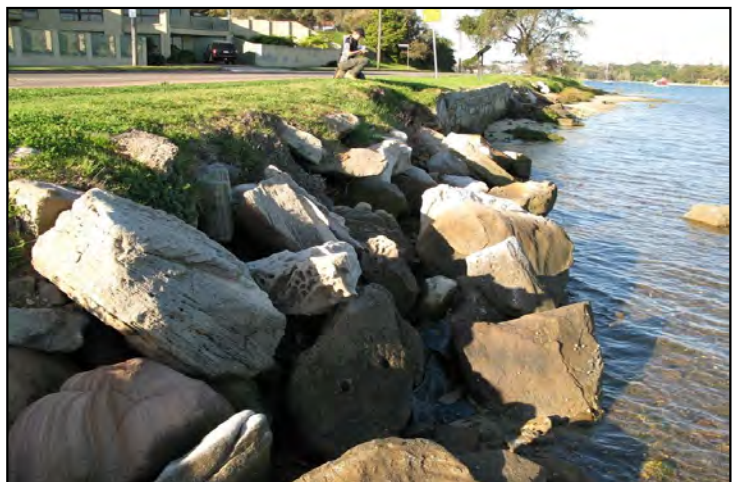
Photo 2

Sandstone boulders placed along shoreline to mitigate erosion.

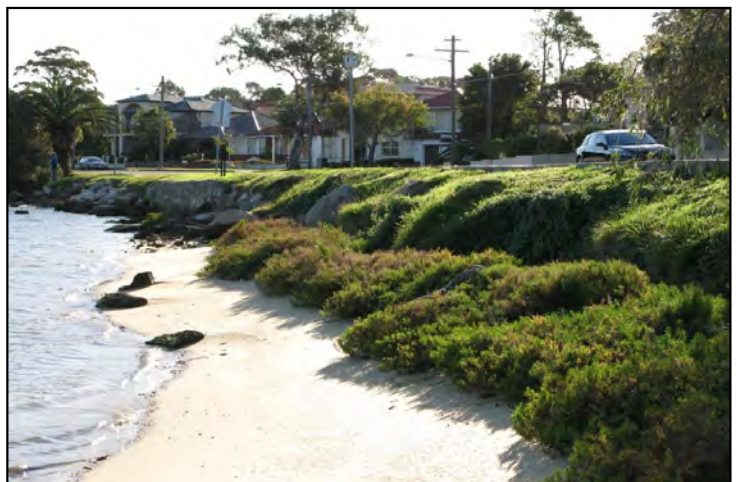
Photo 2

A large erosion scarp, approx 500mm is present. The crest appears to be slumping due to loss of material at the toe. Sandstone boulders have not been placed to typical engineering detail and fine material appears to still be being lost. The adjacent footpath is cracking.

Saltmarsh stand at toe of erosion scarp.

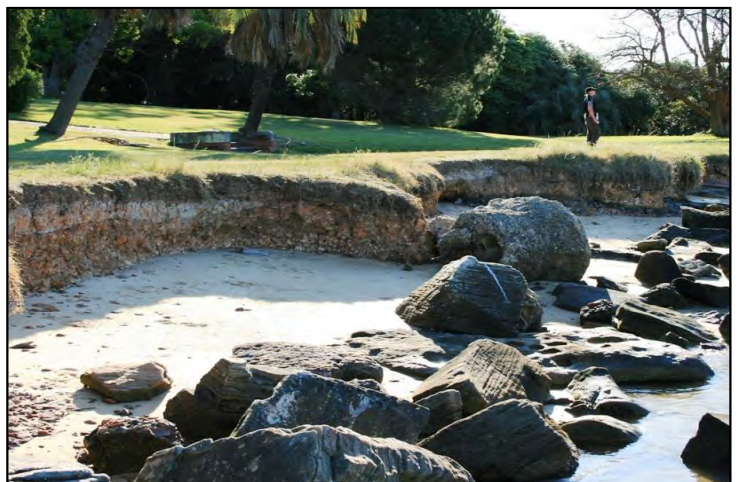
Photo 2

Public access is available to the foreshore via the hospital grounds. The erosion scarp abuts the Concord Hospital Watergate, a heritage listed building, and threatens to undermine its foundations.

Sandstone boulders strewn along foreshore in front of erosion scarp.

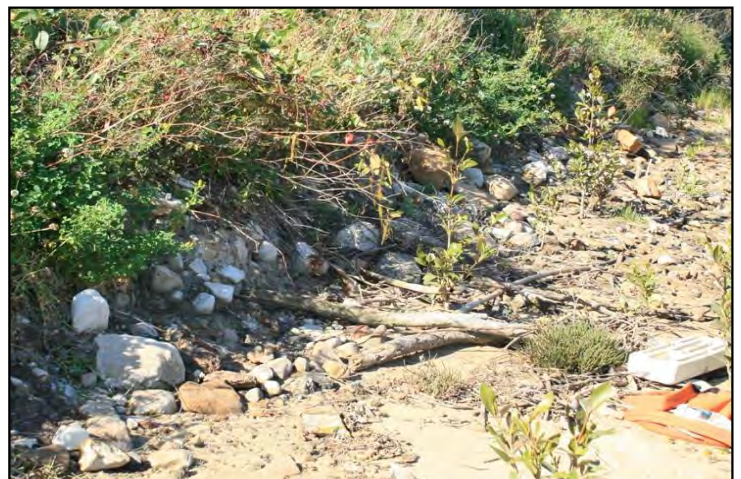
Photo 2

Small erosion scarp at rear of low tide terrace.

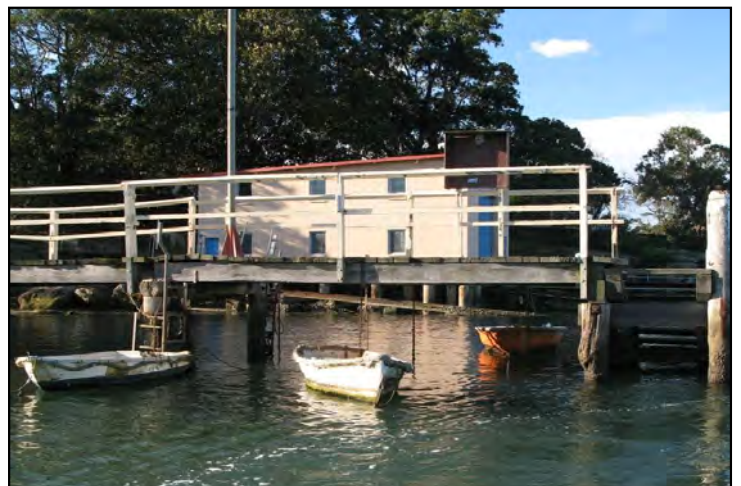
Photo 2

Structure is in poor condition with severe deterioration of timber. The wharf has been abandoned with signage on land indicating that it is unsafe for public use.

Dinghies tethered to timber wharf.

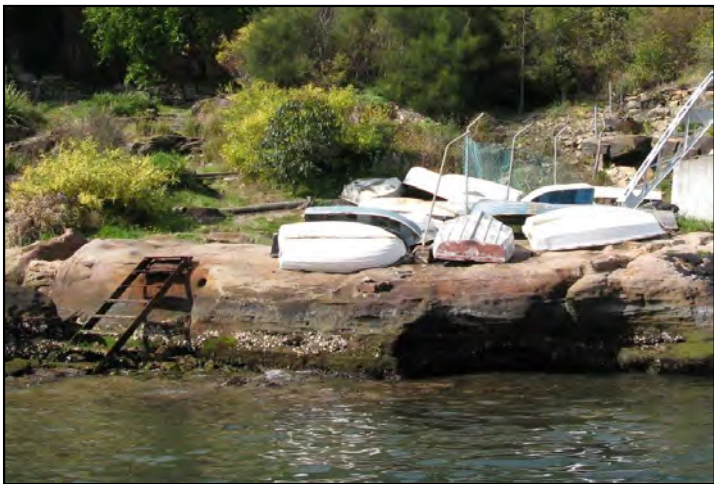
Assets:
Steel fence has barbed wire hanging loose amongst dinghies. Old steel stairs are severely corroded and not properly attached to rocks

Photo 1
View of informal dinghy storage area showing old steel stairs used for access to water.

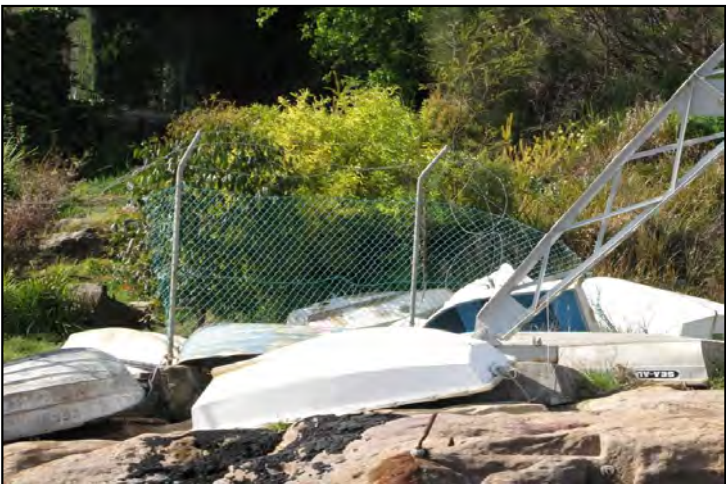
Condition Assessment:
No formal storage structure present. Fence that dinghies are tethered to is collapsing.

Photo 2
Barbed wire from old steel fence amongst dinghies.

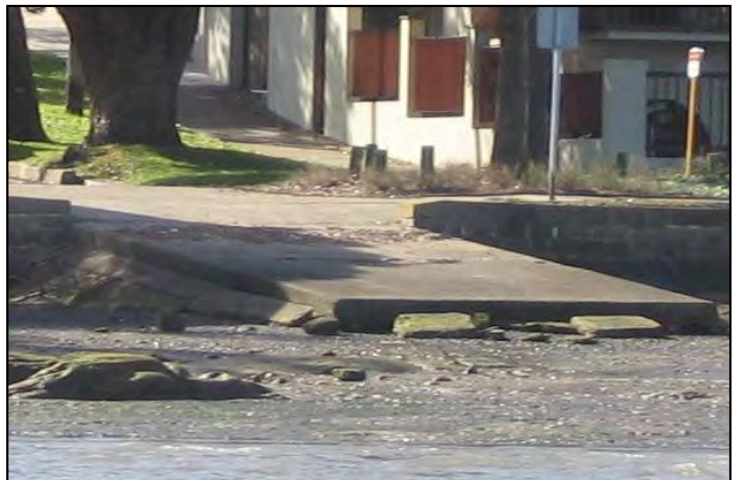
Condition Assessment:
Concrete is cracking and weathered. The front face of the ramp has been undermined.

Photo 2
Sandstone blocks placed at end of boat ramp for low tide access.

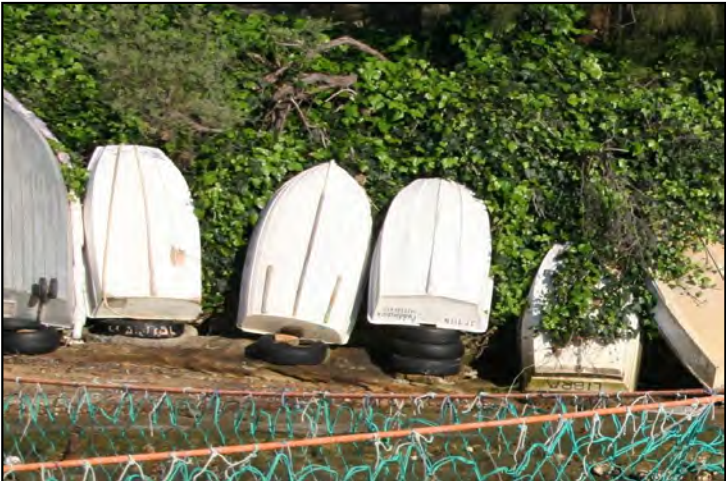
Photo 2

Vessels tethered to connections in cliff and supported by old tires.
