Seawall Inspection Record - SOPA_S01

Date	<u>10/09/09</u>	Locality	<u>Shipwreck Viewing Platform, Homebush Bay</u>	Level	<u>1.28m</u>	LGA	<u>Auburn</u>
Time	<u>13:45</u>			Tide	<u>Mid-High</u>

Seawall Inspection Record

- SOPA_S02

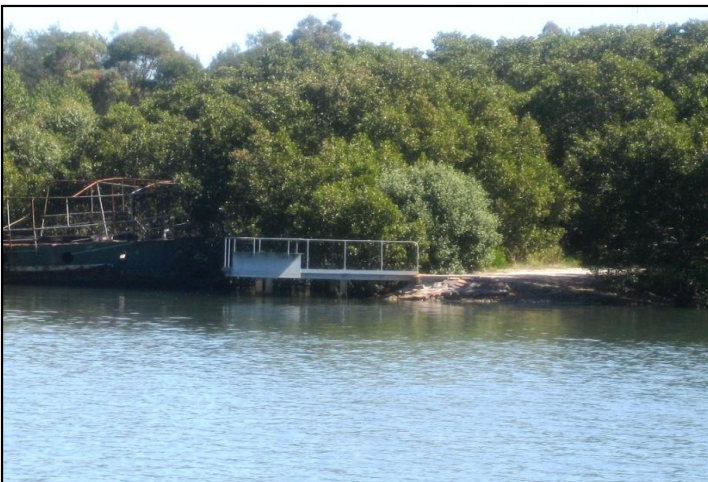
Photo 1
View of concrete block revetment and lookout structure.
Photo: SOPA_S01-01

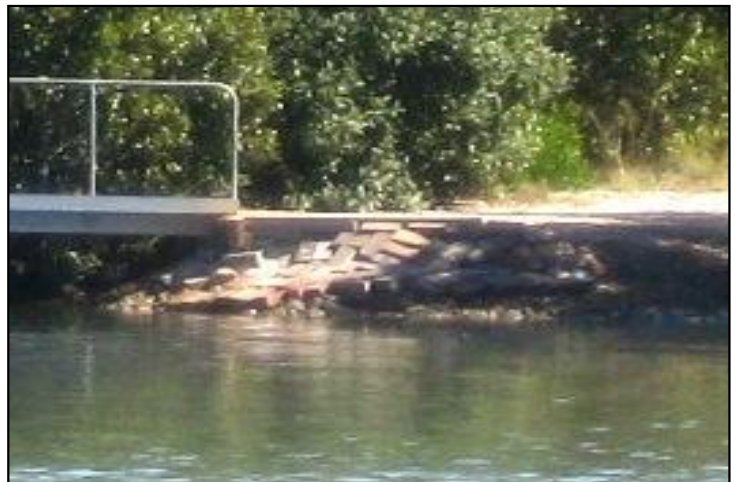
Condition Assessment (Slope, Crest, Toe, Backfill):
Blocks that form the revetment have collapsed due to a loss of fine sediments.

Photo 2
Collapse of blocks that form revetment.

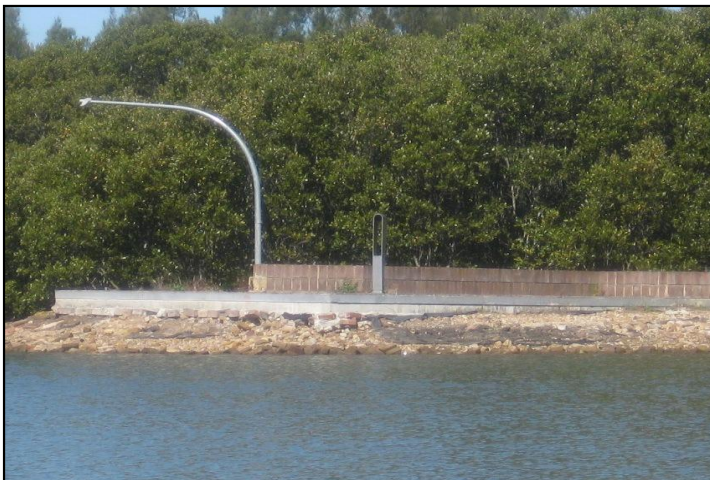
Photo 1
View of revetment and lookout structure.

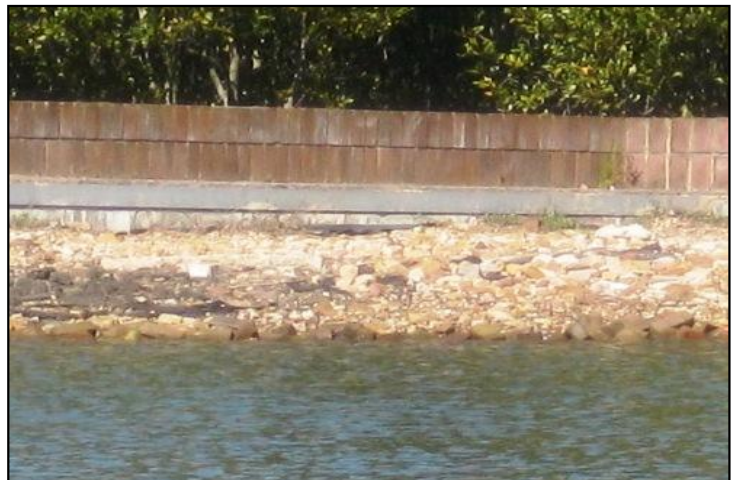
Condition Assessment (Slope, Crest, Toe, Backfill):
Blocks that form the revetment have collapsed and soil beneath is exposed. The concrete slab has been undermined.

Photo 2
Failure of blocks exposing soil and undermining concrete slab on crest.

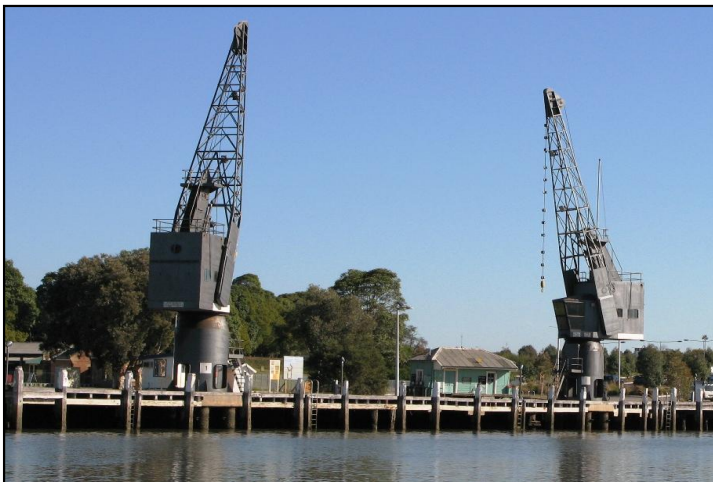
Photo 1
 View of facility.

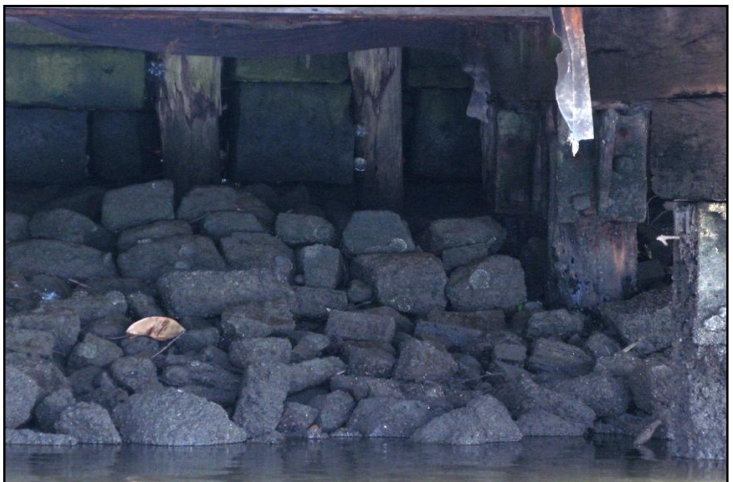
Condition Assessment:
 Timber piles, decking and beams are showing signs of deterioration. The concrete slabs and steel piles that support the crane are corroding.

Photo 2
 Timber piles, sandstone block seawall and rubble revetment beneath structure deck.
