Seawall Inspection Record

- SOPA_S01

Date	<u>10/09/09</u>	Locality	<u>Shipwreck Viewing Platform, Homebush Bay</u>	Level	<u>1.28m</u>	LGA	<u>Auburn</u>
Time	<u>13:45</u>			Tide	<u>Mid-High</u>

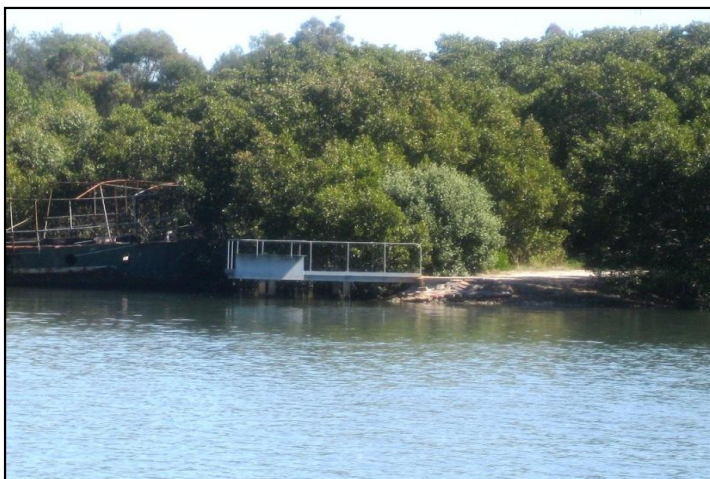
Photo 1

View of concrete block revetment and lookout structure.

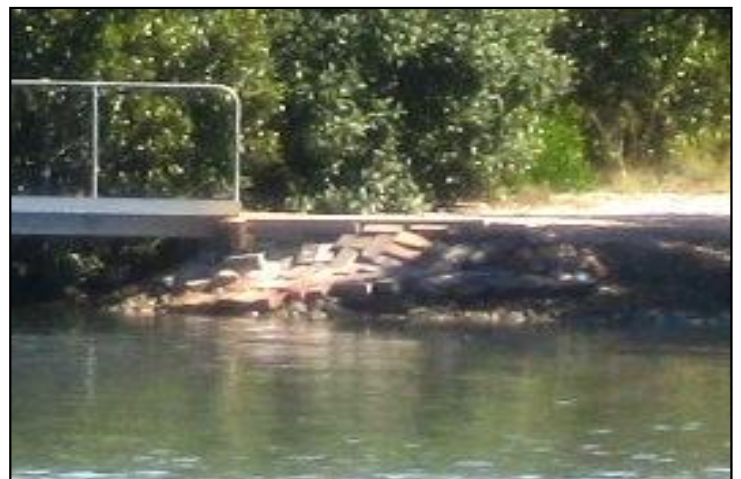
Photo 2

Blocks that form the revetment have collapsed due to a loss of fine sediments.

Collapse of blocks that form revetment.

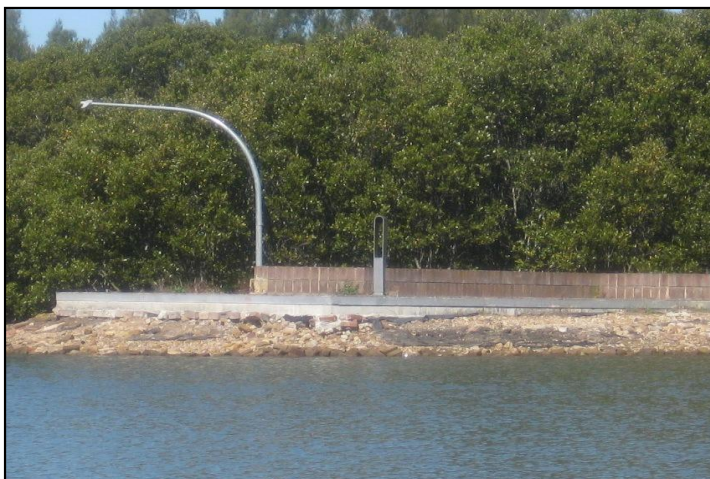
Photo 1

View of revetment and lookout structure.

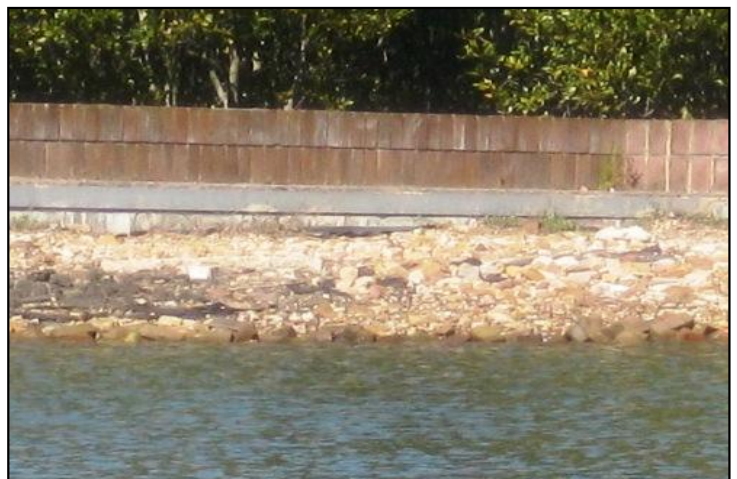
Photo 2

Blocks that form the revetment have collapsed and soil beneath is exposed. The concrete slab has been undermined.

Failure of blocks exposing soil and undermining concrete slab on crest.

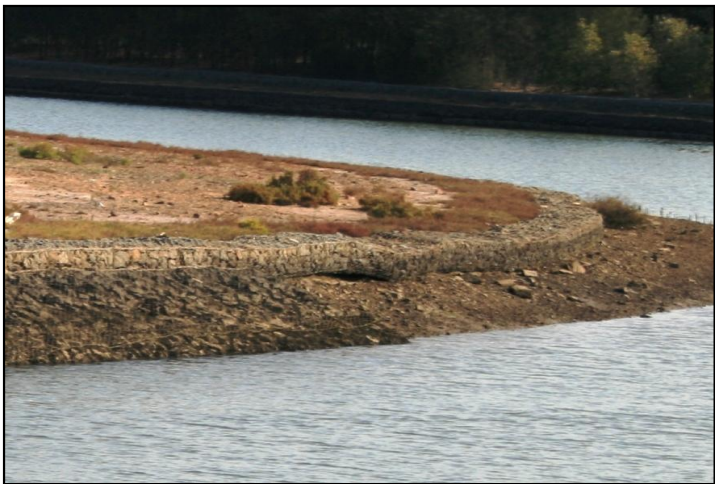
Photo 1

Where the gabion matt is not present, the slope is eroding and the gabion basket crest has been undermined.

View of structure with erosion of slope and undermining of crest shown.

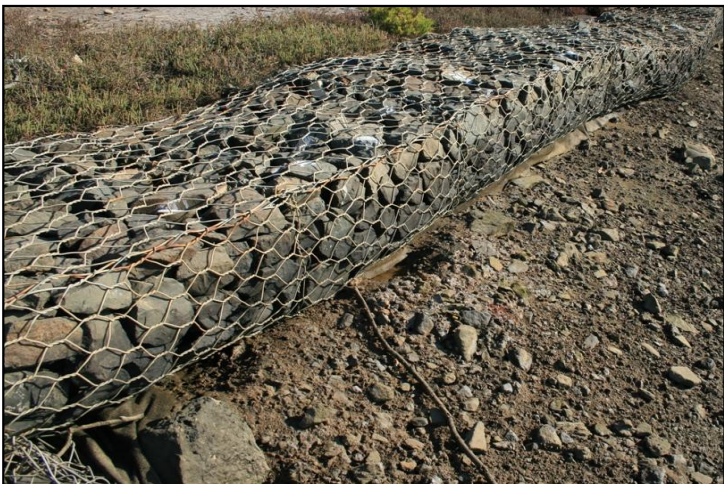
Photo 2

Undermining of crest.

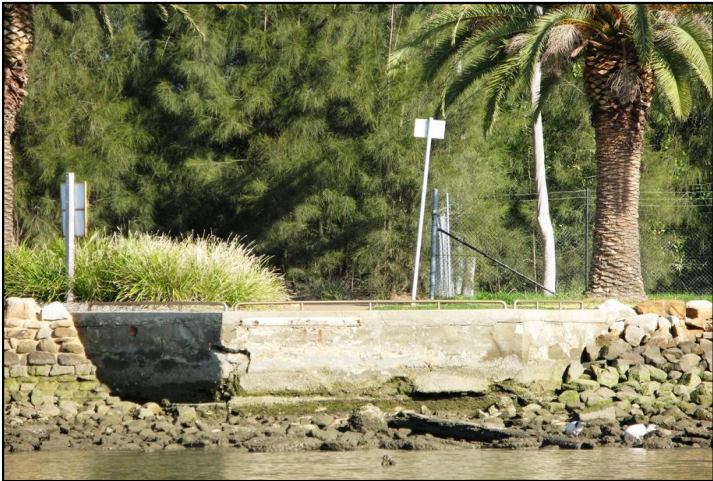
Photo 1

View of facility.

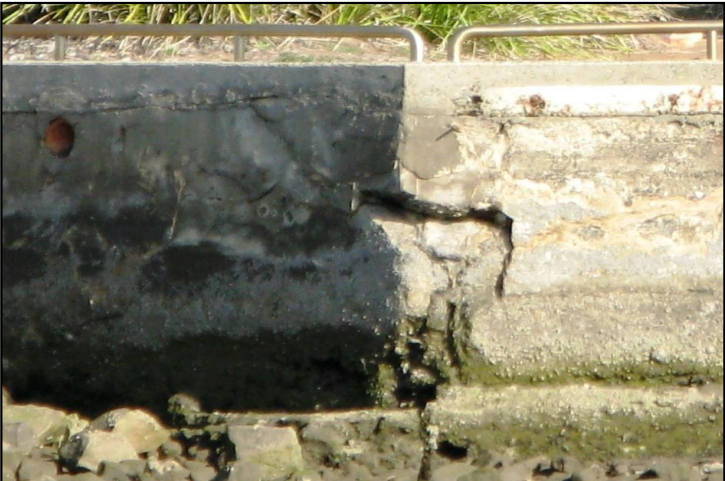
Photo 2

Surface weathering and cracking was observed.

Cracking and weathering of concrete.

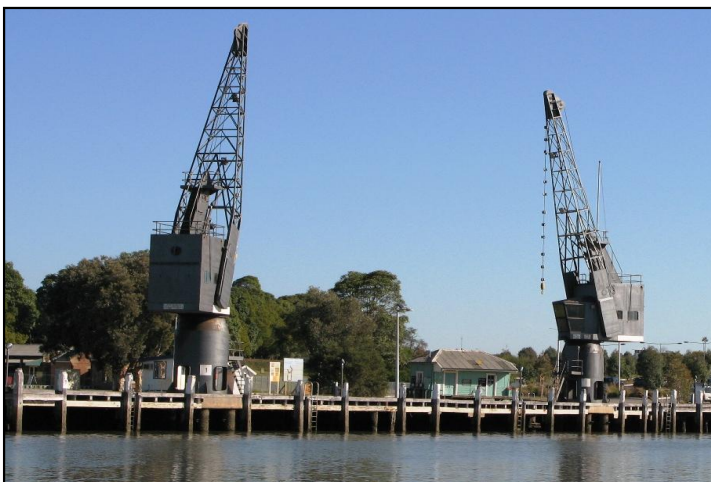
Photo 1

View of facility.

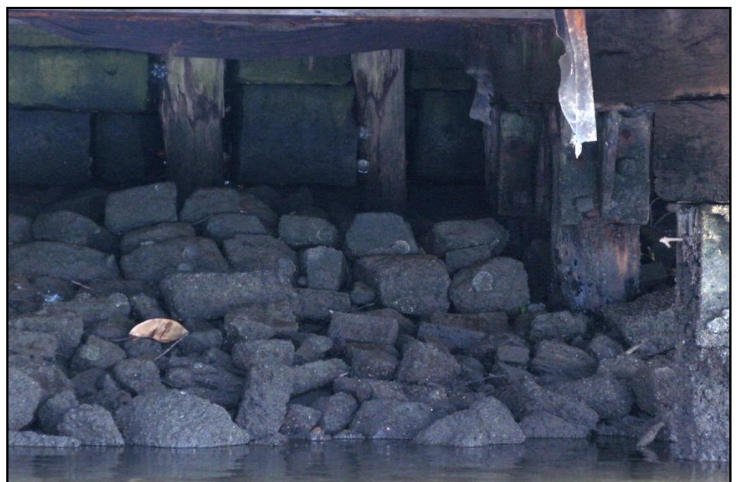
Photo 2

Timber piles, decking and beams are showing signs of deterioration. The concrete slabs and steel piles that support the crane are corroding.

Timber piles, sandstone block seawall and rubble revetment beneath structure deck.
