Seawall Inspection Record - AUB_S02

Date 18/08/09 Locality Homebush Bay Level 0.39m LGA Auburn
 Time 11:27 Tide Low

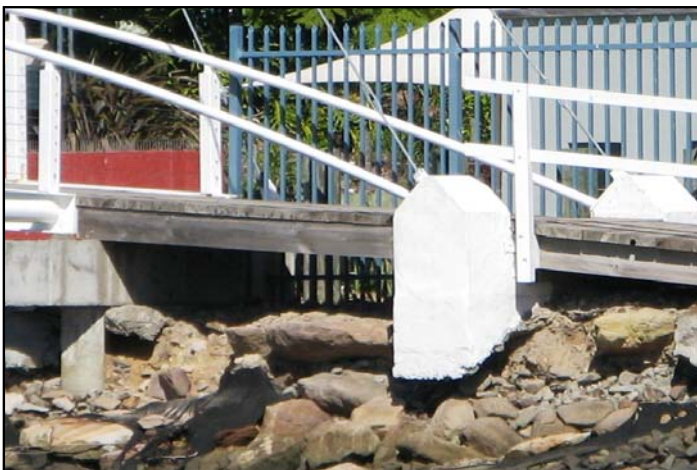
Photo 1

Material has been lost from slope exposing soil/fill beneath. It appears a support of the footbridge has been undermined.

Apparent undermining of footbridge support.

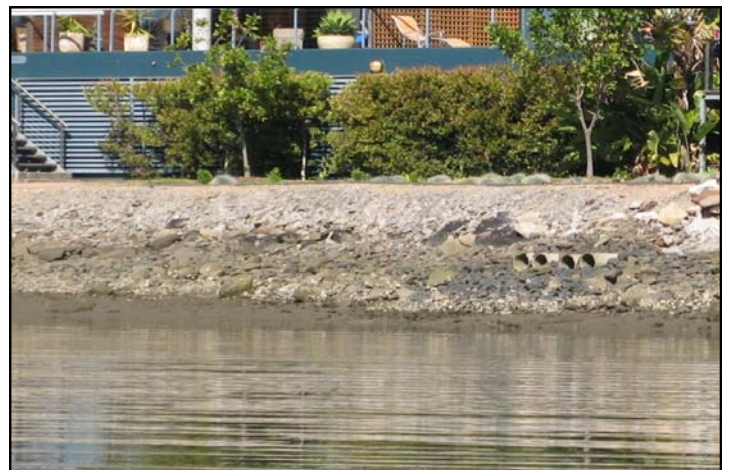
Photo 2

Loss of material from slope at eastern extent of revetment exposing soil/fill beneath

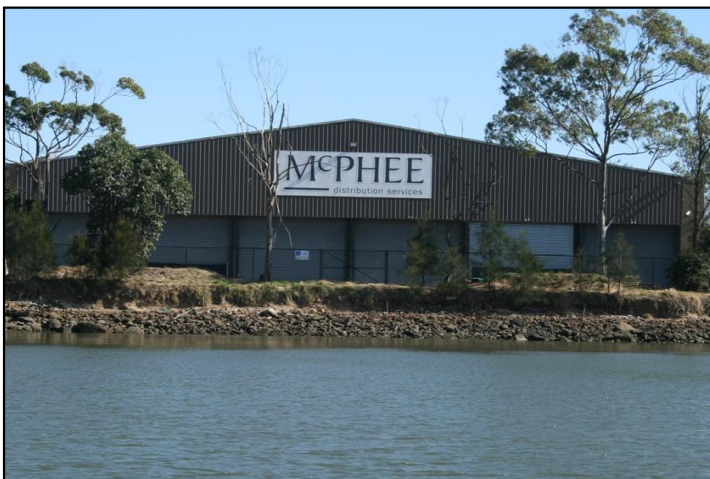
Photo 1

Typical section of revetment.

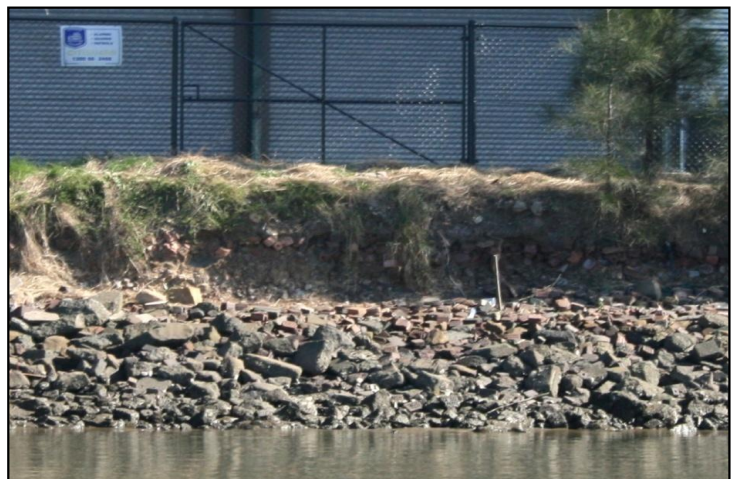
Photo 2

The rubble that forms the revetment has become dislodged and is strewn across the toe. There is also a large erosion scarp behind the structure indicating inundation during periods of elevated water levels.

Loss of rubble material and large erosion scarp at the crest.

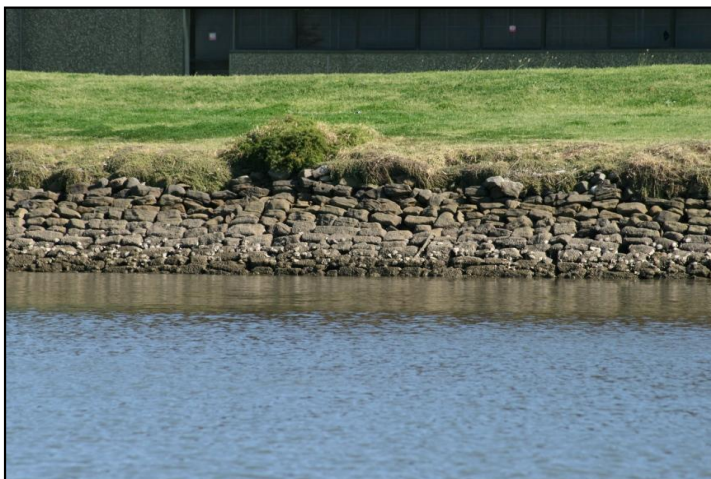
Photo 1

Typical section of revetment.

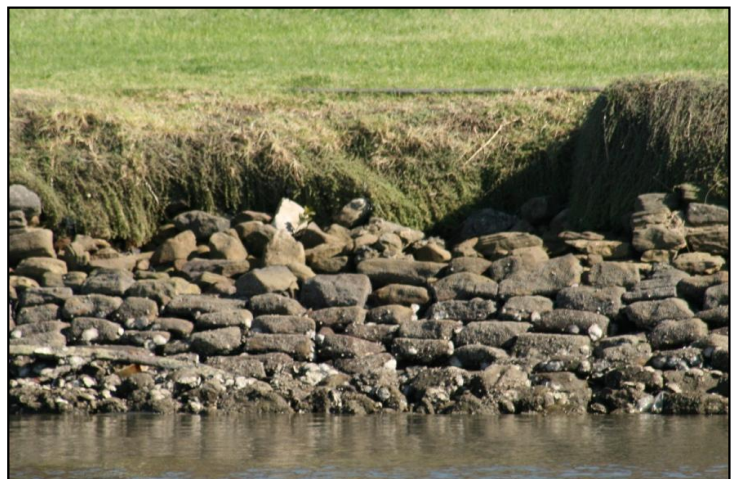
Photo 2

The blocks that forms the revetment are slumping and have become dislodged due to a loss of fine material from behind. There is also a large erosion scarp behind the structure indicating inundation during periods of elevated water levels.

Slumping of revetment and erosion of bank behind.

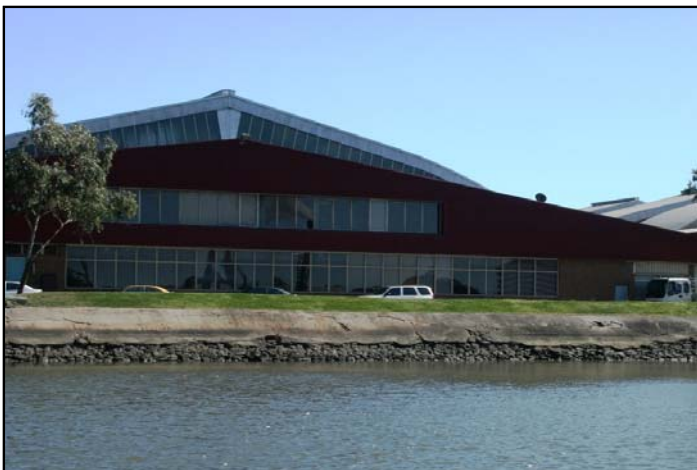
Photo 1

Typical section of revetment.

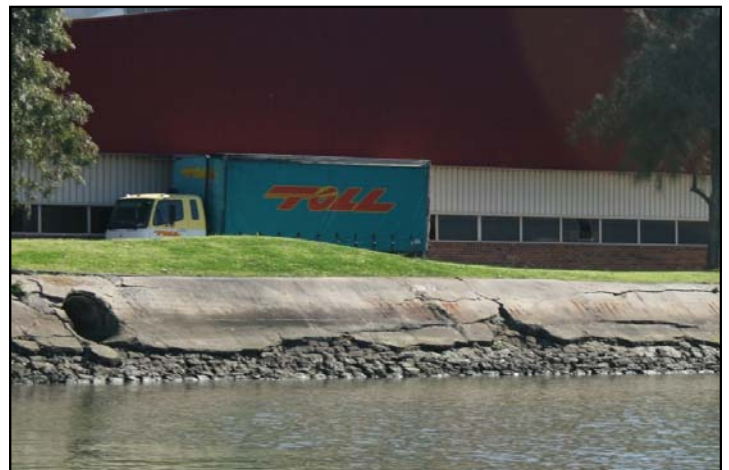
Photo 2

The concrete capping has cracked and failed along the lower section of the wall. The older blocks that forms the revetment are slumping.

Cracked and failed concrete capping with older sandstone block revetment visible.

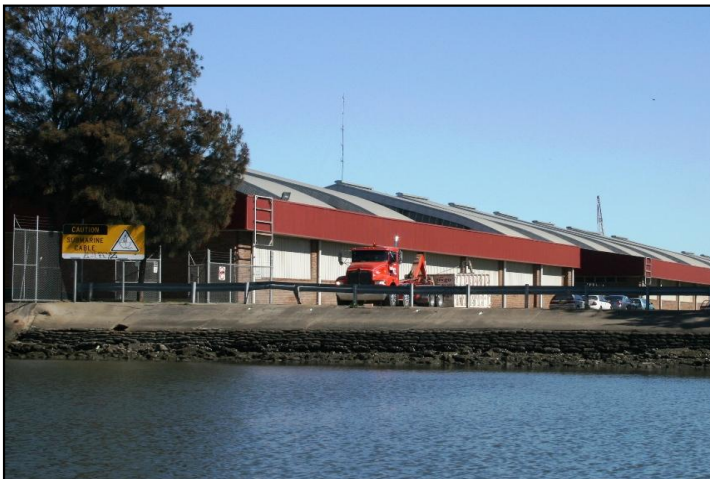
Photo 1

Typical section of revetment.

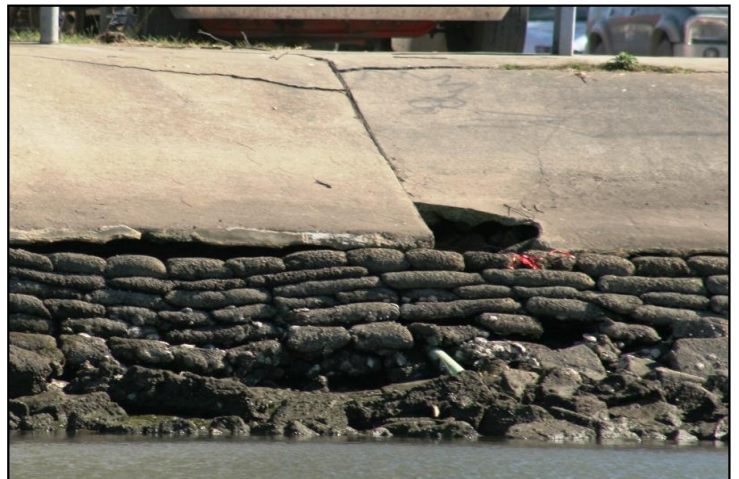
Photo 2

The sloping concrete crest has cracked and failed in places with large voids observed. The blocks that form the toe of the structure are slumping.

Public access is available and the structure forms the end of Burroway Road. If the structure is allowed to continue to deteriorate OH&S and asset issues may arise.

Cracked and failed concrete crest with voids present and slumping of concrete blocks.

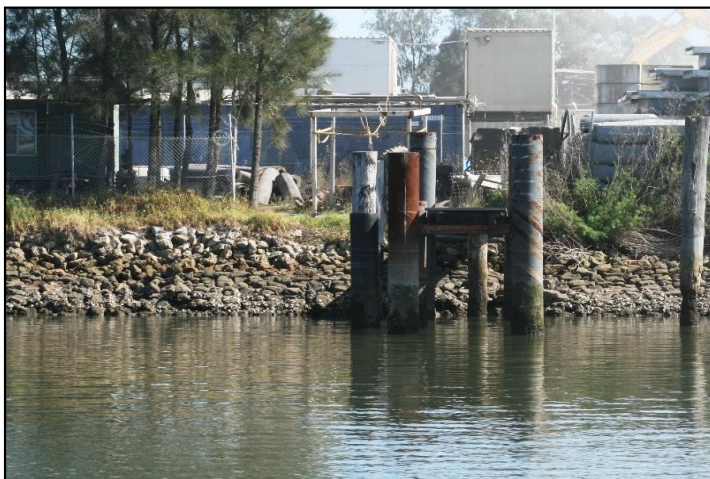
Photo 1

Typical section of revetment with abandoned facility shown.

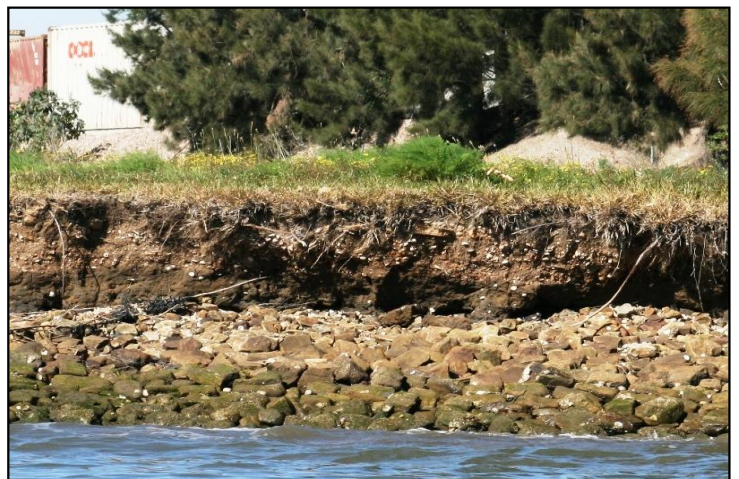
Photo 2

The revetment has failed with material lost from the crest and strewn across the muddy flat in front. A large erosion scarp is present at the crest which increases on the Parramatta River side where it is exposed to ferry wash.

Erosion scarp where material has been lost due to exposure to ferry wash.

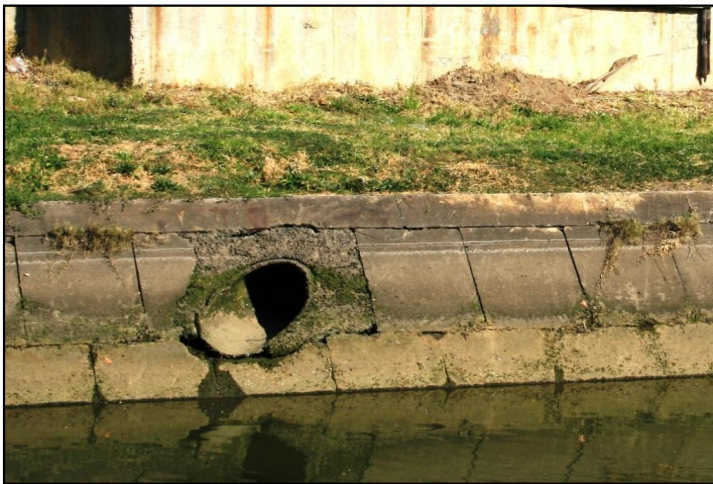
Photo 1

Minor cracking and weathering of concrete observed. Cracks are particularly evident between concrete panels.

Cracking between concrete panels.

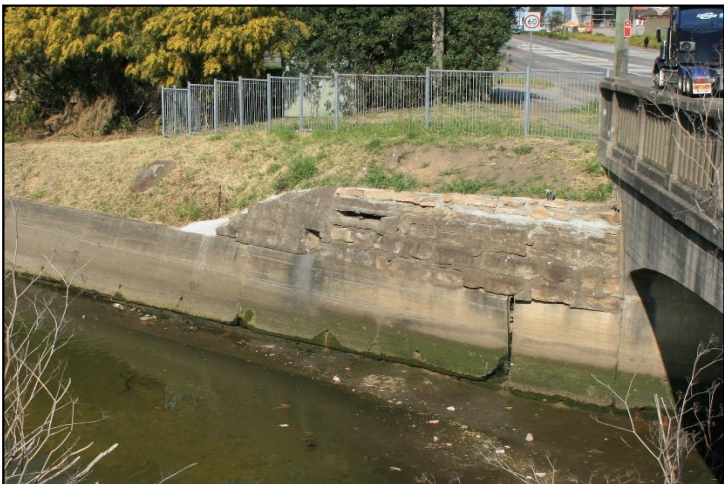
Photo 2

The wall is cracking beneath the eastern abutment of Parramatta Road.

The bank supports abutments for two road bridges and is cracking beneath one.

Cracks beneath eastern abutment of Parramatta Road.

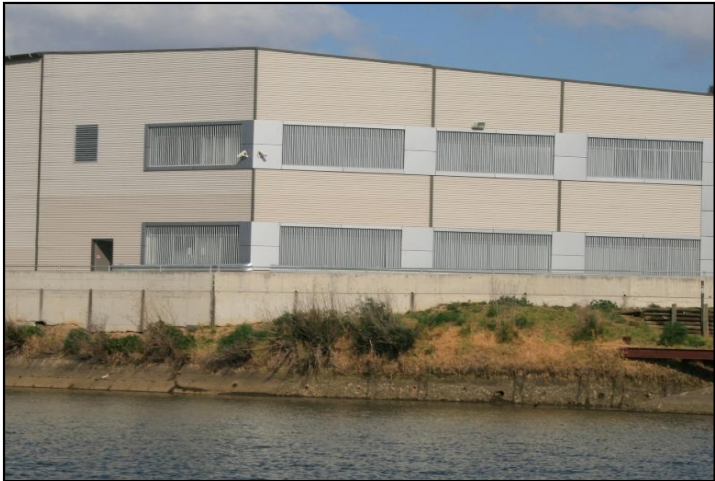
Photo 1
Typical section of concrete bank.

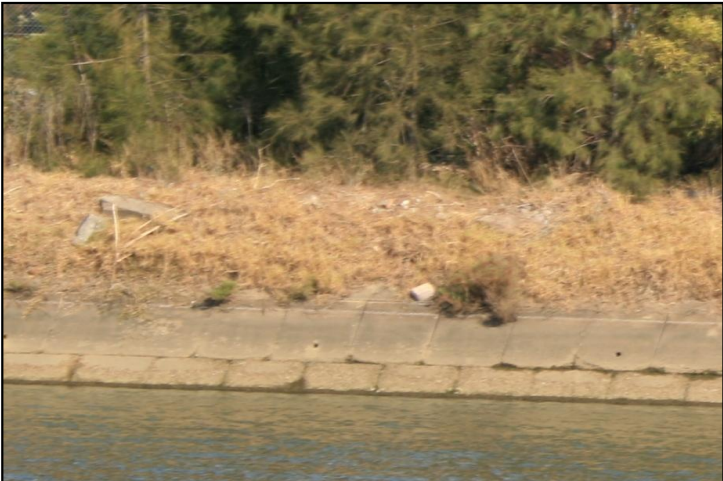
Condition Assessment:	Excellent
Minor cracking and weathering of concrete observed. Cracks are particularly evident between concrete panels.	Good
	Poor
	Failed

Photo 2
Cracks between concrete panels that form canal bank.

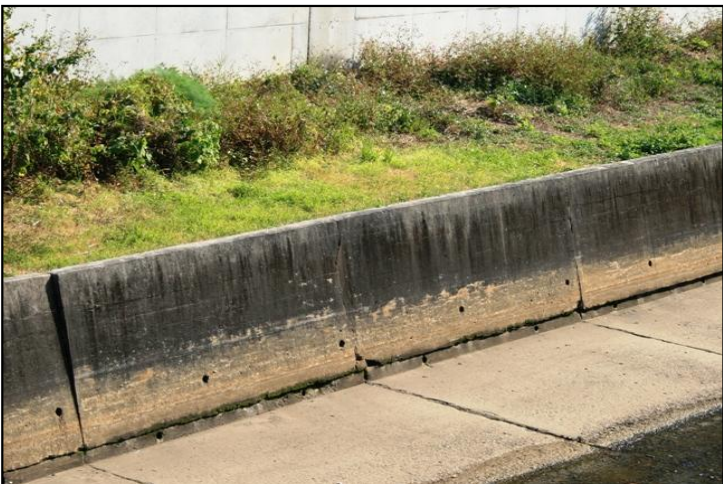
Condition Assessment:
Minor cracking and weathering of concrete observed. Cracks are particularly evident between concrete panels.
Condition worsens to the south.

Photo 2
Cracking and weathering of vertical concrete wall between panels.

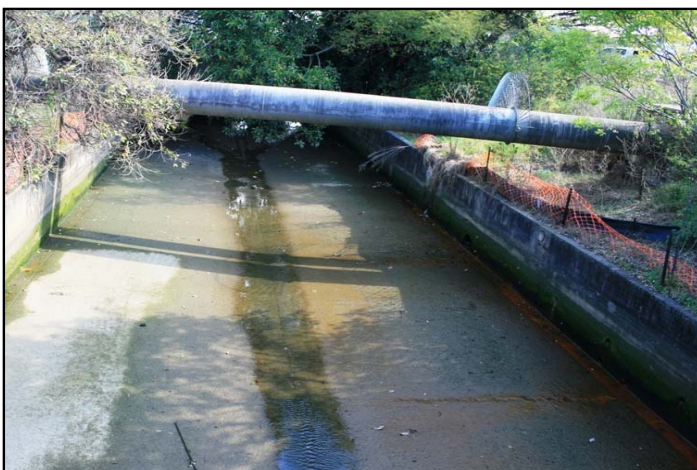
Photo 1

Typical view of concrete canal.

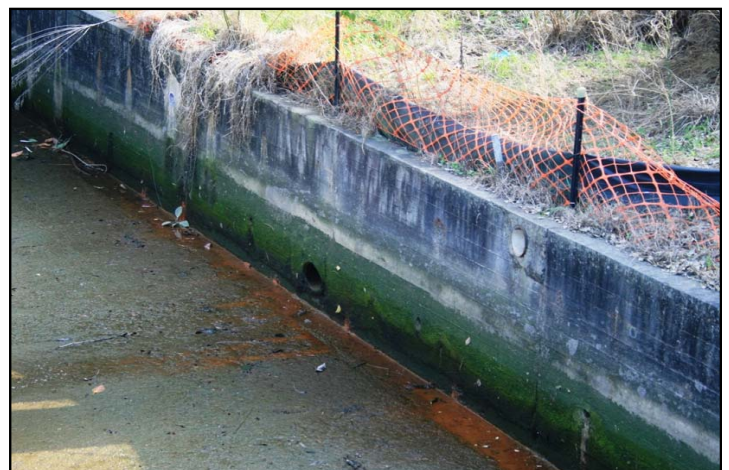
Photo 2

Minor cracking and weathering of concrete observed. Cracks are particularly evident between concrete panels.
Condition worsens to the south.

Minor cracking and weathering of vertical concrete wall.

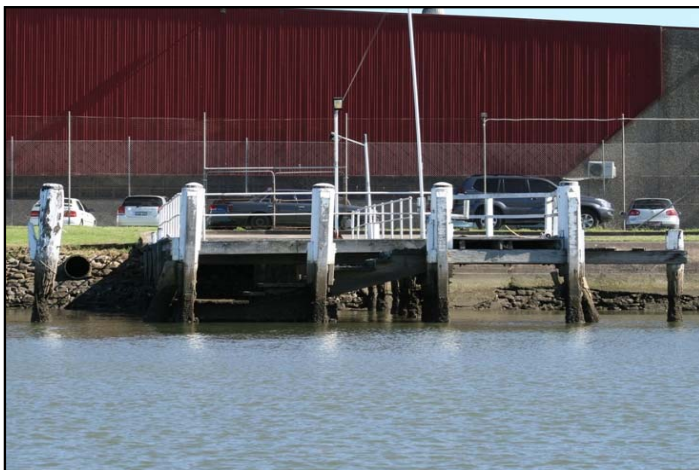
Photo 1

View of facility.

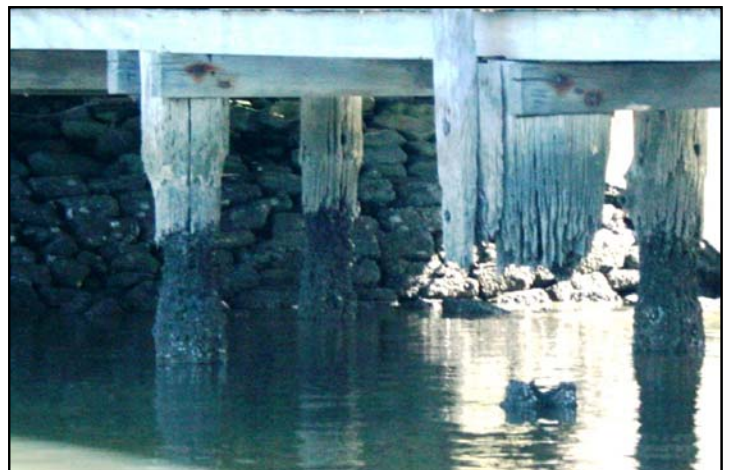
Photo 2

A number of the timber piles have failed at the water line. All other components are showing signs of deterioration.

The piles have failed and the structure may collapse if no action is taken.

Failed timber piles.

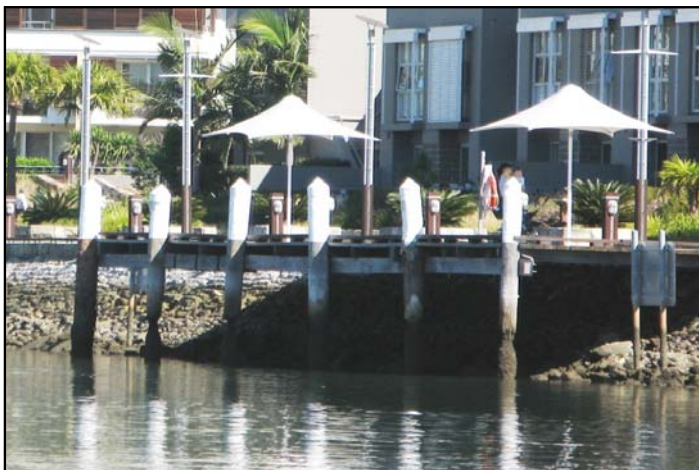
Photo 1

View of facility.

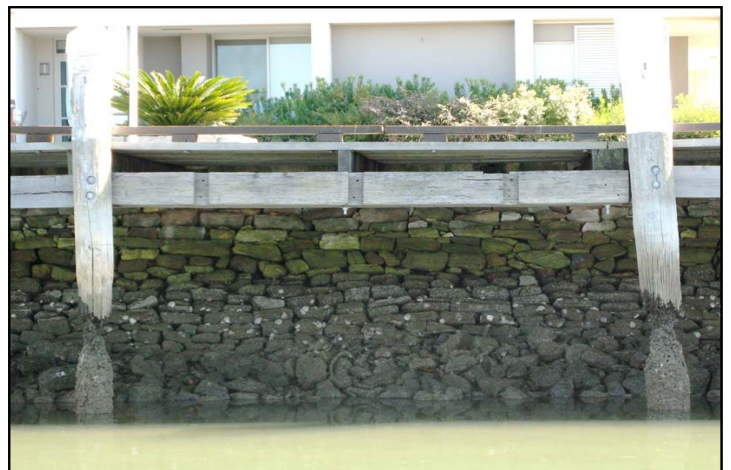
Photo 2

Apart from the new pile at the southern end of the structure, all timber piles have failed at the water line. Other timber components are showing signs of deterioration.

The piles have failed and the structure may collapse if no action is taken. Umbrellas and adjacent residential development mean structure is well utilised by the public. The structure edge is well defined by timber rail.

Failure of timber piles at the water line.

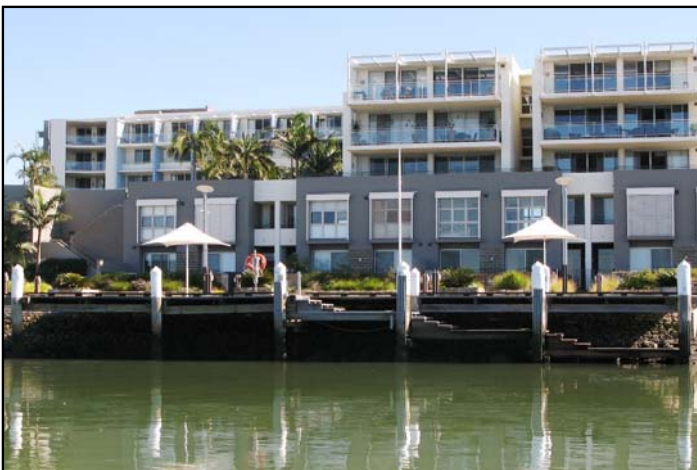
Photo 1

View of facility.

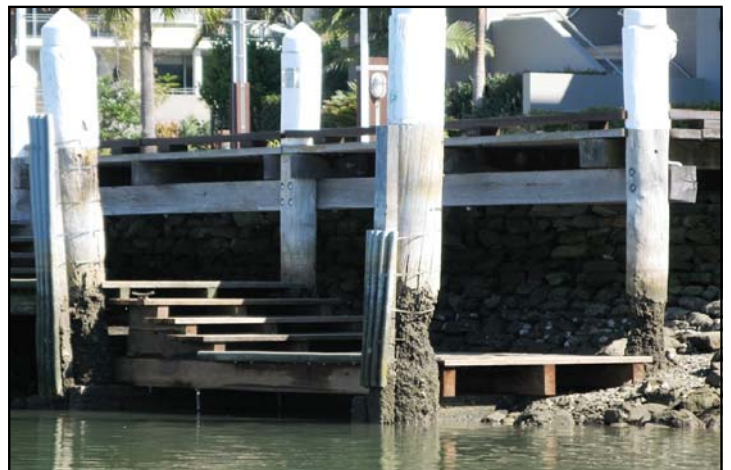
Photo 2

Timber piles are severely deteriorated at the water line. Other timber components are showing signs of deterioration. A number of timber stairs have been replaced.

The piles are in poor condition and may fail if not replaced. Access to structure from the water is difficult at low tide. Umbrellas and adjacent residential development mean structure is well utilised by the public. The structure edge is well defined by timber rail.

Severe deterioration of timber piles at the water line.

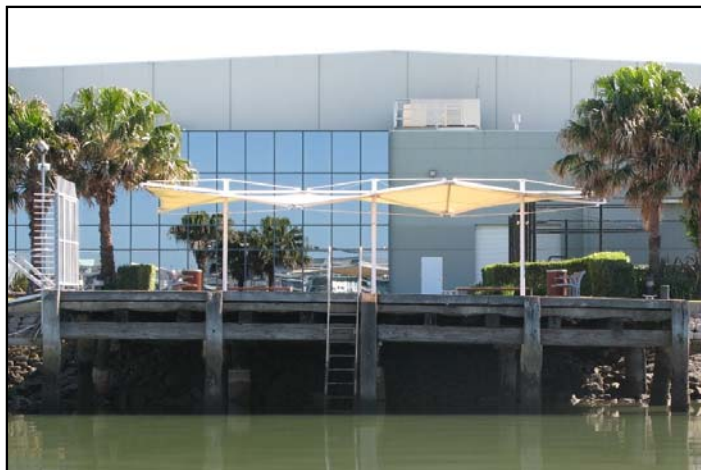
Photo 1

View of facility.

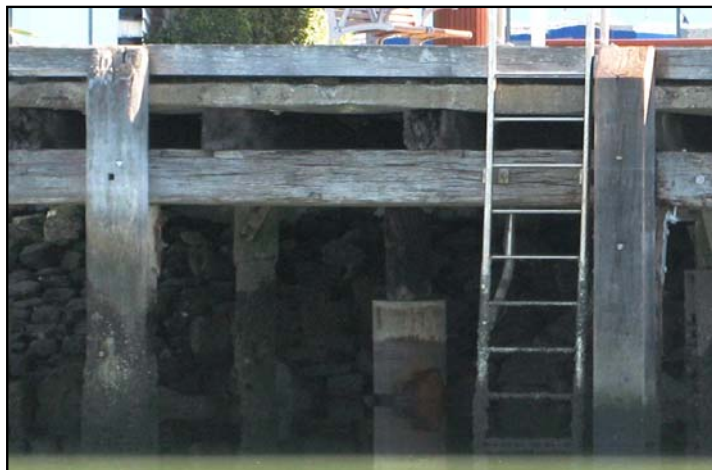
Photo 2

Timber piles and other components are showing signs of deterioration.

Although not as urgent as the two other facilities at this location (AUB_F03 & AUB_F04), the piles are in poor condition and may fail if not replaced. Umbrellas and adjacent residential development mean structure is well utilised by the public. The structure edge is not defined.

Deterioration of timber piles and other components.

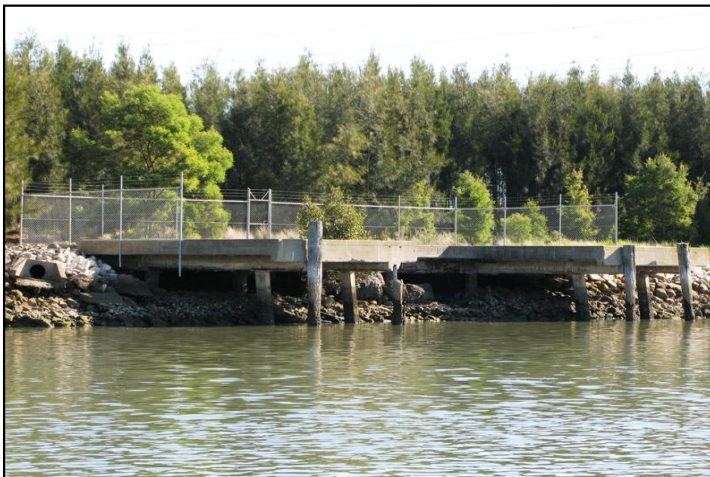
Photo 1

View of facility.

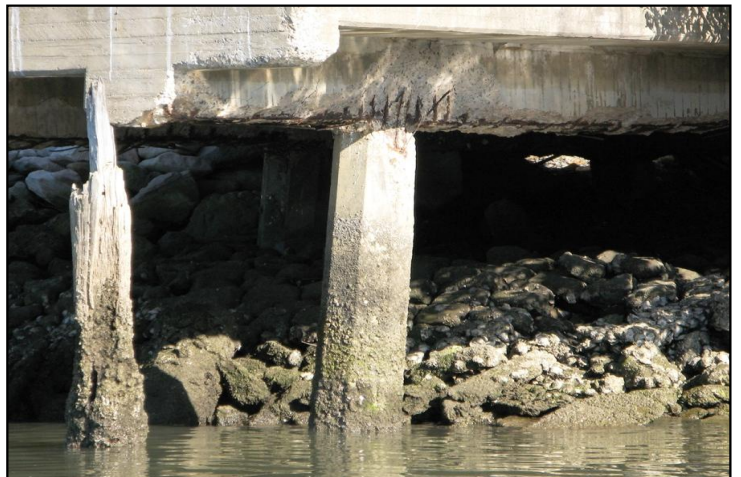
Photo 2

The structure appears condemned/abandoned with severe corrosion of concrete beams beneath landing exposing reinforcement.

Corrosion of concrete beam exposing reinforcement.

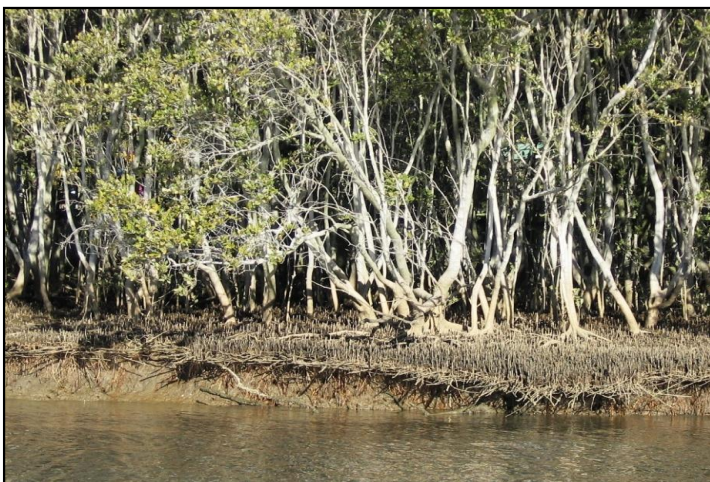
Photo 1

Erosion observed with undermining and loss of fine material from pneumatophores due to exposure to vessel wash. The condition of the shoreline improves upstream of the confluence in the Duck River.

Loss of fine material and undermining of mangroves.

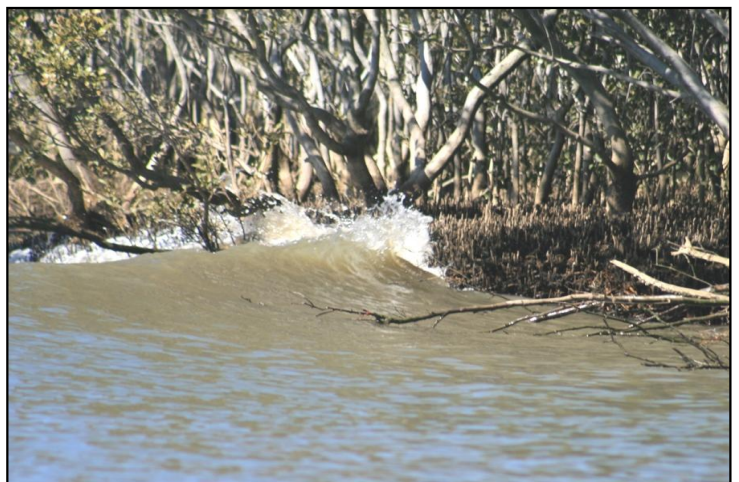
Photo 2

Ferry wash at Duck and Parramatta Rivers confluence.
