Seawall Inspection Record - HUN_S01

Date	<u>5/08/09</u>	Locality	<u>Clarkes Point, River North</u>	Level	<u>0.80m</u>	LGA	<u>Hunters Hill</u>
Time	<u>14:35</u>			Tide	<u>Low-Mid</u>

Seawall Inspection Record - HUN_S02

Facility Inspection Record

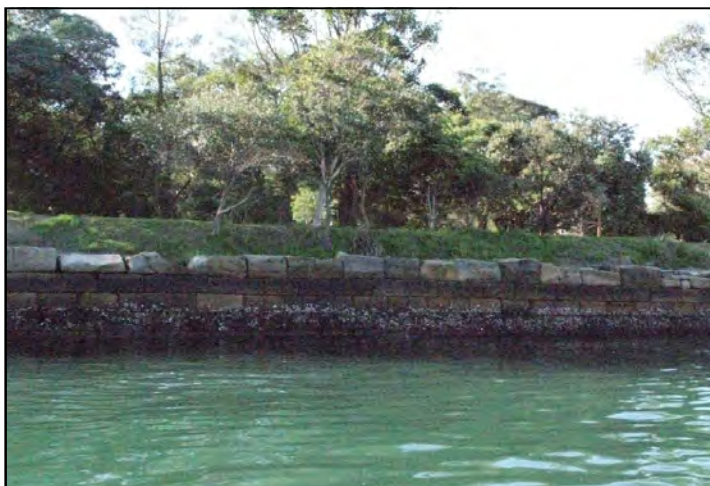
Photo 1

Numerous block failures of the crest were observed with blocks fallen into water below. Surface weathering of the sandstone blocks and sinkholes behind structure crest were also observed.

Typical section of seawall showing failure of blocks at crest, surface weathering and loss of grout material.

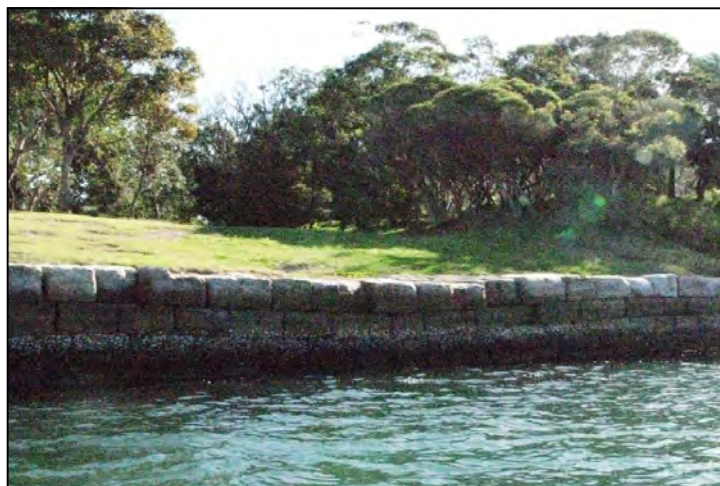
Photo 2

Slumping of sandstone blocks.

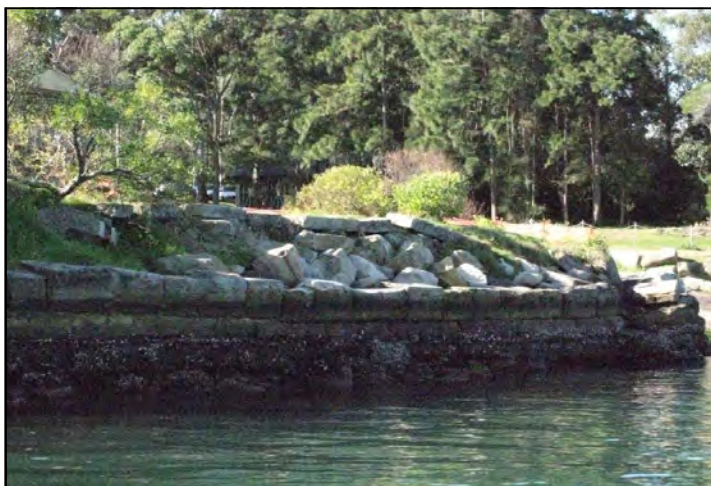
Photo 1

Numerous block failures of the crest were observed with blocks fallen into water below.
Surface weathering of the sandstone blocks and sinkholes behind structure crest were also observed. Western section is in better condition.

Typical section of seawall showing failure of blocks at crest, surface weathering and loss of grout material.

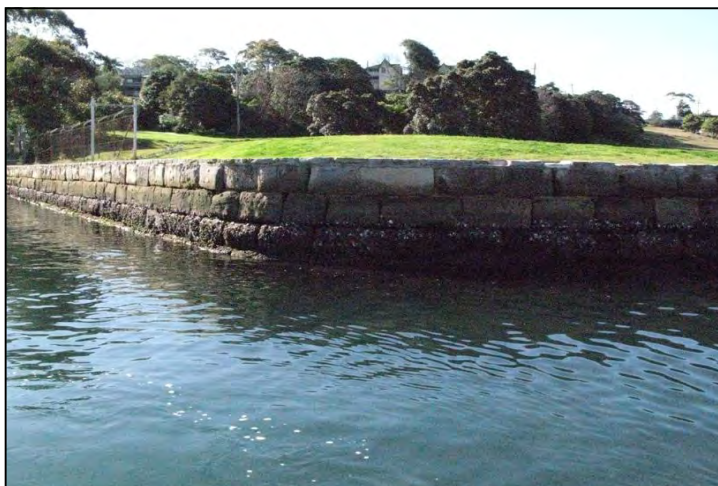
Photo 2

Western section of the seawall leading to boat ramp is in better condition than the rest of the structure

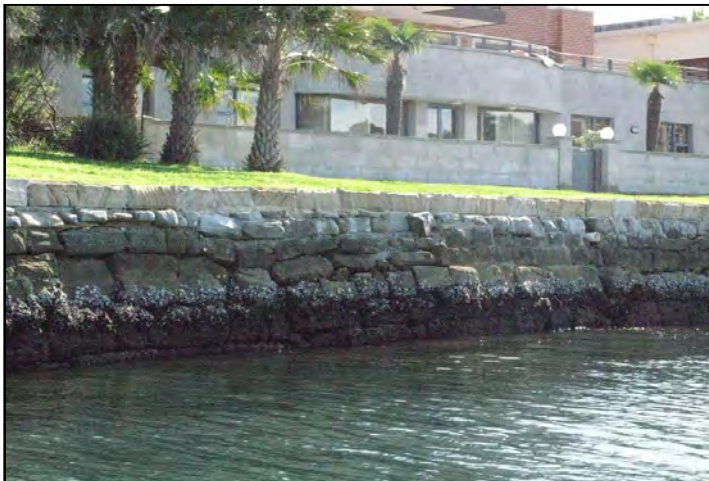
Photo 1

Typical view of seawall.

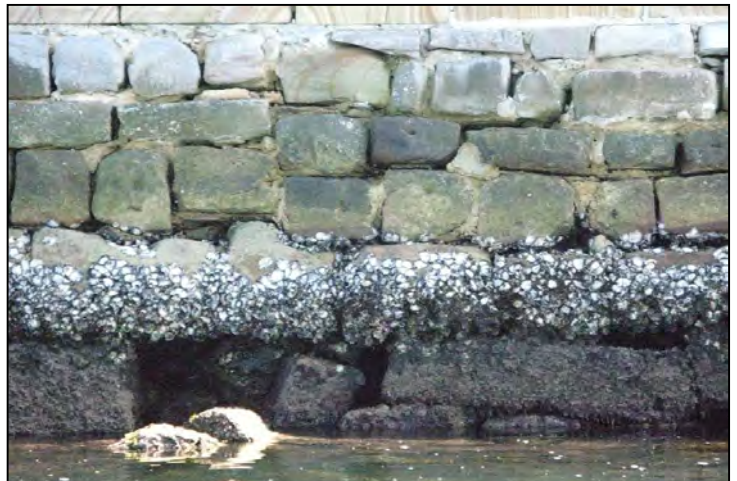
Photo 2

Grout is missing from the lower blocks with extensive slumping and cavities observed. A number of localised block failures at the seawall toe were also observed. The newer, top layer is in good condition with grouting present.

Block failure at toe and loss of grout and clumping of lower, older sandstone blocks.

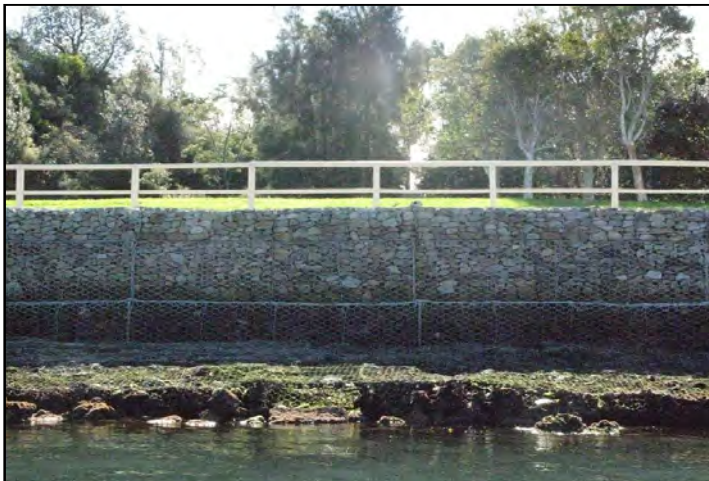
Photo 1

General view of gabion wall.

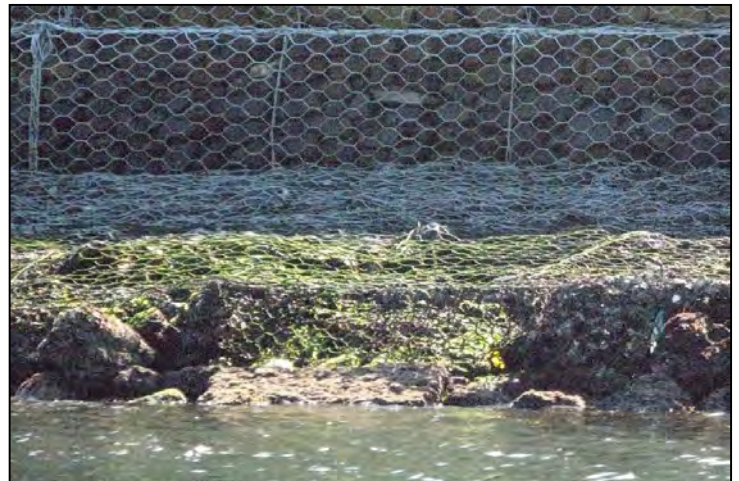
Photo 2

A number of gabion units that make up the toe have failed and have lost fill material. The vertical face component of the structure is in good condition. If the toe continues to deteriorate, the structural integrity of the entire gabion wall may be threatened.

Loss of material from gabion baskets at toe.

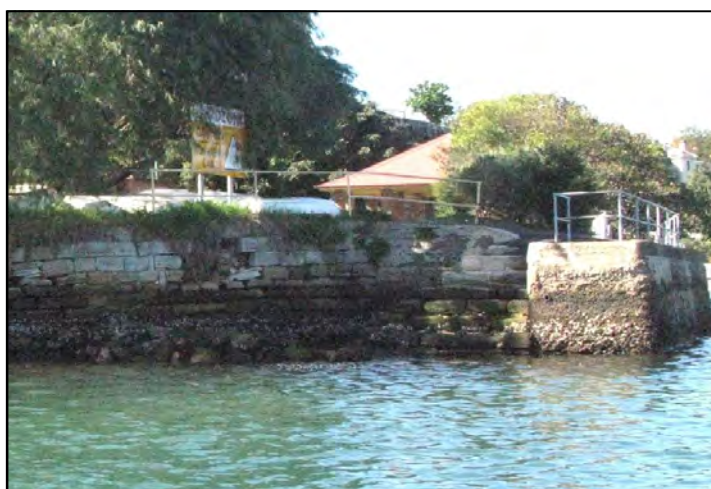
Photo 1

Sandstone blocks are missing grout and are showing severe signs of surface weathering and slumping. Localised block failures were also observed. Surface weathering and cracking of the concrete section of the structure was observed. The sea stairs have lost grout material and are severely weathered.

Sandstone block section of seawall and sandstone sea stairs showing loss of grout, weathering and block failures.

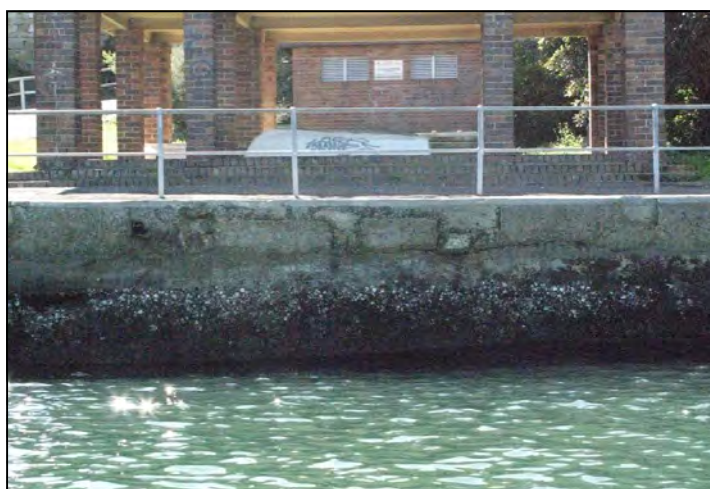
Photo 2

Concrete section of structure showing surface weathering and cracking.

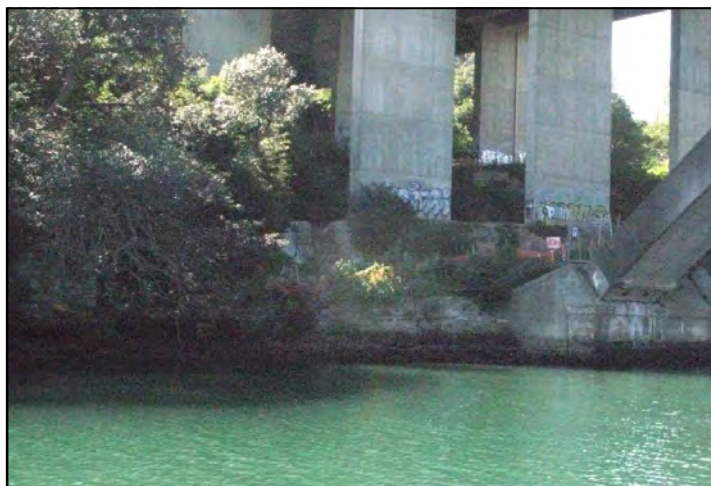
Photo 1

Older sections of the seawall are missing grout and are showing signs of weathering and slumping. Localised block failures were also noted. The new section of wall is in very good condition.

Sandstone block seawall on western side of Tarban Creek Bridge.
Cracking and loss of grout was observed.

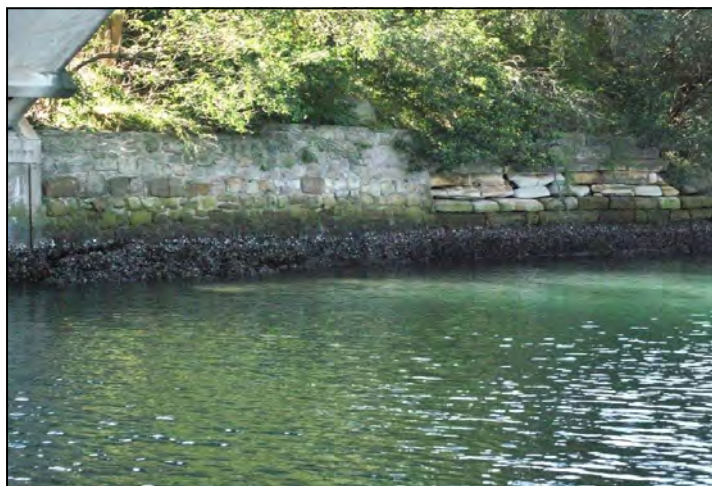
Photo 2

Sandstone block seawall on eastern side of Tarban Creek Bridge showing newer section and older deteriorated section.

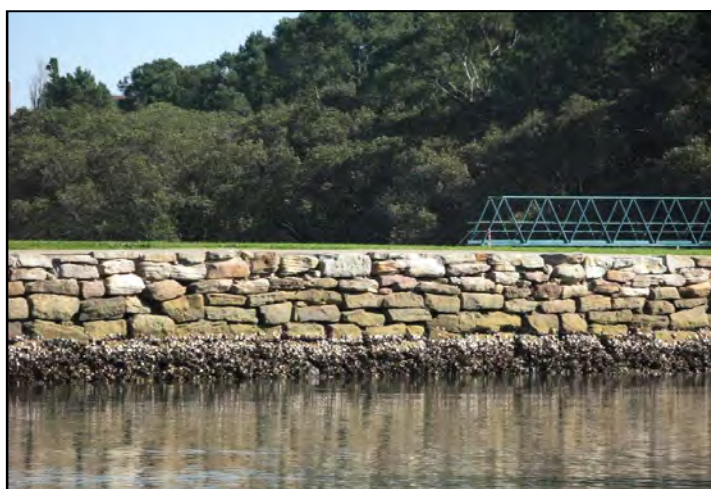
Photo 1

Majority of grout material has been lost from the structure leading to loss of fines from behind and slumping of both the vertical face of the wall and the concrete footpath beyond. Significant weathering of the sandstone blocks was also observed.

Typical view of structure showing loss of grout and slumping of sandstone blocks.

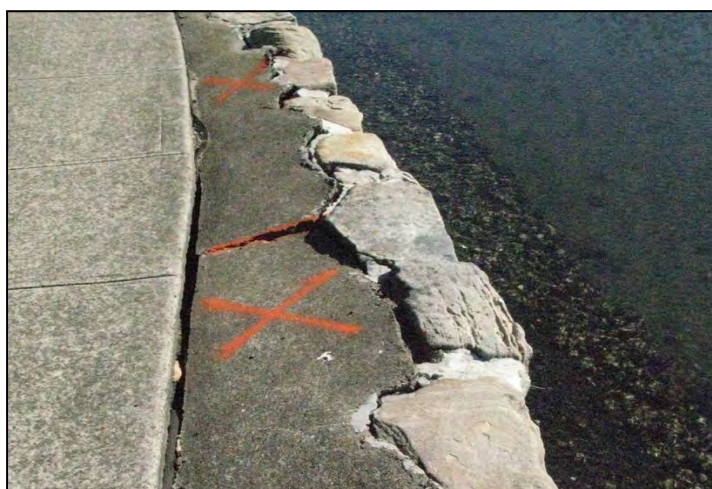
Photo 2

The footpath beyond the wall crest is cracking and many defects were marked with crosses at location (WP 206 327942, 6254391).

Slumping and cracking of public footpath with marked defects shown.

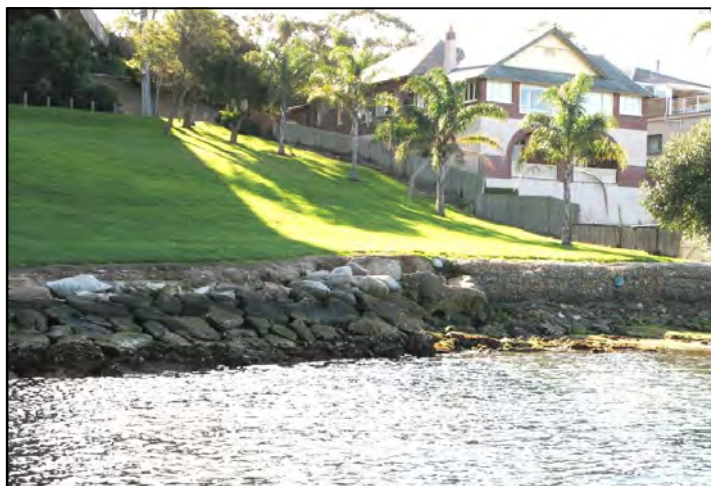
Photo 1

Eastern extent of structure showing specially placed sandstone revetment and gabion baskets.

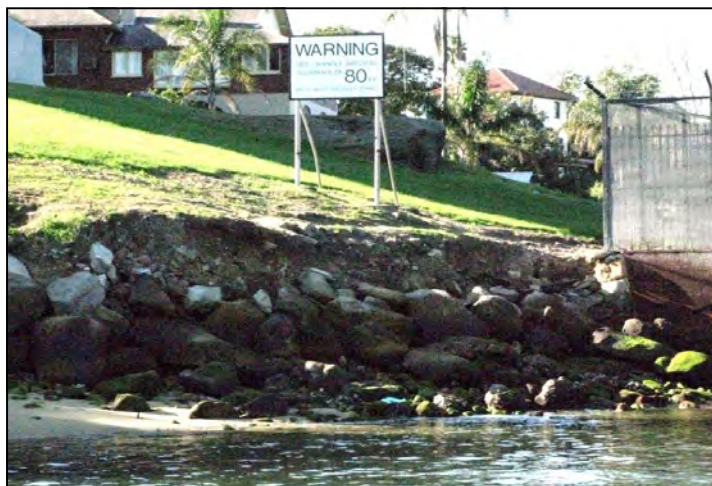
Photo 2

The sandstone block revetment and gabion baskets on the eastern side of the bridge are in a good condition. The sandstone boulder revetment on western side has failed with material from original structure strewn on the sandy beach in front.

Ad-hoc poorly sorted sandstone boulder revetment. Structure has collapsed with material strewn across sandy shoreline.

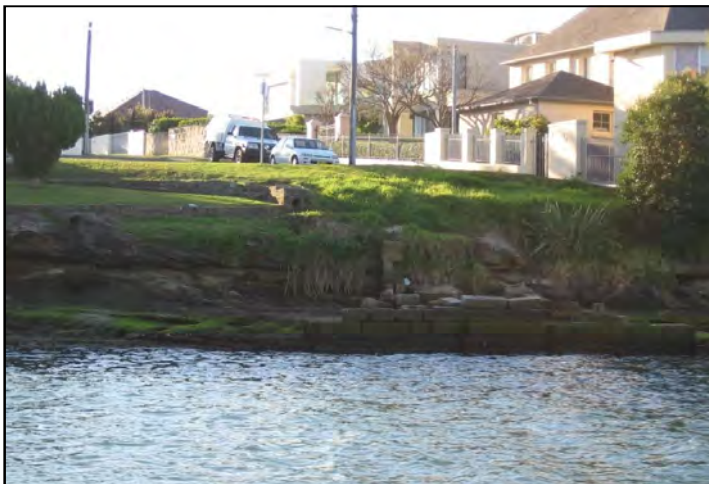
Photo 1

View of seawall.

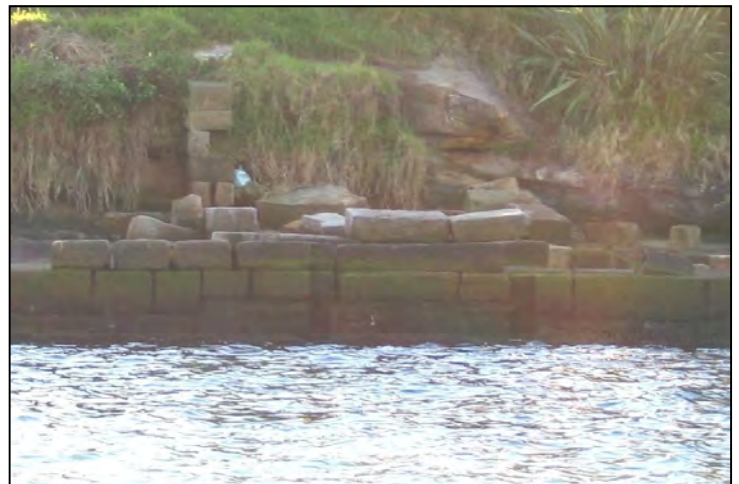
Photo 2

Wall has partially collapsed and appears to be abandoned.

Loss of grout, weathering and failure of sandstone blocks.

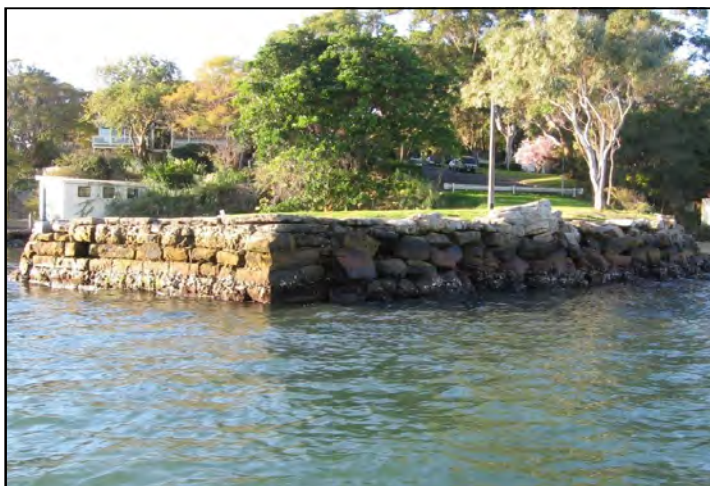
Photo 1

Vertical sandstone block wall that forms front face of structure is missing grout material, a number of block failures were also observed. The revetments on each side of the structure are slumping due to a loss of fine material from behind. Large sinkholes and cracking of concrete capping at crest further confirm the loss of fine material.

Eastern view of structure. Block failures on front vertical face is shown.

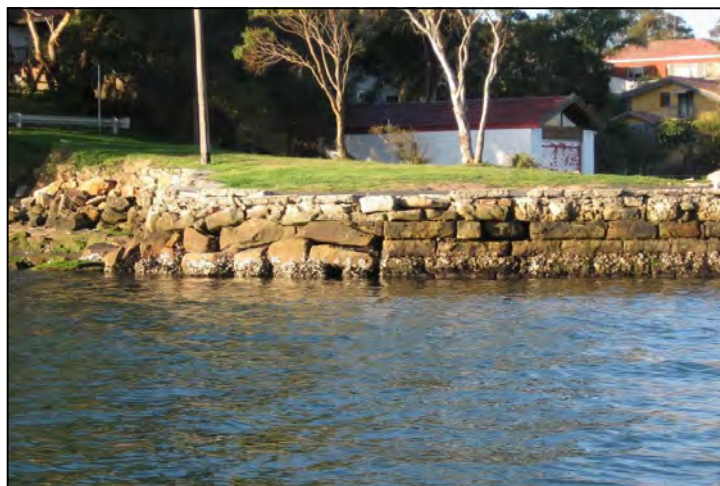
Photo 2

Western section of structure showing extent of slumping of revetment component.

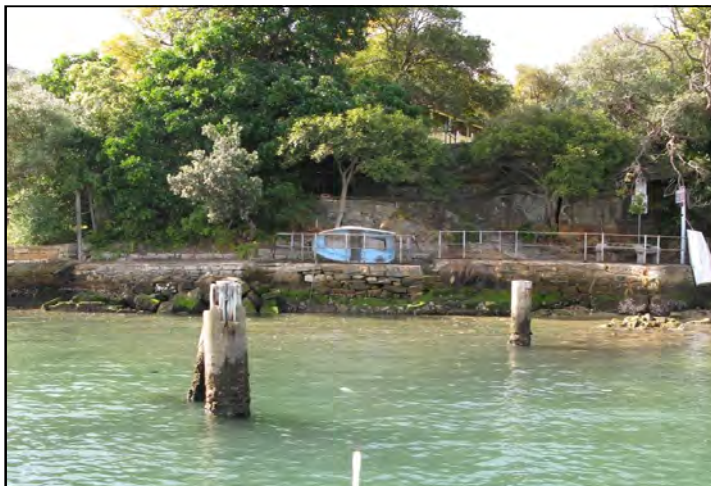
Photo 1

View of structure.

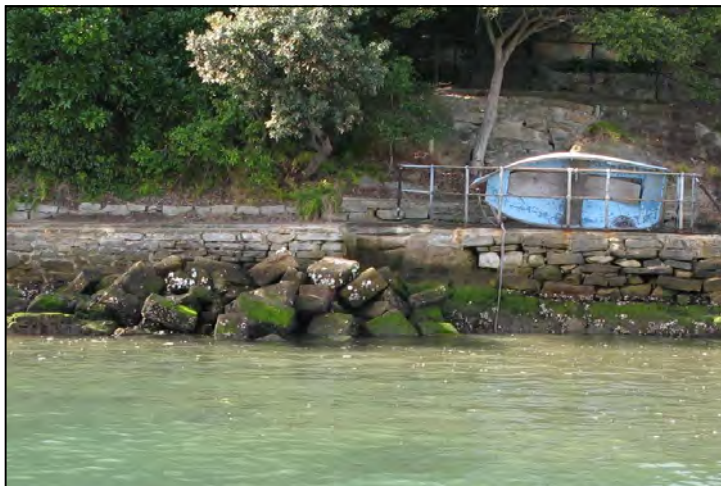
Photo 2

Sandstone seawall has failed in some locations with blocks strewn across bedrock. At other location all grout is missing with surface weathering and large cavities evident while grout has been replaced at discrete locations long the wall. Steel safety fence is corroding. Timber piles are showing signs of deterioration.

Block failure of seawall.

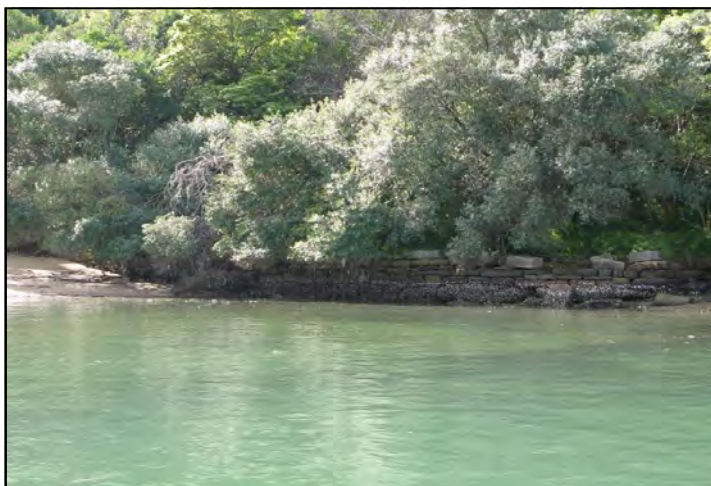
Photo 1

View of structure.

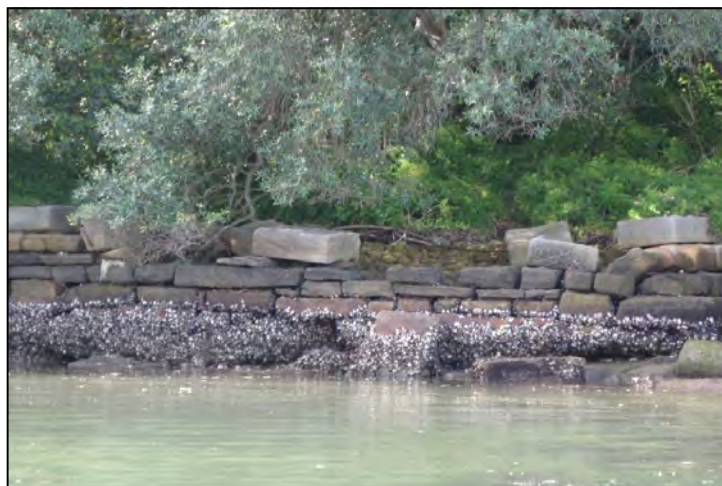
Photo 2

Numerous blocks have collapsed and fallen into water below. No grouting was observed. Surface weathering and slumping also evident.

Block failure of seawall.

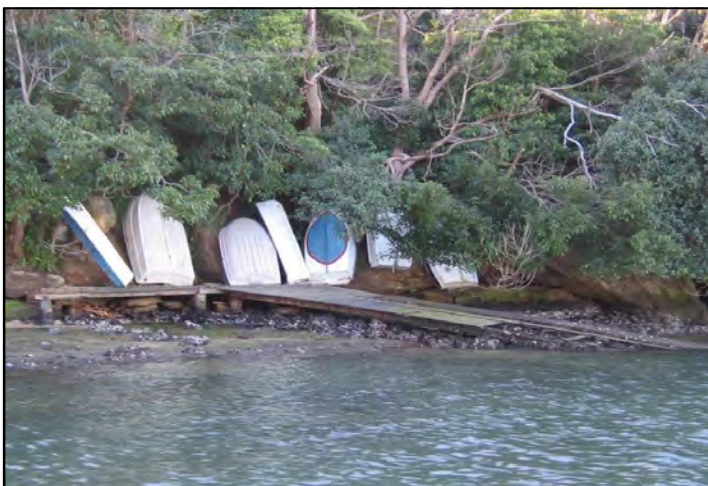
Photo 1

Timber ramp has partly collapsed and is severely deteriorated. Landing has also deteriorated. No formal dinghy storage structure was observed.

View of dinghy storage area showing deterioration of timber ramp.

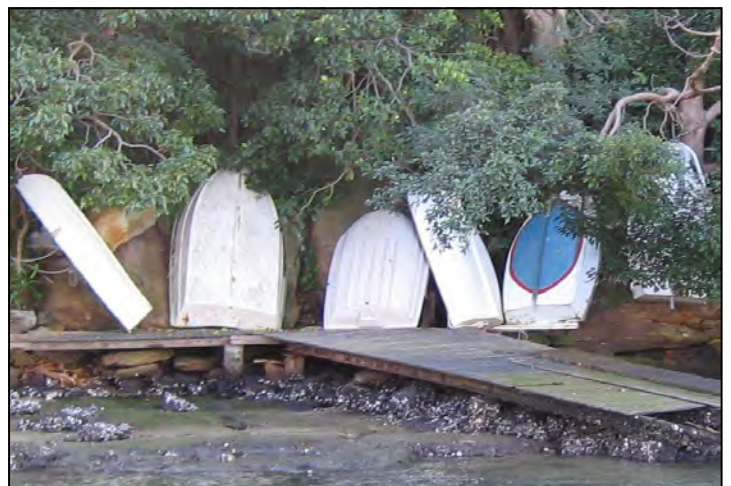
Photo 2

Dinghies on timber landing tethered to trees.

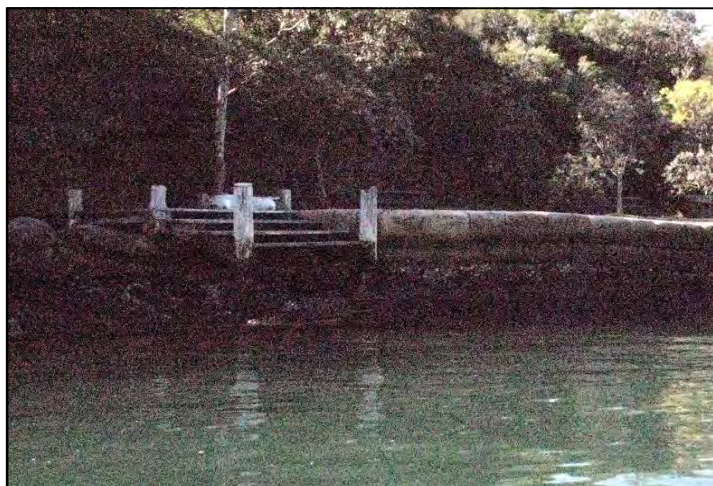
Photo 1

View of structure and adjacent seawall (HUN_S03).

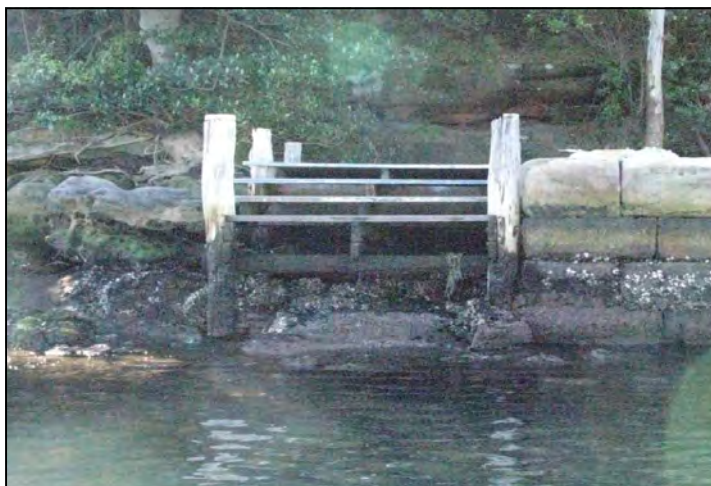
Photo 2

Deterioration of timber landing, stairs and piles was observed. Steel connections are corroding.

View of structure showing deterioration of timber piles.
