Seawall Inspection Record - RYD_S23

Date	<u>19/08/09</u>	Locality	<u>Meadowbank, River North</u>	Level	<u>0.30m</u>	LGA	<u>Ryde</u>
Time	<u>12:33</u>			Tide	<u>Low</u>

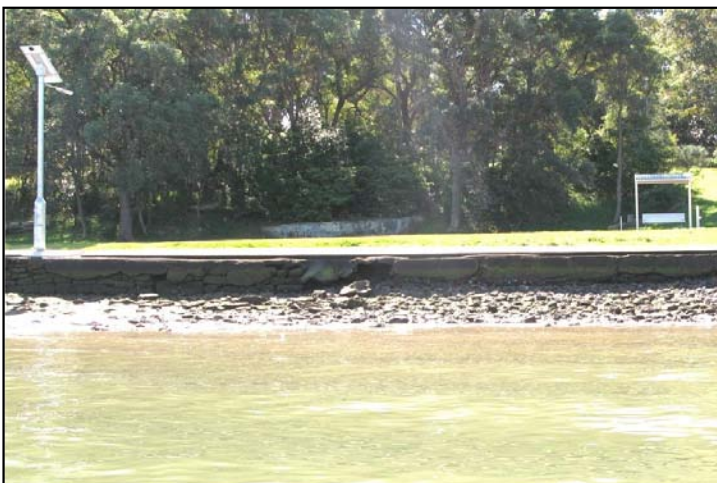
Photo 1

Grout not present, voids and localised block failures were observed. Concrete capping on crest and
face has cracked and failed.

Typical view of structure showing block and concrete
capping failure.

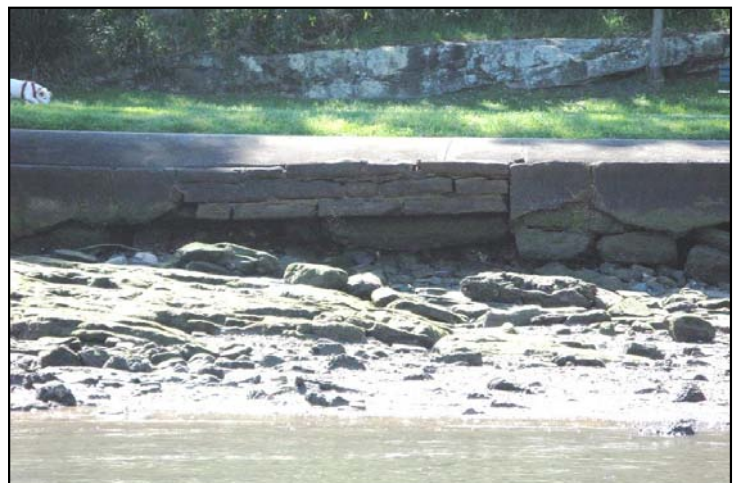
Photo 2

Block failure beneath at toe.

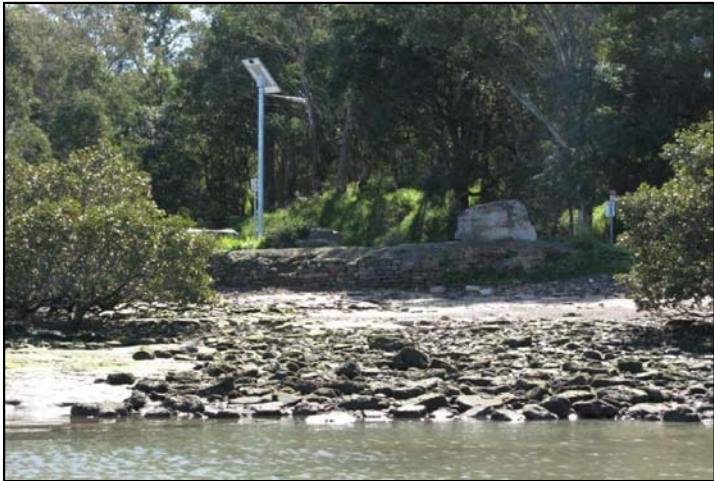
Photo 1
View of structure.

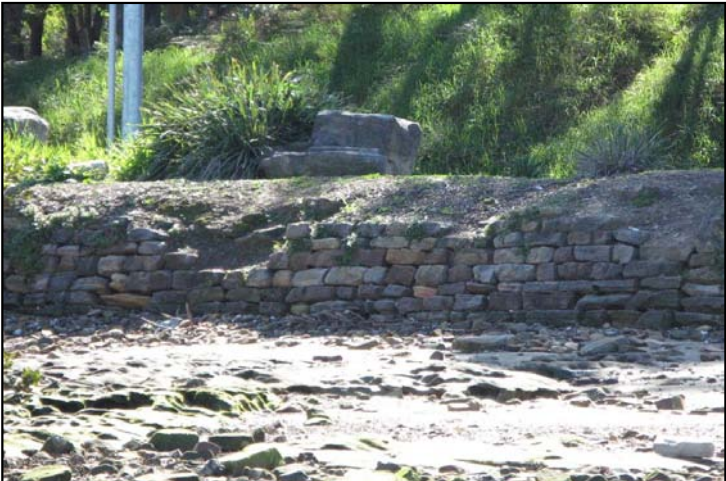
Condition Assessment (Slope, Crest, Toe, Backfill):
Significant slumping, block failures at the crest and weathering of sandstone blocks was observed along the length of the structure. Vegetation is also growing out of the wall.

Photo 2
Block failures and slumping of wall.

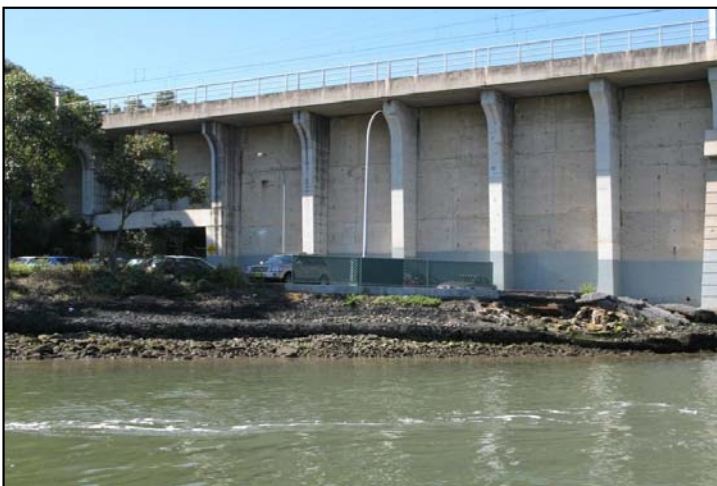
Photo 1

View of structure.

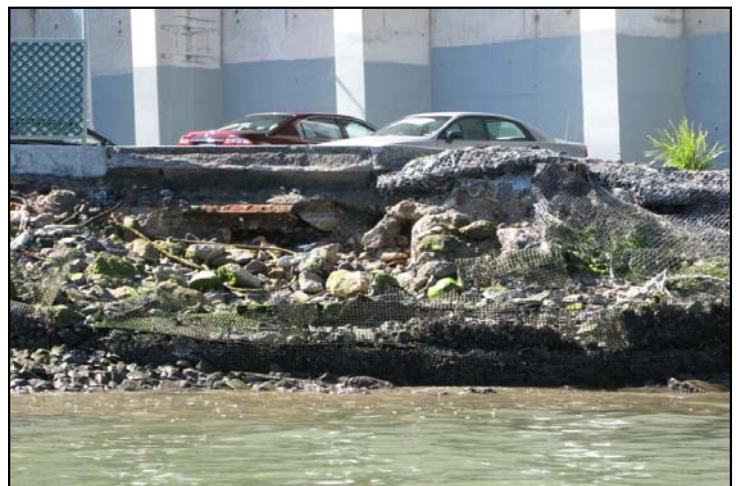
Photo 2

The section adjacent to the bridge abutment has failed and all material has been lost from the baskets. The rest of the structure is slumping.

The structure supports a public carpark and walkway which has been undermined by the failure adjacent to the bridge abutment.

Failure of structure adjacent to John Whitton Bridge.

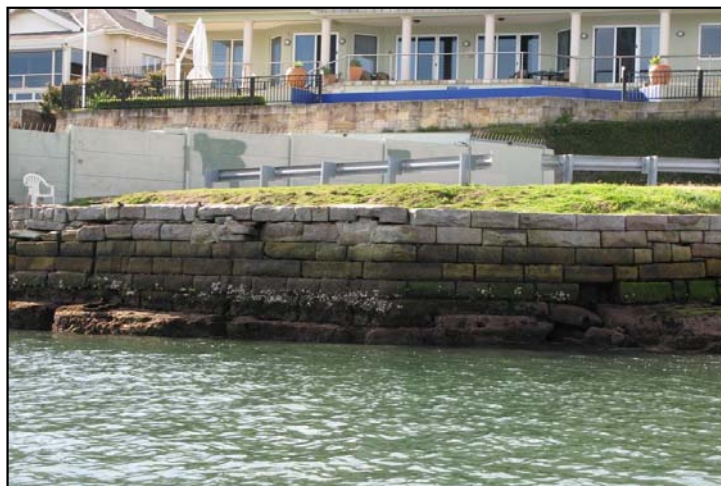
Photo 1

Typical view of wall.

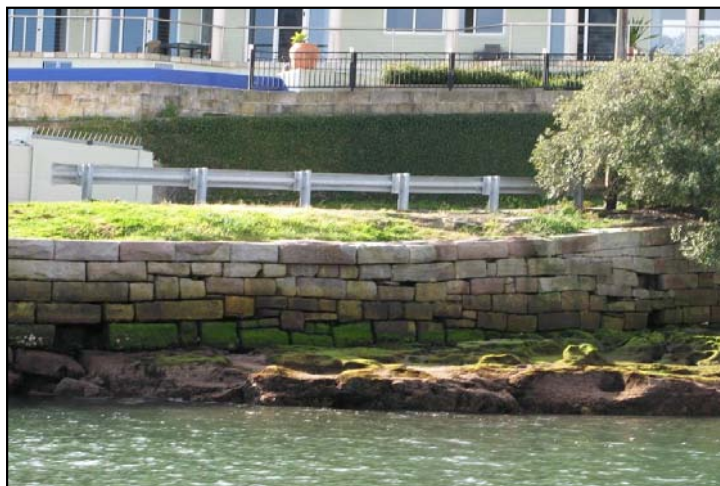
Photo 2

A number of block failures were observed along the length of the wall. Additionally, no grout is present between the blocks, sinkholes are present at the crest and surface weathering of the blocks has taken place.

Block failures along wall.

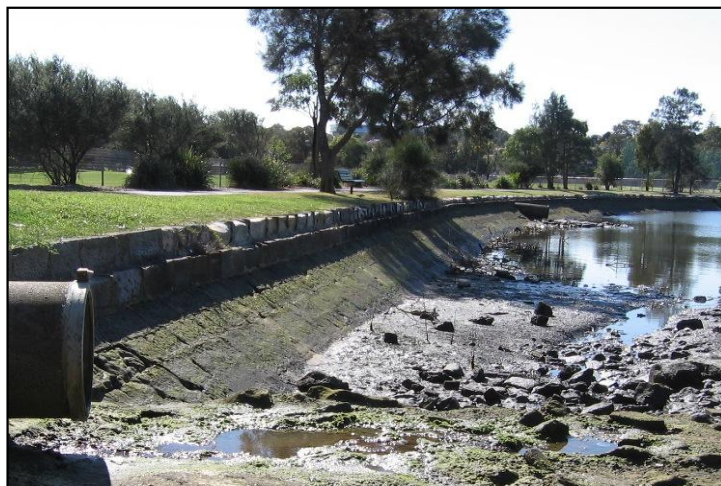
Photo 1

Typical view of seawall.

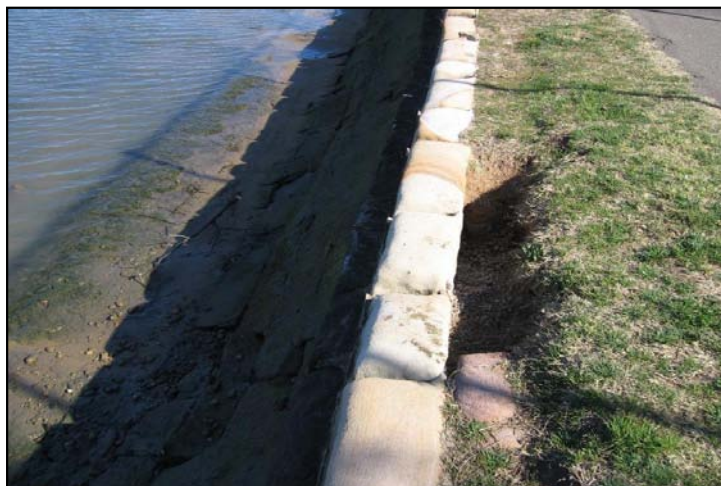
Photo 2

Severe weathering, slumping and loss of grout from between sandstone blocks was observed. A number of sinkholes are present behind the crest indicating a loss of fine material.

Weathering of sandstone blocks at crest and sinkhole behind wall.

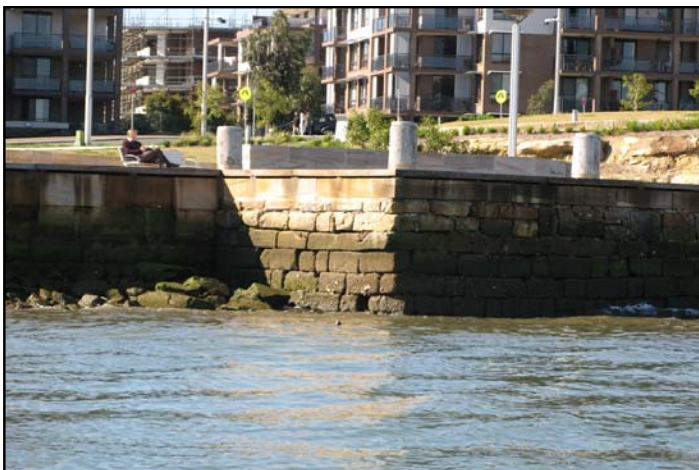
Photo 1

Typical section of wall showing older blocks along toe and newer blocks at crest.

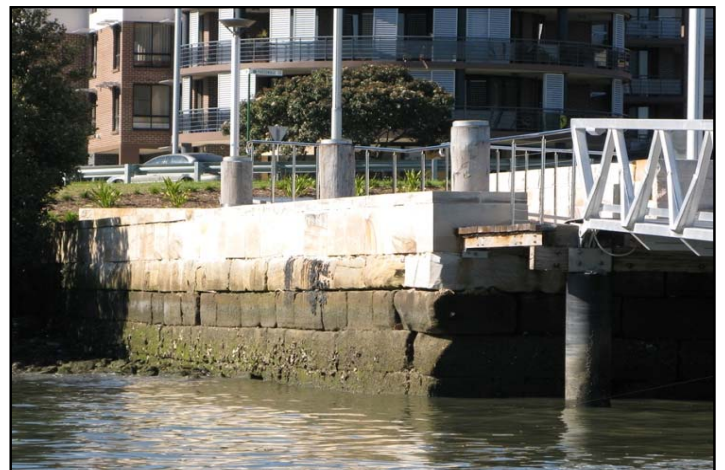
Photo 2

Single block failures were observed along the older, lower section of the wall. The lower section is also slumping and grout material is missing from between the blocks. The newer blocks that form the crest are in excellent condition.

Block failures beneath the connection of the public wharf.

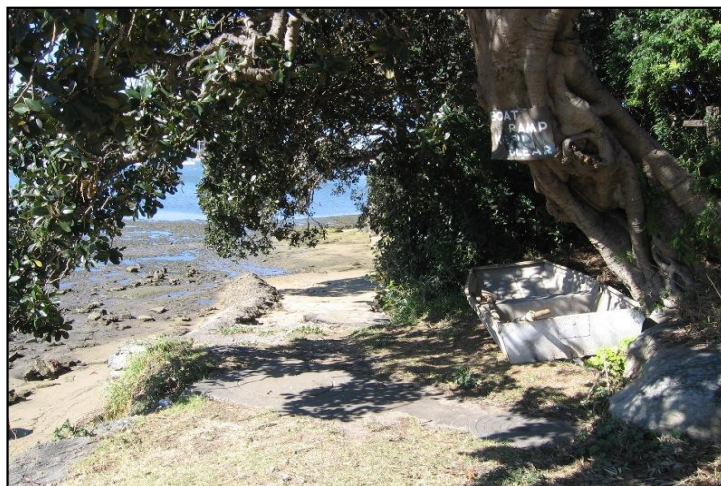
Photo 1

View of ad-hoc boat ramp and informal dingy storage.

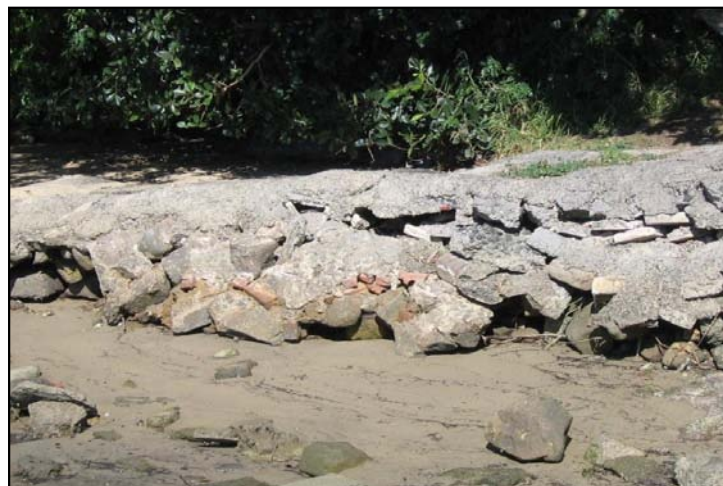
Photo 2

The boat ramp is not constructed to typical engineering standards. The toe has been undermined and the sides of the ramp are failing with aggregate material strewn along adjacent sandy shoreline. There is no formal structure for dingy storage.

Undermining at the toe and failure along the side of the ad-hoc boat ramp.

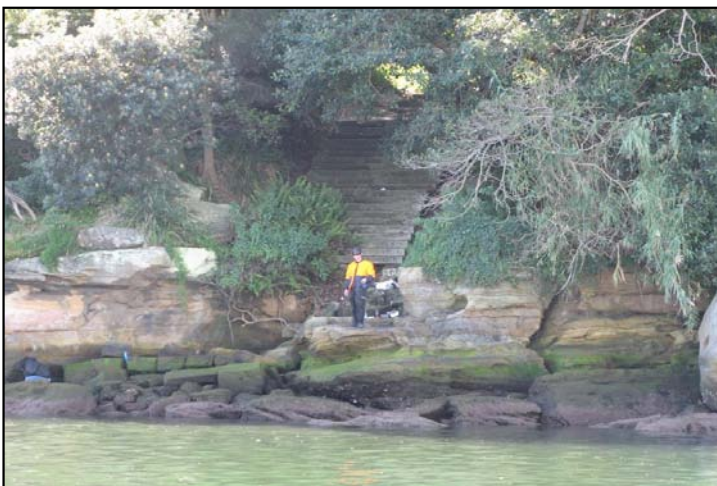
Photo 1

Concrete stairs and rocky shoreline with members of the public fishing and climbing on rocks.

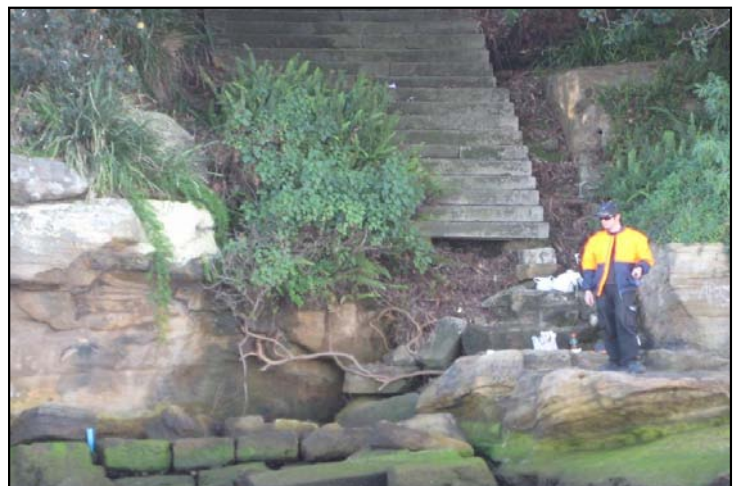
Photo 2

The concrete stairs are in a poor conditions with cracks present and undermining at the lowest point.

Undermining of concrete stairs.

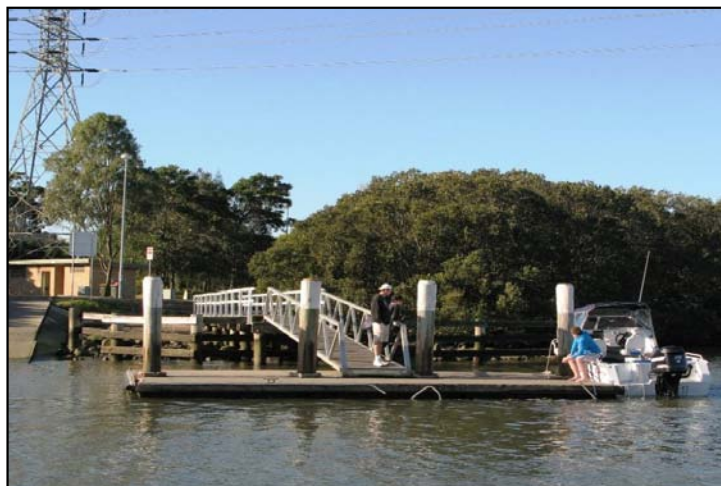
Photo 1

View of structure.

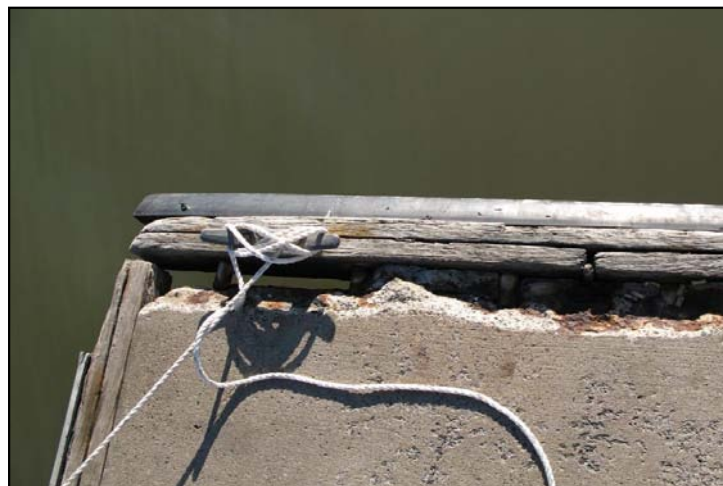
Photo 2

The timber slats on the jetty are loose and deteriorating as is the timber rail. The timber slats on the gangway are also loose and deteriorating. The edges of the concrete that makes up the floating pontoon are severely corroded with reinforcement visible.

Corrosion of concrete which forms floating pontoon.

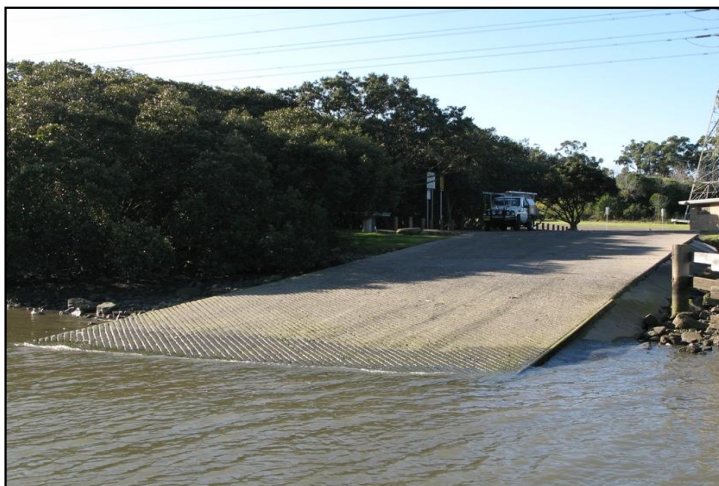
Photo 1

View of boat ramp.

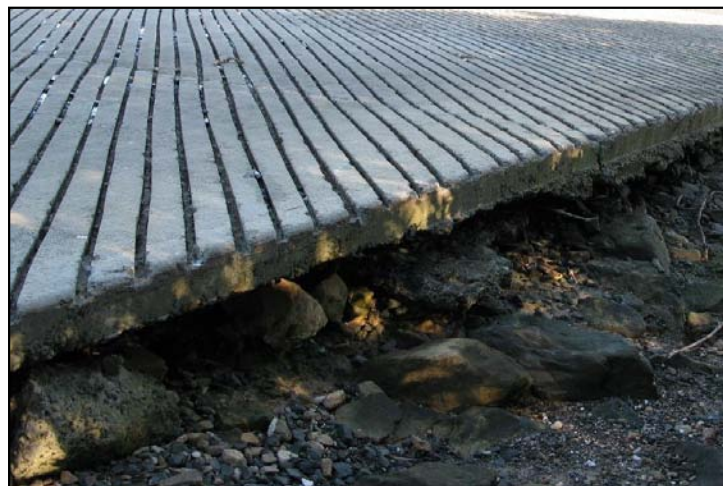
Photo 2

The concrete ramp is cracking and aggregate is exposed. The western side of the structure has been undermined.

Undermining of structure on the western side.

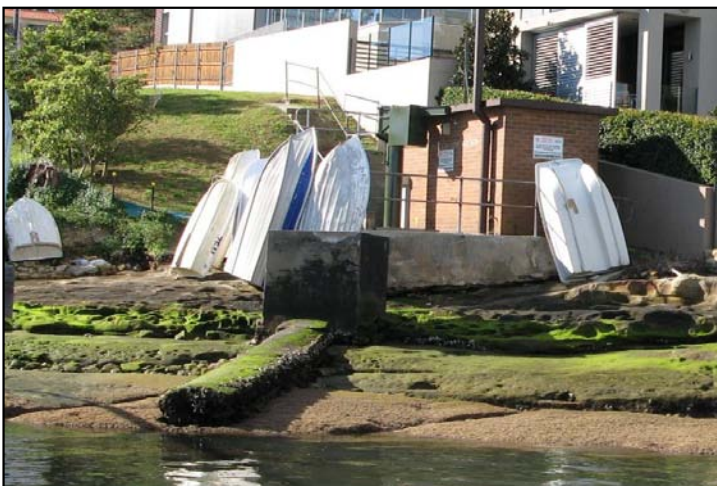
Photo 1

Informal dinghy storage at Sydney Water pumping station.

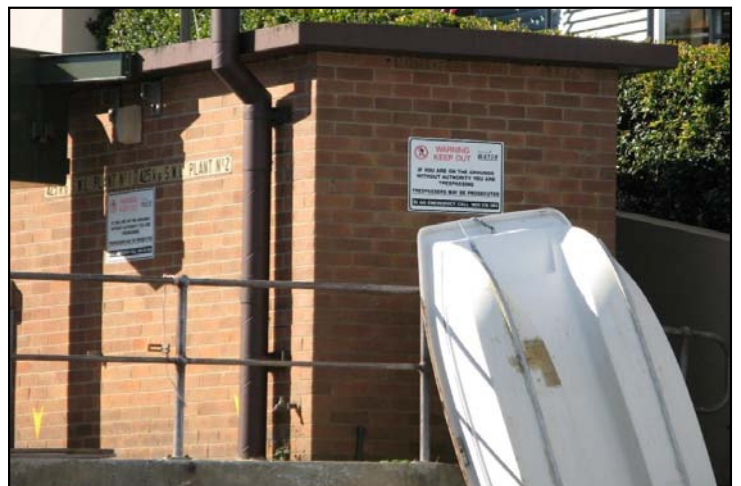
Photo 2

No formal facility. Steel safety rail associated with Sydney Water pumping station is showing signs of corrosion and the concrete slab it sits upon has been undermined.

Dinghy tethered to steel safety rail.

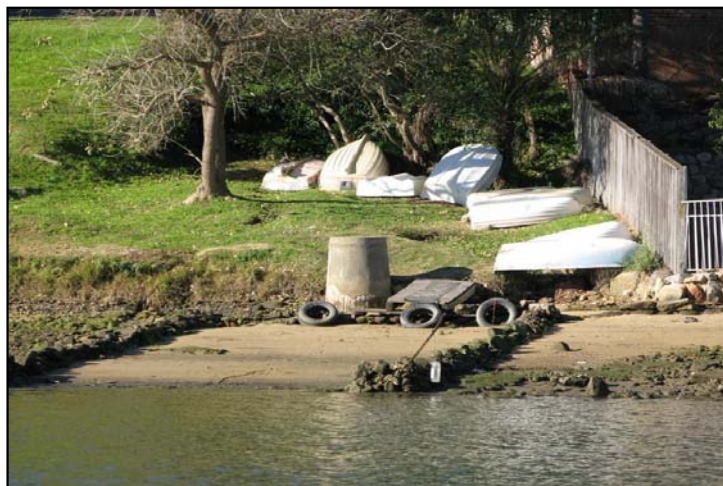
Photo 1

View of informal dinghy storage facility and ad-hoc structures along shoreline.

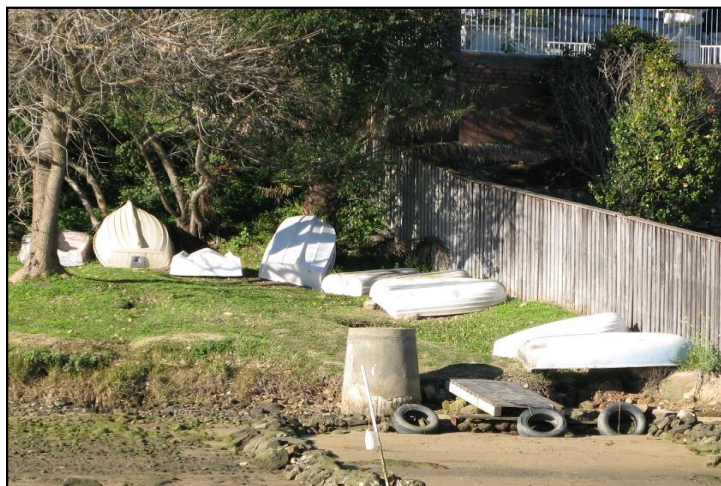
Photo 2

Dinghies tethered to trees and timber fence.

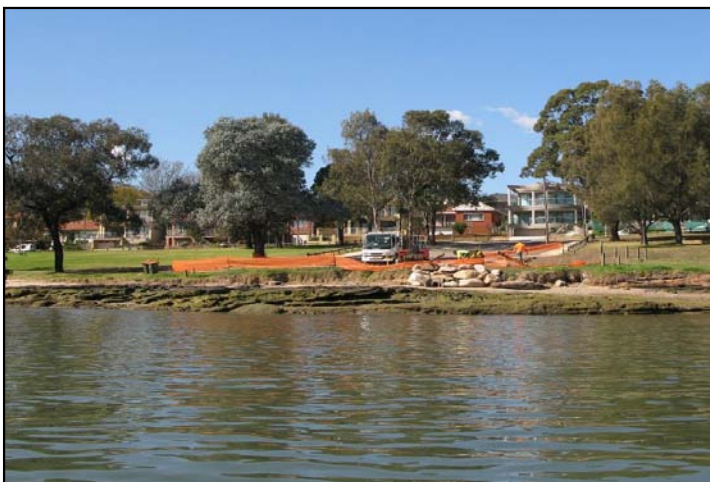
Photo 1

A large, approx. 500mm erosion scarp is present for 50m encompassing the end of Yaralla Road. The section is fenced off from the public and council workers were on site during the inspection and were placing large sandstone boulders along the scarp which don't appear to be designed to typical engineering detail with no filter layer observed.

View of erosion scarp behind rocky shoreline.

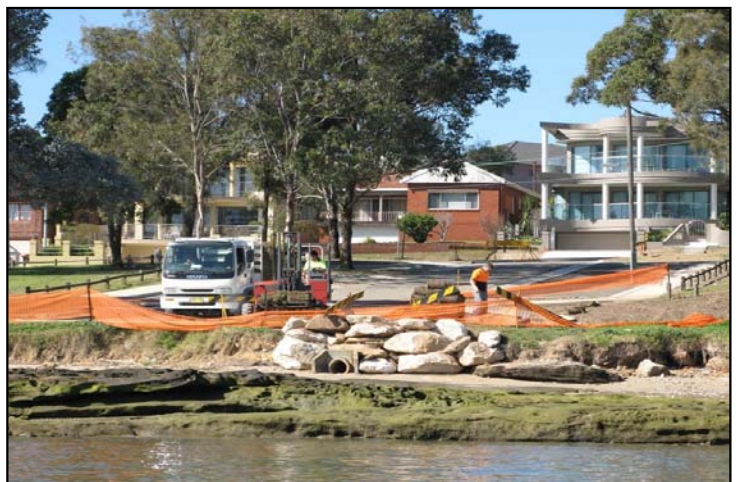
Photo 2

Large sandstone blocks placed along erosion scarp encompassing a new storm water culvert.

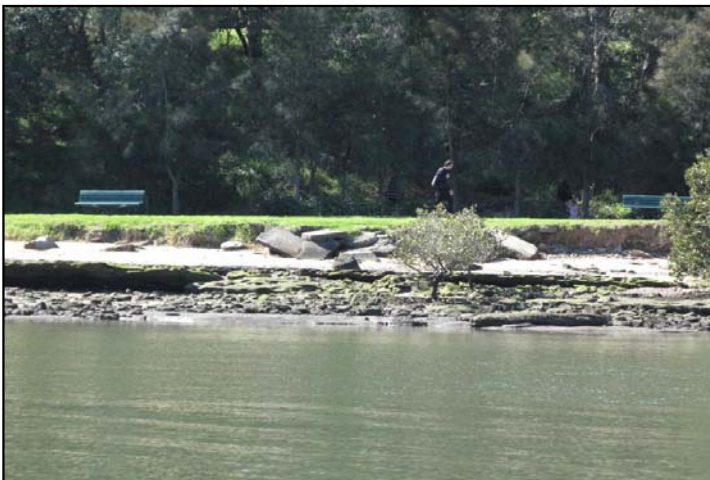
Photo 1

View of foreshore.

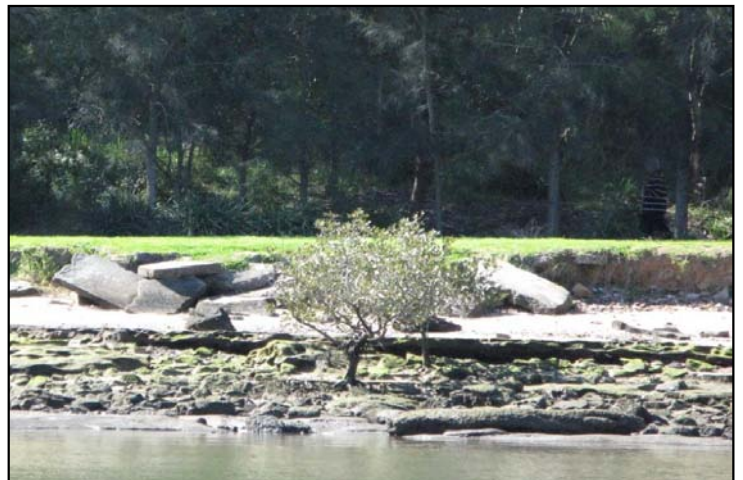
Photo 2

Large erosion scarp (300-500mm) is present at edge of grassy bank indicating exposure and sensitivity to passing vessel wash. Concrete building waste has not been placed to typical engineering standards.

Erosion scarp with concrete building waste.

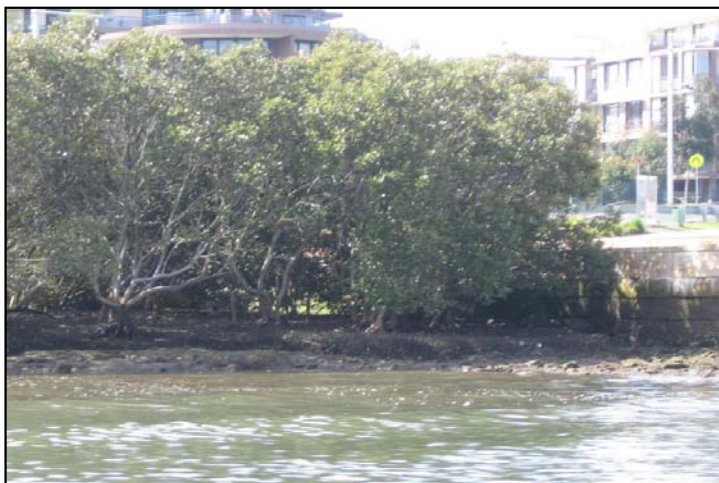
Photo 1

Mangroves adjacent to Seawall RYD_NS11.

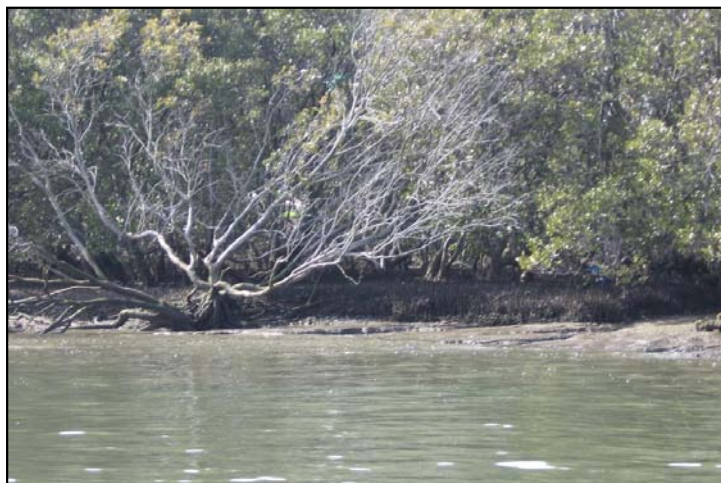
Photo 2

Erosion observed with no fine material present between pneumatophores due to exposure to vessel wash. One mangrove has collapsed.

Collapsed mangrove.

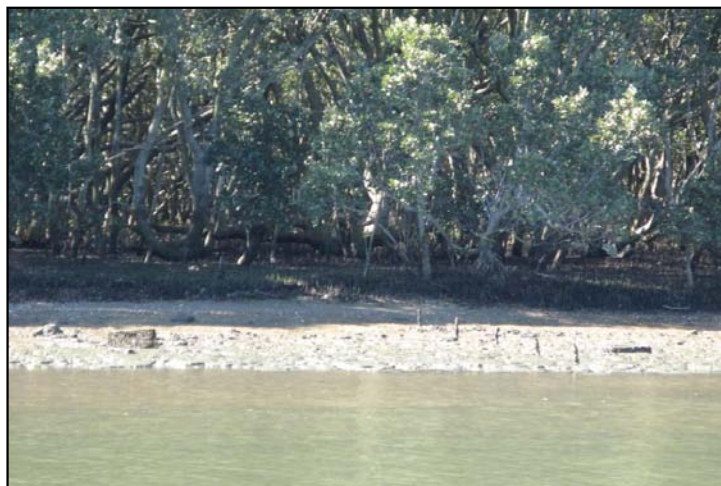
Photo 1

Erosion observed with undermining and loss of fine material from pneumatophores due to exposure to vessel wash.

Loss of fine material from pneumatophores.

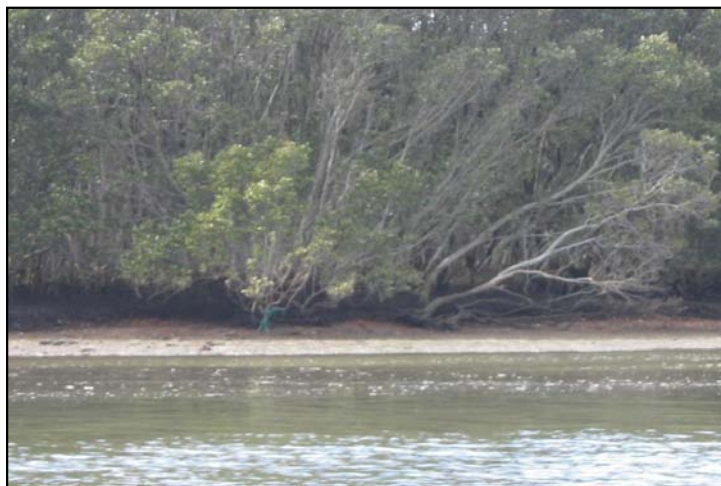
Photo 2

Some trees are collapsing into water.

Undermining and collapsing of mangroves.

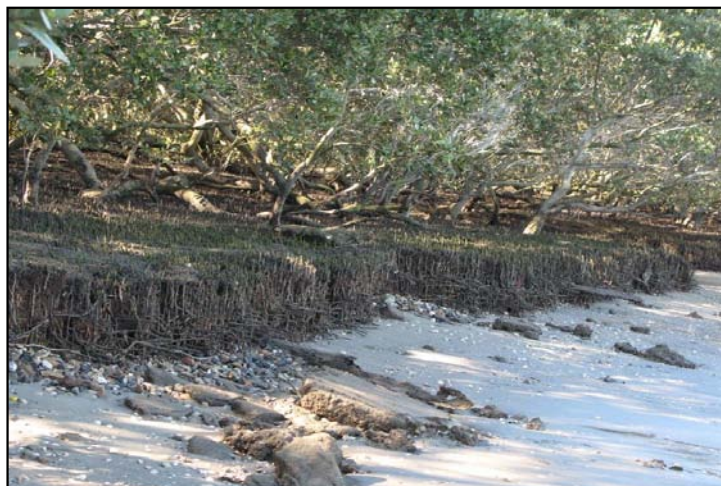
Photo 1

Erosion observed with undermining and loss of fine material from pneumatophores due to exposure to vessel wash.

Loss of fine material from pneumatophores.

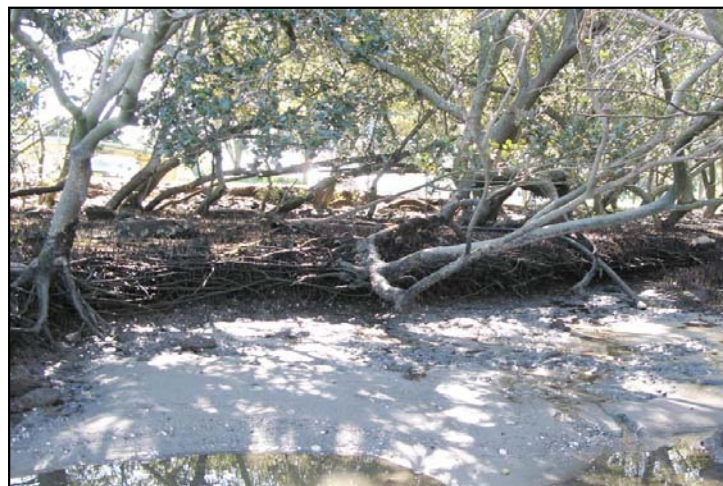
Photo 2

Some trees are collapsing into water.

Mangroves collapsing due to undermining.
