# Seawall Inspection Record - PAR\_S16

Date 21/08/09 Level 0.21m LGA Parramatta  
 Time 14:32 Locality East of Macarthur Street Bridge, River South People Low

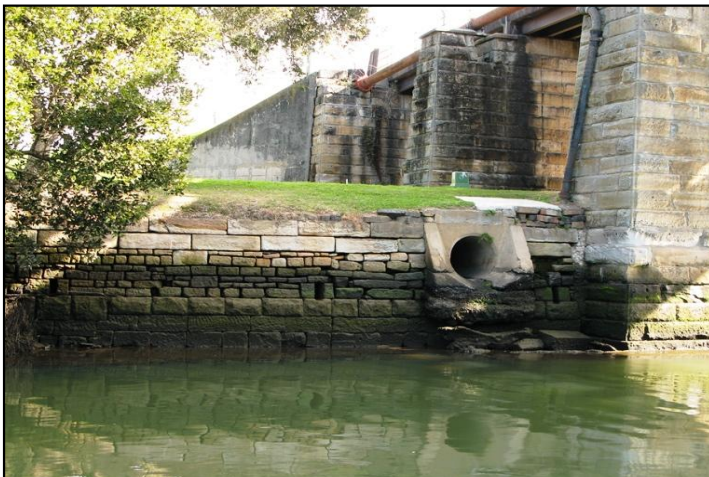
## Photo 1

View of western extent of structure adjacent to the Macarthur Street Bridge Southern Abutment.

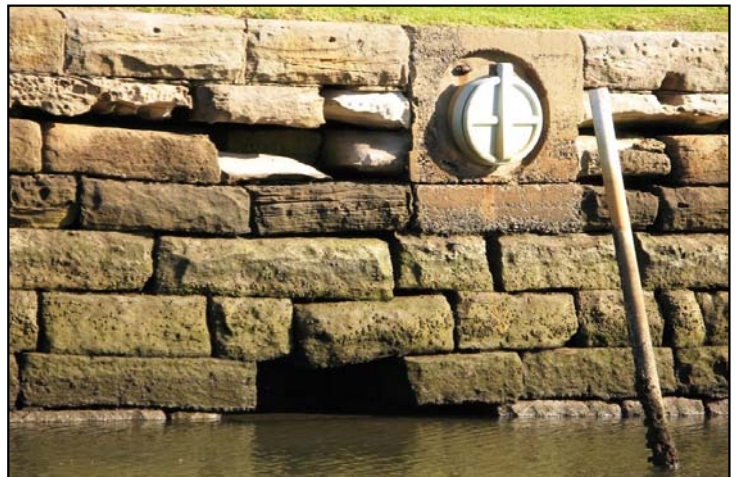
## Photo 2

Localised wall failures at the toe and crest were observed. In general, grout is absent from blocks which are slumping. Some section of the wall have been repaired with grout installed between sandstone blocks.

Block failure at the toe.

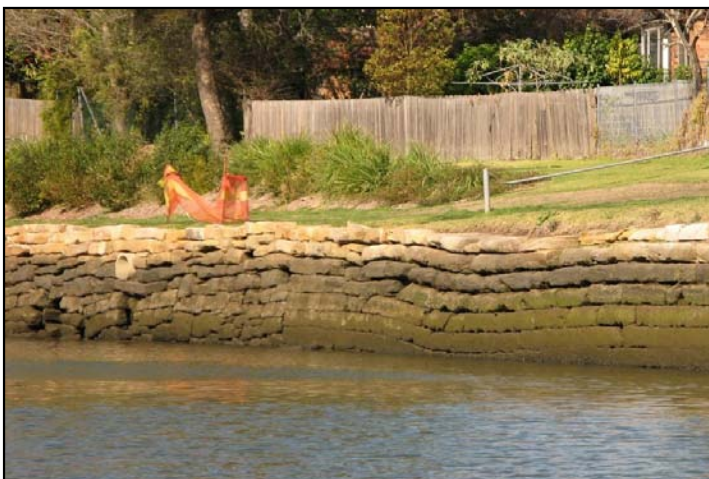
## Photo 1

Localised wall failures at the toe and crest were observed. The blocks are also slumping and weathered.

View of structure showing extent of block slumping.

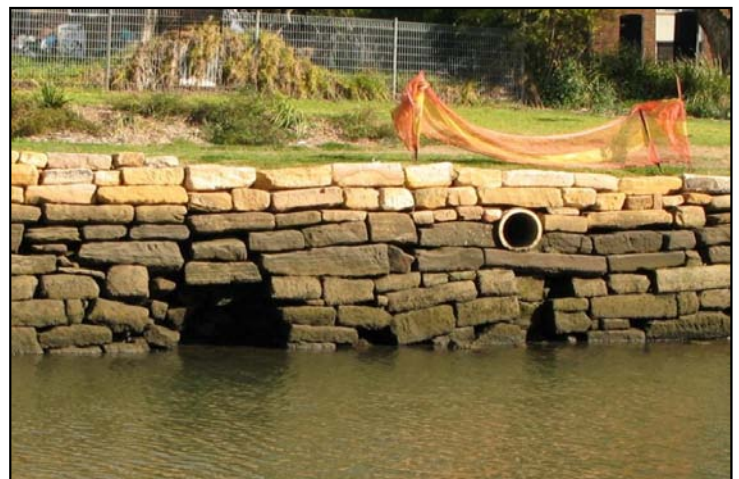
## Photo 2

Block failure at the toe.

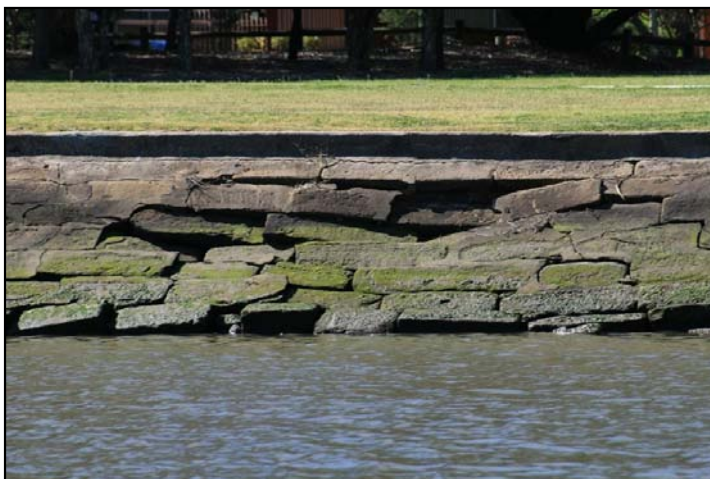
## Photo 1

The revetment is failing at discrete locations which correspond to the absence of mangroves exposing the structure to vessel wash. In general, the structure is ungrouted, slumping and the sandstone blocks are weathered. Mangroves that are present in front of the revetment have been undermined leading to failure.

Block failure of revetment.

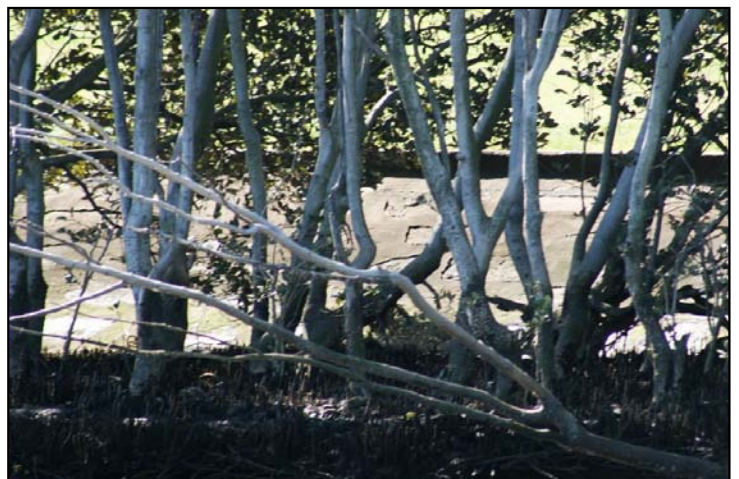
## Photo 2

Collapsed mangrove in front of revetment.

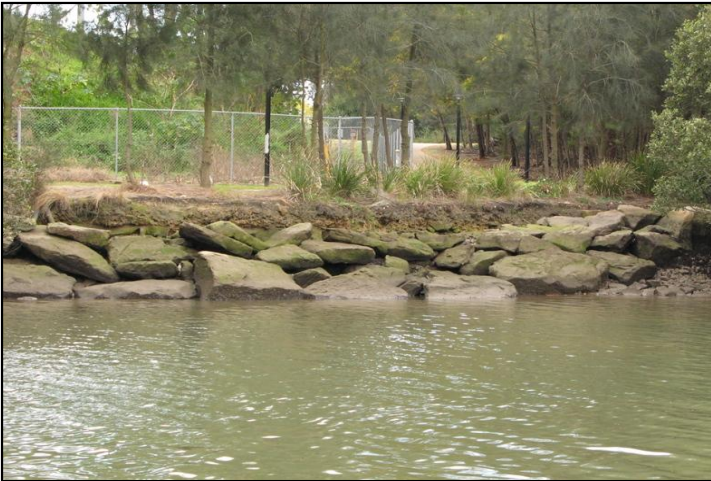
Photo 1  
Eastern extent of structure with erosion scarp beyond crest shown.

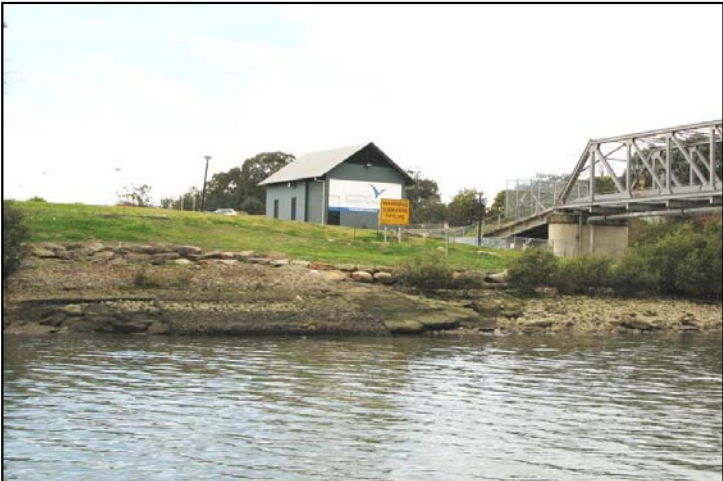
Photo 2  
Western extent of structure with gabion basket storm water outlet shown.

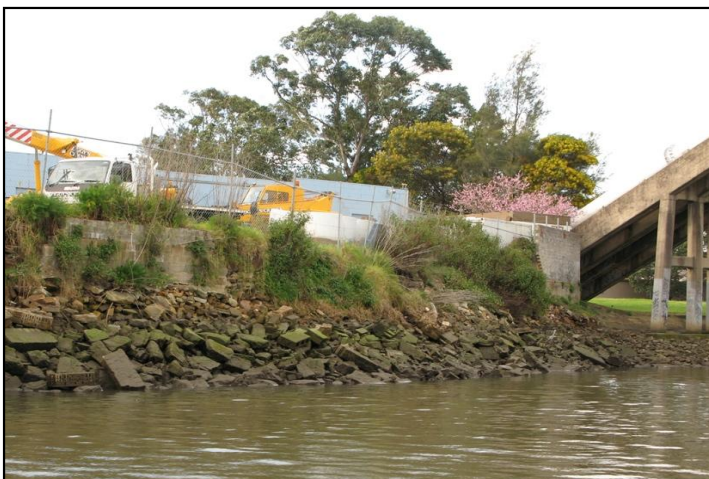
## Photo 1

The revetment has not been constructed to typical engineering detail. The brick wall at the back of the structure has collapsed with bricks strewn across the revetment slope.

View of ad-hoc rubble revetment.

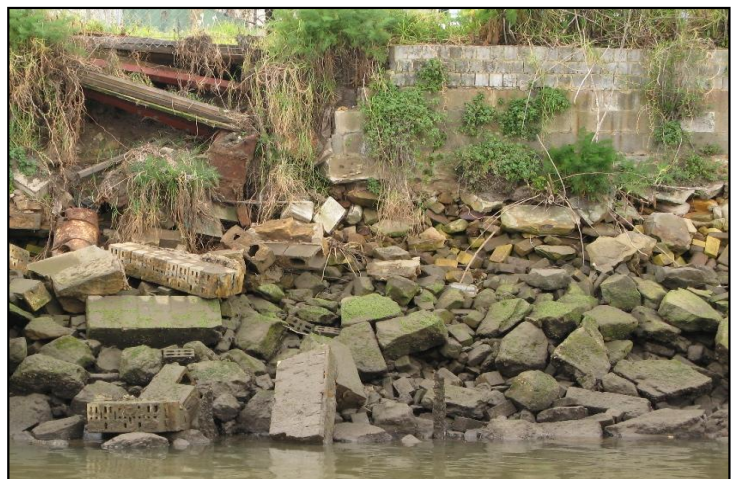
## Photo 2

Failure of brick wall at back of revetment.

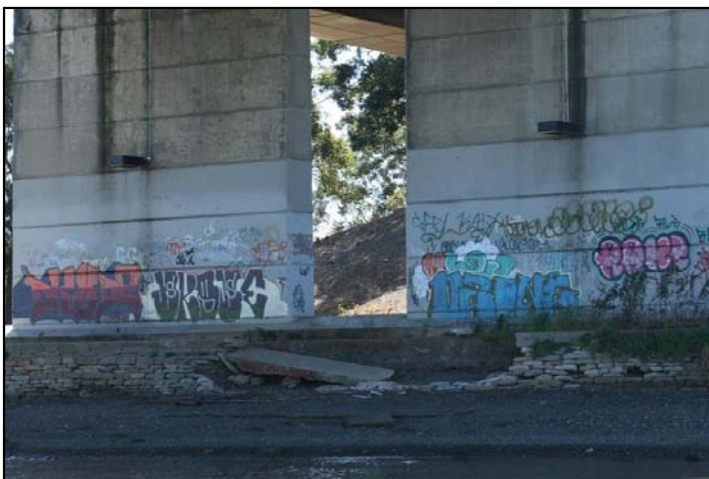
## Photo 1

View of small sandstone block seawall beneath Silverwater Bridge.

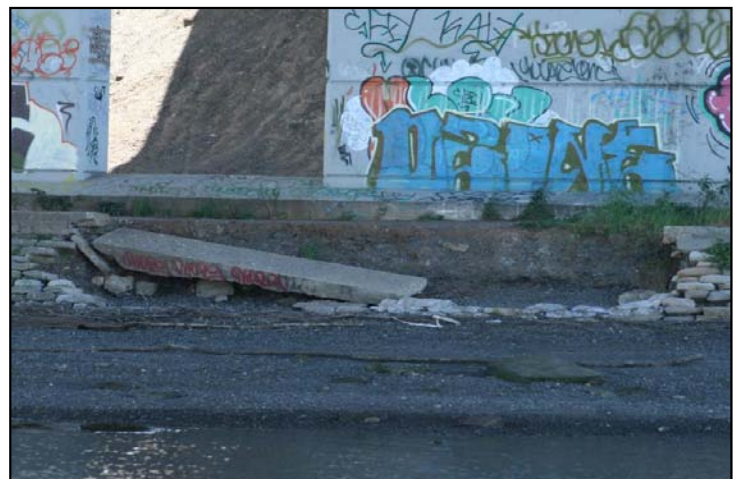
## Photo 2

The structure has failed with a large section of sandstone blocks missing. The concrete crest has collapsed onto the sandy bank below. Gabions baskets are present to the east (PAR\_S03) and west (PAR\_S05) and have probably been installed to replace other section of failed wall.

Failed section of wall.

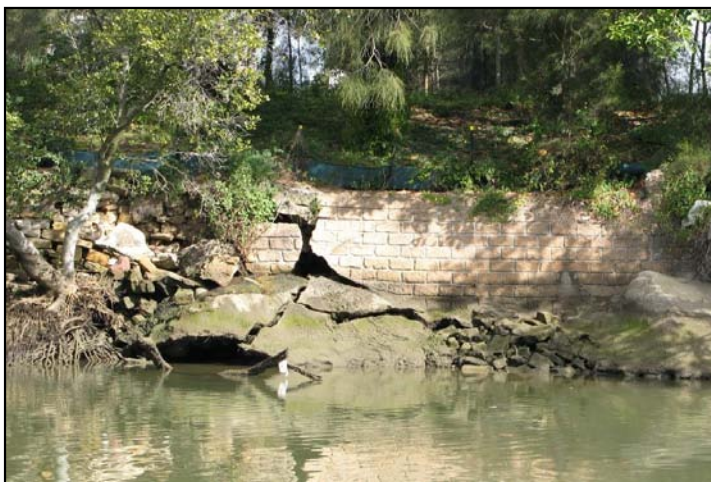
## Photo 1

Failure of new section of brick seawall at north western extent.

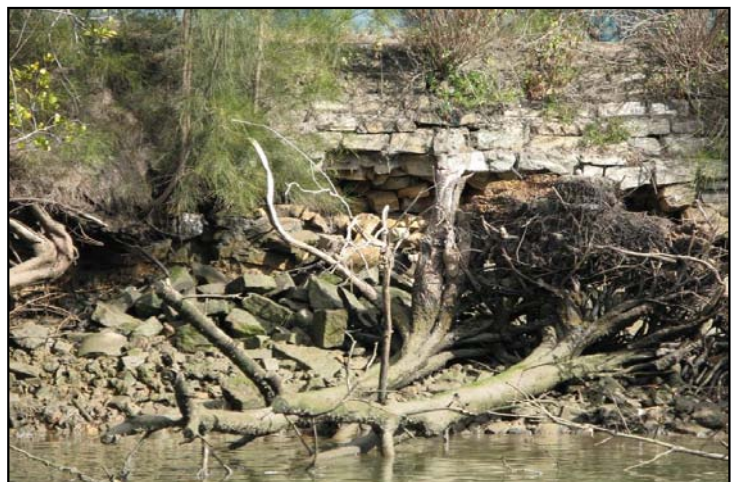
## Photo 2

The majority of the wall has failed due to undermining. The new section of wall at the western extent has also

failed. Mangroves that are in front of the wall have been undermined and have collapsed into the water.

Typical section of wall showing sandstone block wall failure and collapse of mangrove.

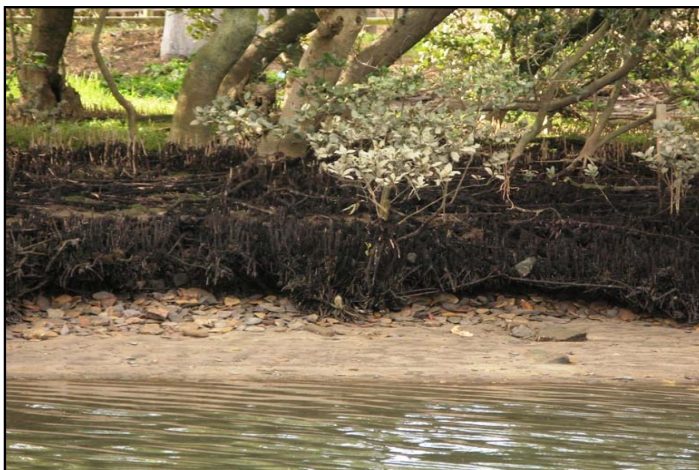
## Photo 1

Erosion observed with undermining and loss of fine material from pneumatophores due to exposure to vessel wash.  
A number of mangroves have collapsed into the water. The A-Jacks units are in good condition with no displacement observed.

Undermining and loss of fine material from pneumatophores.

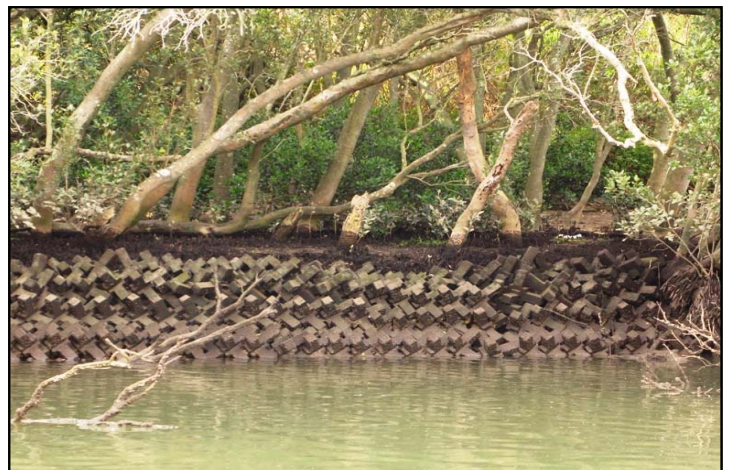
## Photo 2

A-Jacks armour units installed along the shoreline.

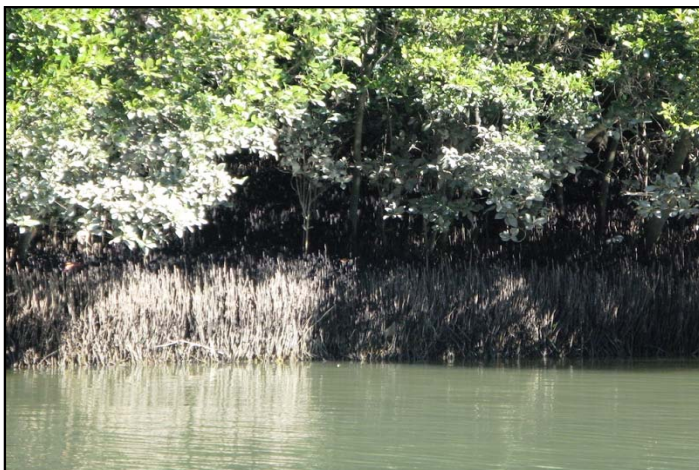
## Photo 1

Loss of fine material from pneumatophores.

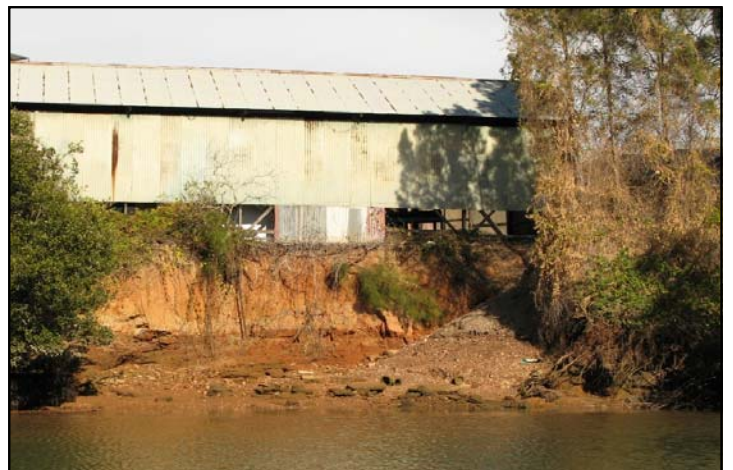
## Photo 2

Loss of fine material from pneumatophores due to exposure to vessel wash observed. A section without mangroves has collapsed with a large, >2m, erosion scarp present. Fill material has been dumped to the side of the failure in an attempt to impede erosion.

Collapse of exposed bank in front of private industrial building.

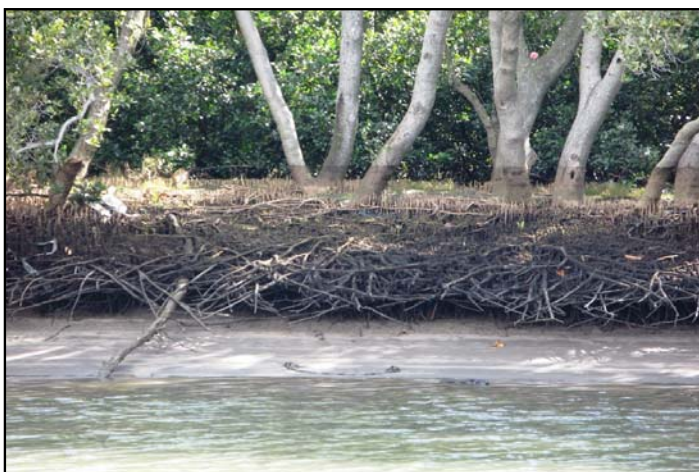
## Photo 1

Loss of fine material and undermining of pneumatophores.

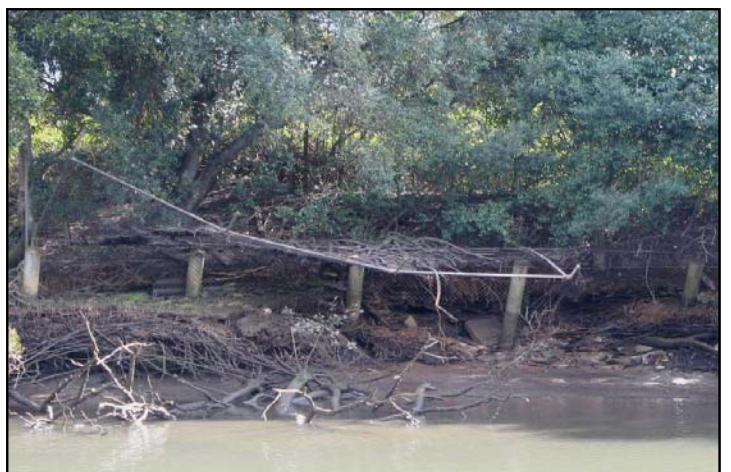
## Photo 2

Erosion observed with undermining and loss of fine material from pneumatophores due to exposure to vessel wash.  
 The steel fence has failed and the surrounding earthen bank is severely eroded.

Failure of fence and bank.

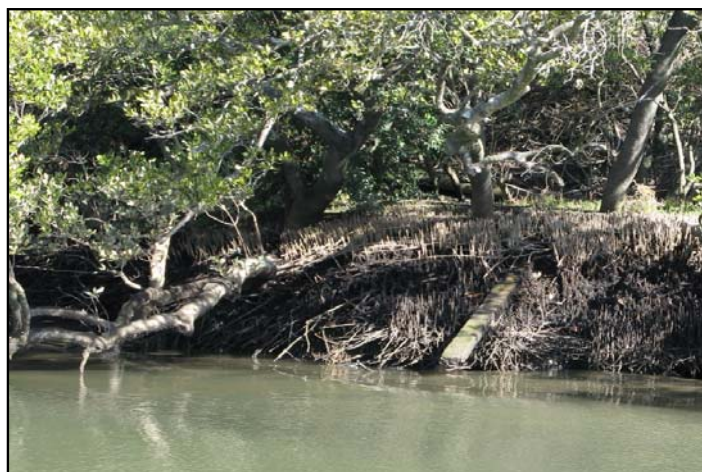
## Photo 1

Loss of fine material from pneumatophores and collapsed mangrove.

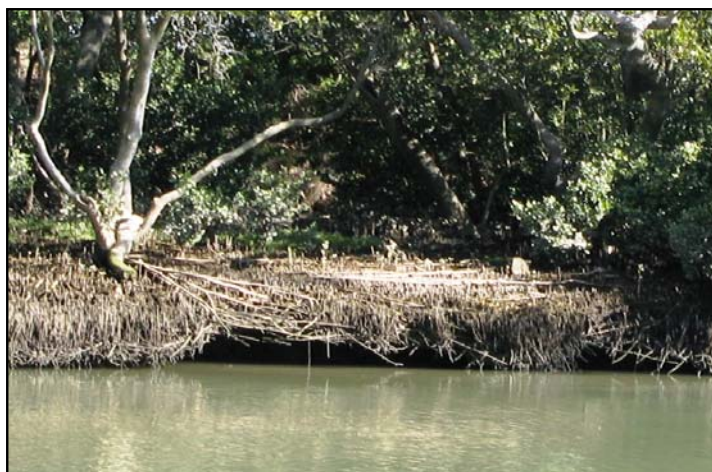
## Photo 2

Undermining of pneumatophores.

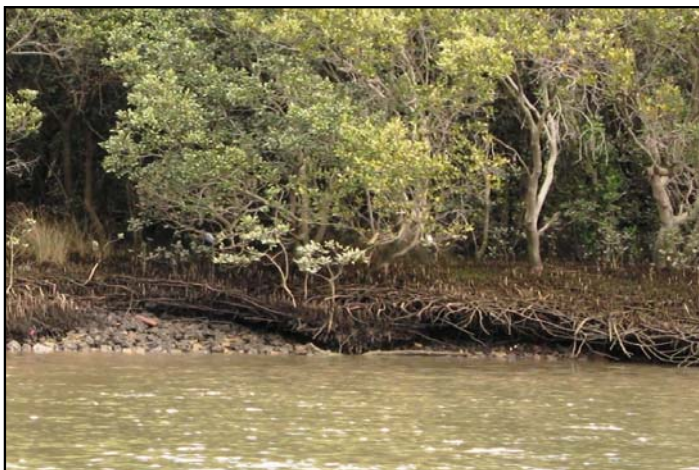
## Photo 1

Loss of fine material and undermining of mangroves.

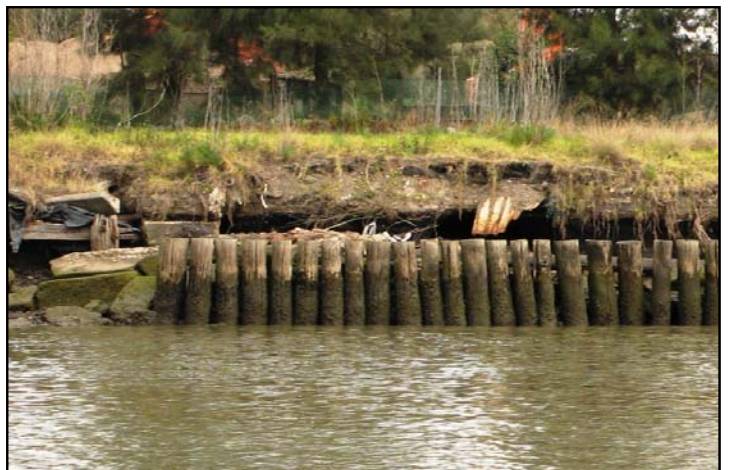
## Photo 2

Erosion observed with undermining and loss of fine material from pneumatophores due to exposure to vessel wash. The abandoned timber pile wharves and concrete stack have been undermined.

Abandoned timber pile facility with large erosion scarp behind.

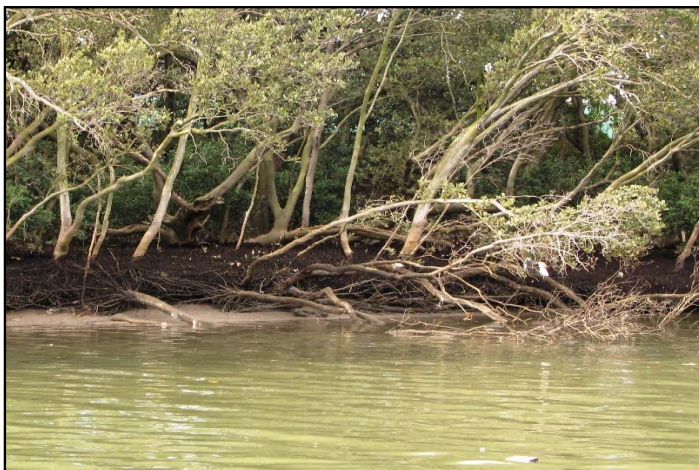
## Photo 1

Typical view of foreshore, mangroves have collapsed due to undermining.

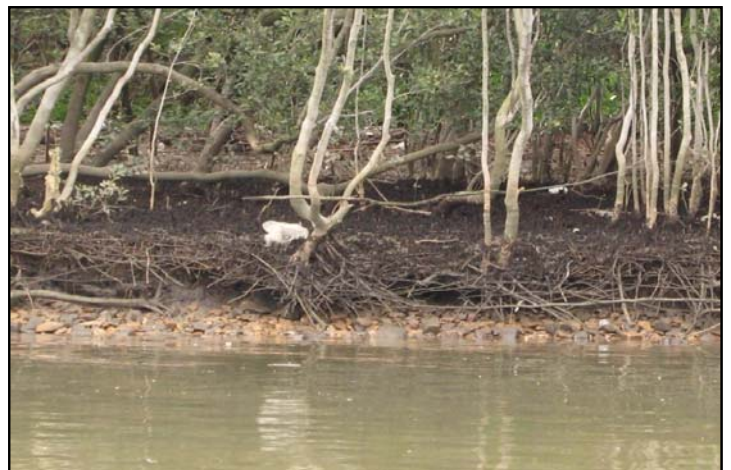
## Photo 2

Undermining of pneumatophores.

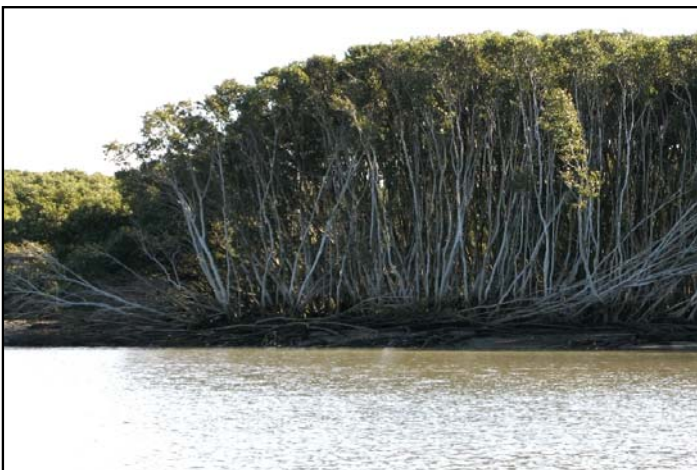
## Photo 1

Typical view of foreshore, mangroves have collapsed due to undermining.

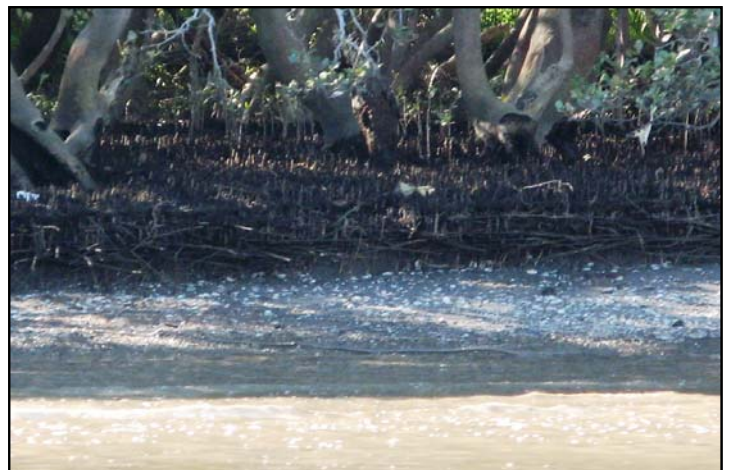
## Photo 2

Undermining and loss of fine material from pneumatophores.

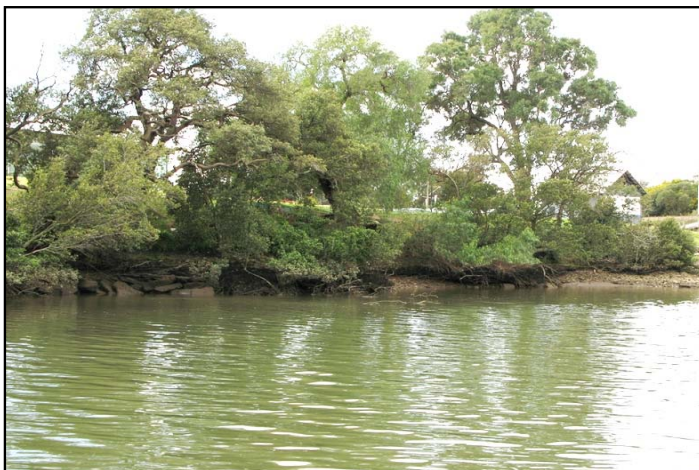
## Photo 1

Typical view of foreshore, mangroves and other vegetation are collapsing into the water

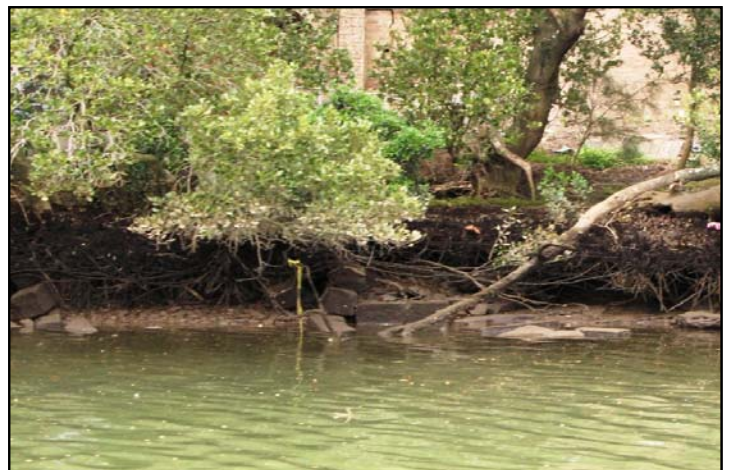
## Photo 2

Undermining of pneumatophores.

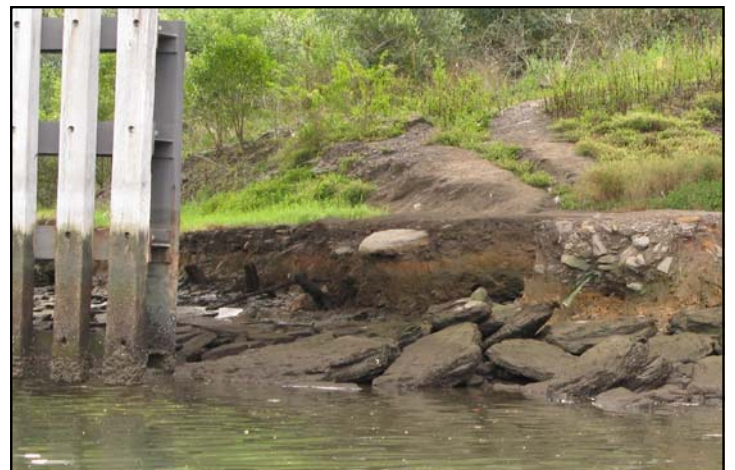
## Photo 2

Erosion scarp behind timber fenders directly under James Ruse Drive.

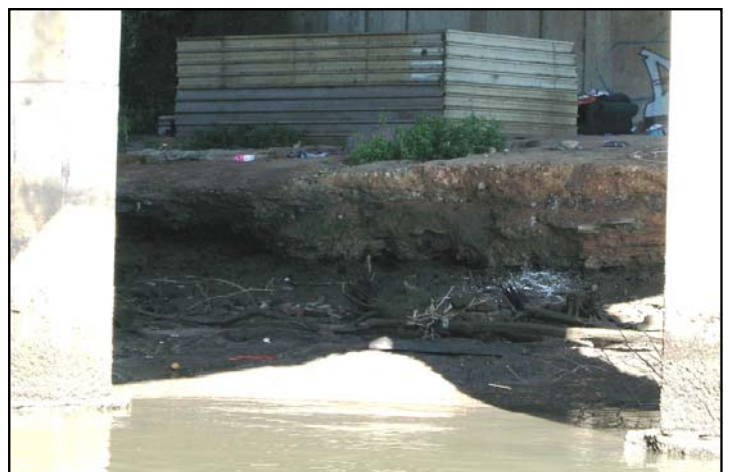
## Photo 2

The large erosion scarp at the foreshore.

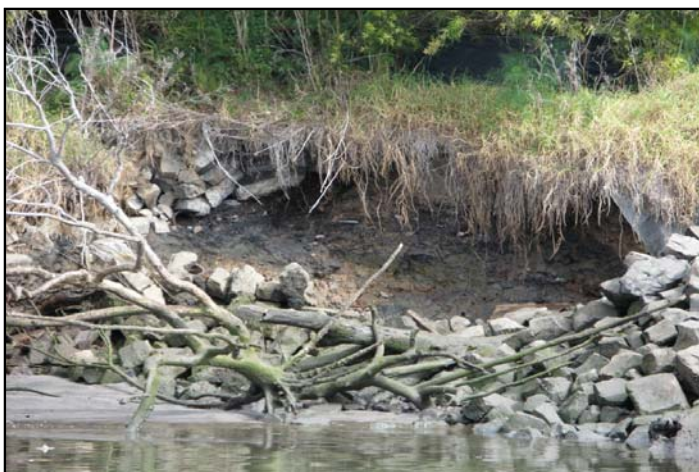
Erosion observed with undermining and loss of fine material from pneumatophores due to exposure to vessel wash.  
A section of bank with no mangroves, adjacent to seawall PAR\_S23 has also failed.

Failure of bank adjacent to seawall PAR\_S23.

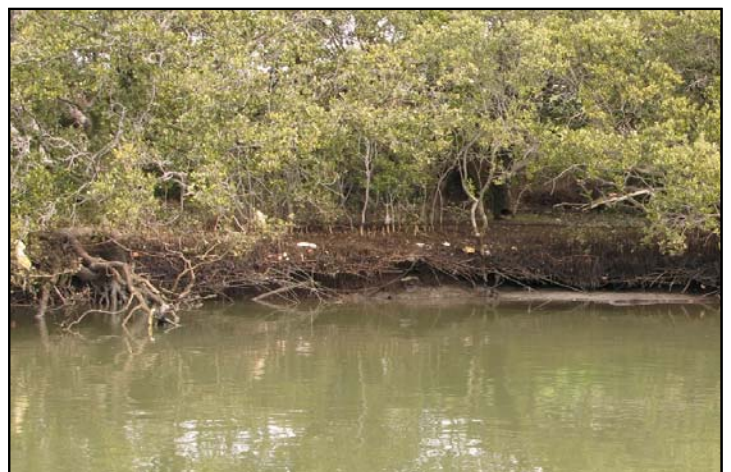
## Photo 2

Loss of fine material and undermining of mangroves.

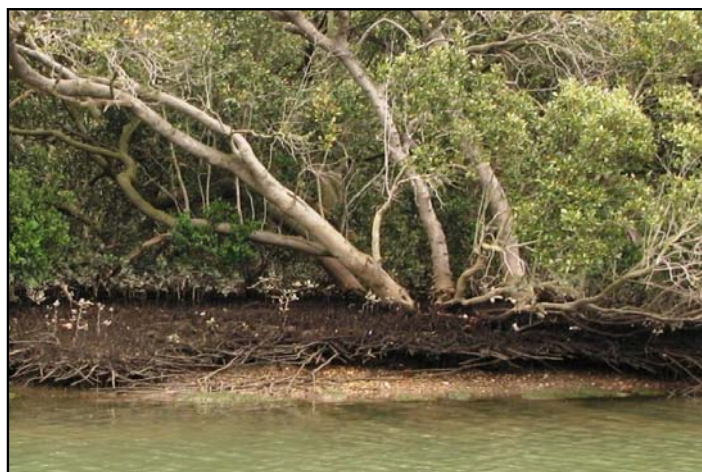
## Photo 1

Loss of fine material and undermining of mangroves at confluence.

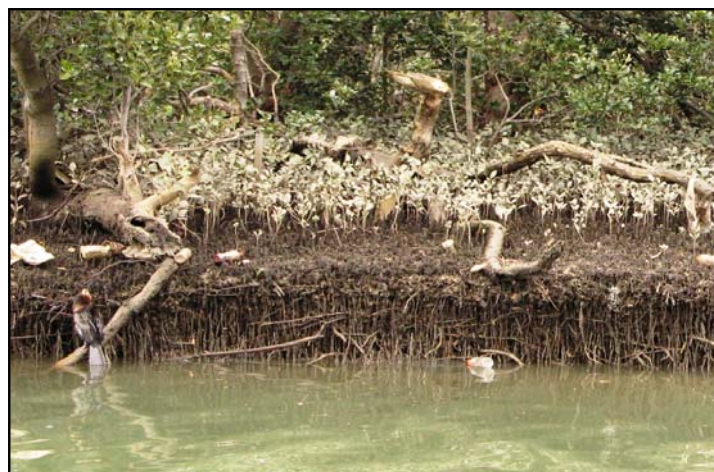
## Photo 2

Loss of fine material from pneumatophores upstream of confluence in the Duck River.

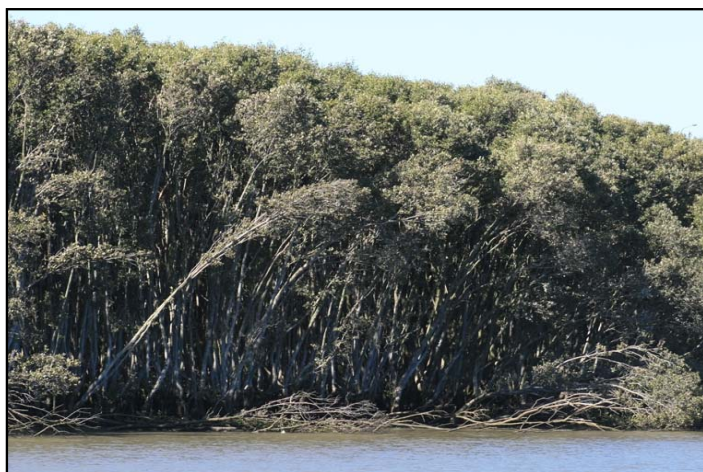
## Photo 1

Typical view of foreshore, mangroves have collapsed due to undermining.

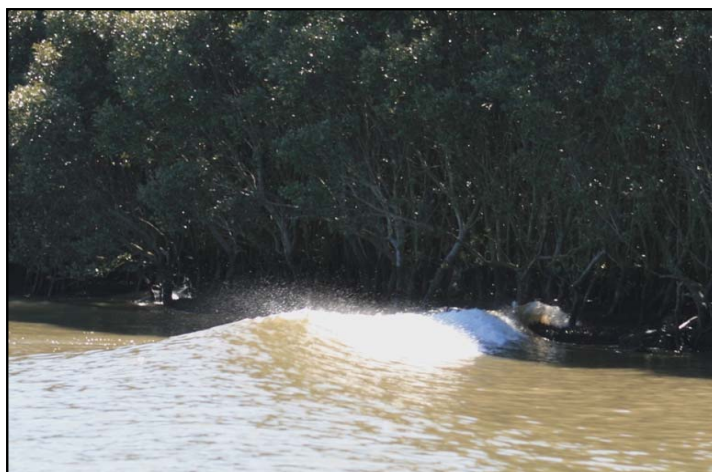
## Photo 2

Vessel wash at foreshore.

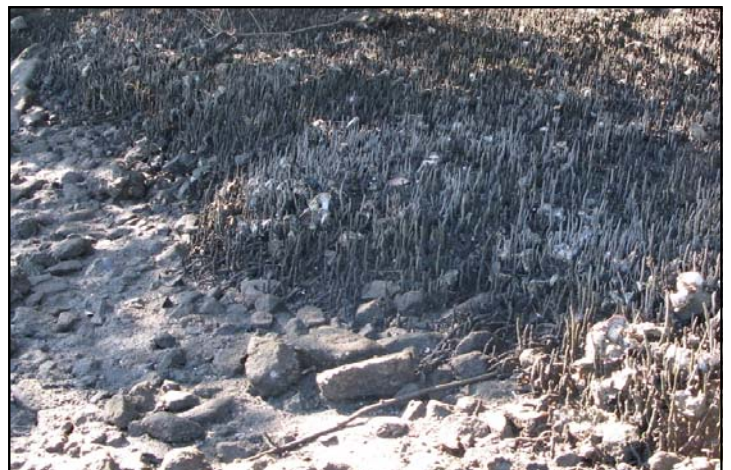
## Photo 2

Loss of fine material from pneumatophores.
