5.0 Foreshore Erosion

PARRAMATTA RIVER ESTUARY PROCESSES STUDY
FORESHORE EROSION UPSTREAM OF SILVERWATER BRIDGE

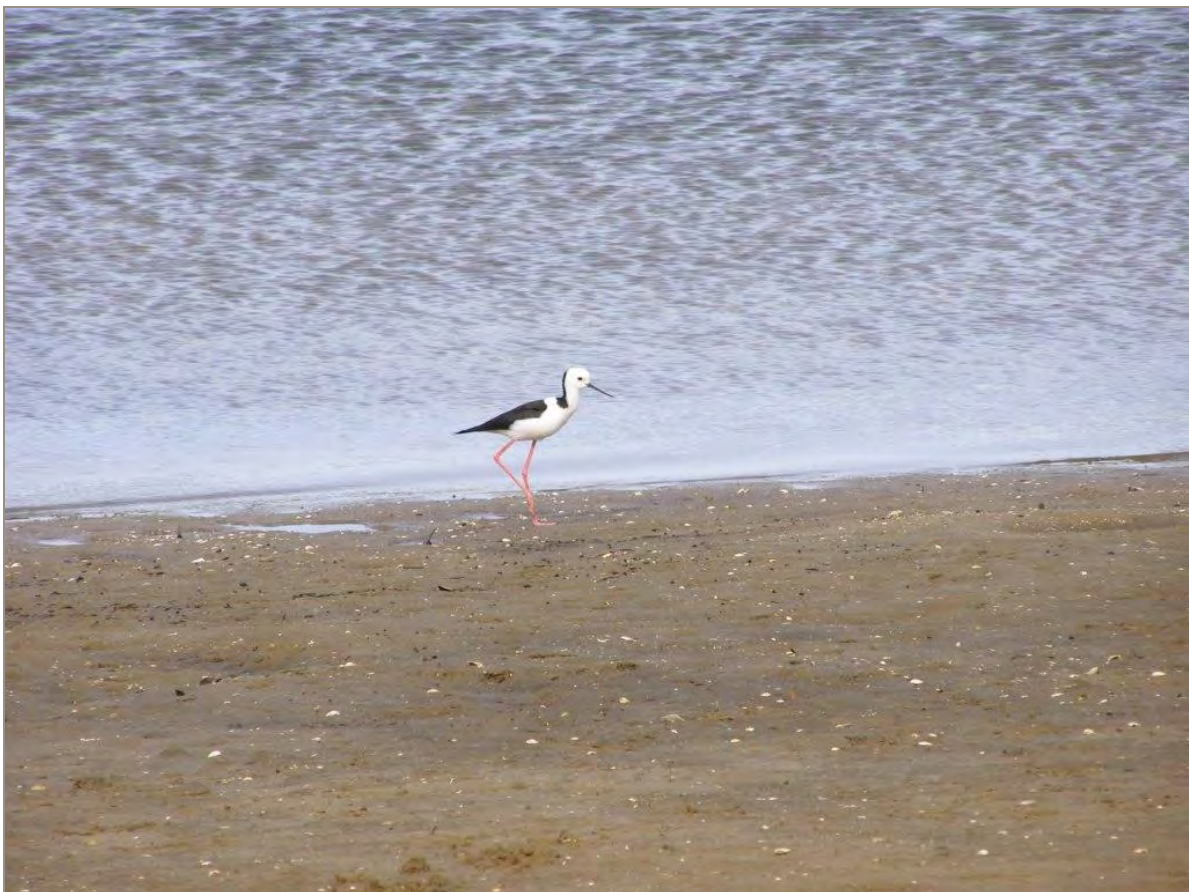
Figure 5-4. Non-vegetated muddy shoreline

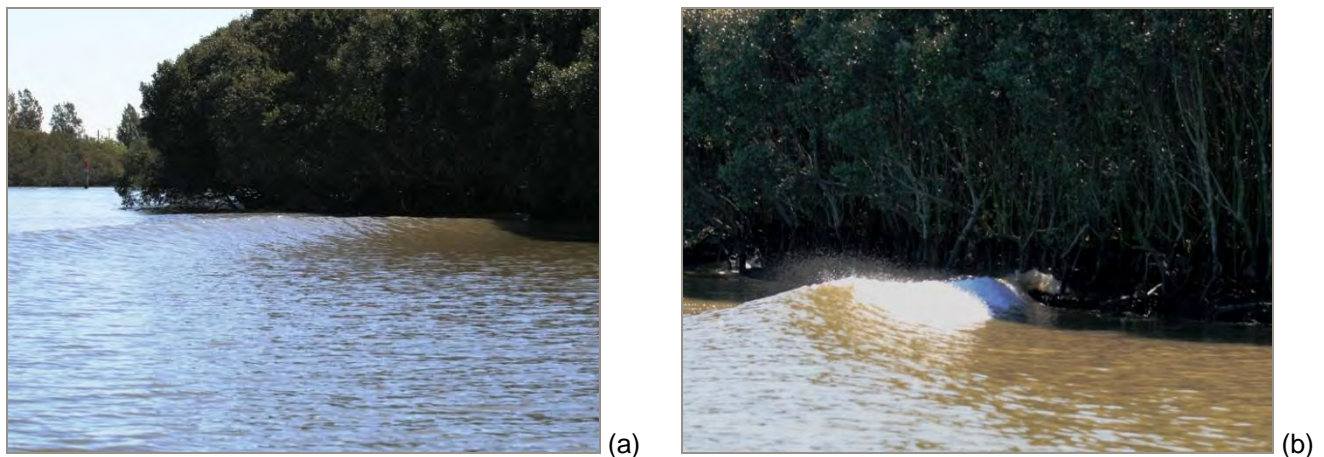
Following commencement of the service, it became apparent that the Rivercat did not meet the design wave climate specifications. The resulting long period waves (Figure 5-6) most likely have led to extensive erosion of the natural foreshore and mangrove stands on the river (Macfarlane and Cox 2007).

Figure 5-6. Ferry wash at Rydalmere upstream of Silverwater Bridge

Severe shoreline erosion from Rivercat wash resulted in restrictions to vessel operations in an attempt to alleviate further shoreline impacts (Macfarlane and Cox 2007). Nielsen and Walker (2001) showed that shoreline sediments in the Parramatta River upstream of Silverwater Bridge are susceptible to re-suspension due to wave induced currents.

The erosion observed in the upper areas of the Parramatta River cannot be wholly attributed to vessel wash. Wind induced waves, high river flow after rainfall and the loss of riparian vegetation also have contributed. In some locations, the upper bank structure has been weakened severely by the loss of riparian vegetation, exacerbating the impact of vessel wash (AMC 2009).

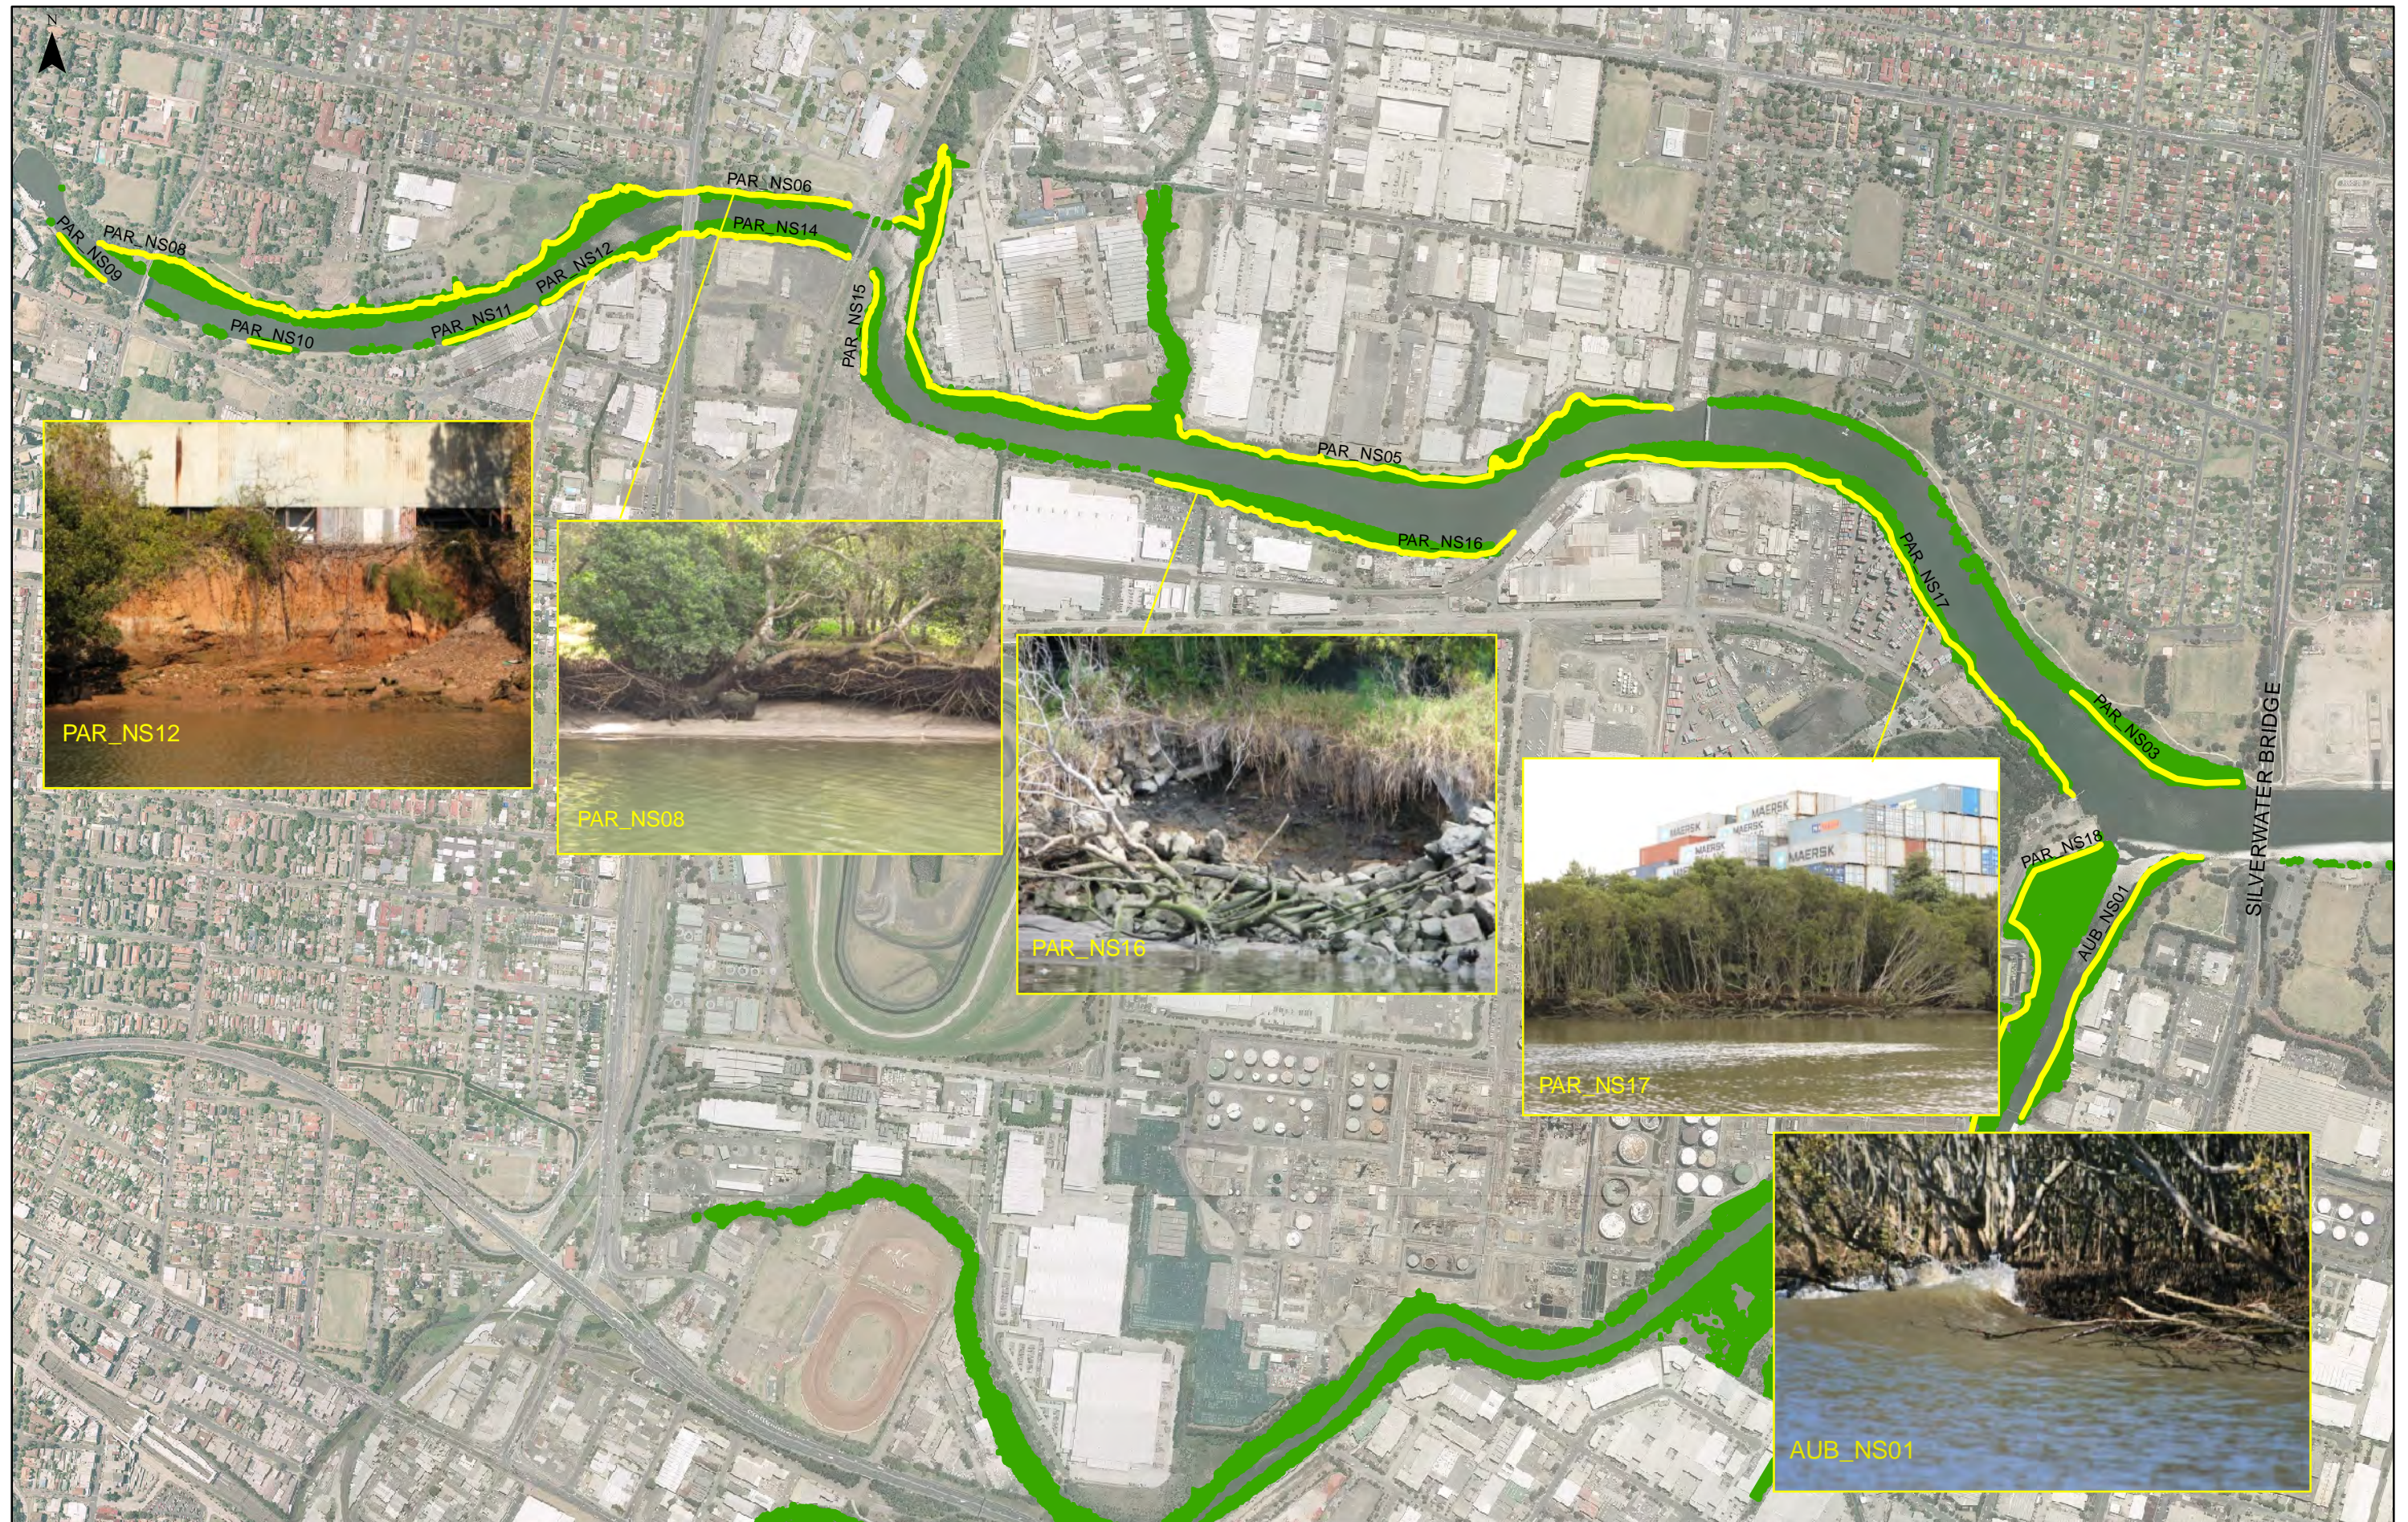
0 0.1 0.2 0.4 km
AUG 2010
60097281
Fig 5.7

Approximately 70% (9.2 km) of shoreline exhibiting erosion is located upstream of Silverwater Bridge. This section of the river is characterised by a narrow channel, shallow water depths and banks vegetated with mangroves, and is subject to long wave durations from Rivercat movements.

The locations of erosion, upstream of Silverwater Bridge, are shown in Figure 5-7.

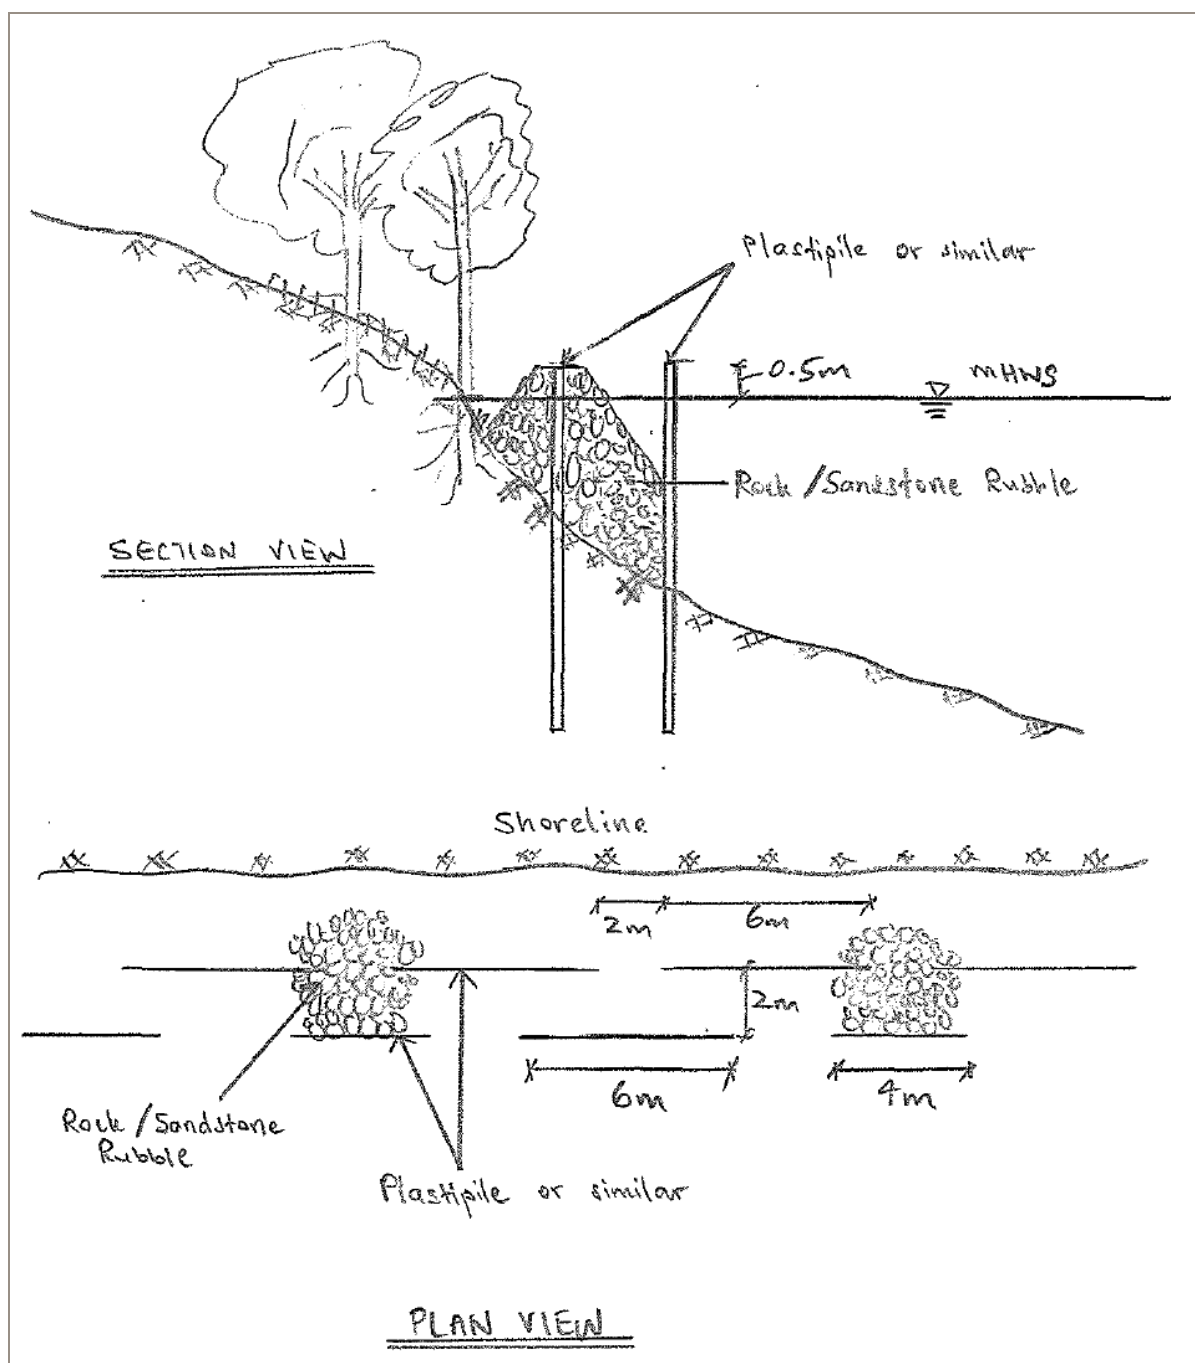
Figure 5-9. Option 1 – Plastic Sheet Pile indicative design

It is envisaged that two intermittent rows of sheet pile wall could be used to retain intertidal exchange and maintain natural habitat (Figure 5-9). A porous rubble rock structure would be used between the pile wall segments to control water flow while providing channels for fish movement at high tide.

This option would require validation by physical model testing and it is recommended that a section be installed along the river for *in-situ* proof of concept testing.

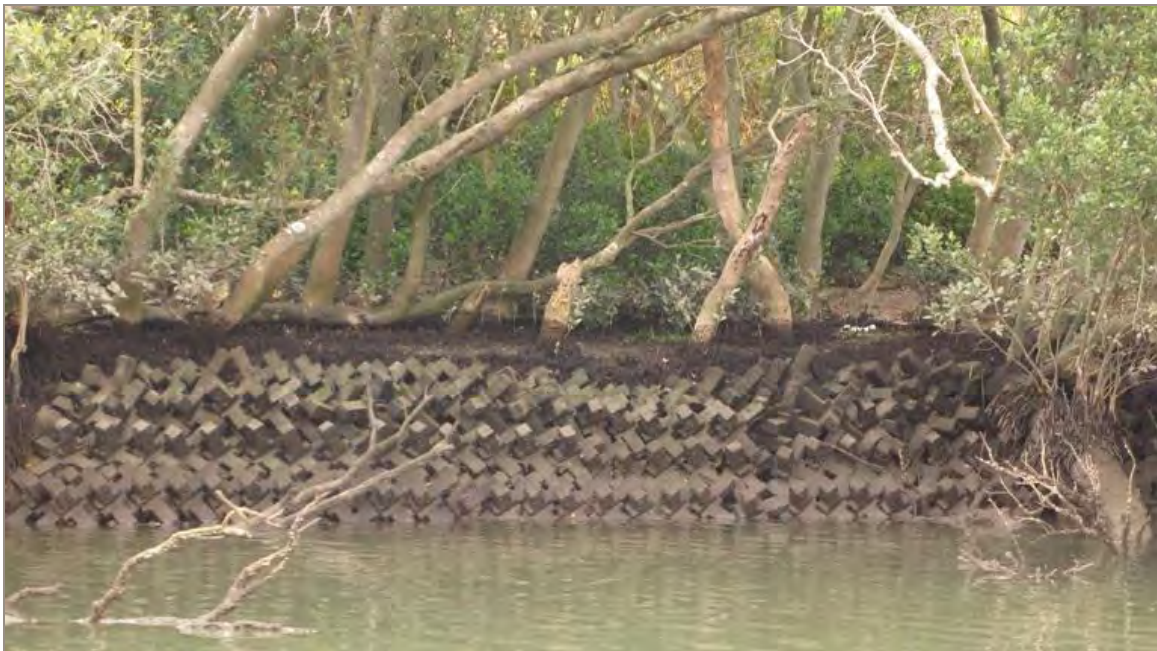
Figure 5-10. A-Jack units installed in front of mangroves on the Parramatta River upstream of Silverwater Bridge

This option has been employed at discrete locations upstream of Silverwater Bridge using A-Jack armour units (Figure 5-10). Prior to additional structures being recommended or installed, a detailed study of the performance of these existing structures should be undertaken. A-Jacks have also been used on the Coomera River in Queensland (Figure 5-11, Derbyshire 2006).

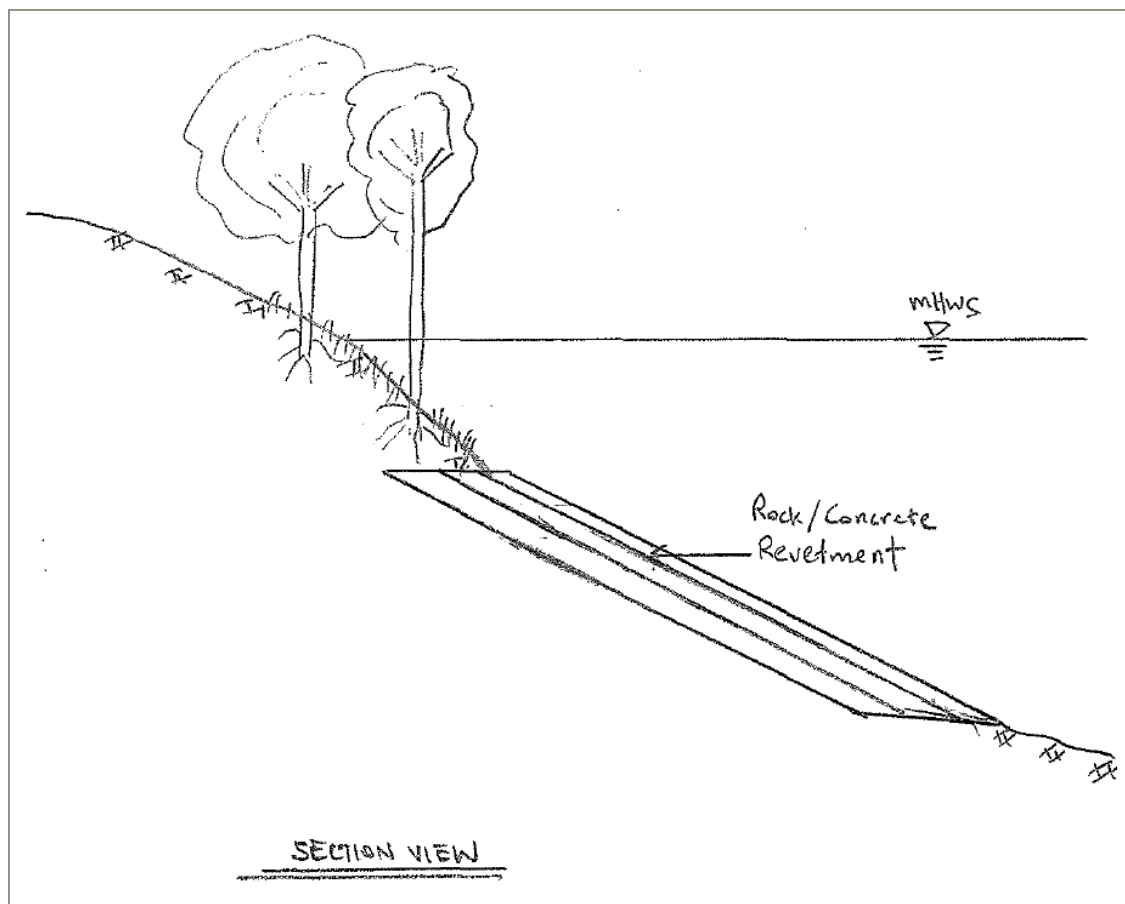
Figure 5-12. Option 2 –Rock/Concrete Armour

The installation of rock or concrete armour units would protect the shoreline. The structure would need to consider typical engineering detail and include appropriate underlayers. Sediment would be allowed to accumulate naturally behind the structure encouraging mangrove re-growth and eventually concealing the structure. Experience in Queensland has found that fish may become stranded behind the structure necessitating the inclusion of 'Fish Pipes' to allow access back to the main channel at low tide (Derbyshire 2006).

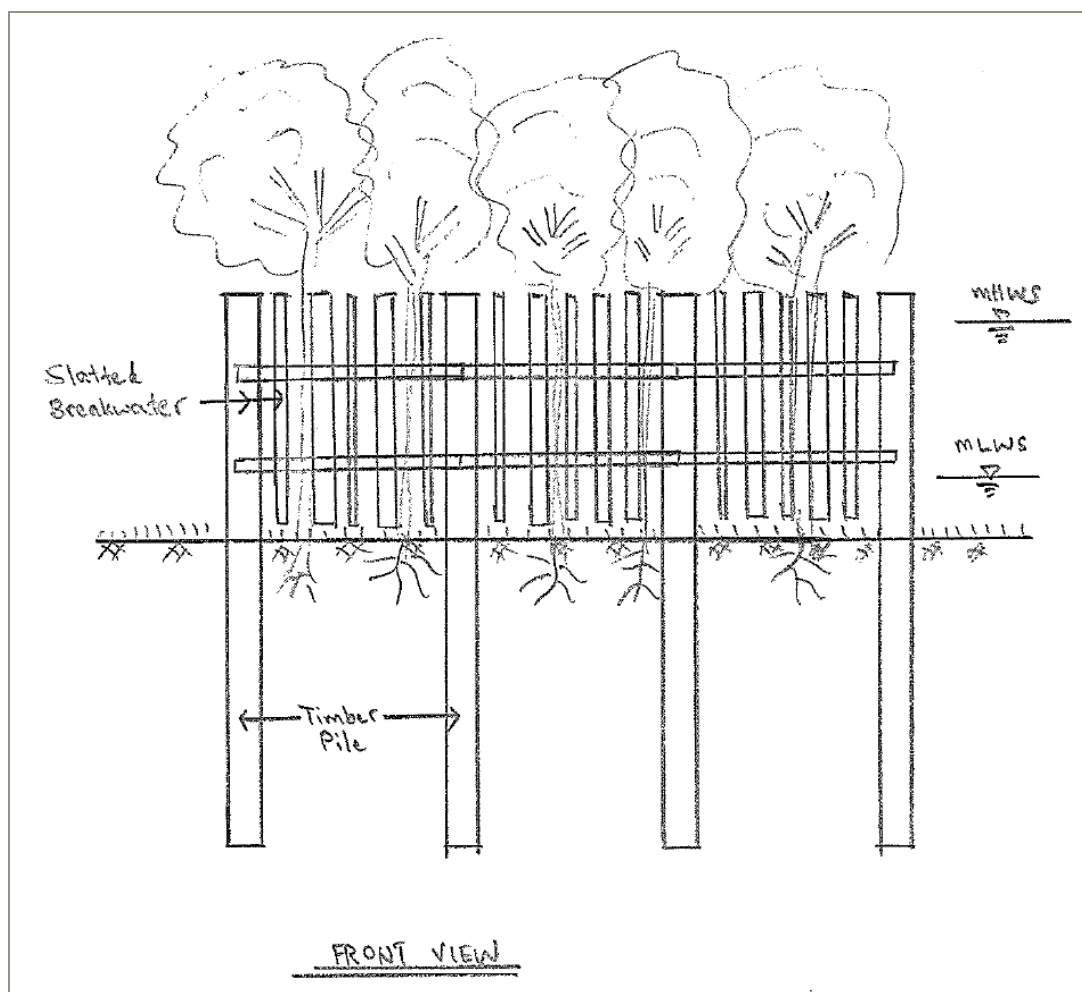
Figure 5-14. Option 3 – Slatted Breakwater

Vertical timber slats installed parallel to the foreshore have been shown to attenuate wave energy (Coghlan *et al.* 2009 and Bettington & Cox 1997). As the breakwater does not extend to the full length of the water column, water circulation and flow regimes can be maintained.

These breakwaters are only effective for short period waves (less than 3s) and for this option to be viable, the current vessels would need to be replaced with a low wash (short wave period) alternative. Prior to consideration of this option a commitment would need to be made to replace the Rivercat vessels. Studies of the wash produced by the proposed alternate vessel would be required to ensure that wash is within acceptable limits.
