5.0 Foreshore Erosion

PARRAMATTA RIVER ESTUARY PROCESSES STUDY
FORESHORE EROSION UPSTREAM OF SILVERWATER BRIDGE

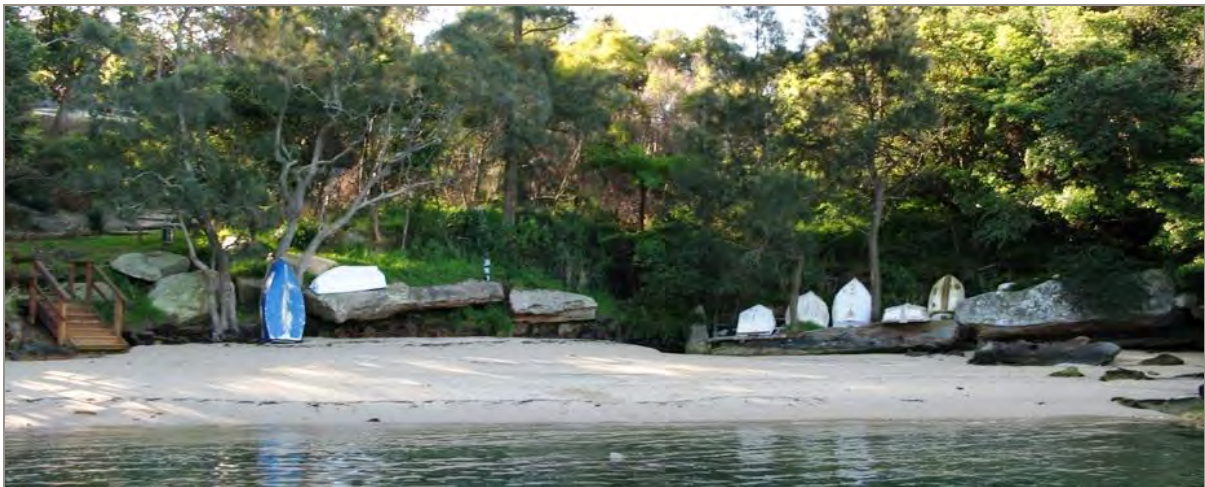
Figure 5-1. Typical estuarine beach comprising medium grained sand constrained by rocky outcrops

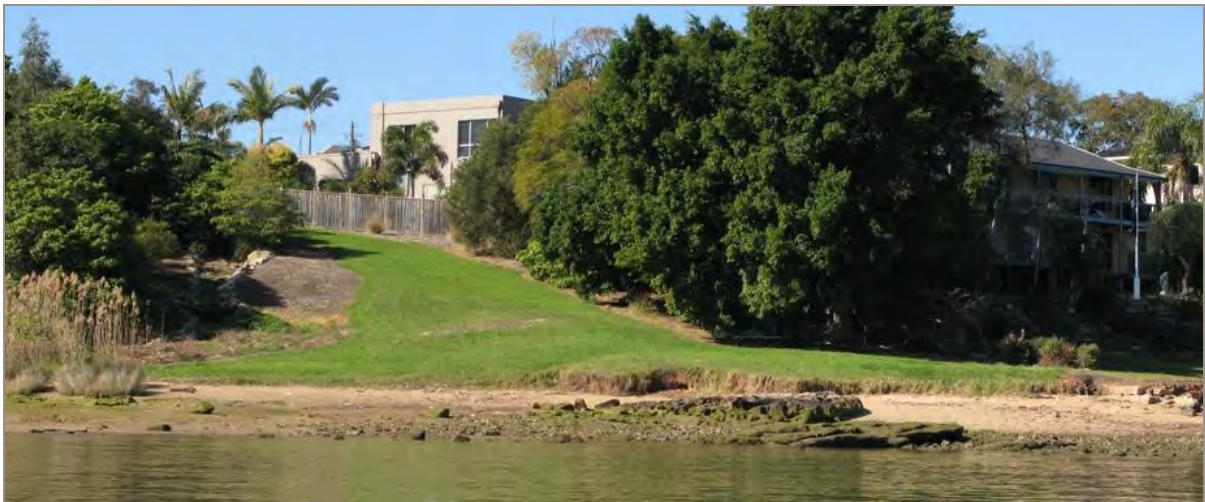
Figure 5-2. Rock platform with sandy deposits at rear

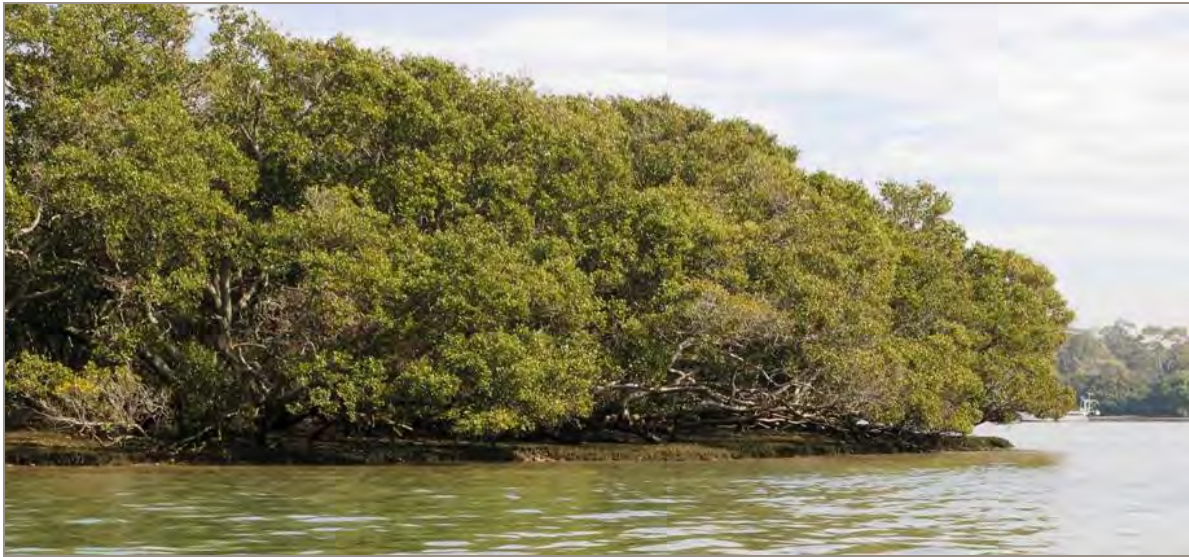
Figure 5-3. Muddy shoreline vegetated with mangroves

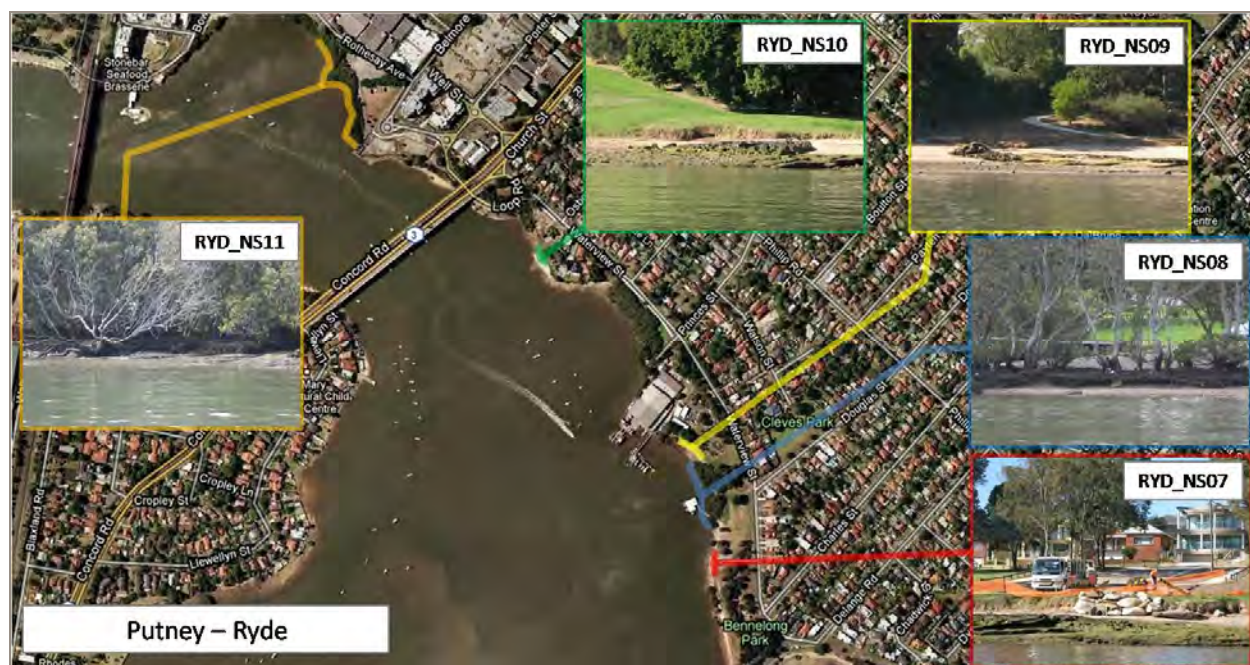
An illustration of this naming convention is shown in Figure 5-5 showing the Putney foreshore located within the Ryde local government area.

Figure 5-5. Illustration of natural shoreline naming convention

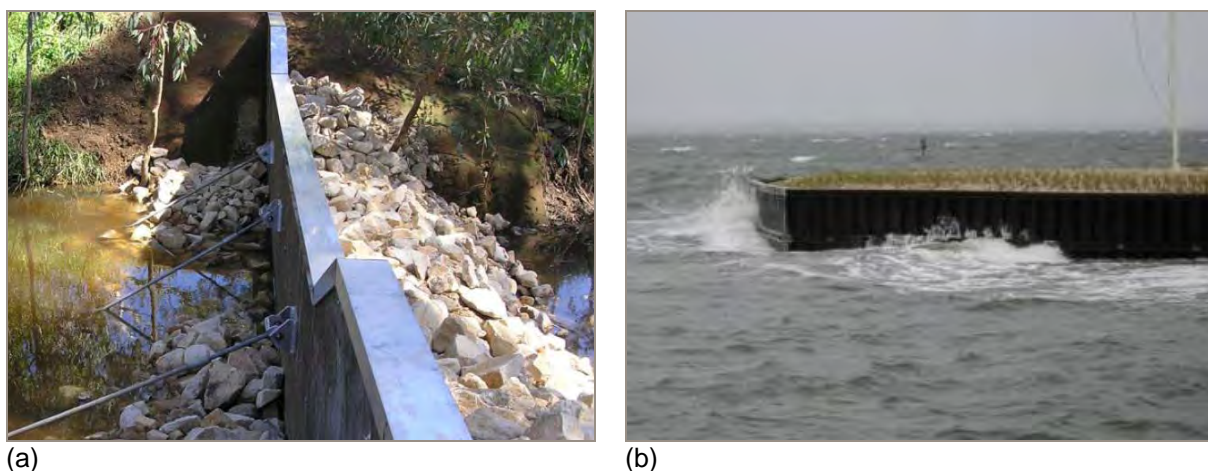
Figure 5-8. (a) Plastipile and rubble installation, Dawson Reserve, SA (Vonmac 2009) and (b) SuperLoc™ used as a seawall allowing for reclamation and / or regeneration of vegetation

Ferry wash at the shoreline can be attenuated by the installation of sheet piles. Sheet piling can be traditional steel or alternative construction materials, such as Plastipile™ Recycled Plastic Sheet Piling (Figure 5-8a, manufactured by Vonmac Engineering) or SuperLoc™ Composite Sheet Pile System (Figure 5-8b, distributed by Australia Pacific Seawall).

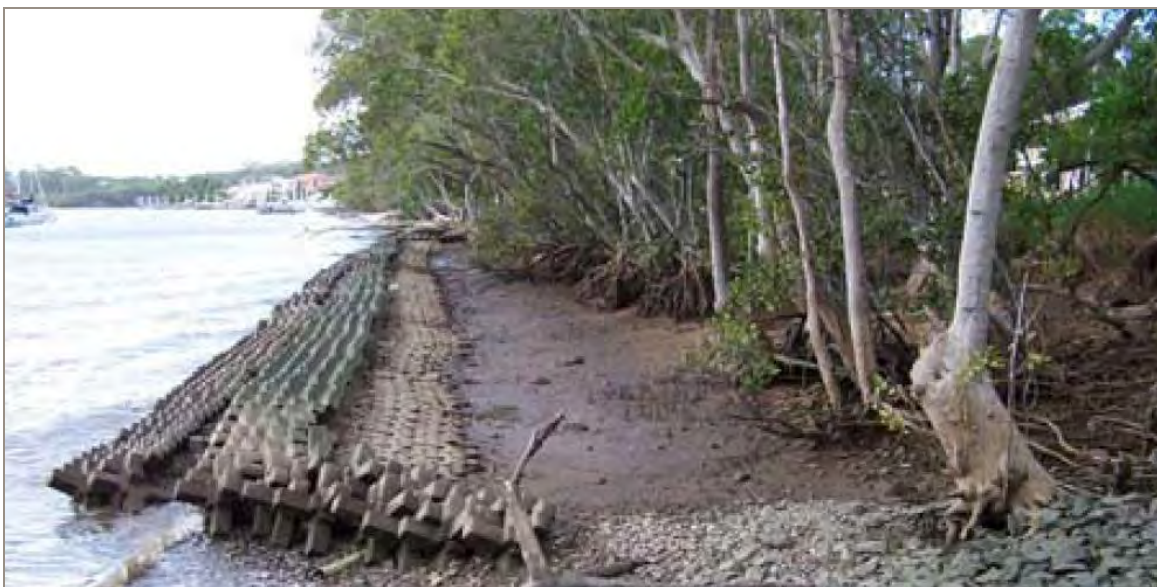
Figure 5-11. A-Jack units installed in front of mangroves at Charles Holm Park on the Coomera River QLD (Derbyshire 2006)

This option has been employed at discrete locations upstream of Silverwater Bridge using A-Jack armour units (Figure 5-10). Prior to additional structures being recommended or installed, a detailed study of the performance of these existing structures should be undertaken. A-Jacks have also been used on the Coomera River in Queensland (Figure 5-11, Derbyshire 2006).

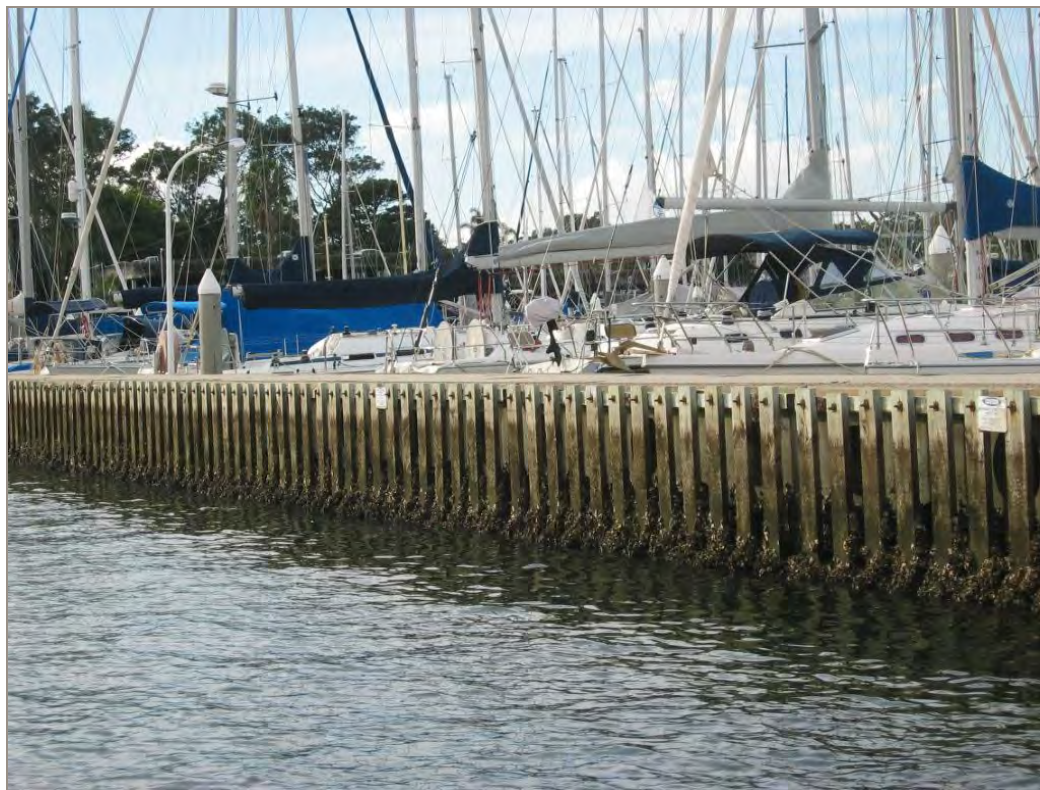
Figure 5-13. Slatted Breakwater, Royal Alfred Yacht Club, Pittwater

Wavescreen breakwaters have been successfully installed at Brotherson Dock in Port Botany and at the Royal Prince Alfred Yacht Club in Pittwater (Figure 5-13) and at many other locations in and around Sydney.

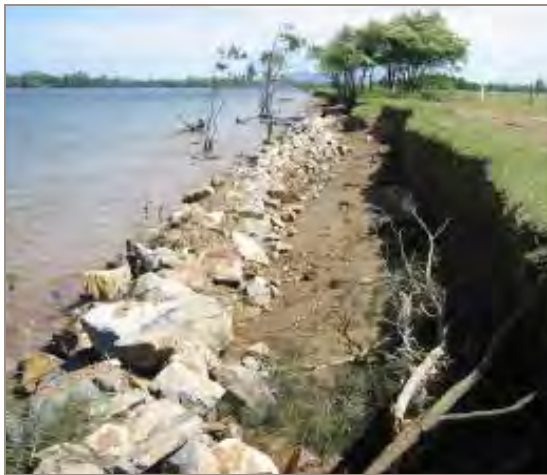
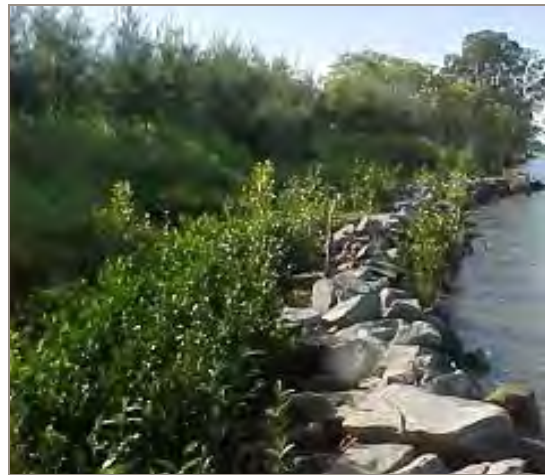
Figure 5-15. Rock fillet work allowing mangrove seedlings to regenerate, (a) Hastings River (b) Dumaresq Island, Manning River

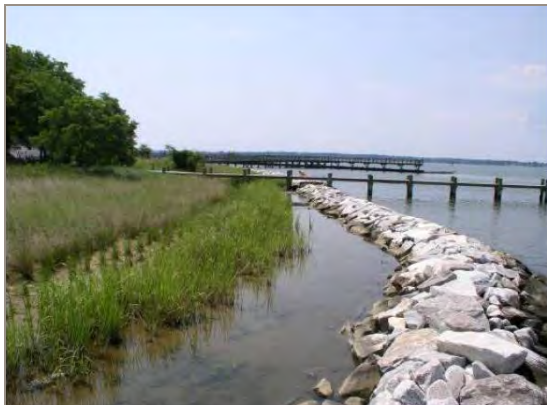
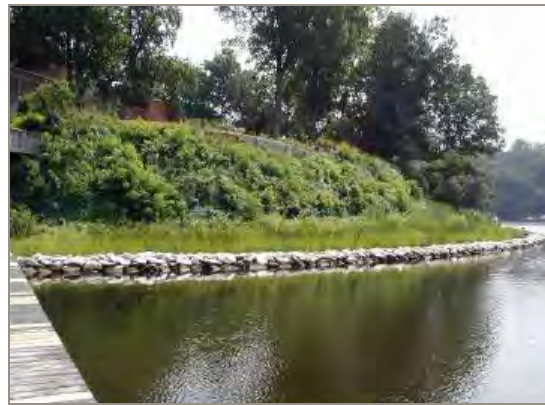
Figure 5-16. (a) Low profile sill and newly created marsh (b) Low profile sill, marsh and stabilised cliff (MDE, 2008)

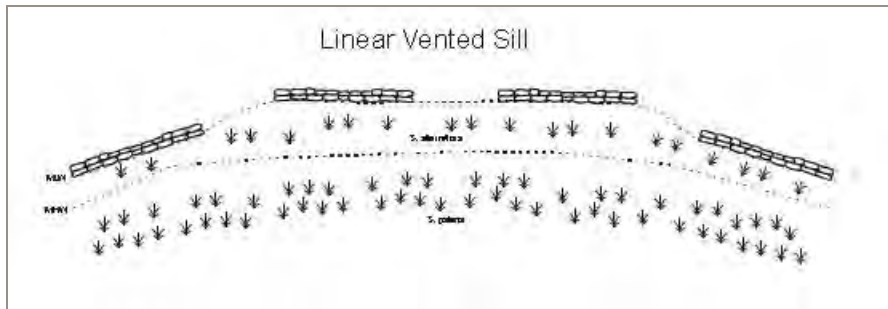
Figure 5-17. Staggered and vented sill (MDE, 2008)

It is essential that low profile sills (also known as rock fillets) be constructed in such a way that allows for flushing and wildlife access to the shore. However, vents can facilitate erosion where the wave action is persistent. This can be overcome by staggering sill placement in a linear manner (Figure 5-17).

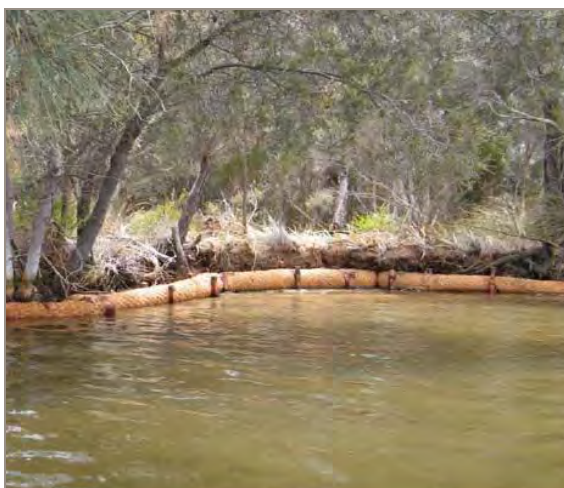
Figure 5-18. (a) Coir logs installed on the banks of the Lower Murray River and (b) Tidal riverbank restoration using mangroves (Southern Rivers CMA)

Coir logs, also known as coir rolls and coconut fibre rolls, are densely packed coconut fibre tubes bound together with coir netting. The coconut fibre is biodegradable, gradually breaking apart through exposure to water movements and weather. Coir logs are anchored along the toe of riverbanks to provide short-term protection for establishing vegetation, as shown in Figure 5-18(a).
