Ashfield LGA

9.3 Ashfield LGA

Seawall Inspection Record - ASH_S03

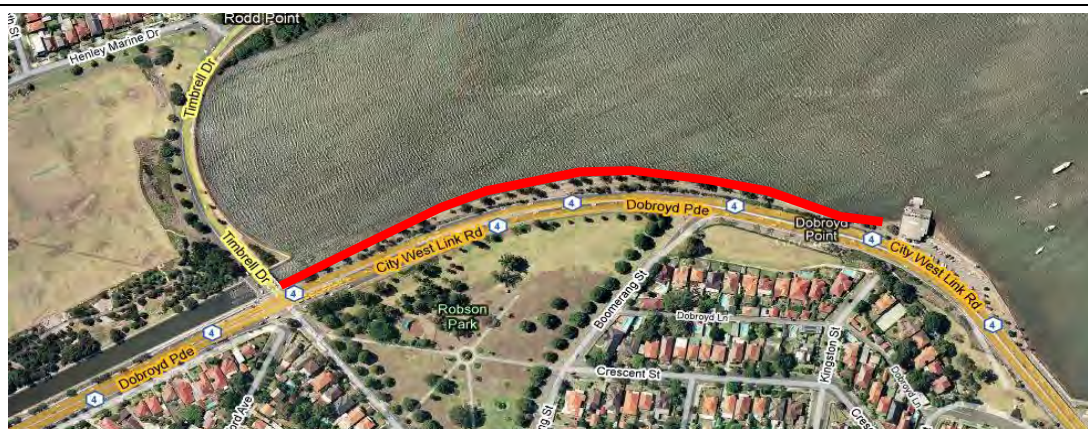
Sandstone seawall is missing grout, slumping and showing signs of weathering on both the sloping and vertical sections. Numerous local block failures were observed. Sea stairs are in good condition, cracking of the stormwater outlets was observed.

Typical view of revetment with block failures, slumping, weathering and loss of grout evident.

- Continue to monitor ASH_S03 for any decrease in structural stability – data collected for all seawalls including referenced site photographs are provided in the project GIS database and should be used as a reference benchmark for ongoing monitoring;
- Eventual repair and / or replacement to include intertidal habitat function such as artificial reef habitat.

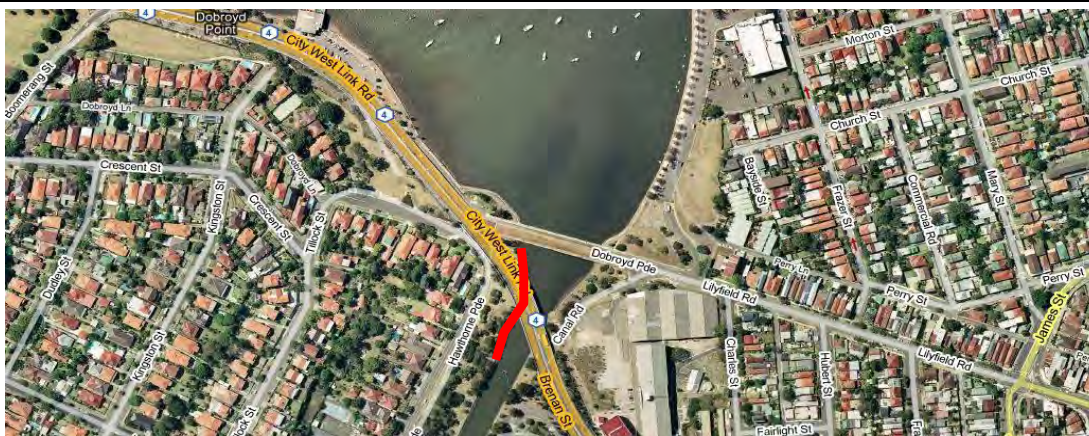
Seawall Inspection Record - ASH_S01

Generally good condition. Shotcrete is showing signs of weathering. Minor weathering and loss of grout of new sandstone blocks at crest.

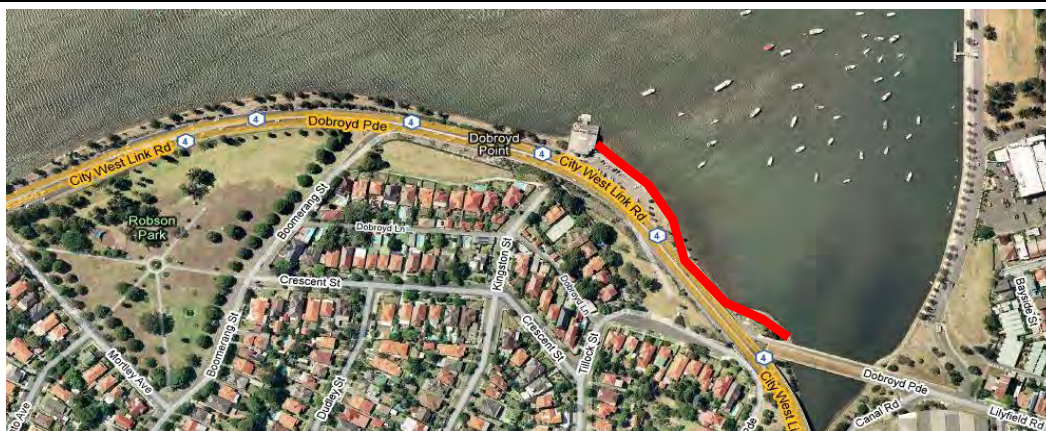
Seawall Inspection Record - ASH_S02

Sandstone seawall is missing grout, slumping and showing signs of weathering on both the sloping and vertical sections. Both sets of sea stairs are in good condition.
