City of Canada Bay LGA

9.4 City of Canada Bay

The City of Canada Bay LGA contains 16.2 km of seawalls of which 75 discrete sections of seawall were assessed (Table 9-15). Assessment details and management recommendations for high priority seawall sections are provided in Table 9-15 and Appendix 3.

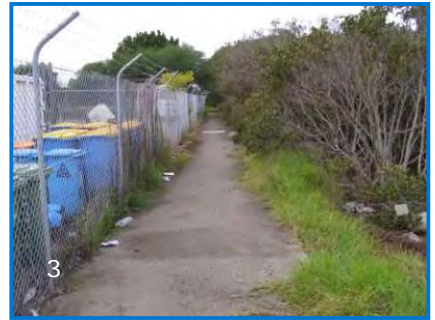
Yaralla Bay is one of many sites within the LGA that contains dumped building rubble and other materials. Litter is also commonly entering the saltmarsh and mangrove communities from the adjacent hospital's garbage receptacles (photo #3).

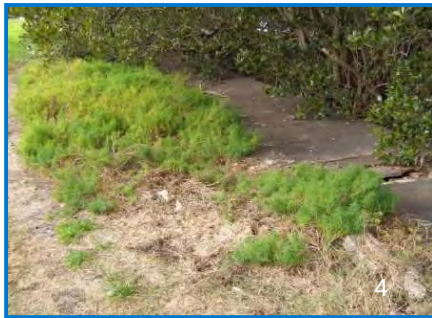
Open space areas adjacent to shoreline are maintained by mowing / slashing. In some areas lawn clippings have been dumped into saltmarsh and mangrove areas (photo #4).

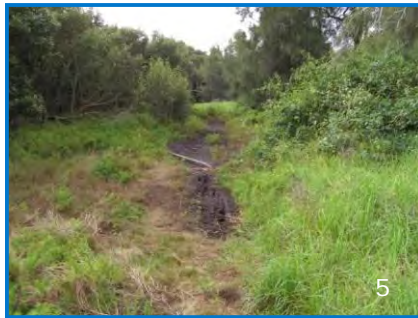
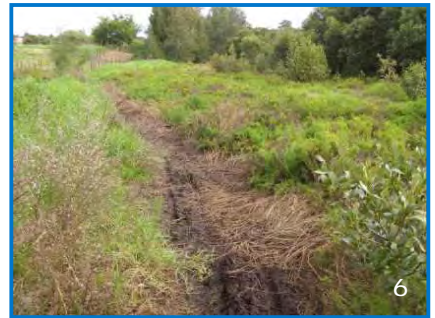
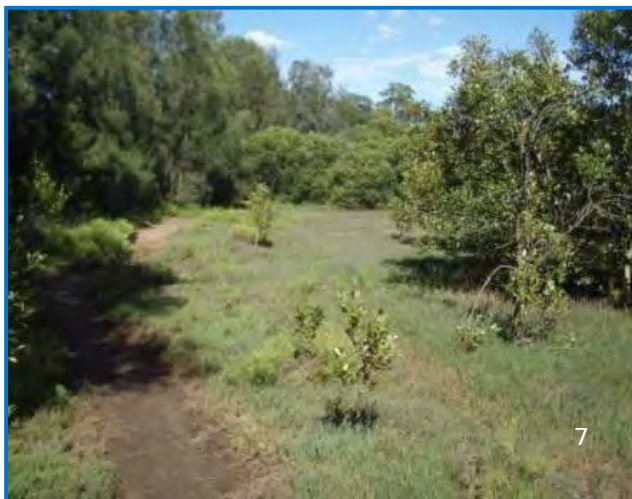
A number of unformalised trails are used frequently, in particular by off road cyclists (photos #5 to #7). These trails should be closed, with alternate formalised trails located away from sensitive saltmarsh areas. Appropriate educational programs and signage should be included.

Both mangroves and *C.glauca* are gradually encroaching into saltmarsh zones (photos #5 to #9), note also Kikuyu and other terrestrial weeds encroaching into saltmarsh). Mangrove encroachment is likely to increase albeit gradually as the predicted impacts of climate change take effect. This will be a significant issue within Yaralla Bay and future landward migration of saltmarsh should be planned for where possible. In the interim it is recommended that the existing thinly distributed *C.glauca* trees that about the main areas of saltmarsh be removed, and mangrove seedlings be removed as they emerge.

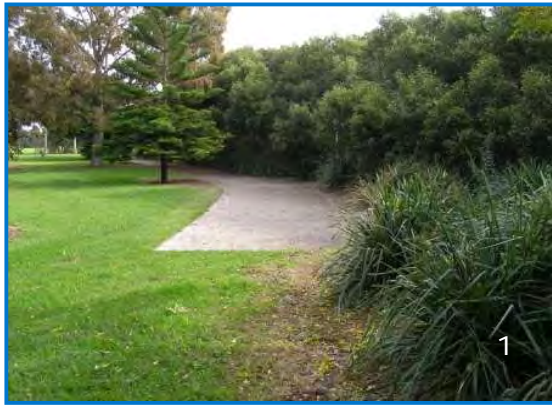
There is limited opportunity to improve vegetative conditions due to the proximity of residential properties, the existing open space use and landscaped edge within the eastern section of Majors Bay Reserve (including a formalised pathway in close proximity to estuarine vegetation – photo #1).

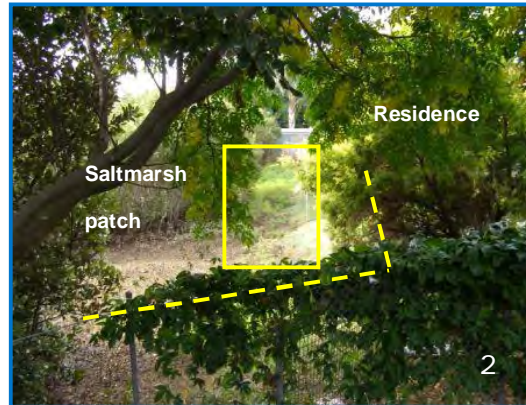
Small highly fragmented patches of saltmarsh are unlikely to remain viable over the long term. Particularly the one located in front of a residential property at the boundary of Majors Bay Reserve (photo #2).

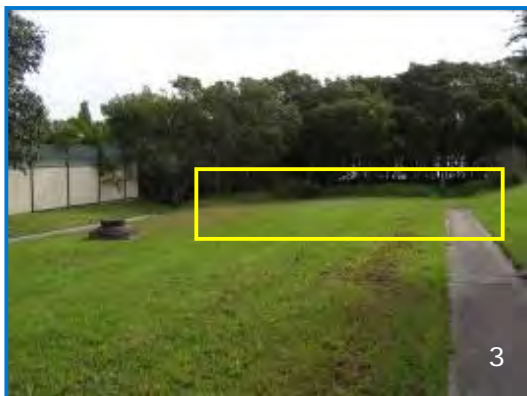
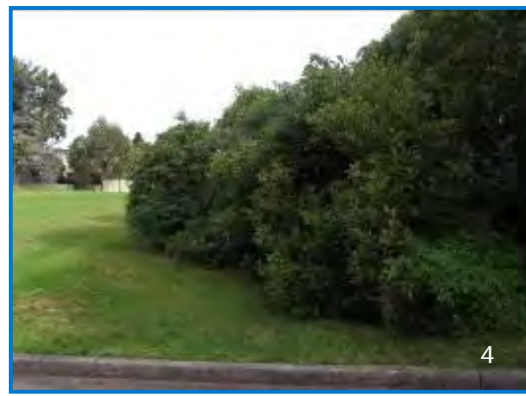
The open space or easement at the end of Kings Street appears to function as both stormwater conveyance (via surface flow) and buried sewer infrastructure (a number of sewer maintenance manholes evident – Photo #3). Depending on the depth of buried sewer infrastructure and Sydney Water overlying soil heights required above such infrastructure, this area could potentially provide an expansion zone or recreation project for saltmarsh vegetation.

Weed control and protection of existing mangroves and saltmarsh growth is recommended (photos #3 & #4). Growth of introduced vines (e.g. Madeira vine) that have the capacity to smother canopy trees, should in the first instance be targeted within weed control programs.

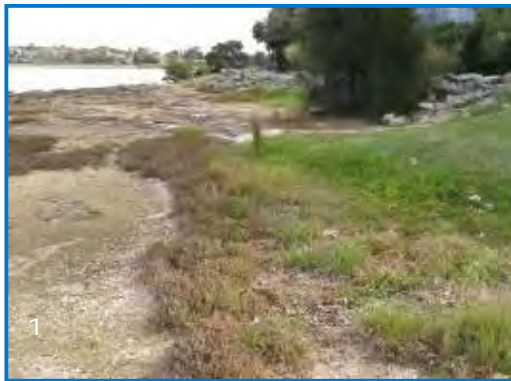
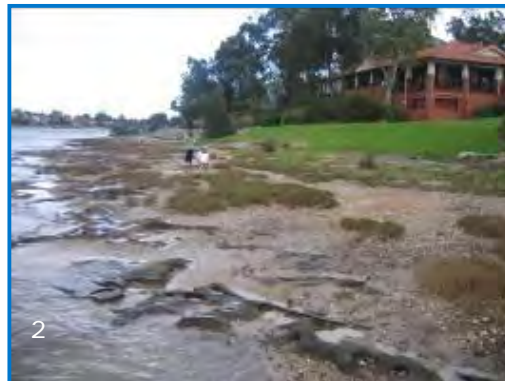
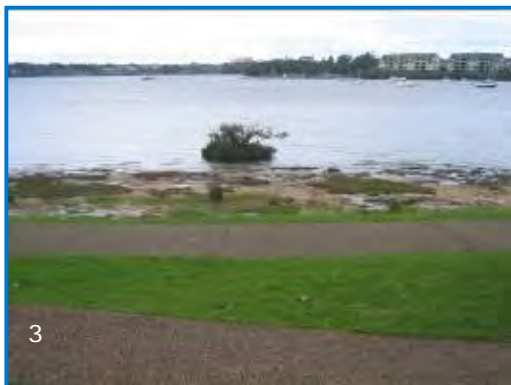
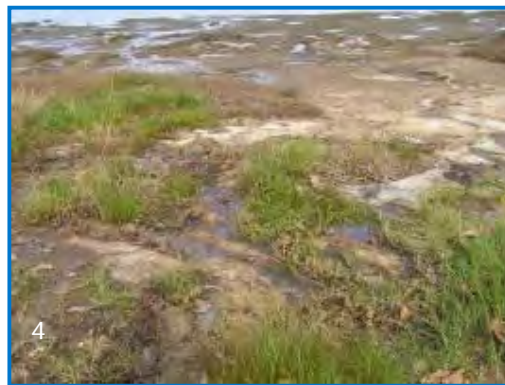
Terrestrial weeds and grasses are encroaching into the saltmarsh, particularly from turfed areas (photos #1 to #4). Where mowed turf abuts saltmarsh (photo #2), a formalised edge should be installed to prevent accidental mowing of saltmarsh and limit growth of terrestrial species into saltmarsh.

Areas presently maintained by mowing that are located in between the formal pathway and foreshore (photo #3) could be replaced with low growing groundcovers that maintain visual access but provide a physical barrier to saltmarsh areas.

Groundwater seepage is entering saltmarsh in Prince Edwards Park at various locations, altering soil salinity and promoting growth of weeds (photo #4) impacting on the saltmarsh.

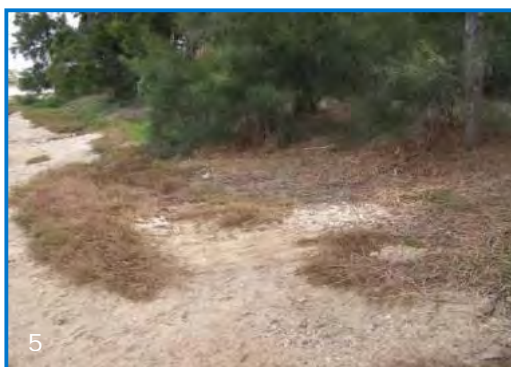
Some areas of saltmarsh, particularly those growing on sandy beach areas are being trampled by pedestrians (photos #2 & #5). Fencing and signage to prevent trampling to existing saltmarsh growth is recommended.

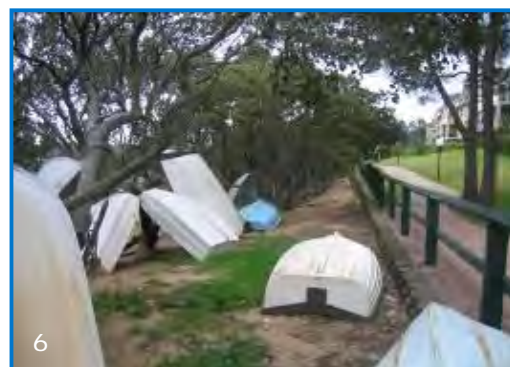
Dinghies are presently stored *ad hoc* underneath mangroves (and/or tied up to trees) located immediately west of Bayview Park, Canada Bay (photo #6). Formalised dinghy storage within, or in close proximity to this area would alleviate impacts to individual trees by concentrating storage to one area, and providing a secure location for boat housing when not in use.

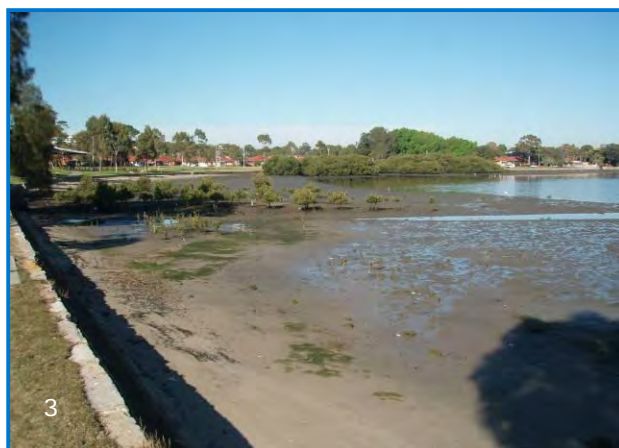
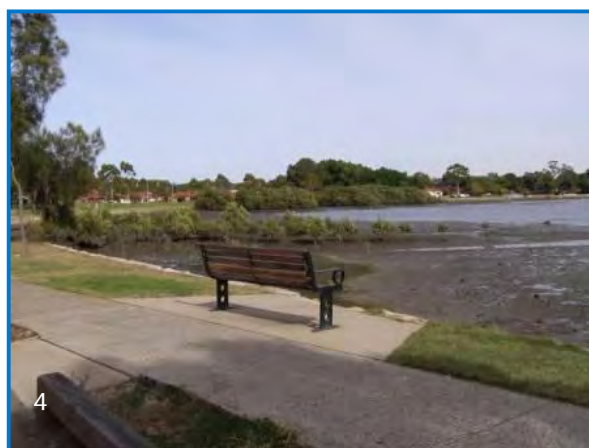
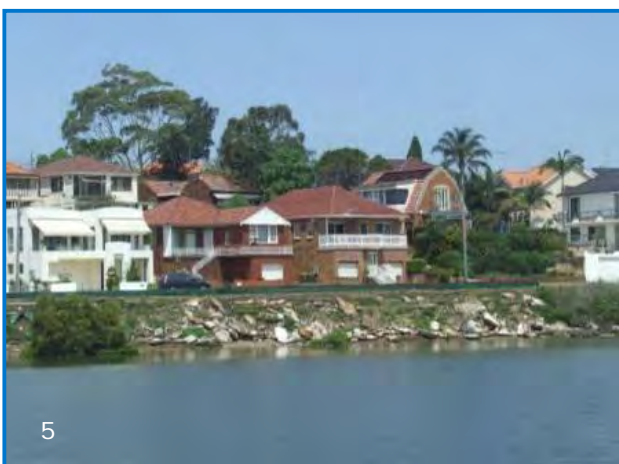
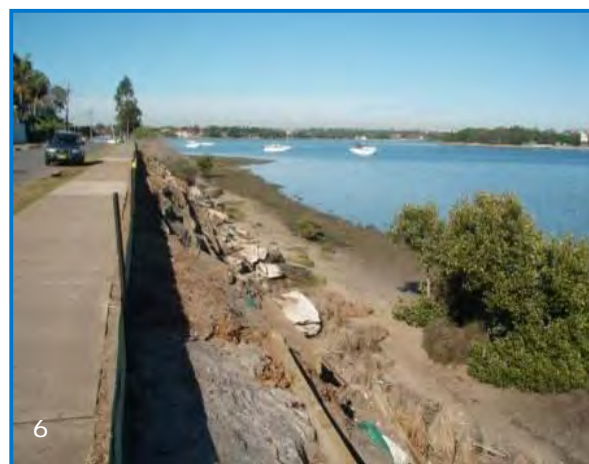
Mangroves occur in two key locations: Quarantine Reserve (Photos #1 & #2) and Halliday Park (Photo #3 & #4). Smaller growth or isolated trees (of modest size) are scattered along the foreshore between Halliday Park and Henry Lawson Park.

A small mangrove stand north of Halliday Park has relatively recently established (i.e. not shown on 2005 aerial photography or mapping). This stand will need to be monitored and an acceptable limit in which growth is allowed to establish adopted (Photos #3 & #4 – smaller growth in foreground, larger stand in background: refer non-vegetated habitat). Any seedlings or propagules removed from this location could be transplanted to other more suitable locations within the LGA.

Scattered mangroves occur along a section of eroding bank adjacent an elevated portion of Wymston Parade. Planting / transplanting could be undertaken along this area of foreshore to increase mangrove extent and protect against wind and wave energy. Alternatively repairs to the eroding bank could incorporate inter-tidal habitat into its design. Note that establishing mangroves at this location will not impinge on residential views to the bay (Photos #5 & #6).

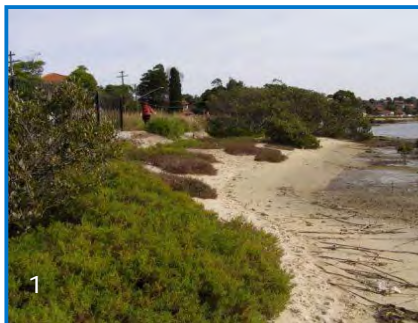
Little scope for expanding saltmarsh growth due to the proximity of Henley Marine Drive and foreshore City to Bay shared pedestrian / cycle way (Photo #1).

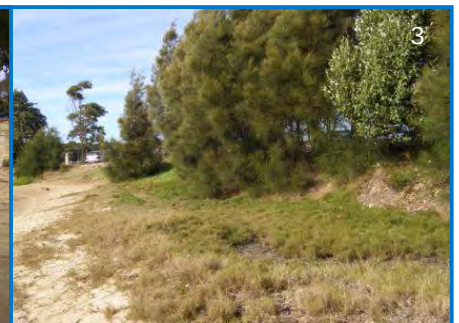
Terrestrial weeds, and to a lesser extent *C.glauca* growth, immediately adjacent the southwestern corner of the Rodd Park car park requires control (Photo #3). Potential to trial salinisation as a weed control method for weed species intolerant of salinity.

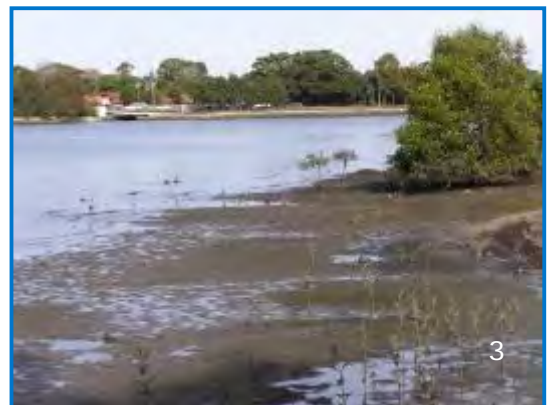
potential conflicts with establishment of estuarine vegetation and use of area to exercise dogs off-leash. South of Rodd Park, the shoreline exhibits prolific seedling recruitment of mangroves (Photo #3). The area along the eastern shore of Rodd Park is commonly used for unleashed dog exercise.

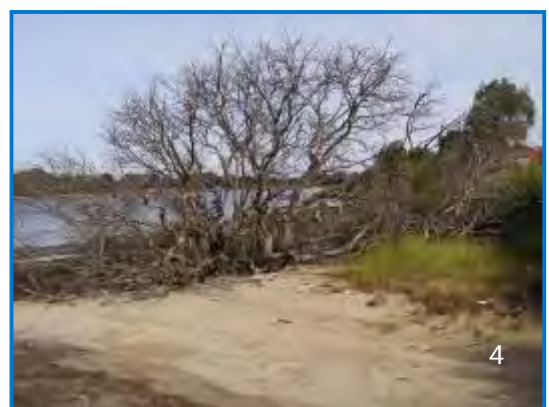
Reinstatement of mangroves where existing die off - potential poisoning has occurred and trial pruning of such to maintain views to adjacent residences in lower elevations may be considered (Photo #4). Alternatively, this area could be used as a trial area for reinstatement of saltmarsh using wrack (dead seagrass) as a growth substrate. Washed up wrack was evident within this site.

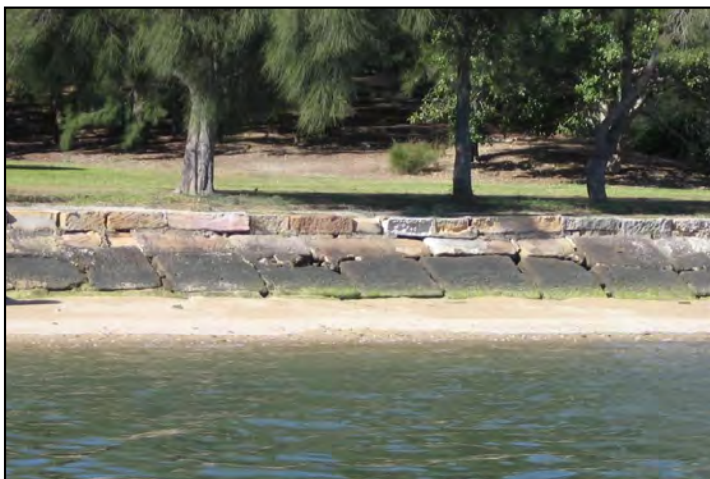
Condition Assessment (Slope, Crest, Toe, Backfill):	Excellent	<input type="checkbox"/>
The blocks that make up the slope are weathered with grout missing leaving voids indicating a loss of material from behind the structure. The vertical blocks at the crest are also weathered and missing grout material, some blocks have collapsed.	Good	<input type="checkbox"/>
	Poor	<input checked="" type="checkbox"/>
	Failed	<input type="checkbox"/>

Photo 1
Typical section of wall showing loss of grout and weathering of blocks.

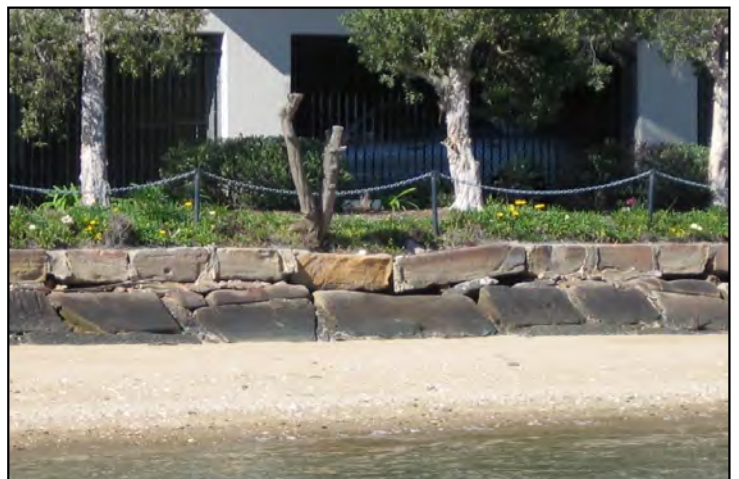
Photo 2
Collapse of blocks at the crest at southern section of structure.

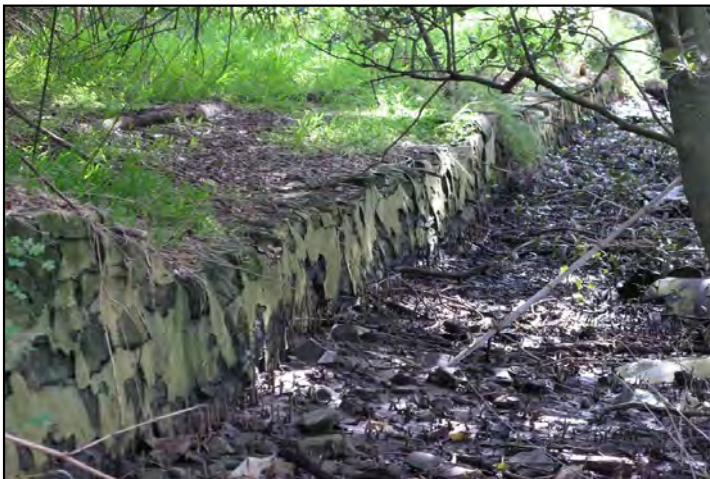
Photo 2

The structure is old and appears abandoned. Sandstone blocks are weathered and grout is missing. Many blocks are missing exposing the earth behind which has eroded. Evidence that wall is inundated during periods of elevated water levels.

Erosion scarp at northern extent of wall where blocks are missing.

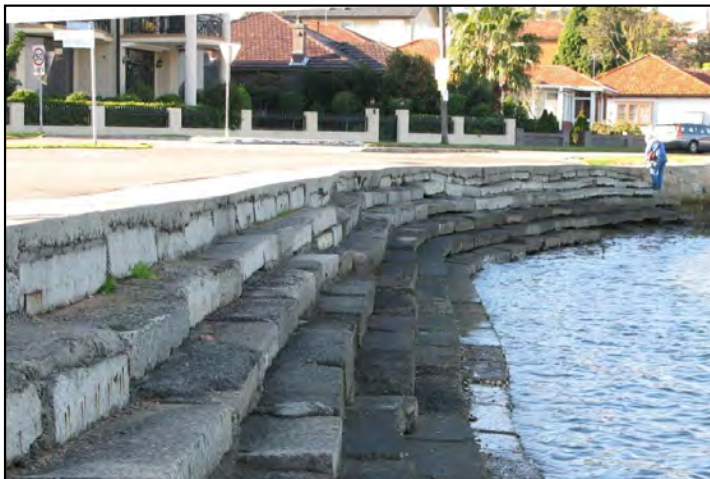
Photo 2

Undermining of the toe and surface weathering of the concrete blocks.

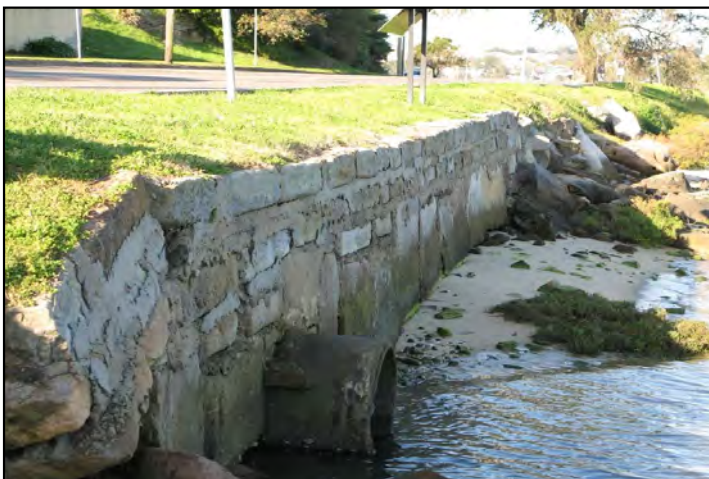
View of seawall showing failure at western extent in foreground.

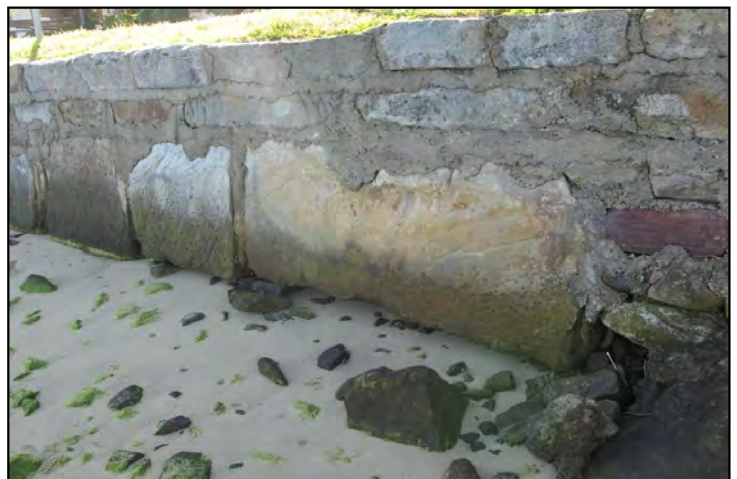
Photo 2

Undermining of structure at toe.

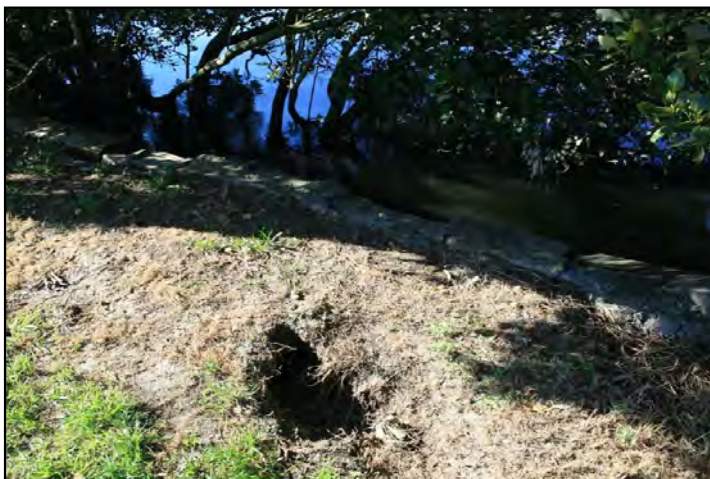
Photo 2

The structure is old and appears abandoned. A number of blocks have become dislodged creating voids in wall. Sinkholes were also observed along the crest indicating a loss of fine material from behind the wall. The blocks are severely weathered. Salt scalds also present indicating inundation.

Block failure on structure slope.

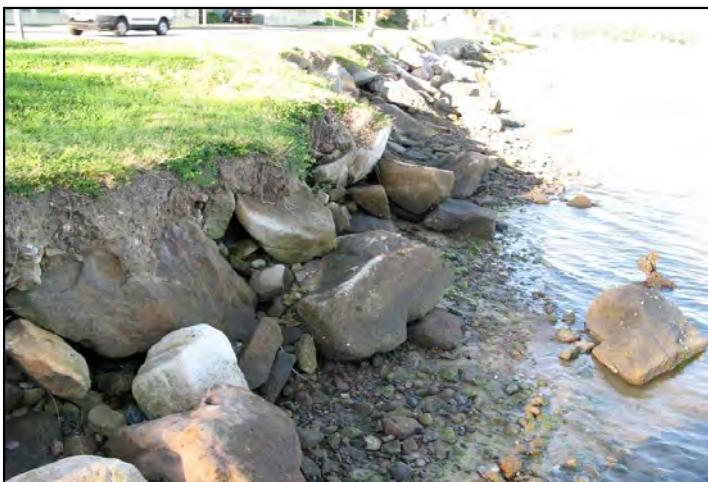
Photo 1

View shoreline showing erosion scarp and sandstone boulders at toe.

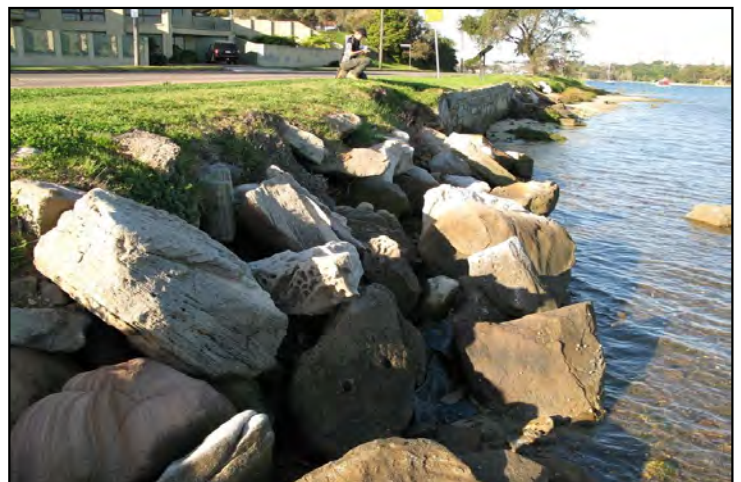
Photo 2

Sandstone boulders placed along shoreline to mitigate erosion.

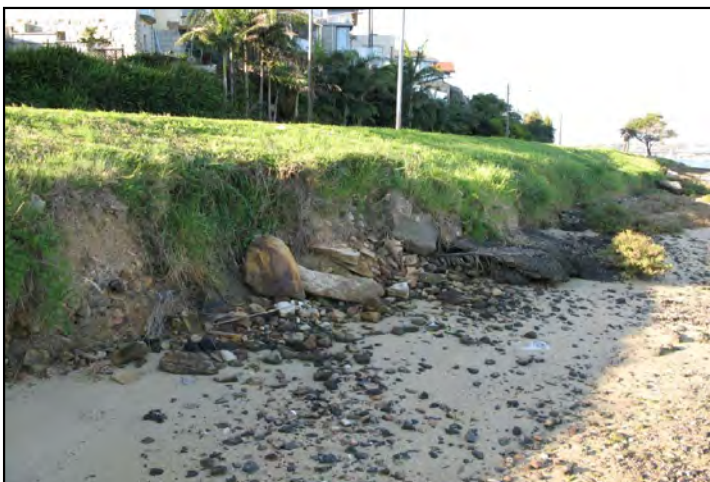
Photo 1

A large erosion scarp, approx 500mm is present. The crest appears to be slumping due to loss of material at the toe. Sandstone boulders have not been placed to typical engineering detail and fine material appears to still be being lost. The adjacent footpath is cracking.

View shoreline showing erosion scarp and rubble at toe.

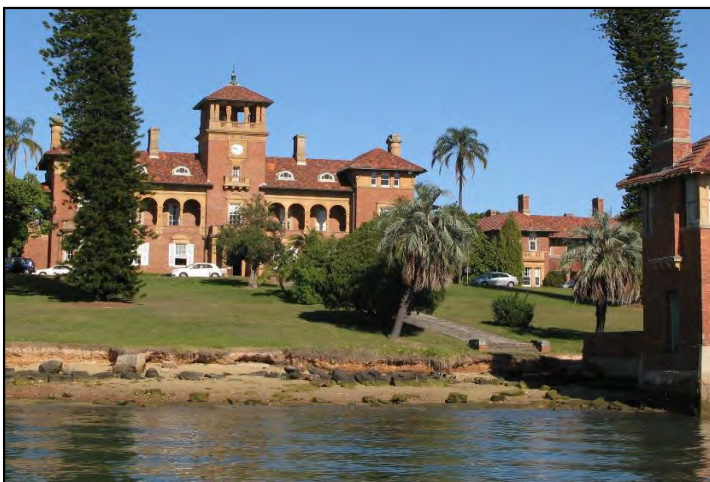
Photo 1

Public access is available to the foreshore via the hospital grounds. The erosion scarp abuts the Concord Hospital Watergate, a heritage listed building, and threatens to undermine its foundations.

Erosion scarp adjacent Concord Hospital Watergate.

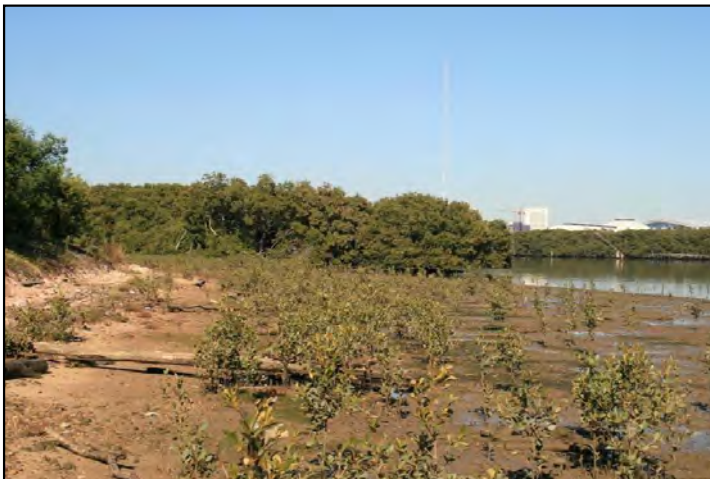
Photo 1

View of foreshore with mangrove saplings shown.

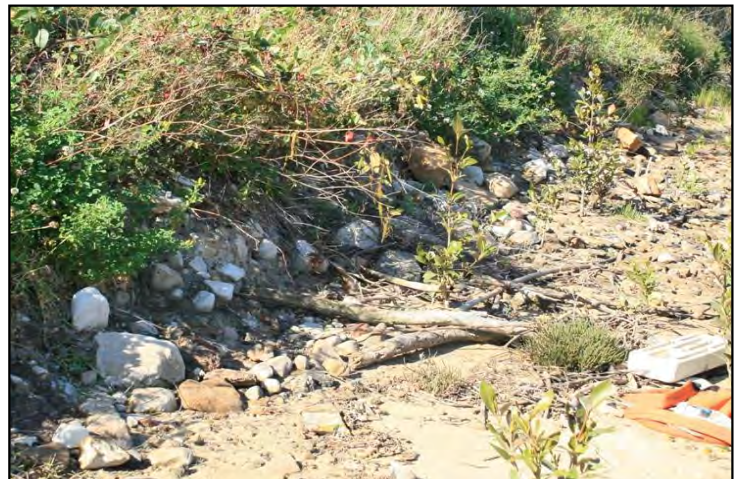
Photo 2

Small erosion scarp at rear of low tide terrace.

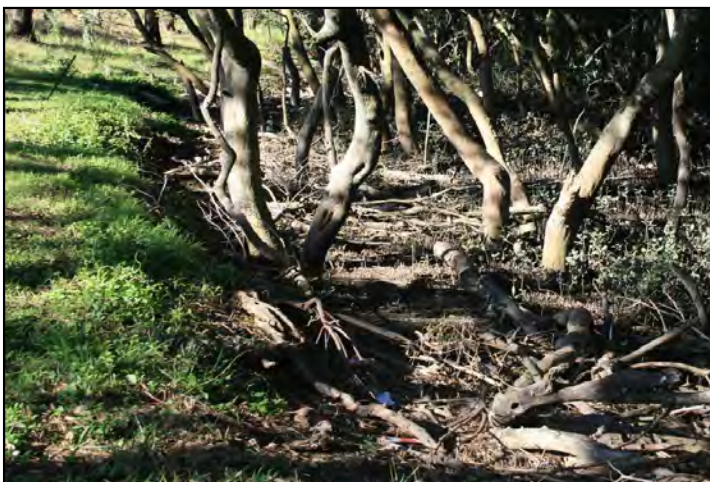
Photo 1

Erosion scarp between muddy terrace and grassy bank at south western extent of foreshore.

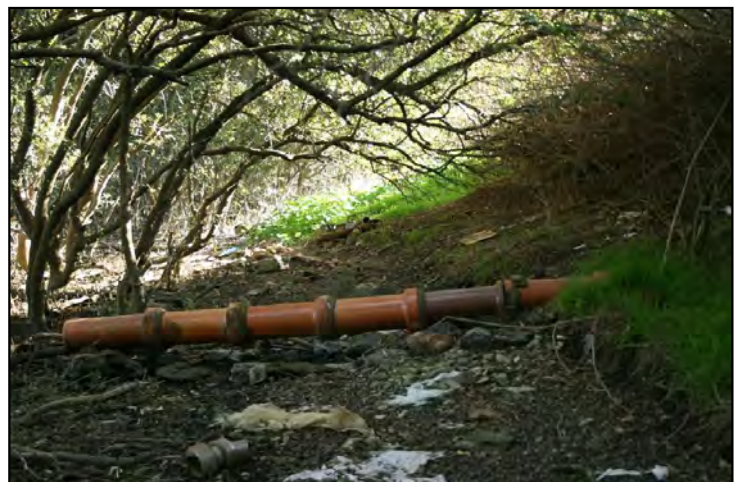
Photo 2

Erosion scarp at base of earthen bank at north eastern extent of foreshore.

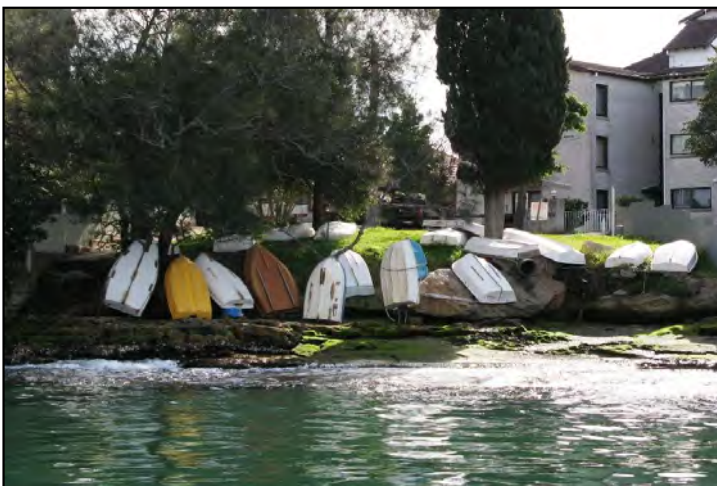
Photo 1

View of informal dinghy storage.

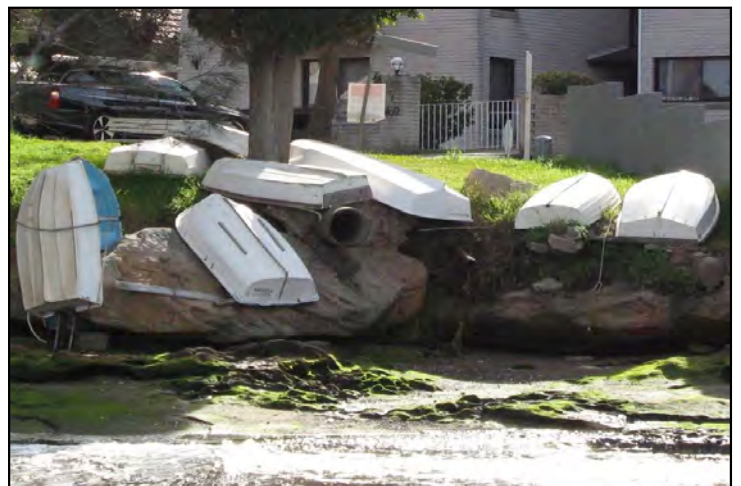
Photo 2

Dinghies tethered to trees atop storm water outlet and rocky shoreline.

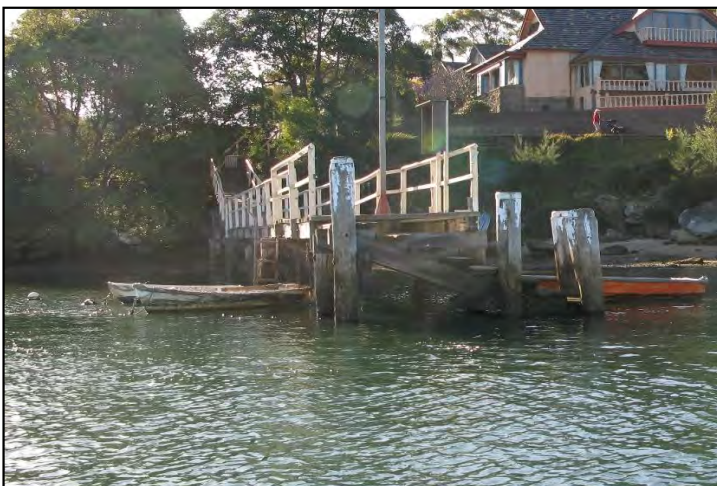
Photo 2

Structure is in poor condition with severe deterioration of timber. The wharf has been abandoned with signage on land indicating that it is unsafe for public use.

Dinghies tethered to timber wharf.

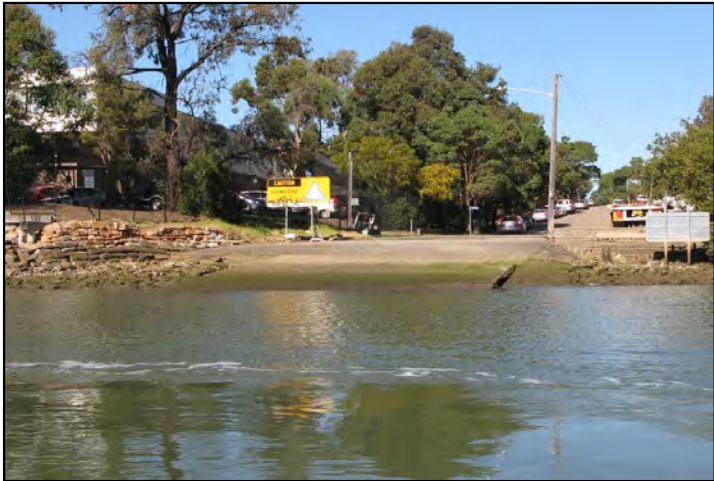
Condition Assessment:
The concrete has cracked and failed at the western corner of the ramp. The rest of the ramp is in good condition with minor weathering and fouling observed.

Photo 2
Failure at western corner of boat ramp.

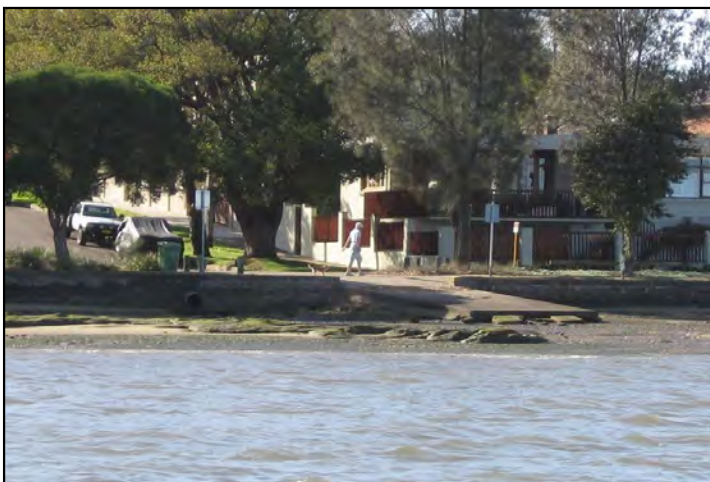
Condition Assessment:
Concrete is cracking and weathered. The front face of the ramp has been undermined.

Photo 1
View of boat ramp.

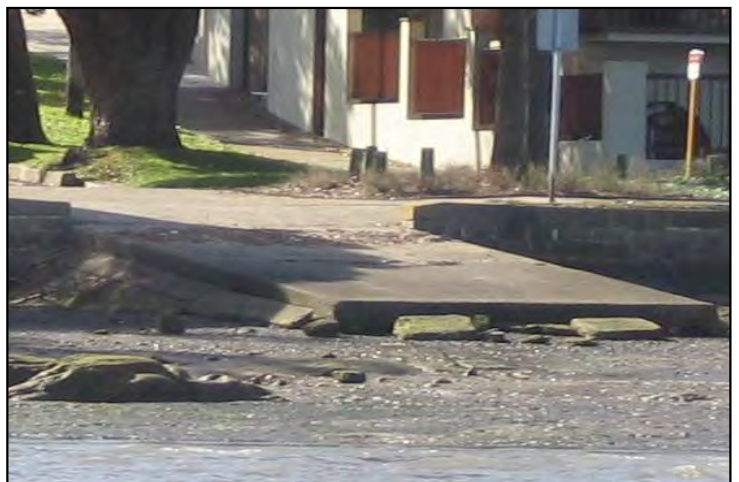
Photo 2
Sandstone blocks placed at end of boat ramp for low tide access.
