Auburn LGA

9.7 Auburn

Appendix 6: Field Assessment Sheets for Priority Sites

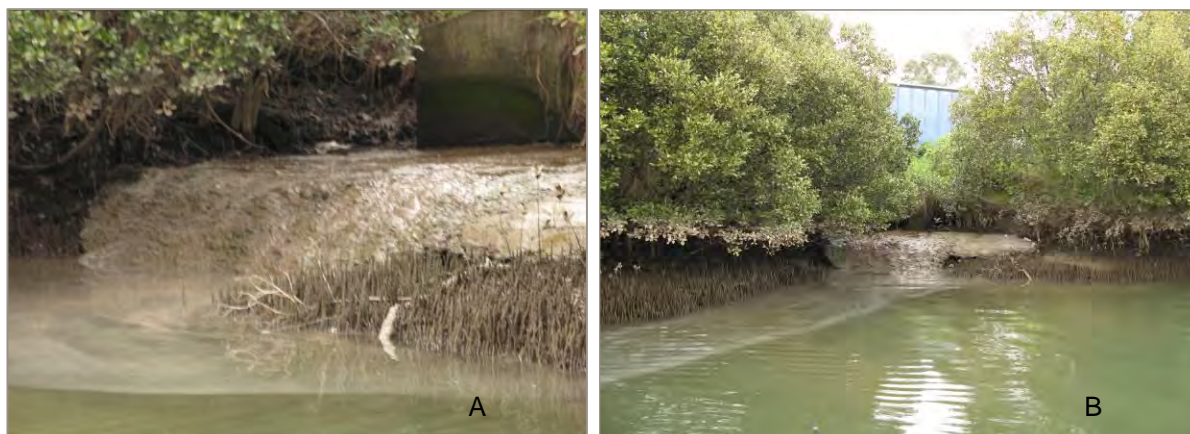
During field investigations, contaminated flows were observed discharging from a stormwater inflow (draining the industrial area in Silverwater) into Duck River: *Photos A and B*. The source of contamination was not ascertained at the time.

The results of the monitoring program were not obtained at the time of preparing this study, and the location of water quality sampling sites not ascertained. Therefore any historical issues with the stormwater outlet pictured in *Photos A and B* were not determined.

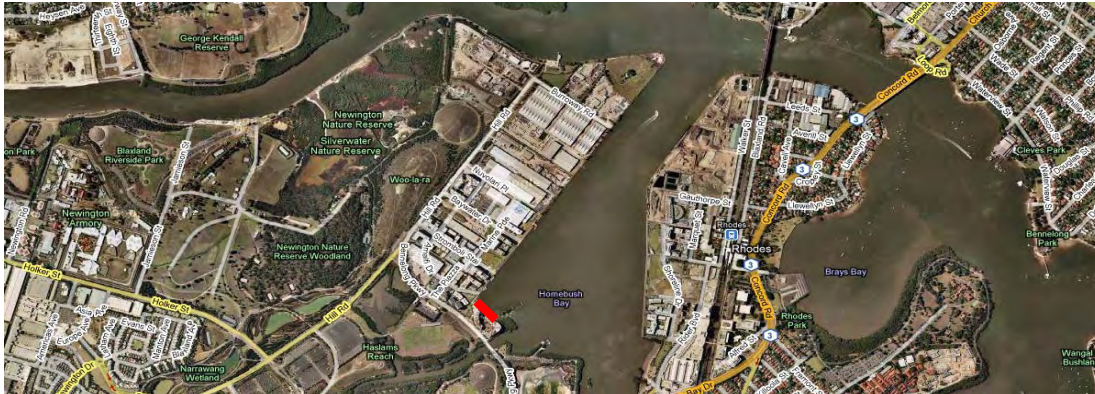
Seawall Inspection Record - AUB_S02

Footbridge and public footpath is supported by revetment which is in poor condition.

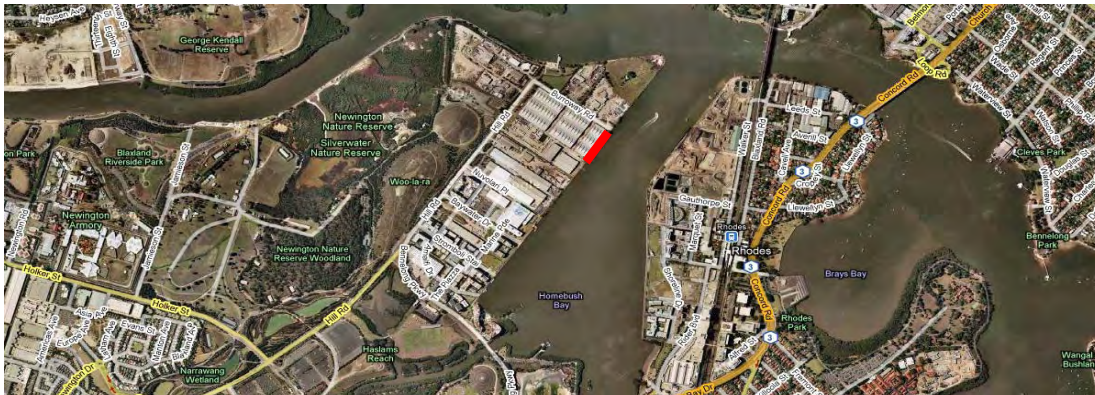
Seawall Inspection Record - AUB_S07

The concrete capping has cracked and failed along the lower section of the wall. The older blocks that forms the revetment are slumping.

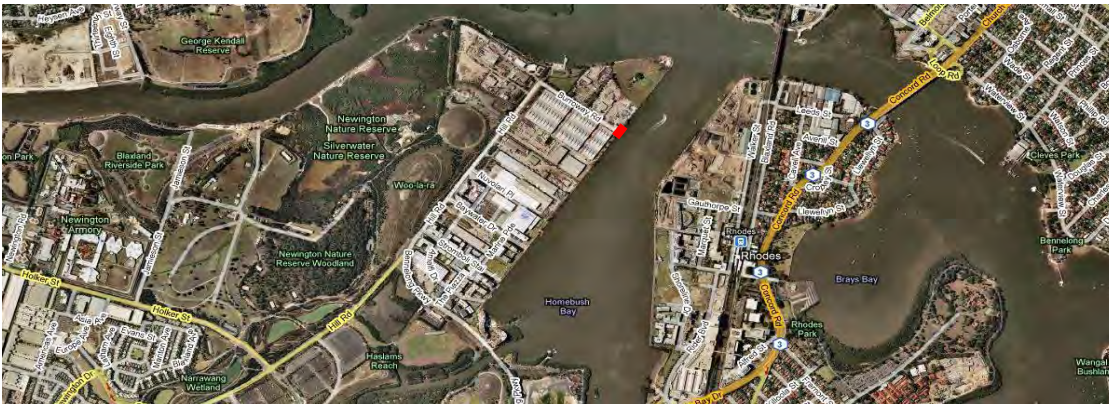
- AUB_S08

The sloping concrete crest has cracked and failed in places with large voids observed. The blocks that form the toe of the structure are slumping.

Public access is available and the structure forms the end of Burroway Road. If the structure is allowed to continue to deteriorate OH&S and asset issues may arise.

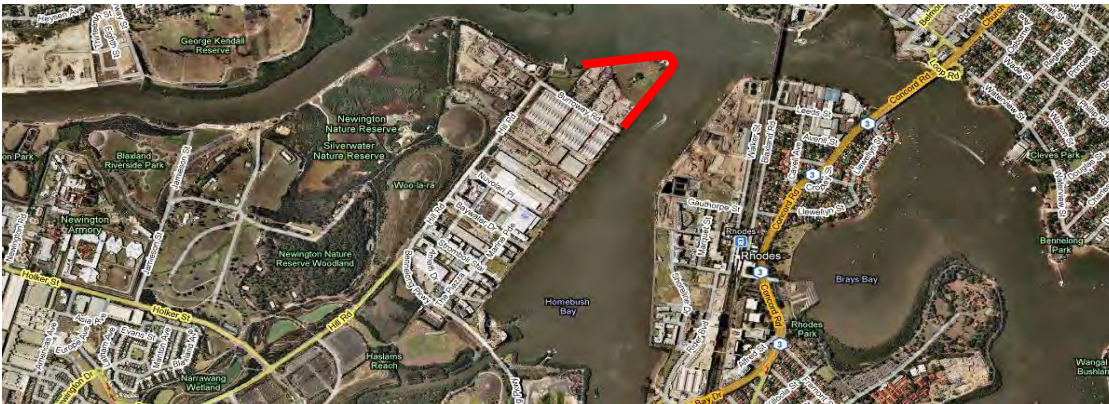
- AUB_S09

The revetment has failed with material lost from the crest and strewn across the muddy flat in front. A large erosion scarp is present at the crest which increases on the Parramatta River side where it is exposed to ferry wash.

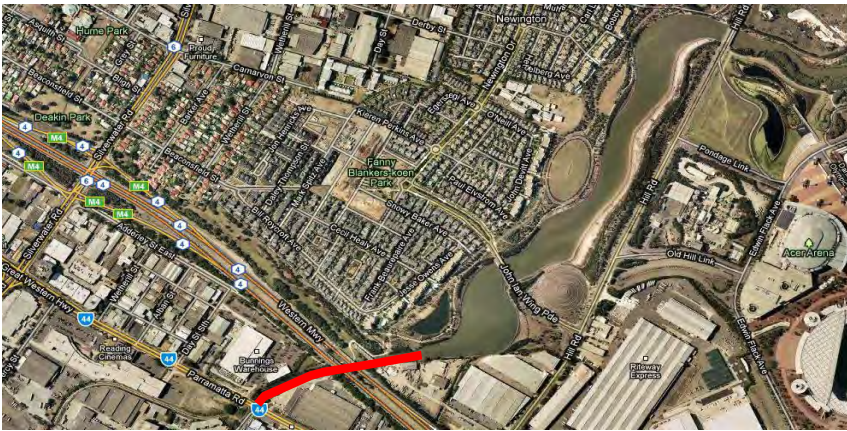
- HAS_E07

Minor cracking and weathering of concrete observed. Cracks are particularly evident between concrete panels.
The wall is cracking beneath the eastern abutment of Parramatta Road.

The bank supports abutments for two road bridges and is cracking beneath one.
