Hunters Hill LGA

9.8 Hunters Hill

Seawall Inspection Record - HUN_S01

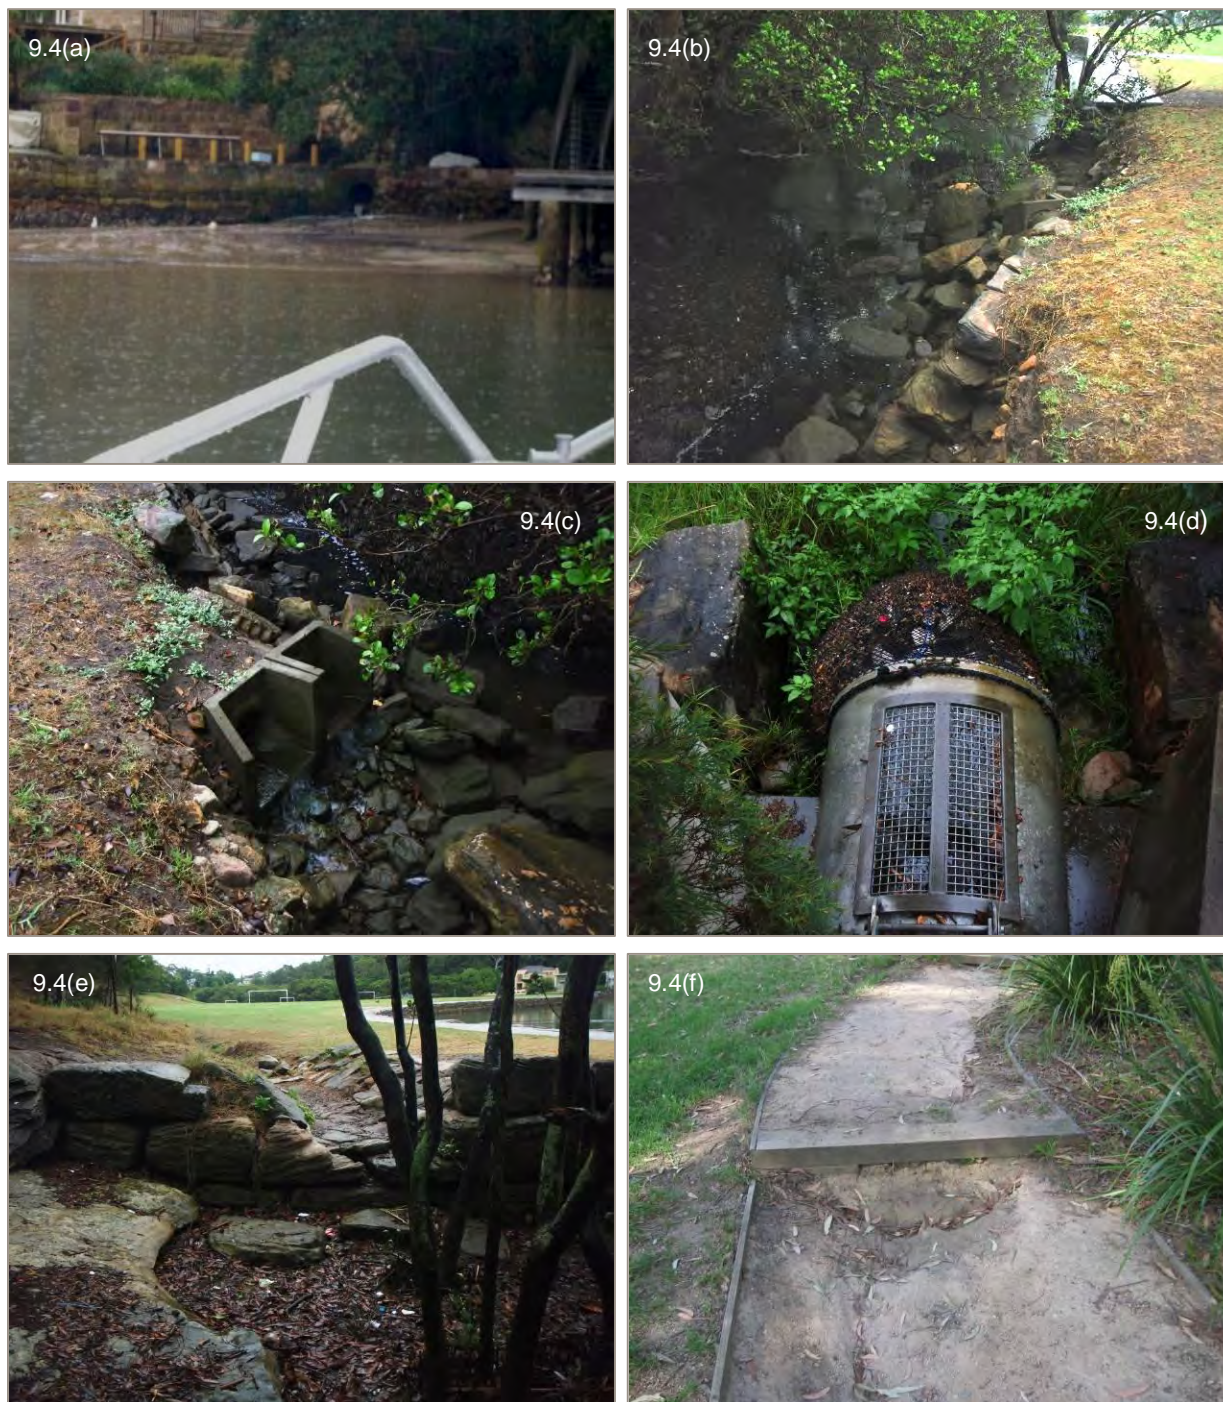
- Review of Tarban Creek catchment and additional areas of gross pollutant trapping considered, e.g. leaf litter entering creek from drainage under Jolie Parade Reserve, quality of flows from unmapped stormwater outlets in seawall HUN_S11, and a (mapped) inflow downstream of Joeys Boat Shed (*Photo 9.4(a)*);

- Minor repairs to southern bank of Tarban Creek (upstream of pedestrian bridge) (*Photo 9.4(b)*) and small inflows which appear to be a potential source of sediments through erosion (*Photo 9.4(c)*);

- Nettech located on (unmapped) drainage inflow to constructed wetlands burgeoning with gross pollutants, erosion evident around surrounding rip rap with landscaping mulch and soils entering wetland (*Photo 9.4(d)*);

- Manage inflows and organic material entering Tarban Creek from swale in the south western area of open space in Riverglade Reserve (*Photo 9.4(e)*);
- Repairs to pedestrian stairs in Gladesville Reserve which are eroding and a source of sediments to Parramatta River (*Photo 9.4(f)*).

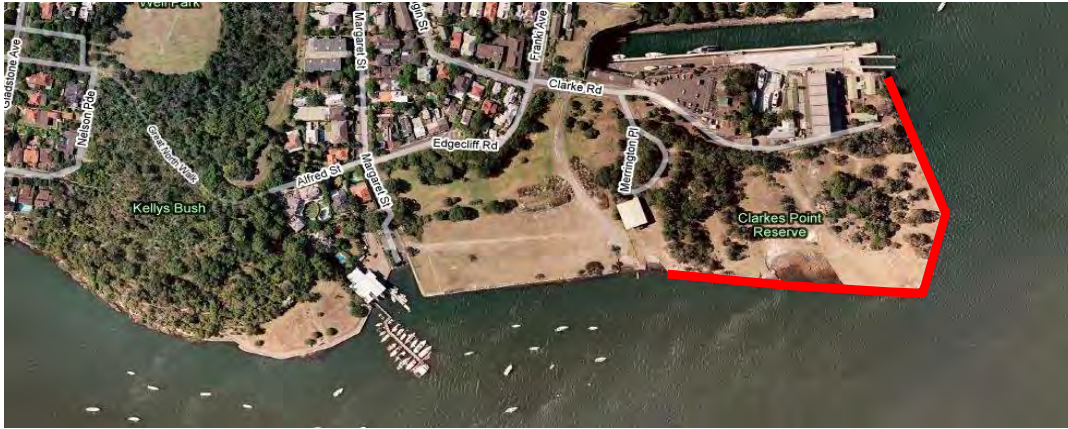
Numerous block failures of the crest were observed with blocks fallen into water below. Surface weathering of the sandstone blocks and sinkholes behind structure crest were also observed.

Typical section of seawall showing failure of blocks at crest, surface weathering and loss of grout material.

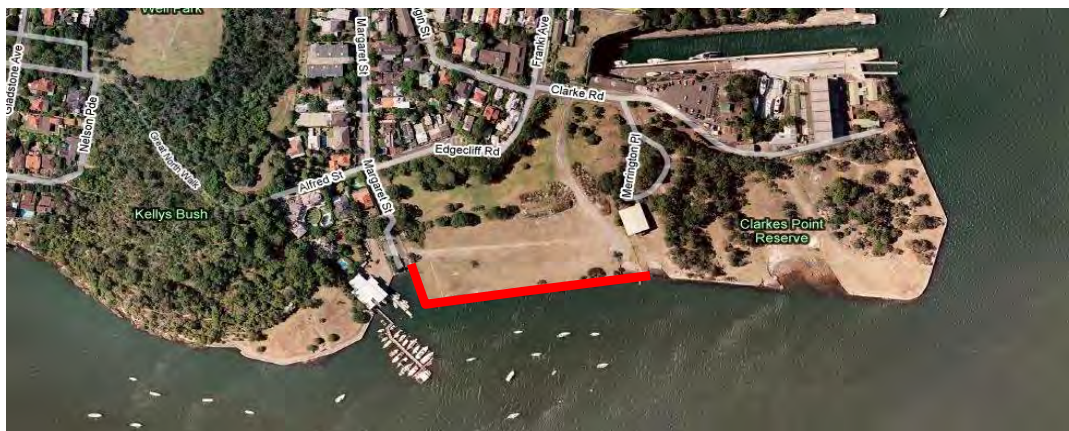
Seawall Inspection Record - HUN_S02

Numerous block failures of the crest were observed with blocks fallen into water below.
Surface weathering of the sandstone blocks and sinkholes behind structure crest were also observed. Western section is in better condition.

Typical section of seawall showing failure of blocks at crest, surface weathering and loss of grout material.

Western section of the seawall leading to boat ramp is in better condition than the rest of the structure

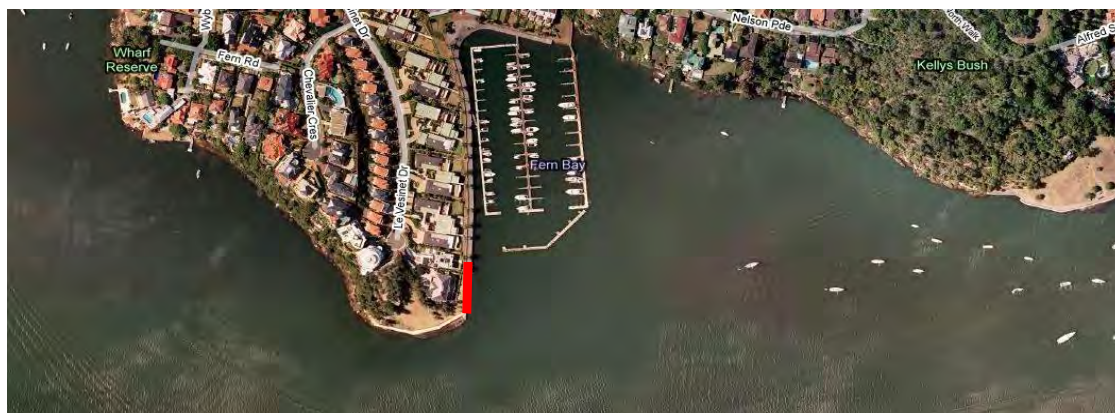
Seawall Inspection Record - HUN_S04

Seawall Details (Slope, Material, Const. Method, Type):
<u>Medium size grouted sandstone block seawall with one layer of newer blocks along crest associated with development of the foreshore. The crest was approx. 2m above the water level at time of inspection.</u>

Condition Assessment (Slope, Crest, Toe, Backfill):	Excellent	<input type="checkbox"/>
<u>Grout is missing from the lower blocks with extensive slumping and cavities observed. A number of localised block failures at the seawall toe were also observed. The newer, top layer is in good condition with grouting present.</u>	Good	<input type="checkbox"/>
	Poor	<input checked="" type="checkbox"/>
	Failed	<input type="checkbox"/>

Photo 2
Block failure at toe and loss of grout and clumping of lower, older sandstone blocks.

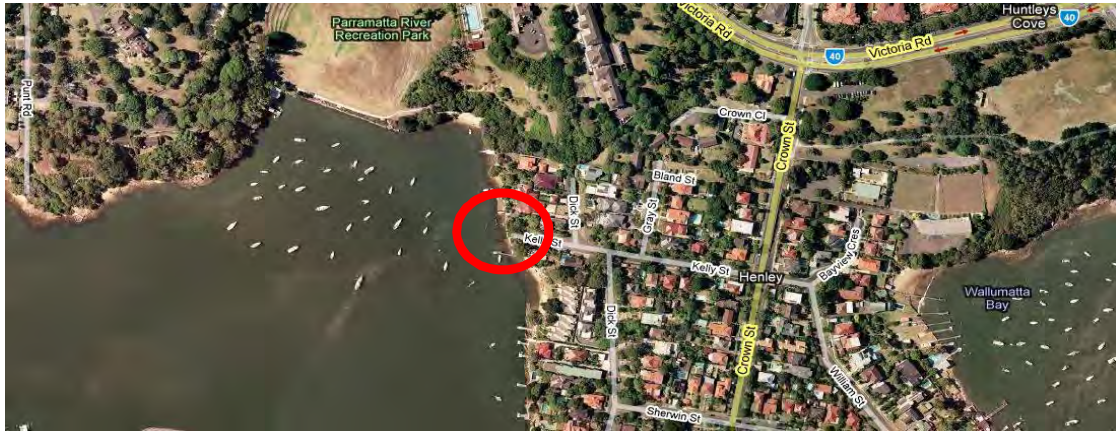
Seawall Inspection Record - HUN_S16

Block failure of seawall.

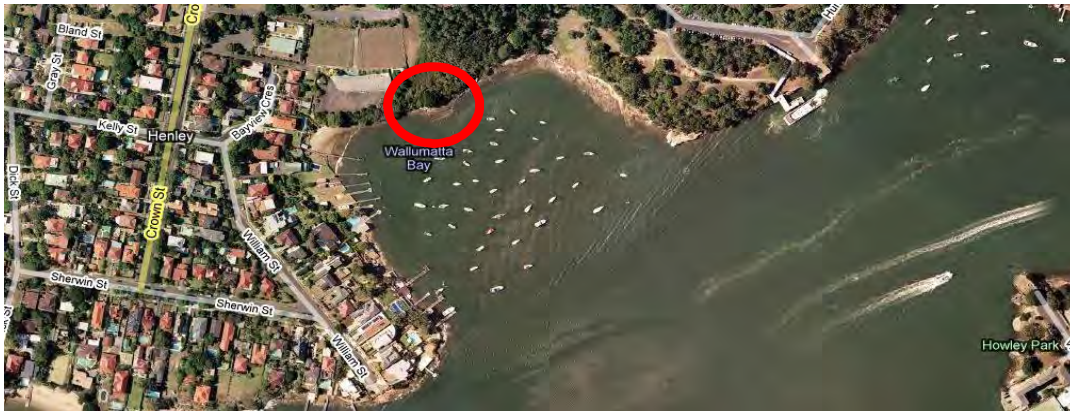
- HUN_F14

Asset Name	Asset Description
HUN_F14	<p>Description: Timber landing and ramp with informal dinghy storage beneath trees on rocky shoreline.</p> <p>Condition - Failed: Timber ramp has partly collapsed and is severely deteriorated. Landing has also deteriorated. No formal dinghy storage structure was observed. Vessels must be launched using failed timber ramp.</p> <p>Recommendations: It is recommended that dinghies are either relocated and ad-hoc structures removed or formal dinghy storage and launching facilities are installed.</p>
HUN_F02	<p>Description: Timber landing and stairs with steel connections supported by timber piles which appear to be embedded into rock. Stairs are 1.5m above rocky outcrops and water. Dinghies are tethered to structure and trees on foreshore.</p> <p>Condition - Poor: Deterioration of timber landing, stairs and piles was observed. Steel connections are corroding. Access to water is difficult as fouling of the lower sea stairs has occurred making them slippery. Bedrock is also exposed at low tide below the structure. No major assets are affected by this facility.</p> <p>Recommendations: The timber components that form the sea stairs have corroded and are slippery. The structure should be repaired or public access prevented.</p>
