9.9 Ryde

9.9.3 Seawalls

Seawall Inspection Record - RYD_S23

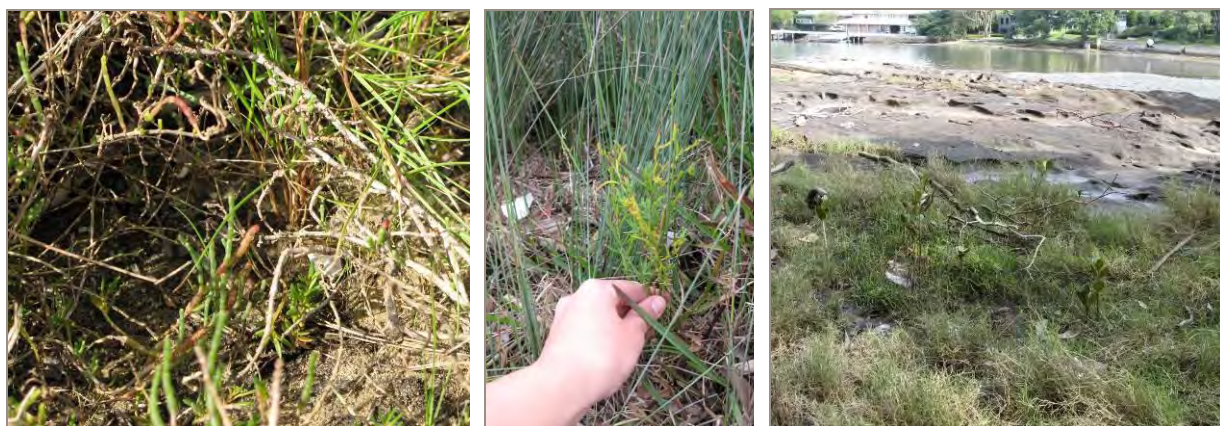
Above left: *Wilsonia backhousei* growing amongst saltmarsh. **Centre:** Buffalo grass growing amongst *Baumea juncea* and small seedlings of *Suaeda australis*. **Right:** Mangrove seedlings emerging in *Sporobolus virginicus*.

- Small amounts of *Wilsonia backhousei* found which should be monitored and conserved;
- Weed control to reduce competition from buffalo grass and other weeds;
- Removal of debris and gross pollutants stranded on saltmarsh at high tides;
- Reduction of trampling and dinghy storage;
- Removal of mangrove seedlings as they emerge in saltmarsh; and
- Seed collection and propagation of native saltmarsh species (in particular *Baumea juncea* which is a difficult species to procure).

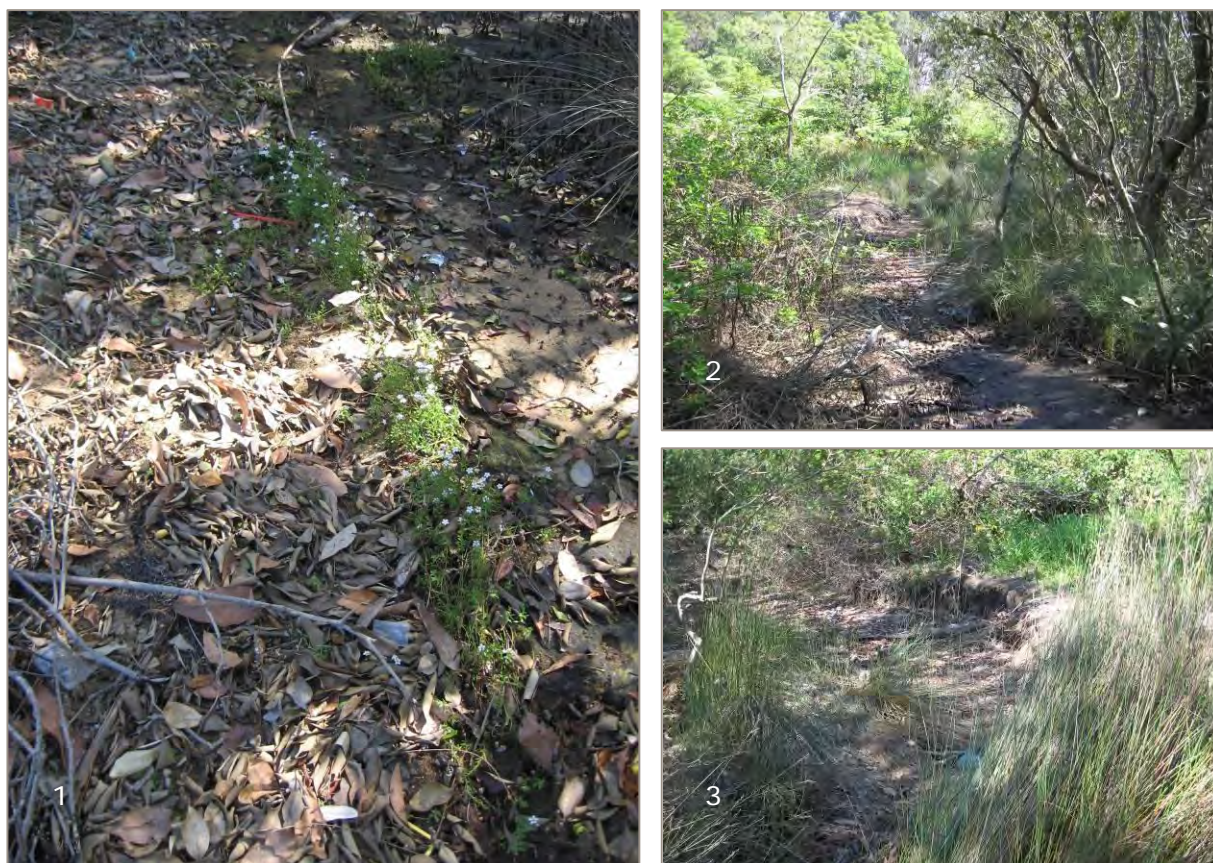
Photo #1 (above left): Leaf litter and *Samolus repens* colonising edge of mangroves. **Photo #2 (top right):** Salinised boundary, Lantana landward (left) & saltmarsh and mangroves seaward (right). **Photo #3 (bottom right):** Salinised boundary, Lantana in background and *Baumea juncea* in foreground.

- Weeds such as Lantana are presently limited by saline incursion (*Photo #2 & #3*), potential to artificially salinise weed infestations fringing saltmarsh and mangroves as a weed control tool and to allow expansion of saltmarsh vegetation;
- Formalisation of walking trails would benefit saltmarsh (beyond existing trail);
- Seed collection and propagation of native saltmarsh species, in particular *Samolus repens* (*Photo #1*) and *Baumea juncea* (*Photo #3*), both of which are difficult to procure.

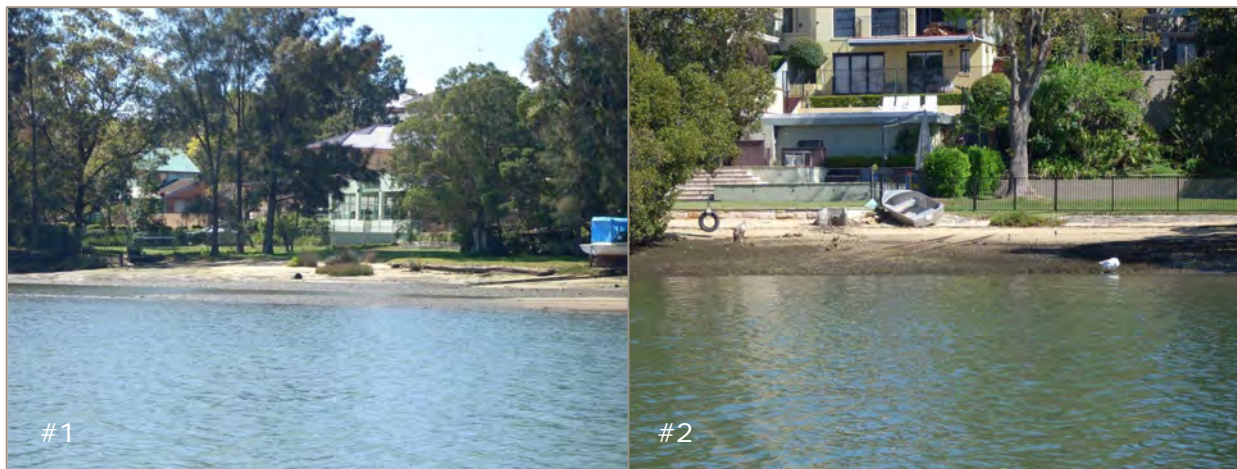
Photo #1 (above left): Saltmarsh on sandy beach. **Photo #2 (above right):** Isolated patch of *Suaeda australis* adjacent stormwater outlet

Small isolated areas of saltmarsh vegetation (*Photo #1 & #2*), which have limited landward migration potential due to proximity of private properties, recommendations include, either:

- Use as potential source of plant propagation materials, or
- Liaise with private landowners to conserve and increase extent of saltmarsh growth.

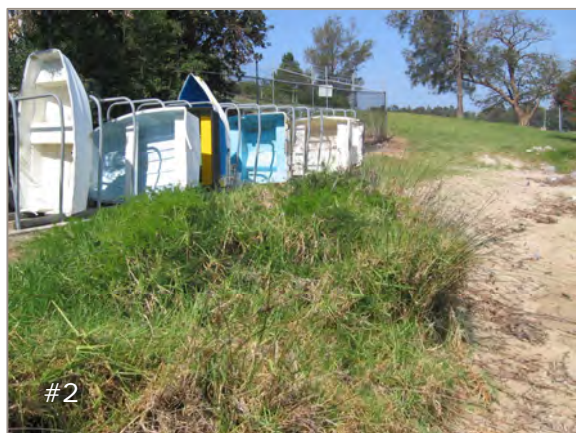
Photo #2 (above): stormwater outlet and deposition of organic gross pollutants.

- Investigation and mitigation of large quantities of organic matter (particularly leaf litter) contained in outflows, which are depositing in the near shore environment and being trapped by mangroves growing in close proximity to the outlets (*Photo #1, right*).

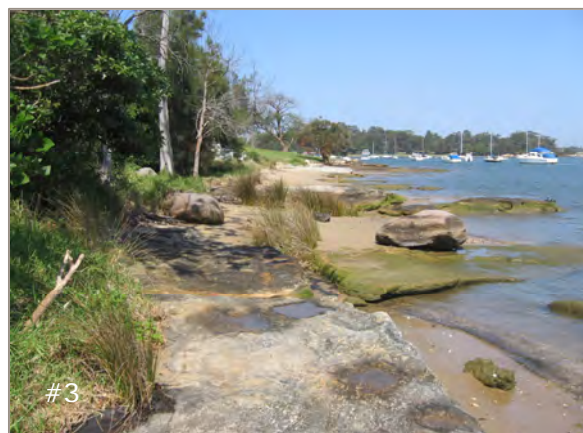
Photo #3 (above right): Scattered *Juncus kraussii* growing along beach with limited landward migration potential.

- Control of Buffalo grass which overrunning *Juncus kraussii* (*Photo #2*) adjacent RYD_F11, and remove Coral tree sapling at same location.
- Seed collection from isolated patches of *Juncus kraussii* along shoreline between stormwater outlets River_North_49 and River_North_50 (*Photo #3*). Ongoing monitoring to determine whether plants should be translocated to a more suitable location. *Juncus acutus* also present as an individual plant in this location which requires control and ongoing monitoring for regrowth or seed germination.
- Alternanthera philoxeroides* (Alligator weed) is growing among lawn adjacent Kissing Point Wharf car park. Alligator weed is noxious in NSW, and also a weed of national significance (WONs) and requires immediate and ongoing control (*Photo #4*).

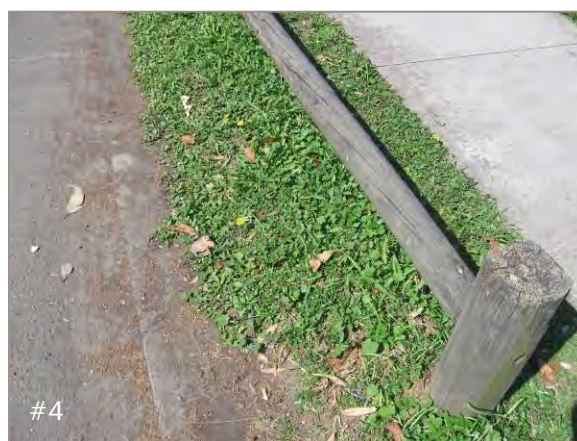
Photo #4 (above right): Alligator weed growing in road verge turf being maintained by mowing.

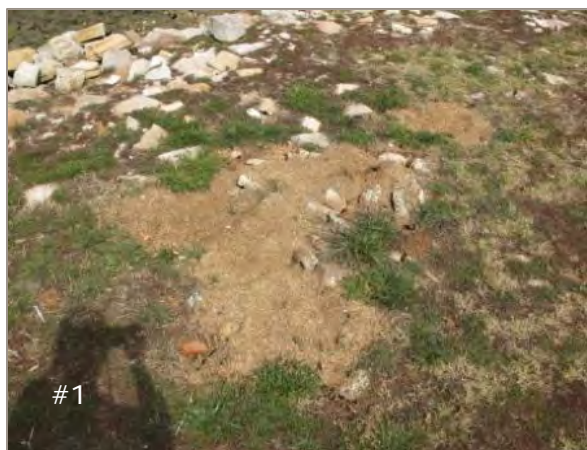
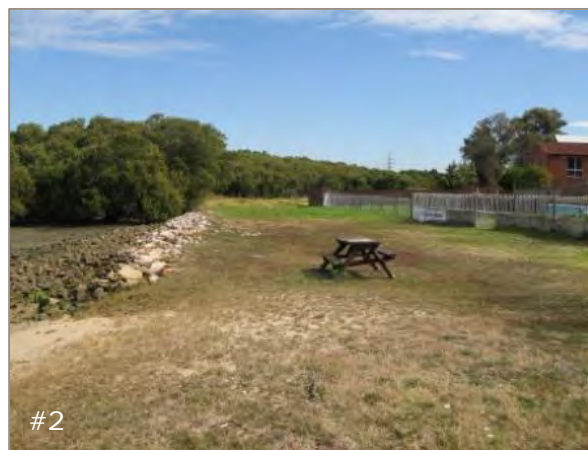
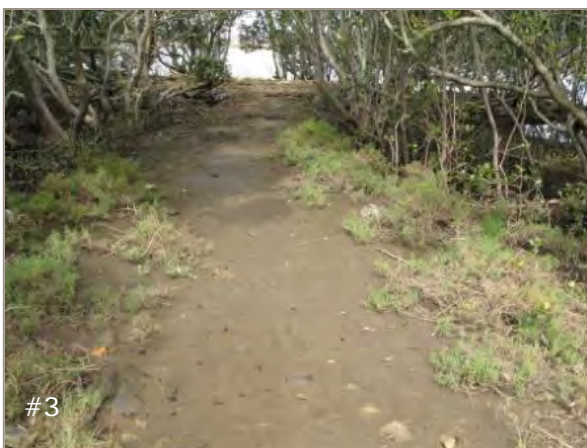
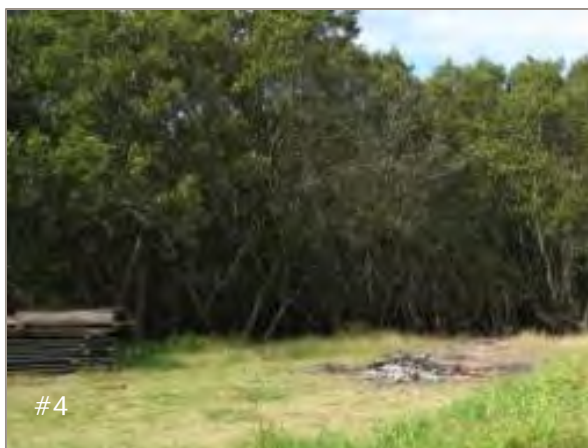
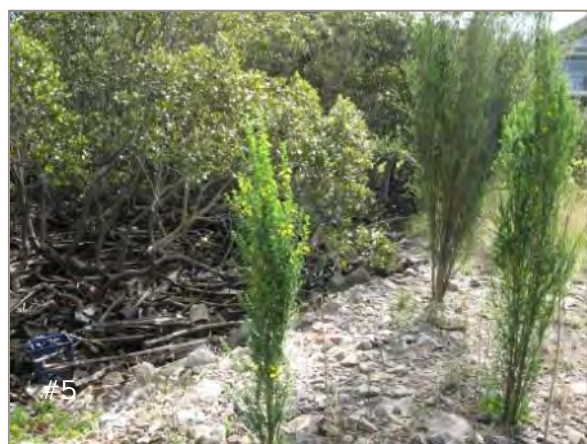
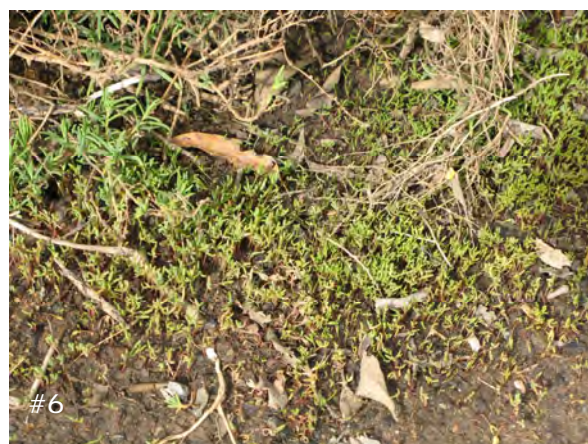
Multiple issues impacting on mangroves and saltmarsh require management. Recommend area located from Archers Creek to West Ryde Jetty (RYD_F16) be the subject of a management plan that addresses the following issues:

- Mowing management of lawn clippings (*Photo #1*);
- Extension of landscaping activities from residential land into foreshore (*Photo #2*);
- Access management to formalise trampling impacts *Photo #3*;
- Vandalism (*Photo #4*);
- Weed control (*Photo #5*); and
- *Wilsonia backhousei* conservation (*Photo #6*).

A range of opportunities are possible at this site which should incorporate: protection of existing saltmarsh and expansion of its extent; formalised access (potential for boardwalk and viewing platform); and education / interpretation (community consultation, signage).

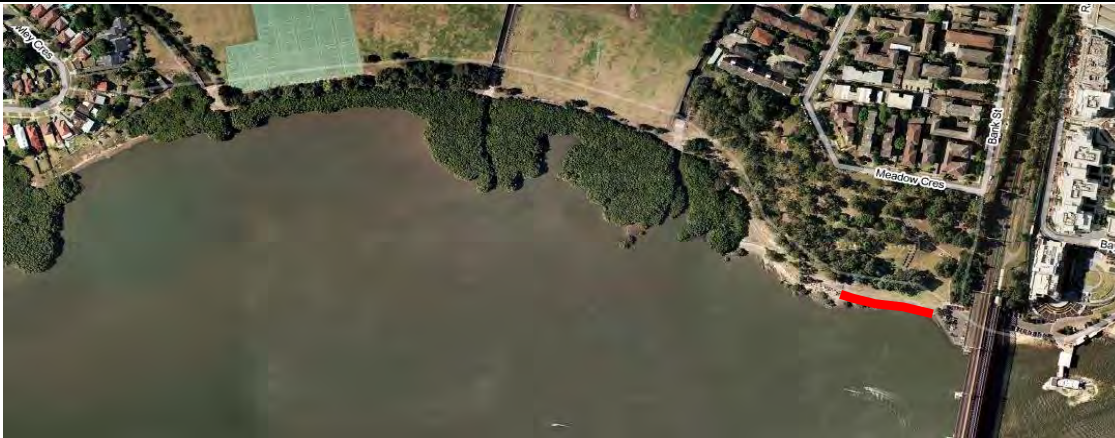
Grout not present, voids and localised block failures were observed. Concrete capping on crest and face has cracked and failed.

Typical view of structure showing block and concrete capping failure.

Block failure beneath at toe.

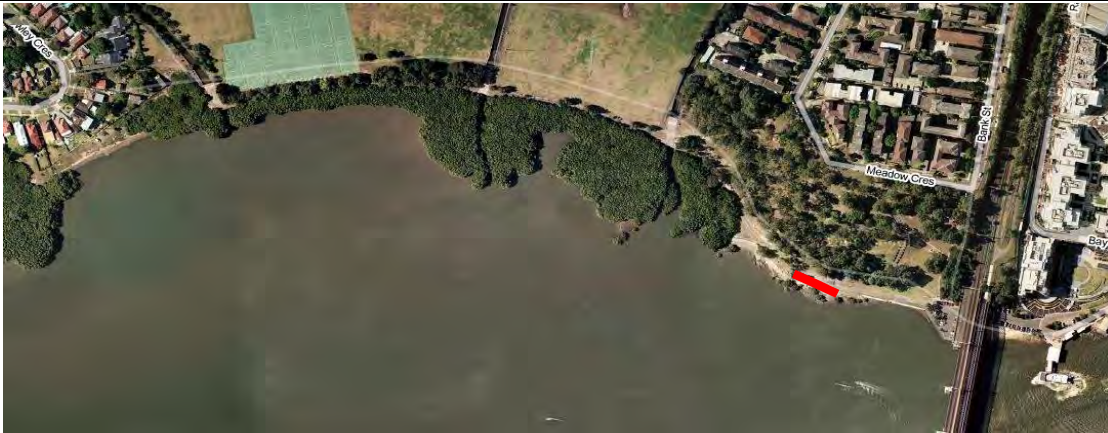
- RYD_S24

Significant slumping, block failures at the crest and weathering of sandstone blocks was observed along the length of the structure. Vegetation is also growing out of the wall.

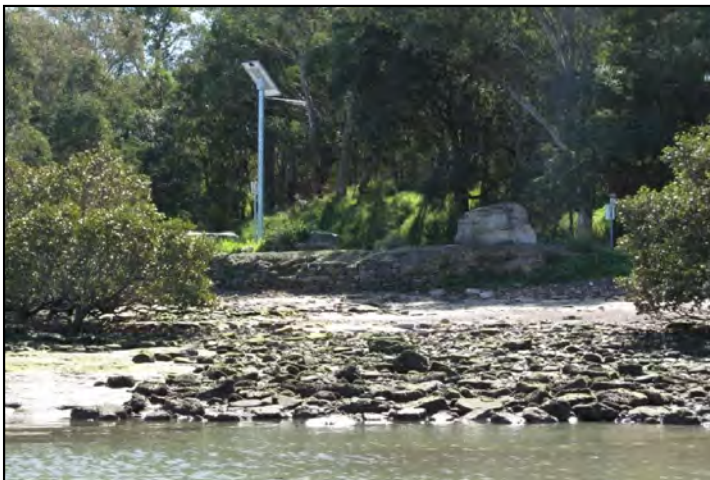
Photo 2

Block failures and slumping of wall.

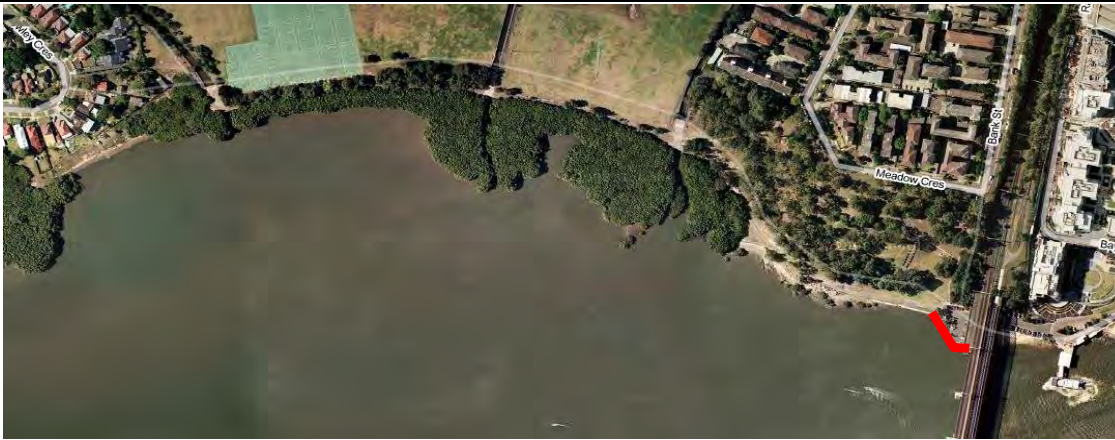
Seawall Inspection Record - RYD_S22

The section adjacent to the bridge abutment has failed and all material has been lost from the baskets. The rest of the structure is slumping.

The structure supports a public carpark and walkway which has been undermined by the failure adjacent to the bridge abutment.

Failure of structure adjacent to John Whitton Bridge.

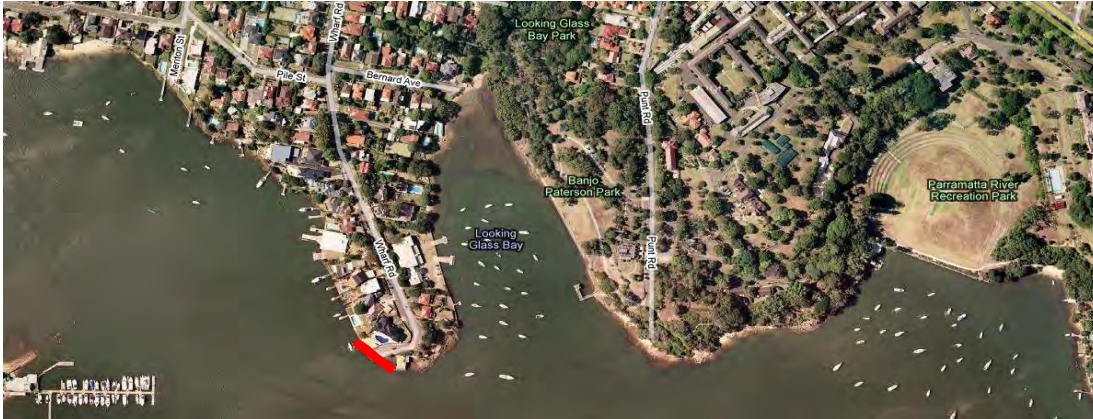
- RYD_S03

A number of block failures were observed along the length of the wall. Additionally, no grout is present between the blocks, sinkholes are present at the crest and surface weathering of the blocks has taken place.

Block failures along wall.

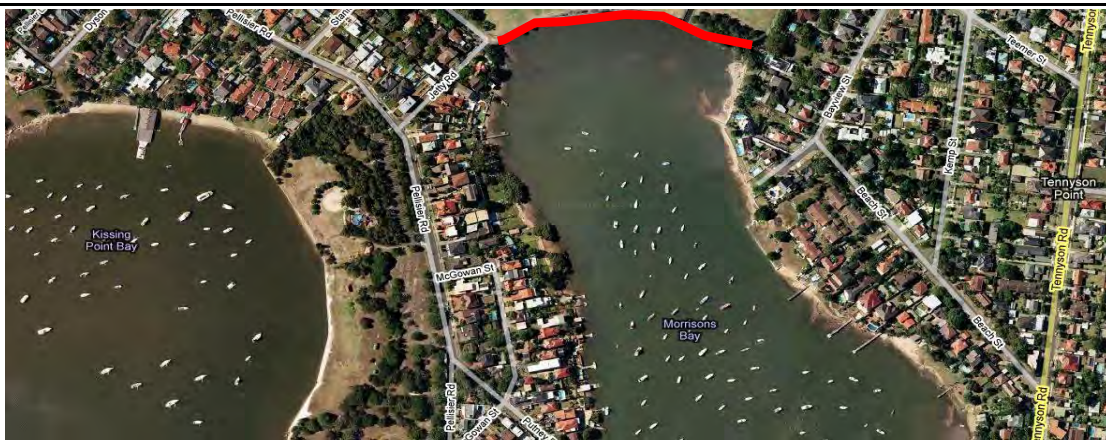
- RYD_S06

Severe weathering, slumping and loss of grout from between sandstone blocks was observed. A number of sinkholes are present behind the crest indicating a loss of fine material.

Caps are missing from storm water outlets. Photos RYD_S06-01 to RYD_S06-22.

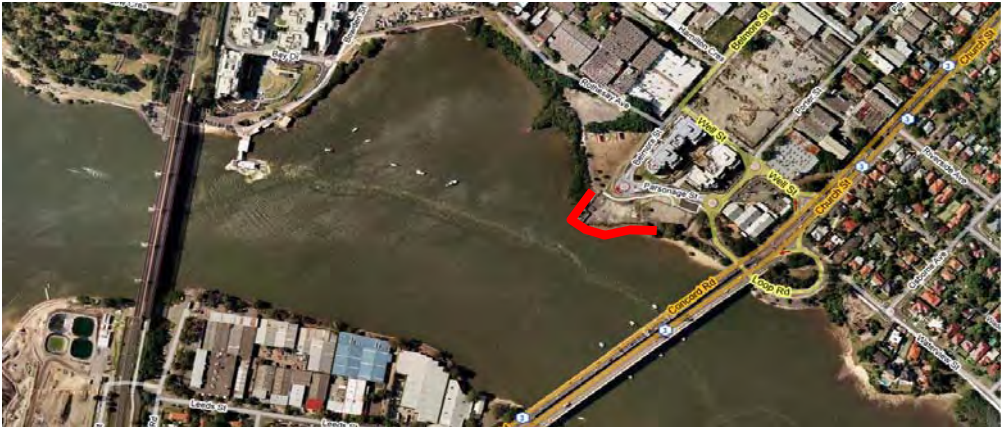
Seawall Inspection Record - RYD_S11

Condition Assessment (Slope, Crest, Toe, Backfill):
Single block failures were observed along the older, lower section of the wall. The lower section is also slumping and grout material is missing from between the blocks. The newer blocks that form the crest are in excellent condition.

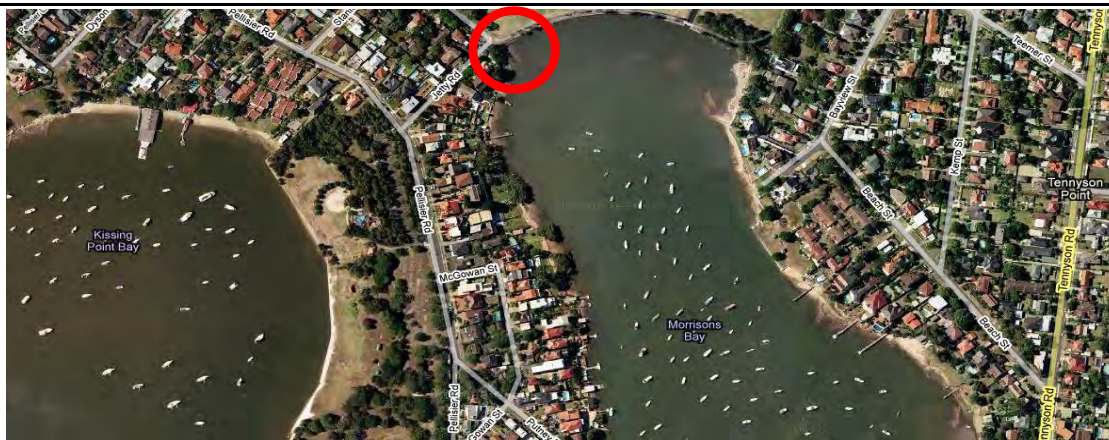
- RYD_F08

The boat ramp is not constructed to typical engineering standards. The toe has been undermined and the sides of the ramp are failing with aggregate material strewn along adjacent sandy shoreline. There is no formal structure for dingy storage.

Dinghies are launched via the ad-hoc boat ramp which is failing.

Undermining at the toe and failure along the side of the ad-hoc boat ramp.

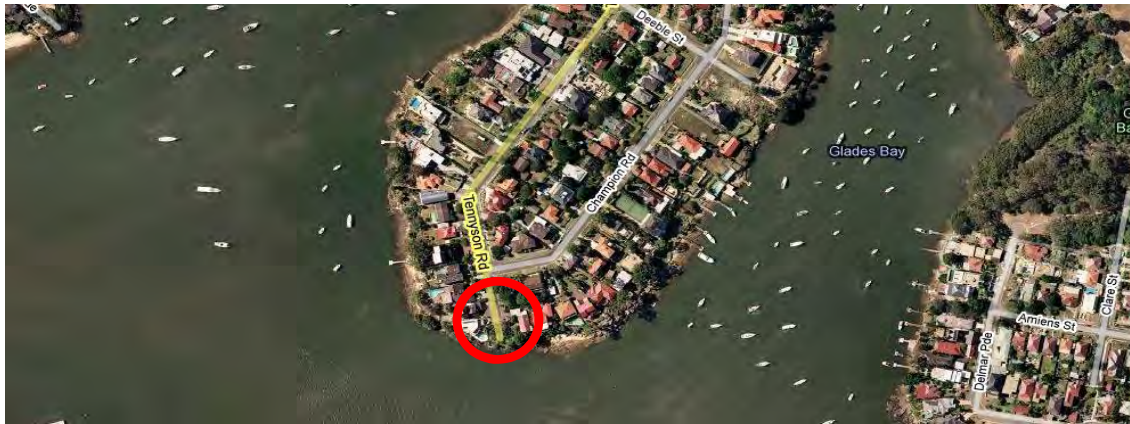
- RYD_F05

The concrete stairs are in a poor conditions with cracks present and undermining at the lowest point.

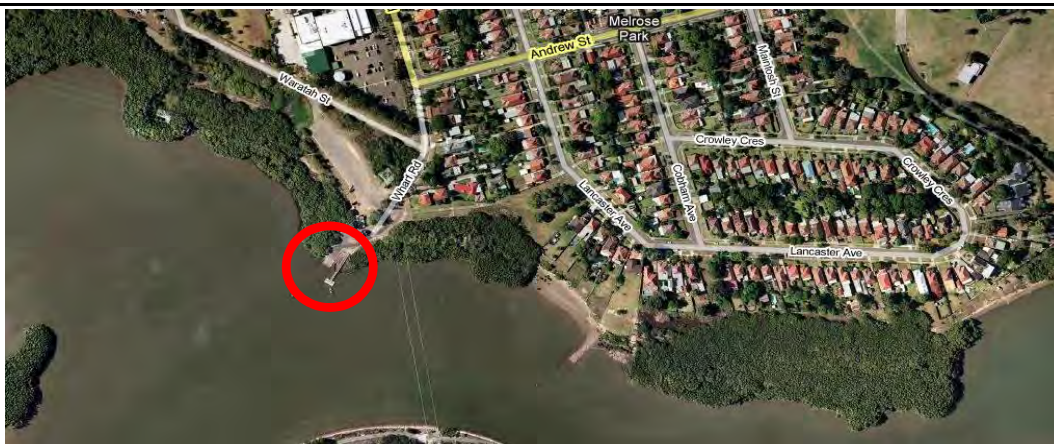
- RYD_F16

The timber slats on the jetty are loose and deteriorating as is the timber rail. The timber slats on the gangway are also loose and deteriorating. The edges of the concrete that makes up the floating pontoon are severely corroded with reinforcement visible.

Timber safety rails are loose and deteriorating. The structure is exposed to ferry wash making berthing and mooring difficult.

The structure is situated atop old timber piles and beams which may have formed an old wharf. A sign in the adjacent car park indicated that the whole facility is to be replaced in 2010. Photos of the facility, RYD_F16-01 to RYD_F16-10.

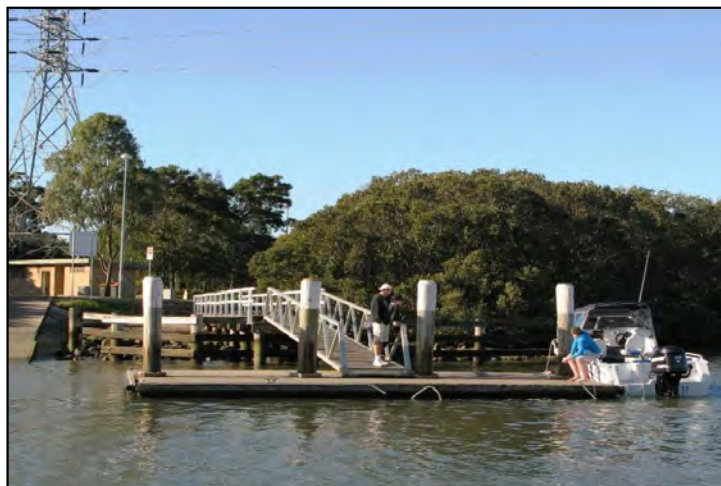
Photo 2

Corrosion of concrete which forms floating pontoon.

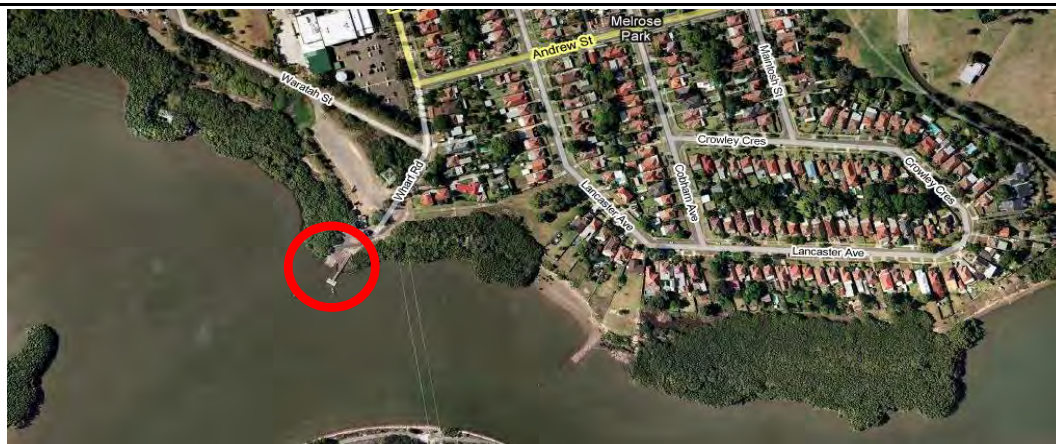
- RYD_F17

The concrete ramp is cracking and aggregate is exposed. The western side of the structure has been undermined.

A sign in the adjacent car park indicated that the whole facility is to be replaced in 2010.

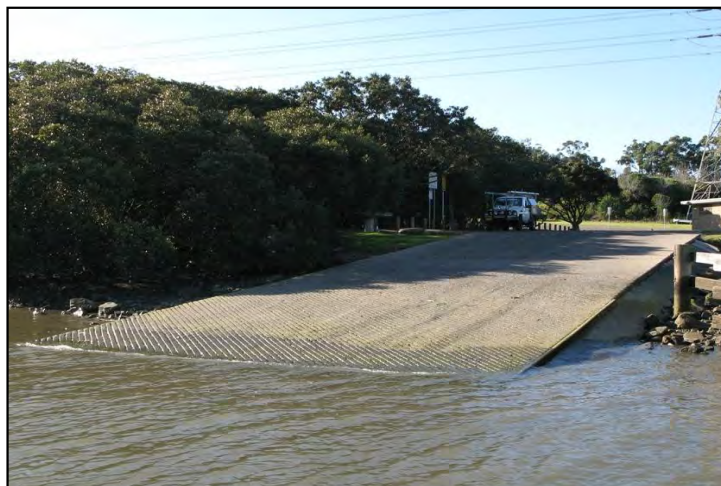
Photo 2

Undermining of structure on the western side.

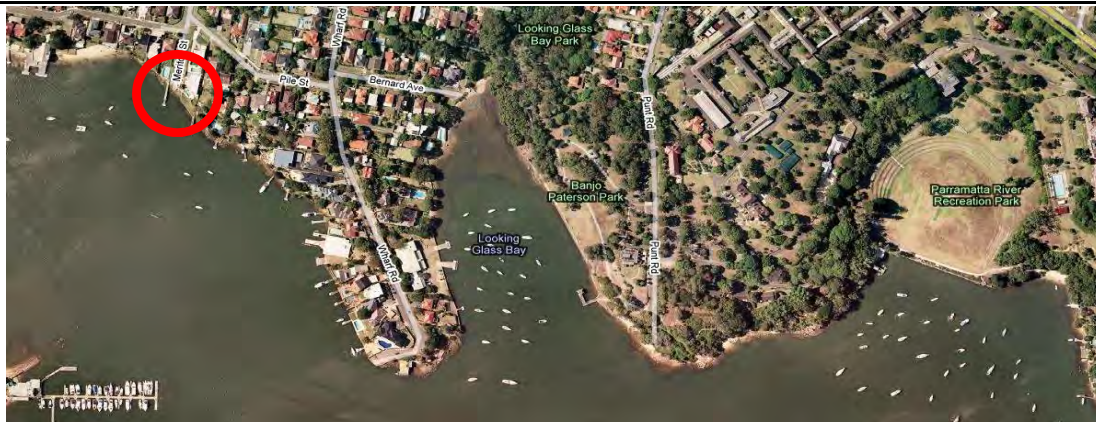
- RYD_F03

No formal facility. Steel safety rail associated with Sydney Water pumping station is showing signs of corrosion and the concrete slab it sits upon has been undermined.

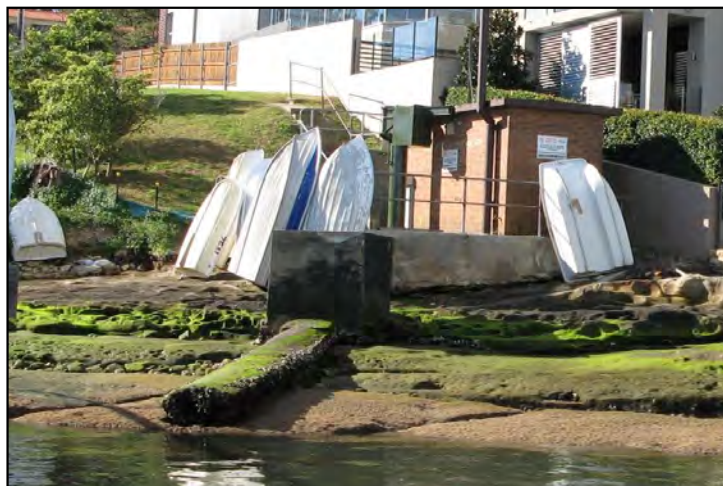
Photo 2

Dinghy tethered to steel safety rail.

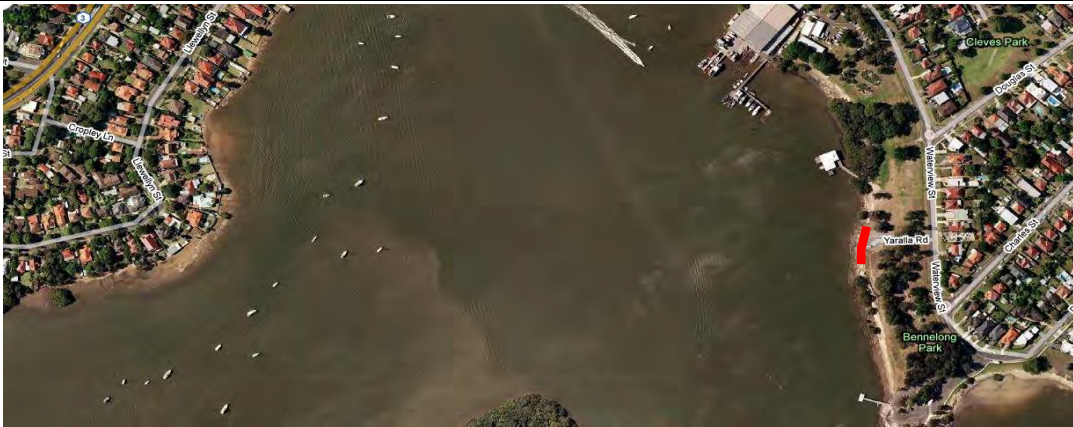
- RYD_NS07

A large, approx. 500mm erosion scarp is present for 50m encompassing the end of Yaralla Road. The section is fenced
off from the public and council workers were on site during the inspection and were placing large sandstone boulders
along the scarp which don't appear to be designed to typical engineering detail with no filter layer observed.

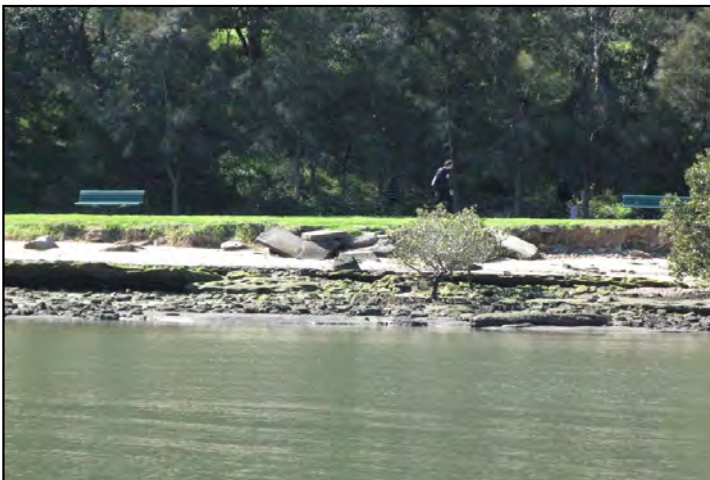
Photo 2

Erosion scarp with concrete building waste.

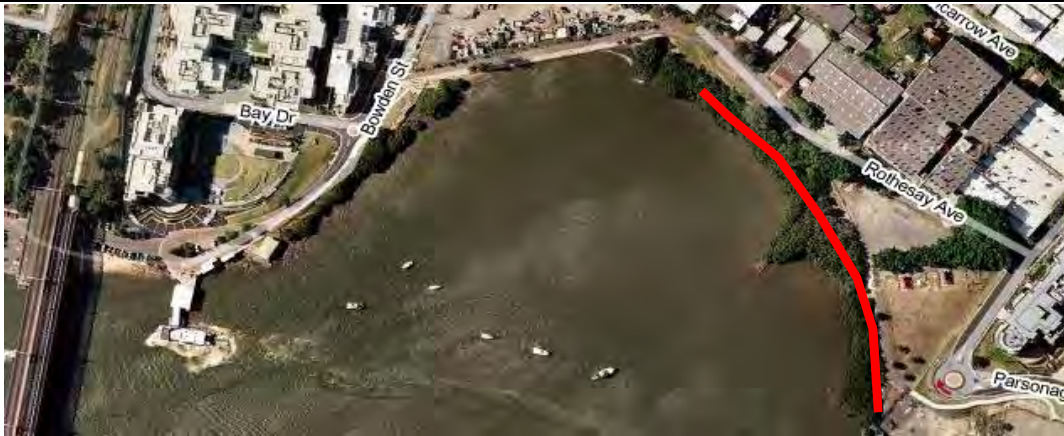
- RYD_NS11

Erosion observed with no fine material present between pneumatophores due to exposure to vessel wash. One mangrove has collapsed.

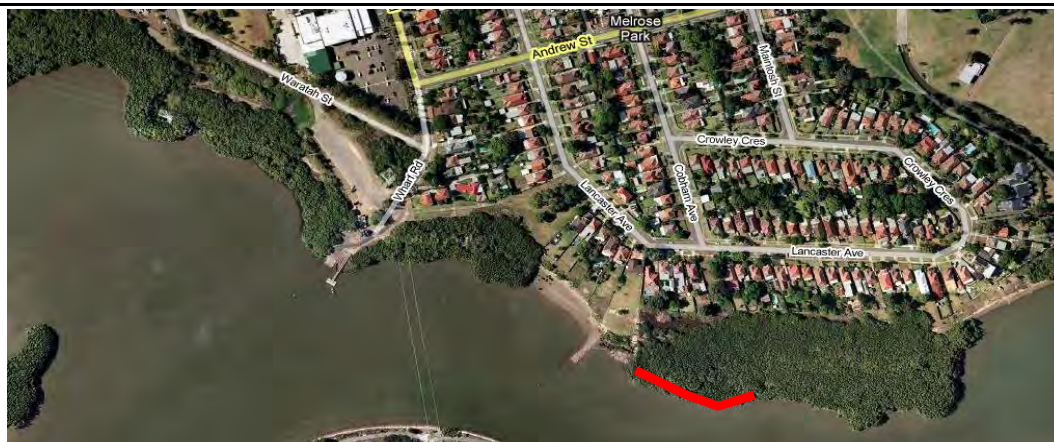
- RYD_NS14

Erosion observed with undermining and loss of fine material from pneumatophores due to exposure to vessel wash.

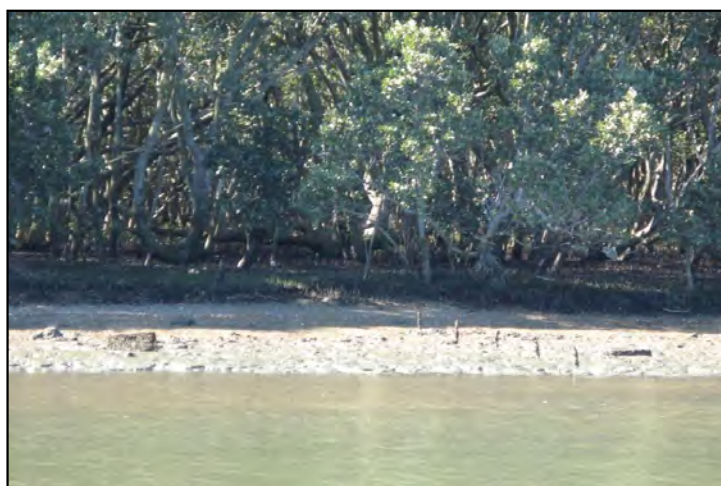
Photo 2

Undermining and collapsing of mangroves.

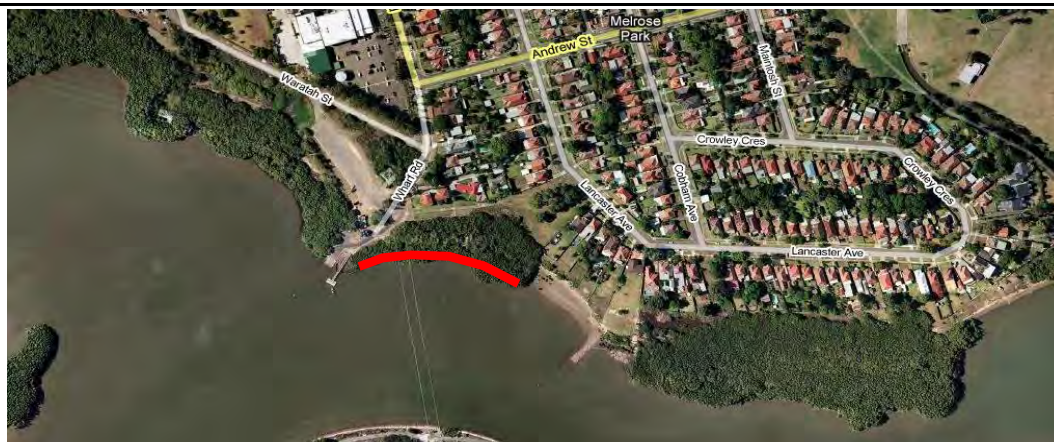
- RYD_NS15

Erosion observed with undermining and loss of fine material from pneumatophores due to exposure to vessel wash.
