9.11 Sydney Water

9.11.2 Canals

Appendix 10: Field Assessment Sheets for Priority Sites

Canal Inspection Record - POW_E01

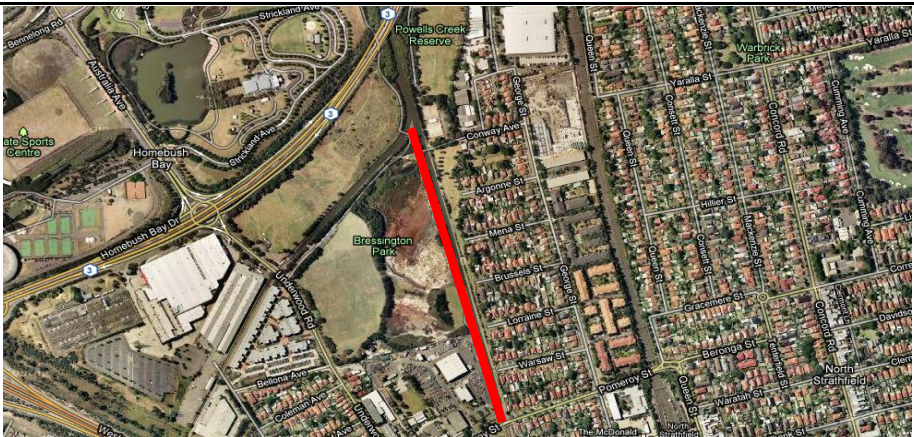
- POW_W02

Condition Assessment:
The concrete panels that form the canal sides have cracked and along their lower half. The bed is also cracking.
Sinkholes are present behind the structure crest. The conditions improves to the south.

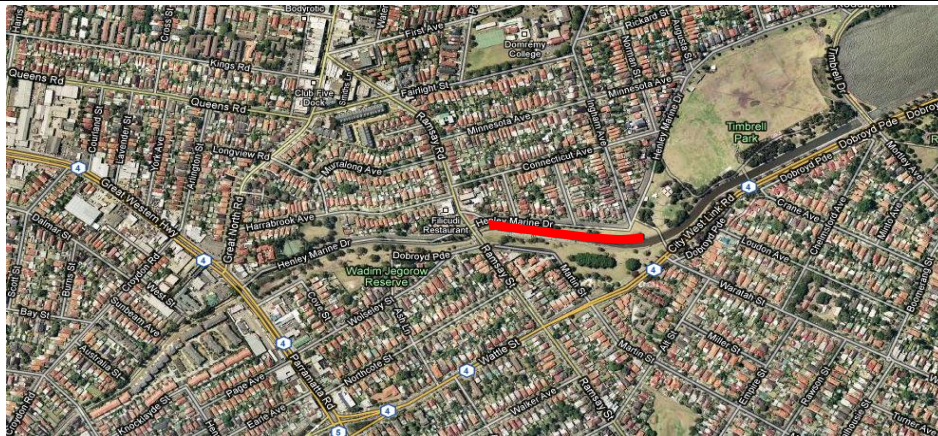
- DOB_W03

The canal is cracking between the concrete panels. The concrete that forms both the sides and the bed is also weathered with aggregates visible.

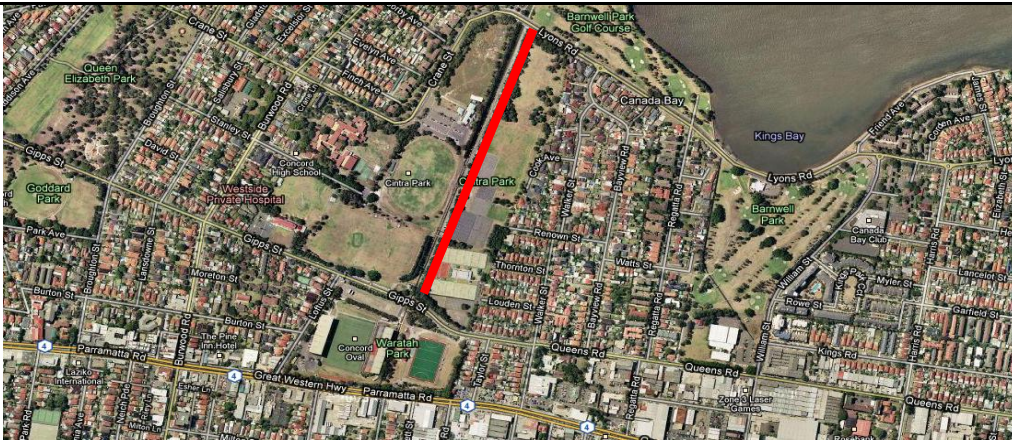
- BPW_E02

Concrete panels are cracked and weathered. Many have collapsed backwards due to a loss of fines from behind the wall. The concrete bed has corroded with aggregates visible.

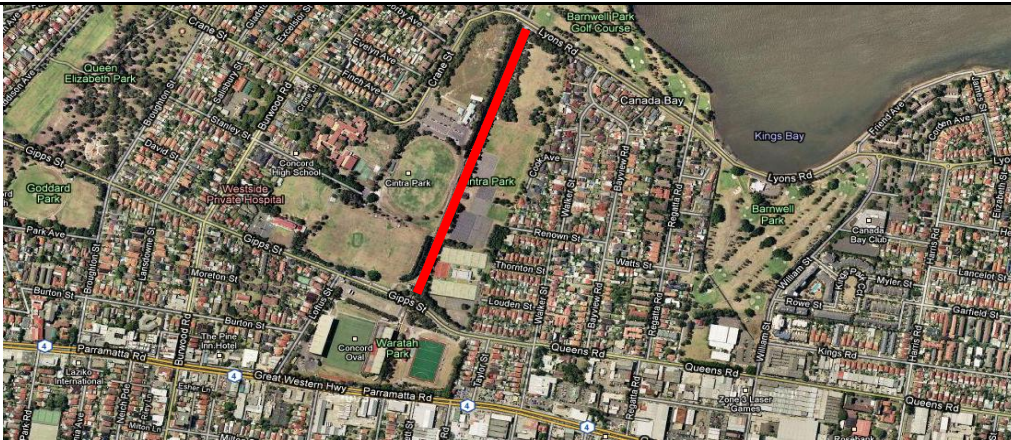
- BPW_W02

Concrete panels are cracked and weathered. Many have collapsed backwards due to a loss of fines from behind the wall. The concrete bed has corroded with aggregates visible.

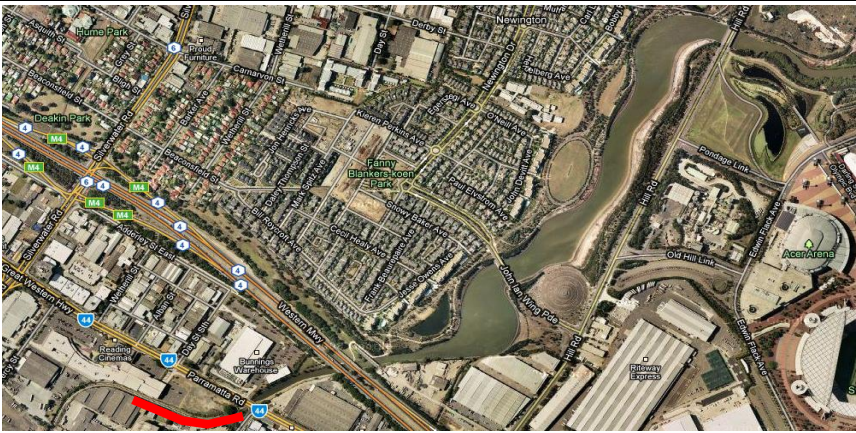
Canal Inspection Record - HAS_E08

Condition Assessment:
Minor cracking and weathering of concrete observed. Cracks are particularly evident between concrete panels.
Condition worsens to the south.
