Canal Inspection Record

- POW\_E01

LocalityPowells Creek East Bank, Concord West

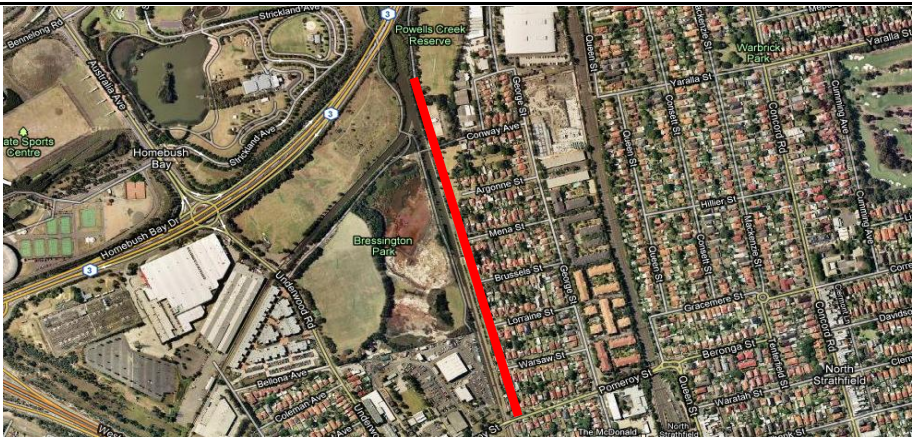
Concrete lined drainage canal with sloping sides. A steel fence is present along the length of the canal. Drainage is present at wall mid-height.

The concrete panels that form the canal sides have cracked and failed along their lower half. The bed has also failed. Sinkholes are present behind the structure crest. The conditions improves to the south.

Saltmarsh is present in cracks between concrete panels and on the wall crest. Photos of structure are POW\_E01-01 to POW\_E01-14.

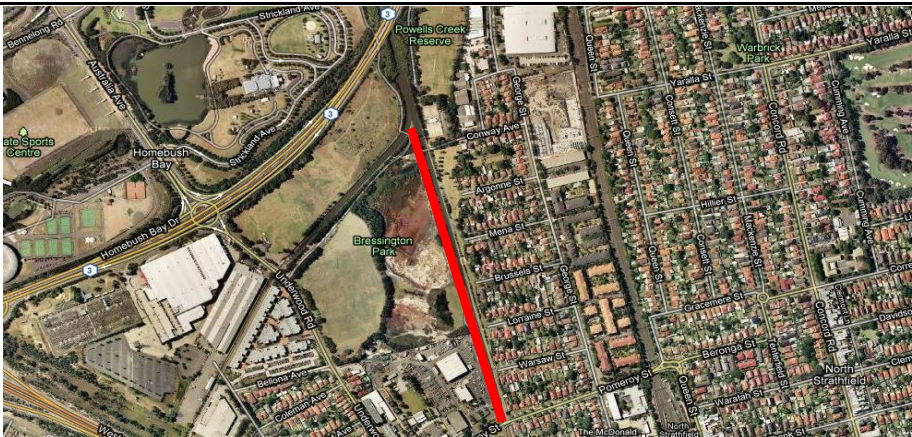
- POW\_W02

The concrete panels that form the canal sides have cracked and along their lower half. The bed is also cracking.

Sinkholes are present behind the structure crest. The conditions improves to the south.

Saltmarsh is present in cracks between concrete panels and on the wall crest. Photos of structure are POW\_W02-01 to POW\_W02-09.

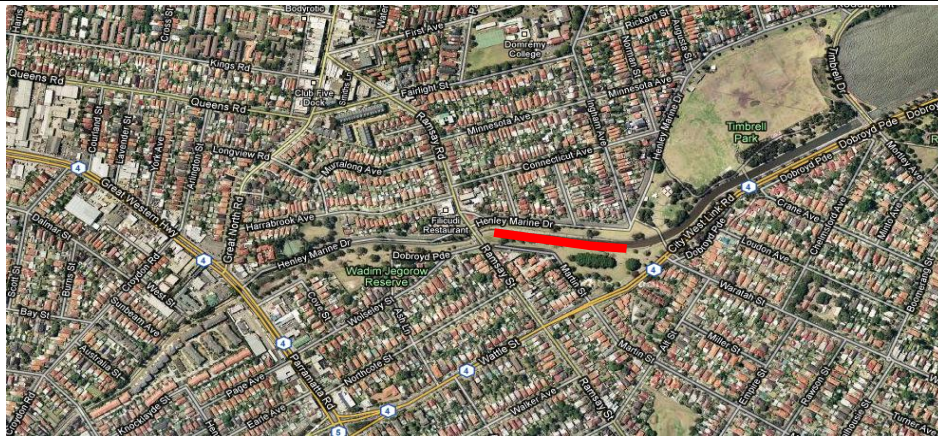
- DOB\_E03

The canal sides are cracking between the concrete panels. The concrete that forms both the sides and the bed is also weathered with aggregates visible.

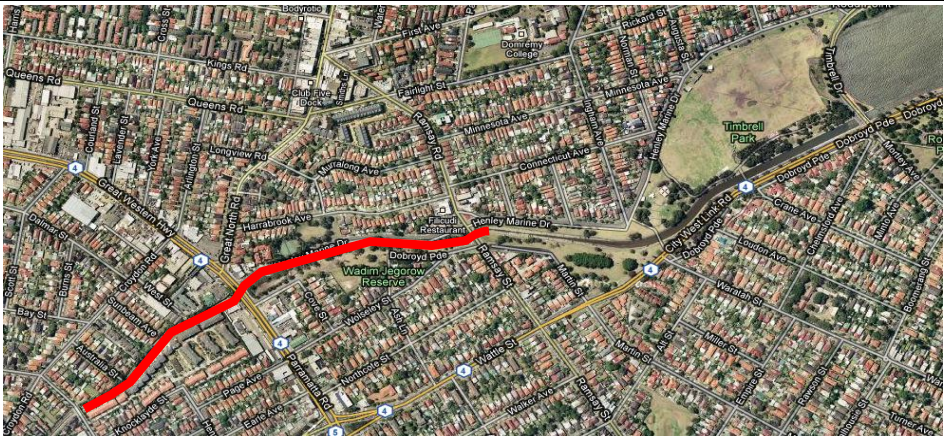
Canal Inspection Record - DOB\_E04

Condition Assessment:  
The canal wall is cracking between the concrete panels and also between the panels and the bed. The concrete that forms both the sides and the bed is also weathered with aggregates visible. The condition of the canal improves to the south east.

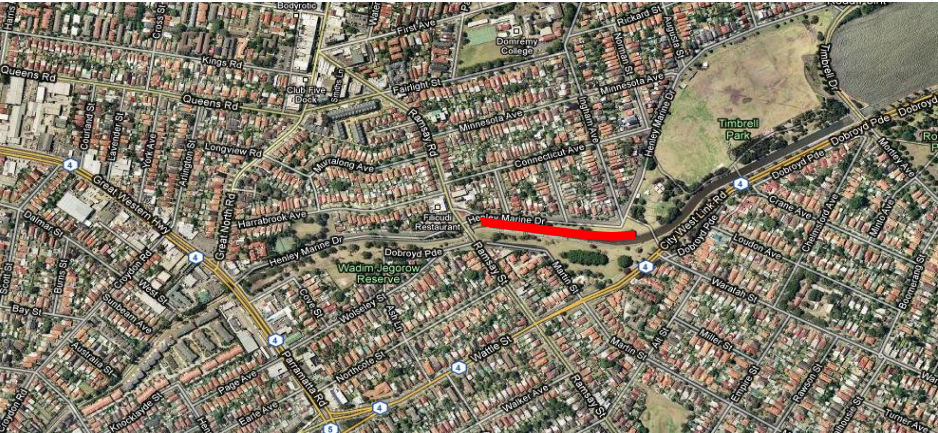
- DOB\_W03

The canal is cracking between the concrete panels. The concrete that forms both the sides and the bed is also weathered with aggregates visible.

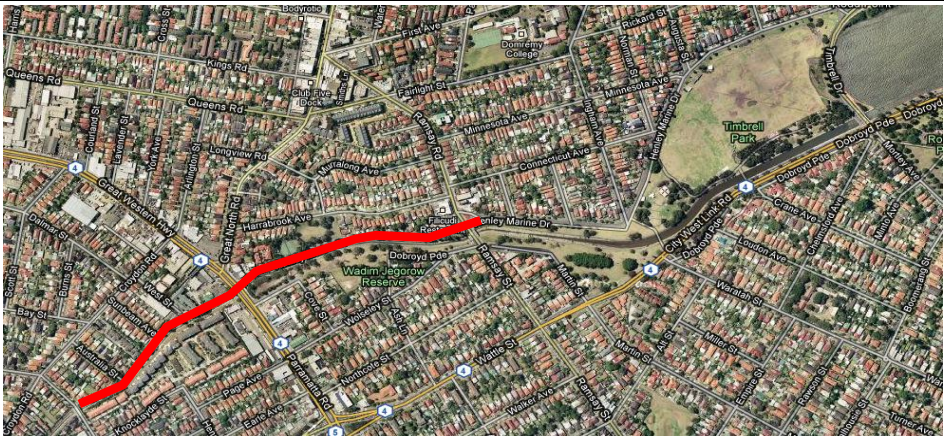
Canal Inspection Record - DOB\_W04

Condition Assessment:  
The canal wall is cracking between the concrete panels and also between the panels and the bed. The concrete that forms both the sides and the bed is also weathered with aggregates visible. Leachate is present from the wall.  
The condition of the canal improves to the south east.

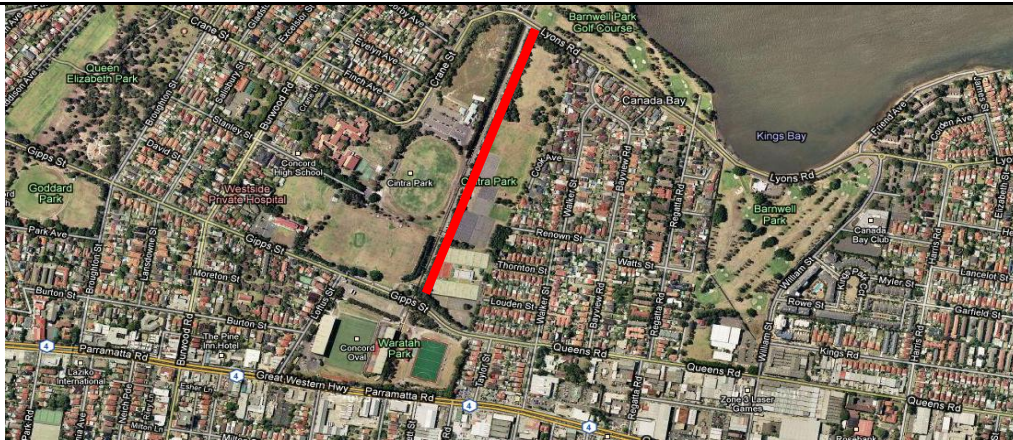
- BPW\_E02

Concrete panels are cracked and weathered. Many have collapsed backwards due to a loss of fines from behind the wall. The concrete bed has corroded with aggregates visible.

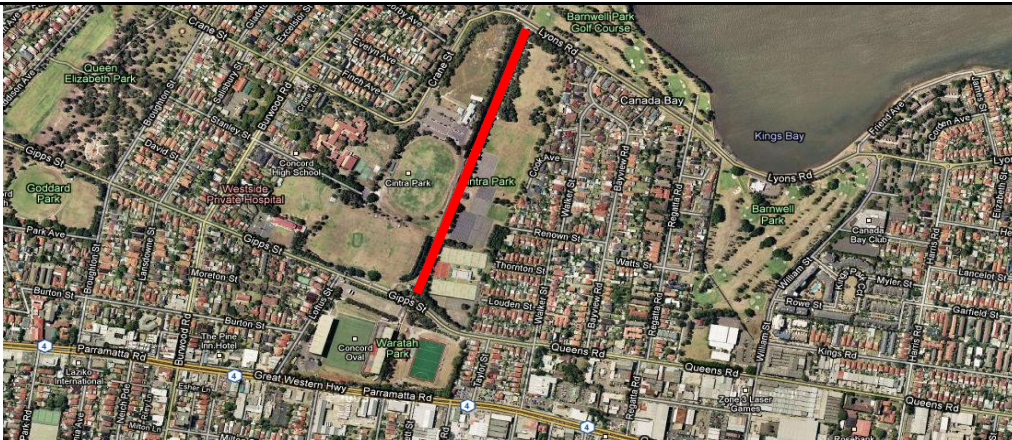
- BPW\_W02

Concrete panels are cracked and weathered. Many have collapsed backwards due to a loss of fines from behind the wall. The concrete bed has corroded with aggregates visible.

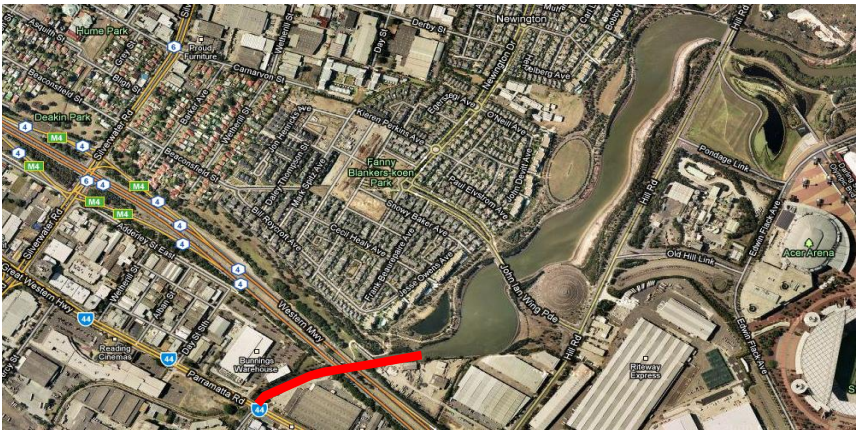
Canal Inspection Record - HAS\_E07

Condition Assessment:  
Minor cracking and weathering of concrete observed. Cracks are particularly evident between concrete panels.  
The wall is cracking beneath the eastern abutment of Parramatta Road.

Assets:  
The bank supports abutments for two road bridges and is cracking beneath one.

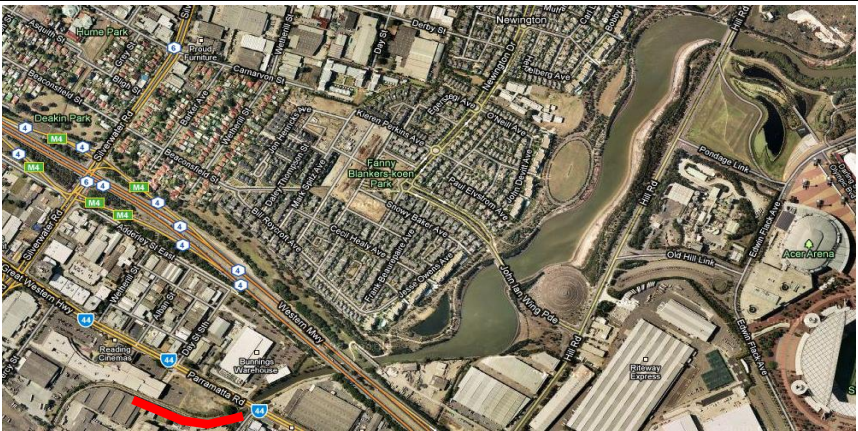
Canal Inspection Record - HAS\_E08

Condition Assessment:  
Minor cracking and weathering of concrete observed. Cracks are particularly evident between concrete panels.  
Condition worsens to the south.

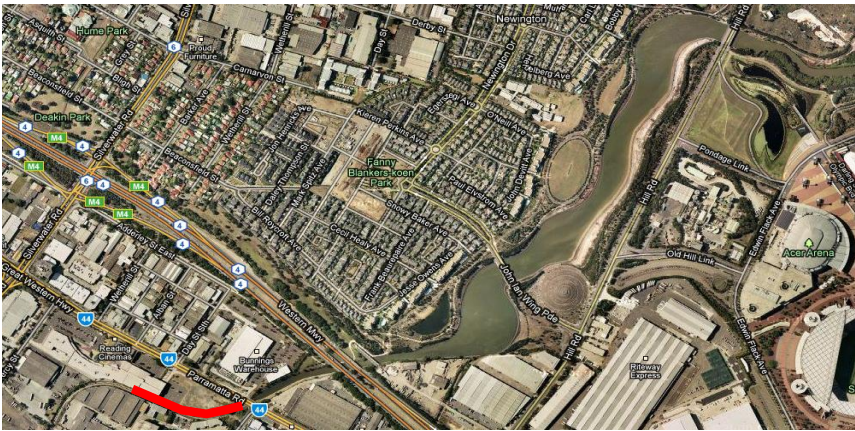
Minor cracking and weathering of concrete observed. Cracks are particularly evident between concrete panels.

Condition worsens to the south.
