Seawall Inspection Record - LEI_S08

Date	<u>4/08/09</u>	Locality	<u>Rozelle, Iron Cove Bay</u>	Level (AHD)	<u>0.82m</u>	LGA	<u>Leichhardt</u>
Time	<u>13:35</u>			Tide	<u>Low-Mid</u>

Seawall Inspection Record - LEI_S09

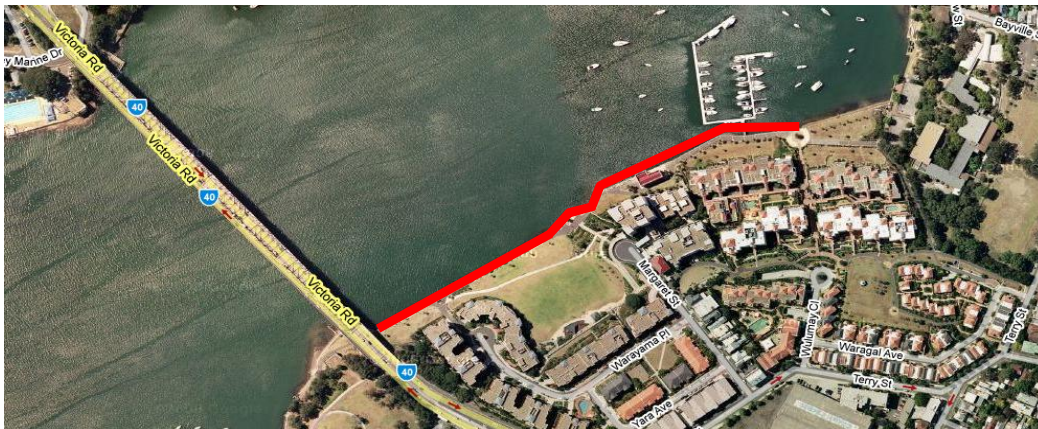
The seawall comprises a vertical grouted large sandstone block seawall, crest was 2m above WL at time of insp. Numerous sections along the wall have been capped with concrete along the crest and face. A number of sections have newly installed, grouted medium size sandstone blocks near the crest associated with developments along foreshore. Old sandstone blocks are present at the toe of the wall at discrete locations.

Exposed old sandstone blocks along bottom of wall are slumping. Concrete capping is showing signs of surface weathering and has in many places begun to crack and has fallen away from the old sandstone wall. Major undermining is present at discrete locations.

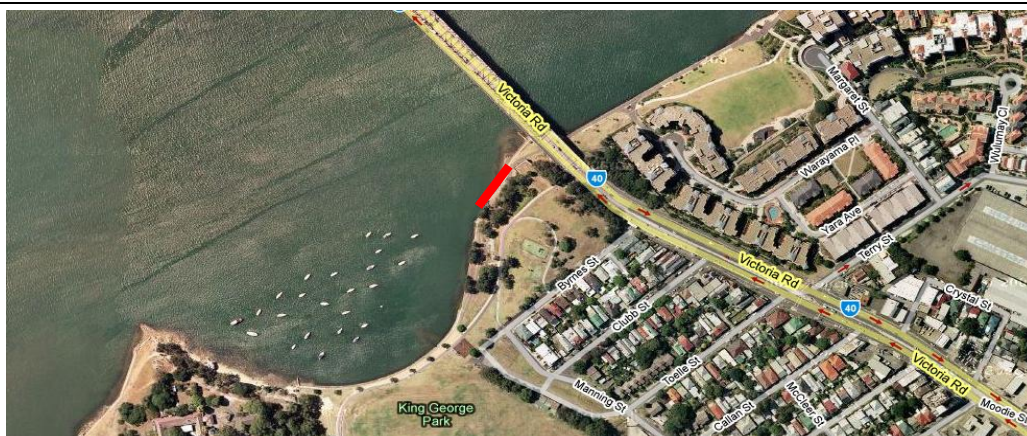
Concrete has been lost from the vertical face of the wall. The concrete is showing signs of severe surface weathering with aggregates visible. Major horizontal and vertical cracks are also present. The safety fence has significantly corroded and has collapsed in some places.

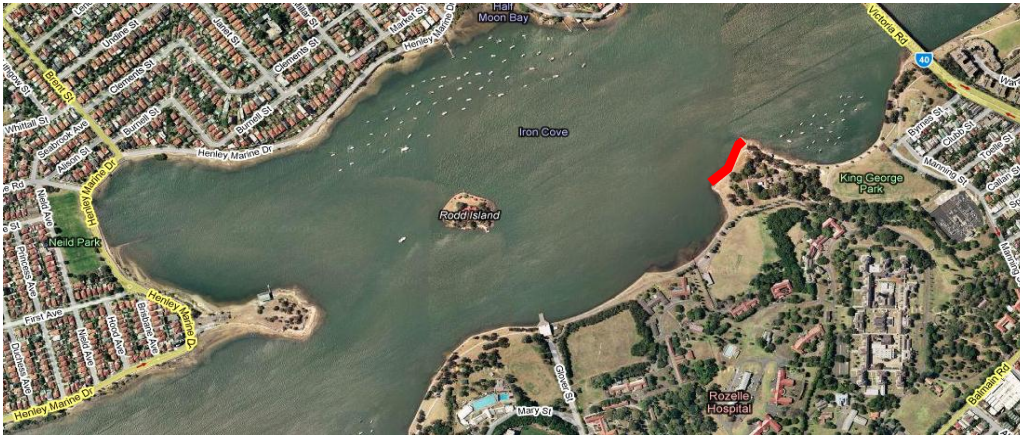
The structure has failed at its northern extent with a large cavity present behind the wall. The rest of the revetment is slumping and is undermined at the toe particularly at the southern extent.

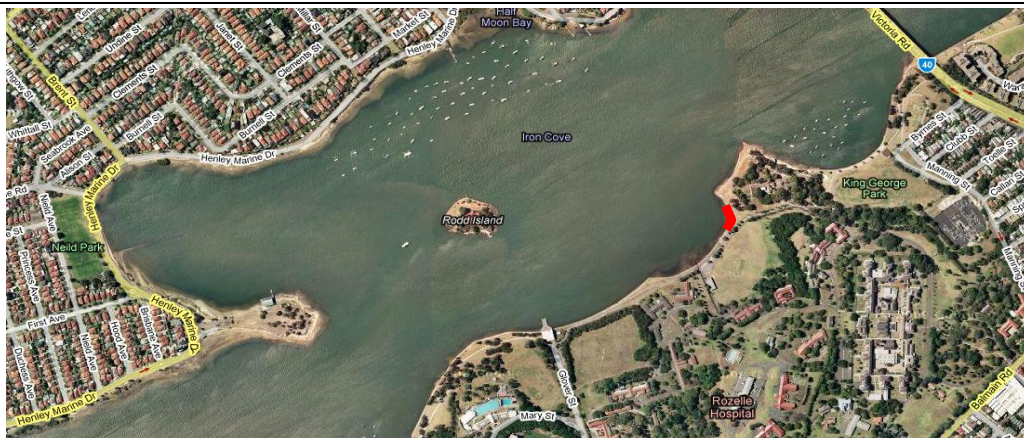
Surface weathering with aggregate exposed and slumping due to loss of fine material was observed. Sinkholes and erosion of earth behind structure was observed indicating inundation and/or exposure to wash during periods of elevated water levels.

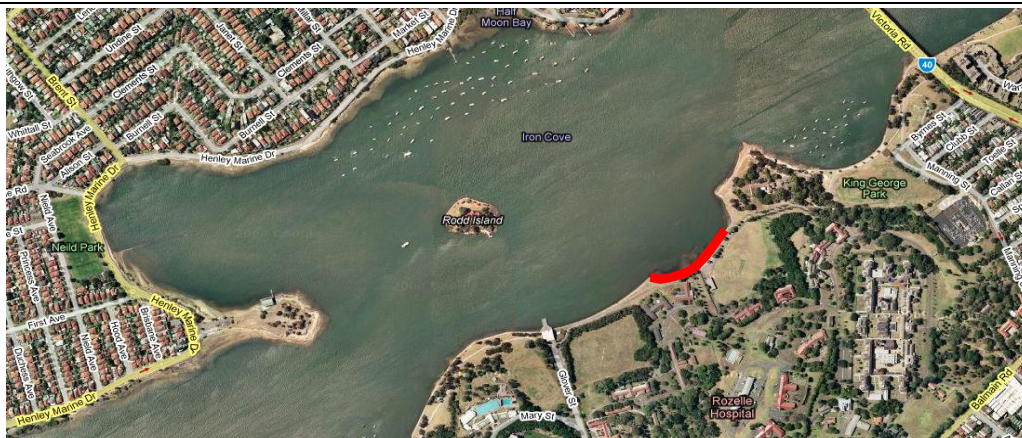
The revetment has failed at its southern extent where it joins LEI_S15 with a large cavity present behind the wall.
Surface weathering of sandstone blocks & slumping due to loss of fine material was also observed. Sinkholes & erosion of earth behind structure indicates inundation and/or exposure to wash during periods of elevated water levels.

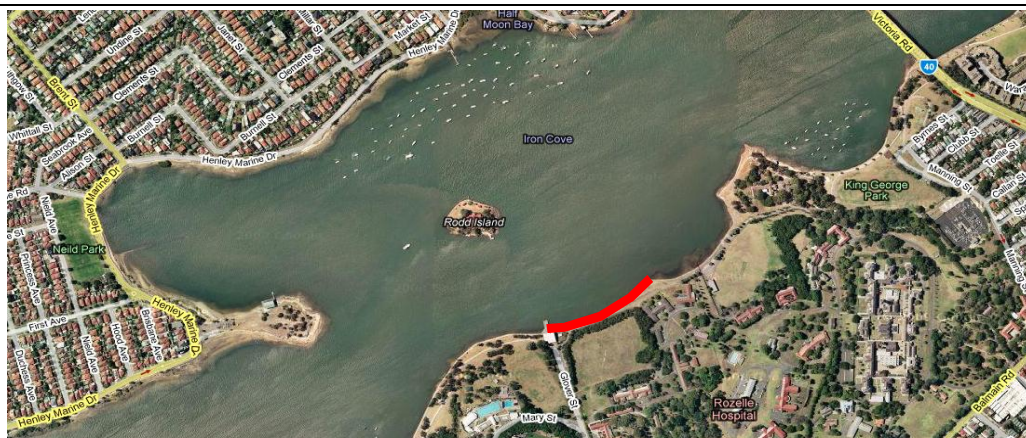
The structure has failed at its northern extent where it meets seawall LEI_S14. The rest of the structure, surface weathering of sandstone blocks & slumping due to loss of fine material was observed. The concrete retaining wall is leaning towards the water in some places with minor cracking observed.

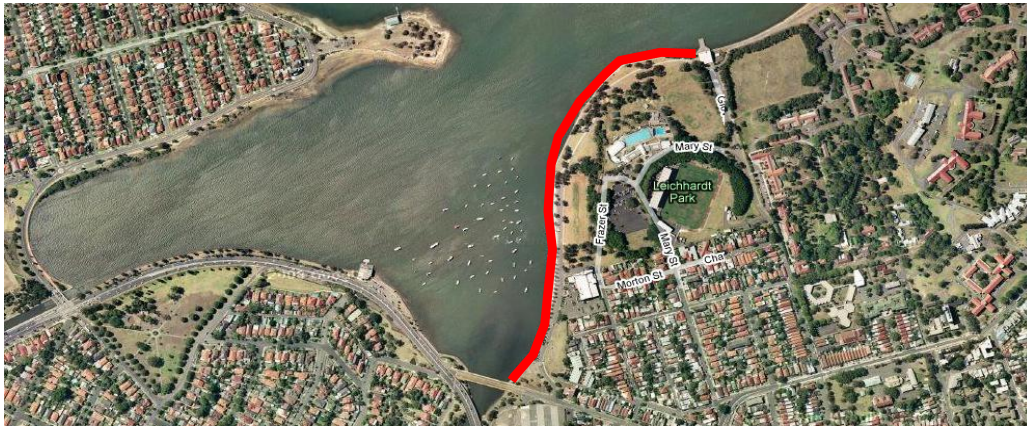
Loss of grout from both sloping and vertical sections. Block failures and sever undermining of adjacent footpath are also present. The newer vertical sandstone blocks have began to weather indicating that a low-grade sandstone may have been used. The old concrete footpath between the two sandstone section is cracking in many places.
