Seawall Inspection Record - ASH_S01

Date	<u>1/09/09</u>	Locality	<u>Adjacent City West Link</u>	Level	<u>0.87m</u>	LGA	<u>Ashfield</u>
Time	<u>9:20</u>			Tide	<u>Mid</u>

Seawall Inspection Record

- ASH_S02

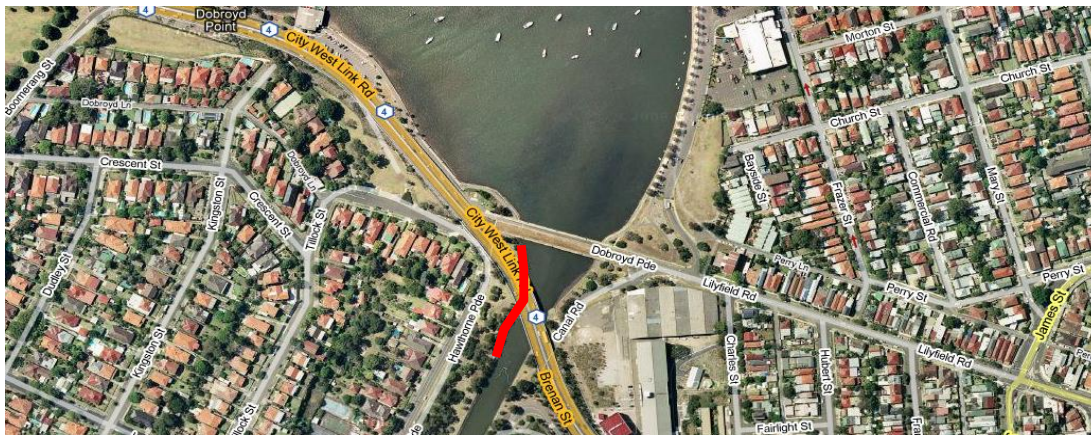
Shotcrete revetment possibly covering older sandstone blocks or rubble structure. A single layer of medium sized sandstone blocks runs long the crest. The revetment links Hawthorne Canal to the Ashfield foreshore.

Generally good condition. Shotcrete is showing signs of weathering. Minor weathering and loss of grout of new sandstone blocks at crest.

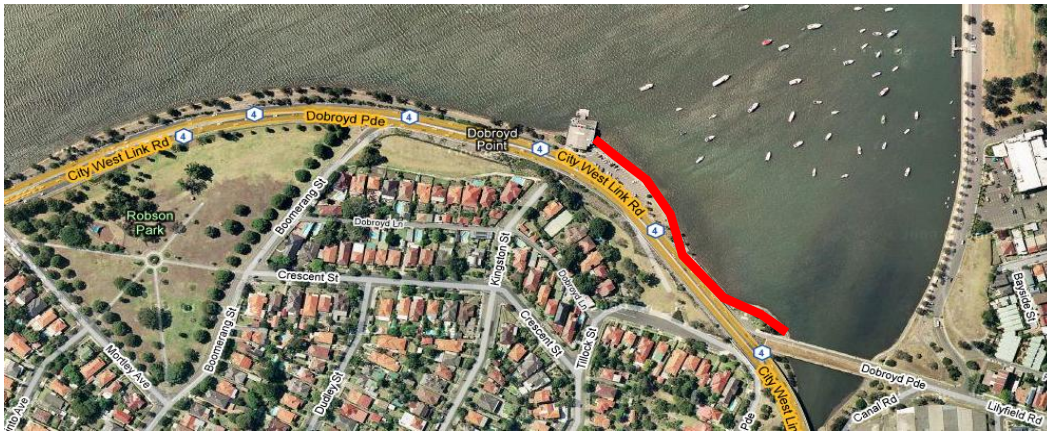
Medium sized sandstone block grouted revetment backed by newer vertical medium sized grouted wall. Two sections of the original seawall have been replaced with sea stairs, one concrete approx. 50m from the M4 and one sandstone adjacent to the UTS Rowing Club house.

Sandstone seawall is missing grout, slumping and showing signs of weathering on both the sloping and vertical sections. Both sets of sea stairs are in good condition.

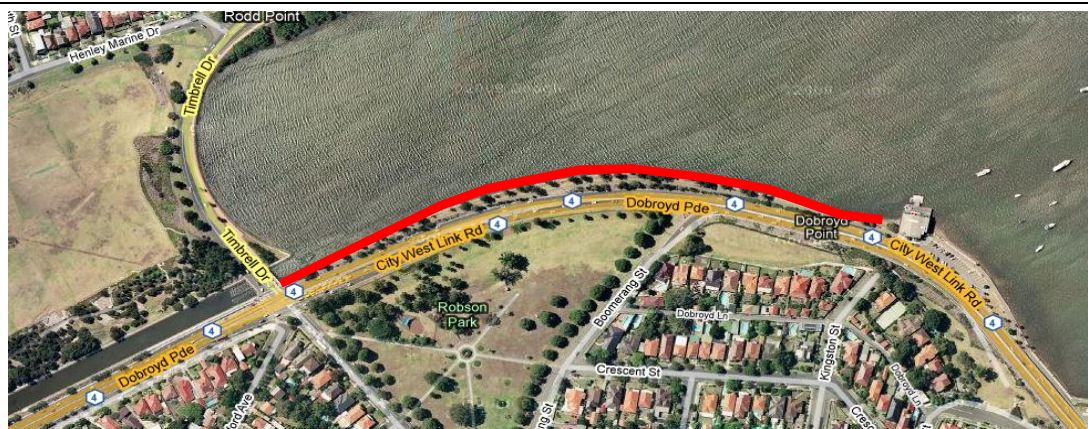
Medium size grouted sandstone block revetment backed by newer vertical medium sized grouted wall. Sandstone sea stairs and a number of stormwater outlets were also observed.

Sandstone seawall is missing grout, slumping and showing signs of weathering on both the sloping and vertical sections. Numerous local block failures were observed. Sea stairs are in good condition, cracking of the stormwater outlets was observed.
