Seawall Inspection Record - ASH_S01

| Date | <u>1/09/09</u> | Locality | <u>Adjacent City West Link</u> | Level | <u>0.87m</u> | LGA | <u>Ashfield</u> |

Seawall Inspection Record - ASH_S02

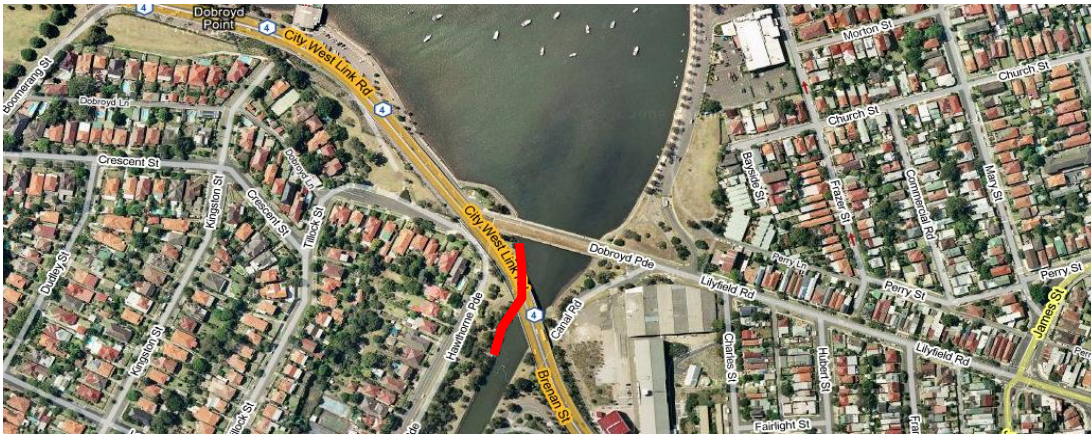
Seawall Details (Slope, Material, Const. Method, Type):
 Shotcrete revetment possibly covering older sandstone blocks or rubble structure. A single layer of medium sized sandstone blocks runs long the crest. The revetment links Hawthorne Canal to the Ashfield foreshore.

Condition Assessment (Slope, Crest, Toe, Backfill):
 Generally good condition. Shotcrete is showing signs of weathering. Minor weathering and loss of grout of new sandstone blocks at crest.
