Seawall Inspection Record - CAN_S60

Date	17/08/09	Locality	Mortlake Point, River South	Level	1.13m	LGA	
Time	13:17			People	Mid	Canada Bay

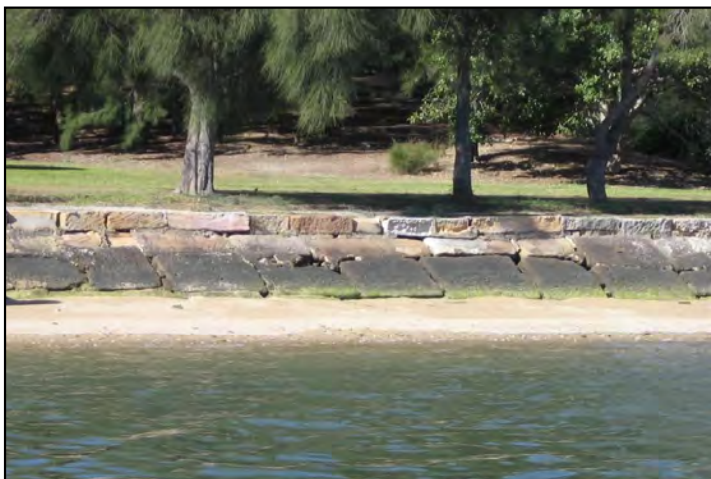
Photo 1
Typical section of wall showing loss of grout and weathering of blocks.

Condition Assessment (Slope, Crest, Toe, Backfill):	Excellent	<input type="checkbox"/>
The blocks that make up the slope are weathered with grout missing leaving voids indicating a loss of material from behind the structure. The vertical blocks at the crest are also weathered and missing grout material, some blocks have collapsed.	Good	<input type="checkbox"/>
	Poor	<input checked="" type="checkbox"/>
	Failed	<input type="checkbox"/>

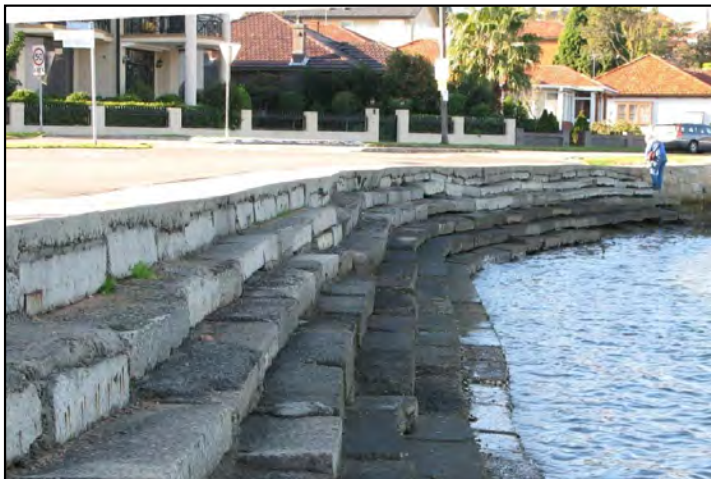
Photo 2

The structure is slumping along its entirety with undermining of the toe, severe weathering of the concrete blocks with aggregate and reinforcement visible and loss of grout observed. The public footpath is cracked in places.

Undermining of the toe and surface weathering of the concrete blocks.

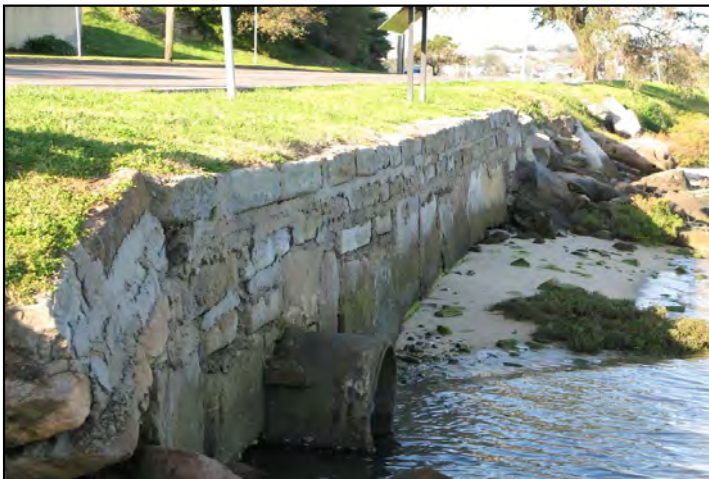
Photo 2

The western extent of the wall has failed with a large void left behind the structure. The rest of the structure is showing signs of weathering and has been undermined at the toe.

Undermining of structure at toe.

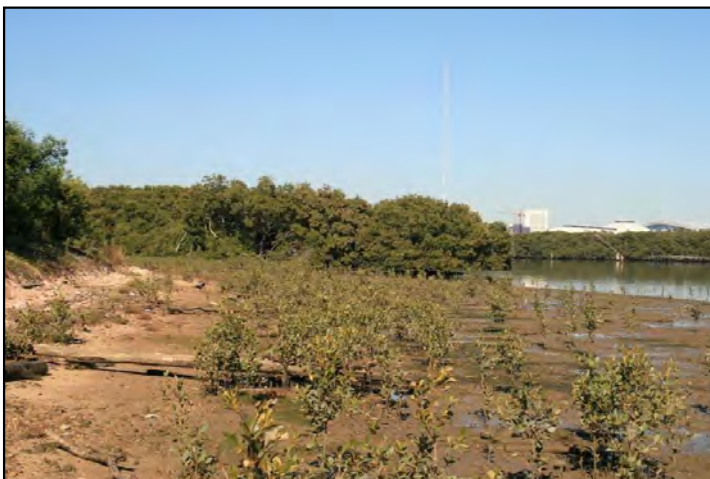
Photo 1

View of foreshore with mangrove saplings shown.

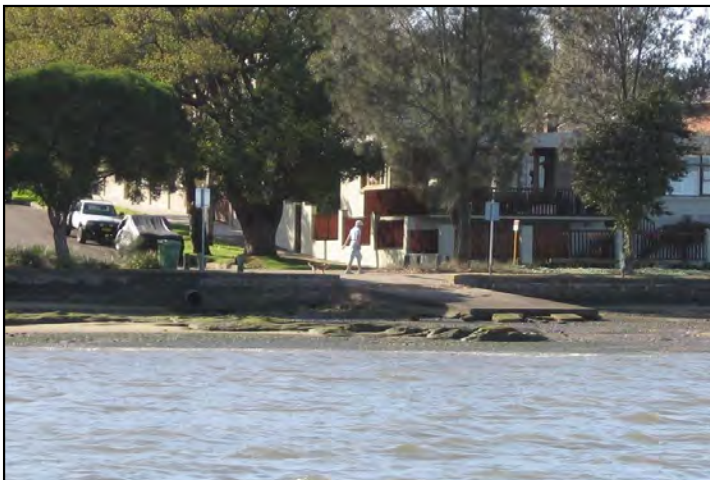
Photo 2
Sandstone blocks placed at end of boat ramp for low tide access.
