Seawall Inspection Record - SOPA_S01

Date	<u>10/09/09</u>	Locality	<u>Shipwreck Viewing Platform, Homebush Bay</u>	Level	<u>1.28m</u>	LGA	<u>Auburn</u>
Time	<u>13:45</u>			Tide	<u>Mid-High</u>

Seawall Inspection Record

- SOPA_S02

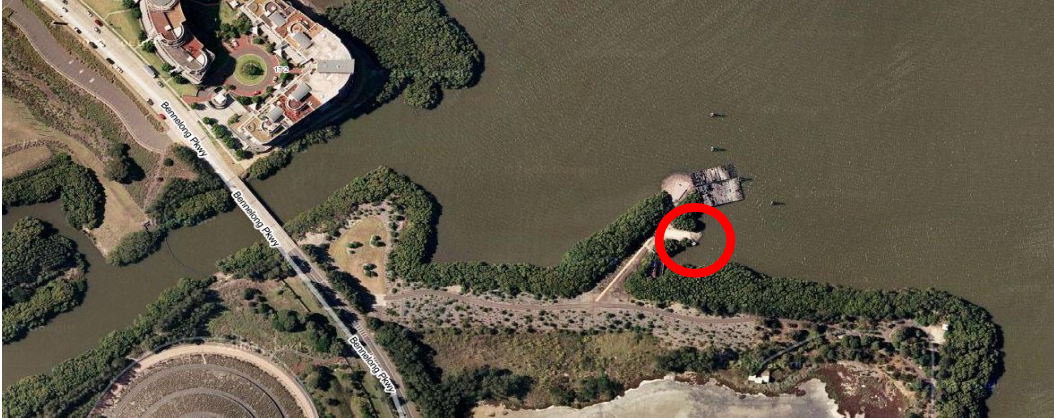
Seawall Details (Slope, Material, Const. Method, Type):
Concrete block revetment around public lookout structure within Homebush Bay.

Condition Assessment (Slope, Crest, Toe, Backfill):
Blocks that form the revetment have collapsed due to a loss of fine sediments.

Excellent	<input type="checkbox"/>
Good	<input type="checkbox"/>
Poor	<input type="checkbox"/>
Failed	<input checked="" type="checkbox"/>

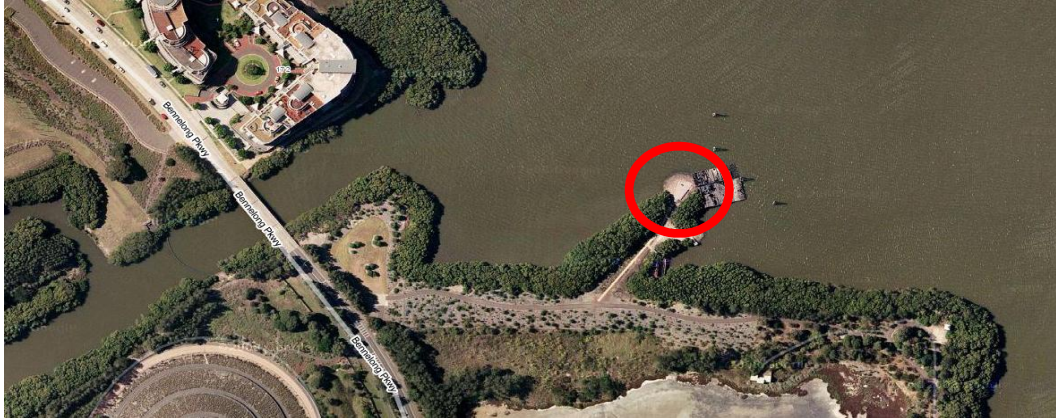
Seawall Details (Slope, Material, Const. Method, Type):
Rubble and building waste ad-hoc revetment around public lookout structure within Homebush Bay. A new concrete slab is present on the crest and forms a viewing platform.

Condition Assessment (Slope, Crest, Toe, Backfill):
Blocks that form the revetment have collapsed and soil beneath is exposed. The concrete slab has been undermined.

Excellent	<input type="checkbox"/>
Good	<input type="checkbox"/>
Poor	<input type="checkbox"/>
Failed	<input checked="" type="checkbox"/>

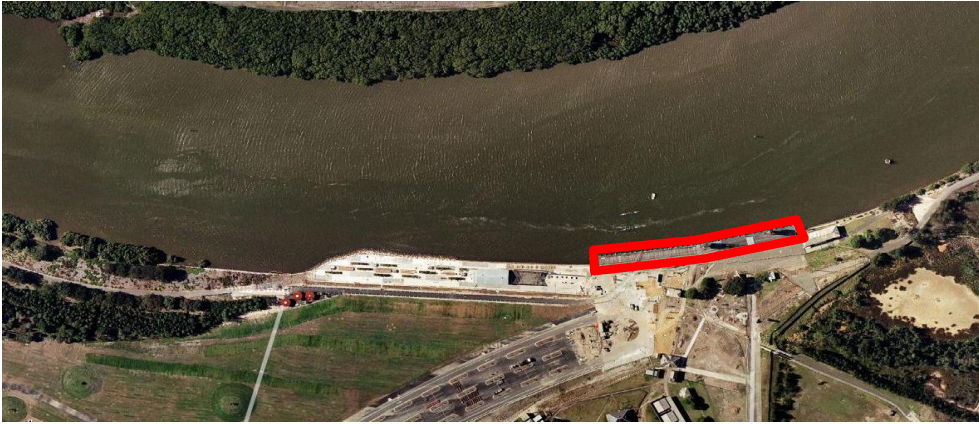
Condition Assessment:
 Timber piles, decking and beams are showing signs of deterioration. The concrete slabs and steel piles that support the crane are corroding.

Excellent	<input type="checkbox"/>
Good	<input checked="" type="checkbox"/>
Poor	<input type="checkbox"/>
Failed	<input type="checkbox"/>
