Seawall Inspection Record

- SOPA_S01

Date	<u>10/09/09</u>	Locality	<u>Shipwreck Viewing Platform, Homebush Bay</u>	Level	<u>1.28m</u>	LGA	<u>Auburn</u>
Time	<u>13:45</u>			Tide	<u>Mid-High</u>

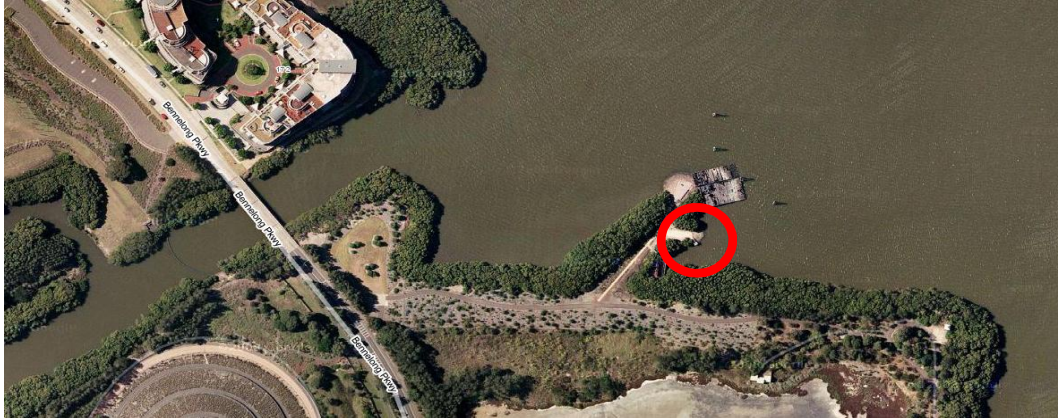
Concrete block revetment around public lookout structure within Homebush Bay.

Blocks that form the revetment have collapsed due to a loss of fine sediments.

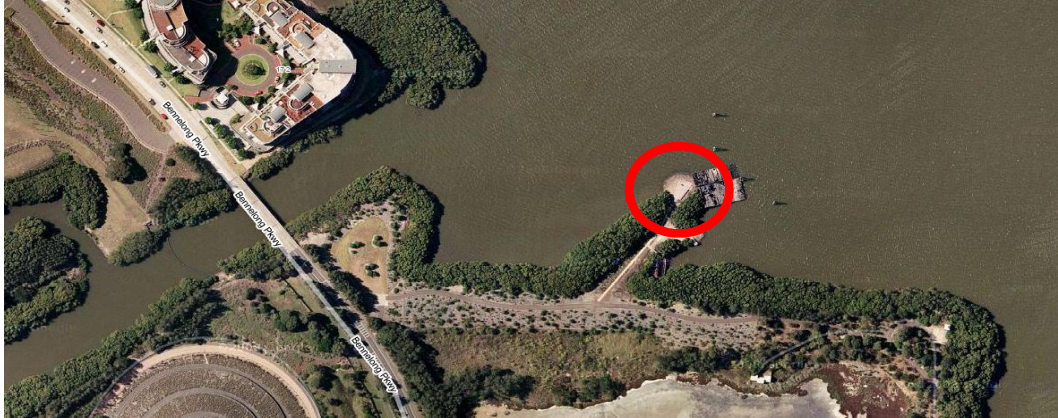
- SOPA_S02

Rubble and building waste ad-hoc revetment around public lookout structure within Homebush Bay. A new concrete slab is present on the crest and forms a viewing platform.

Blocks that form the revetment have collapsed and soil beneath is exposed. The concrete slab has been undermined.

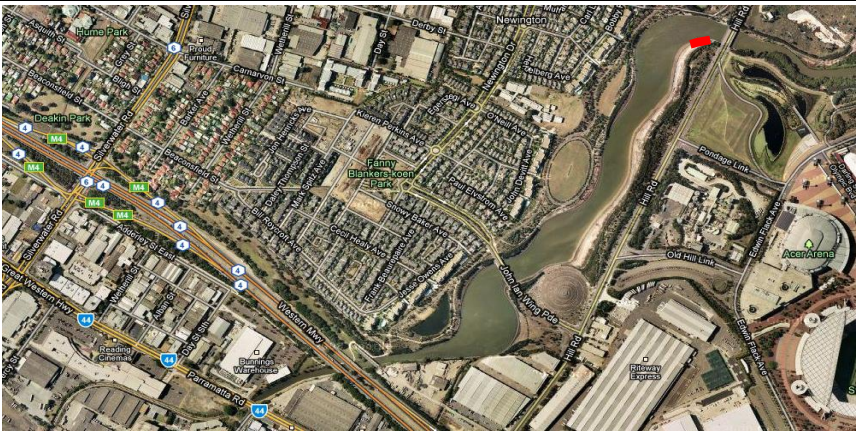
- HAS_E02

Gabion matt revetment with a gabion basket crest. The matt appears to have been placed to prevent erosion of the slope and undermining of the gabion crest. No public access is available.

Where the gabion matt is not present, the slope is eroding and the gabion basket crest has been undermined.

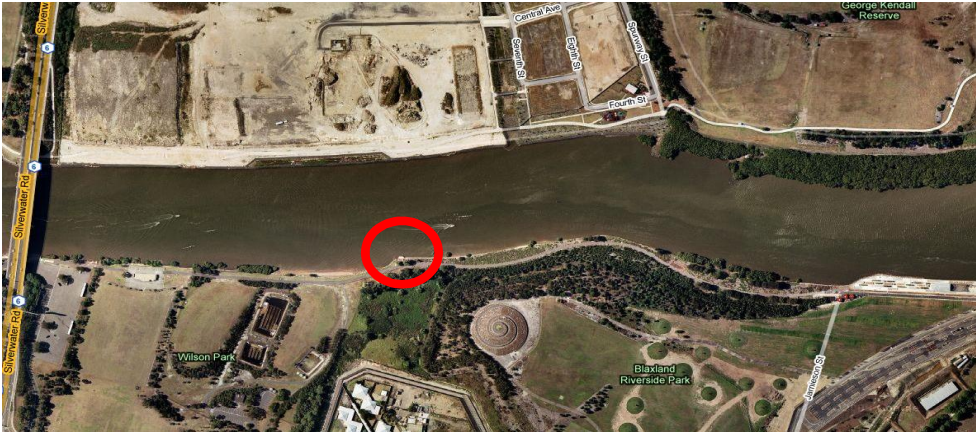
- SOPA_F04

Concrete landing that appears to be an abutment for an older wharf structure that is no longer present. A low steel rails has been installed around the structure edge. A public footpath/cycleway is located adjacent to the structure.

Surface weathering and cracking was observed.

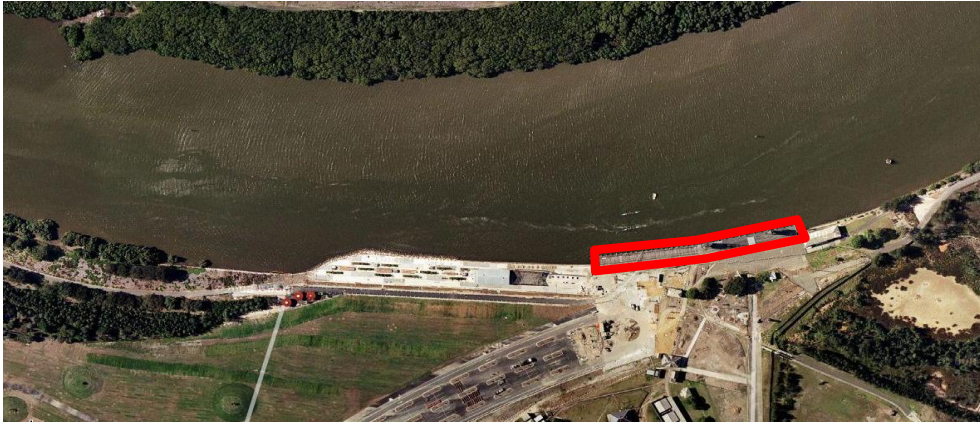
- SOPA_F02

Timber piles, decking and beams are showing signs of deterioration. The concrete slabs and steel piles that support the crane are corroding.
