Seawall Inspection Record - AUB_S02

Date 18/08/09 Locality Homebush Bay Level 0.39m LGA Auburn
 Time 11:27 Tide Low

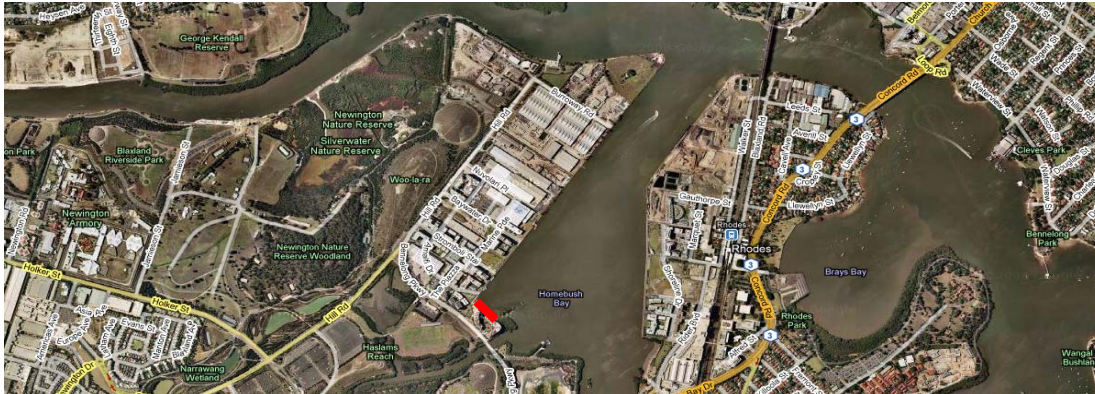
Variable sized rubble and building waste revetment with a new concrete footpath on the crest. A new residential development is located on the land beyond the structure. A public footbridge is located on the structure crest.

Material has been lost from slope exposing soil/fill beneath. It appears a support of the footbridge has been undermined.

Footbridge and public footpath is supported by revetment which is in poor condition.

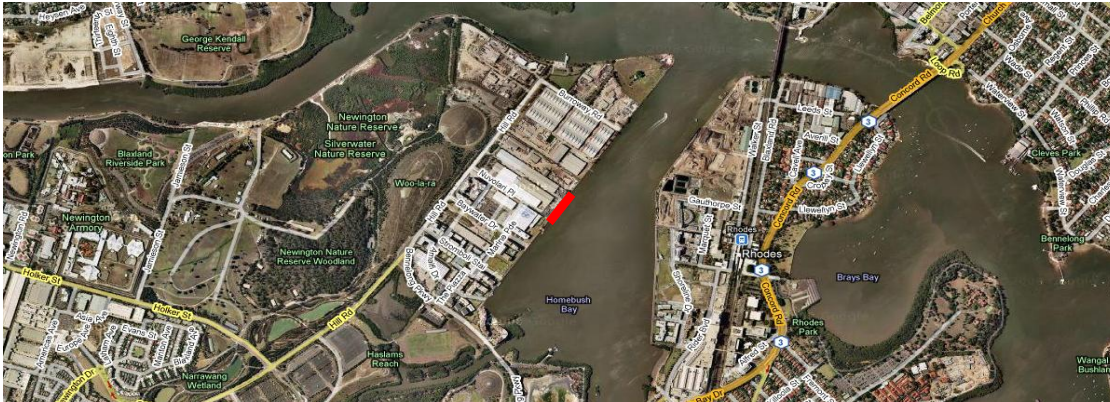
Ad-hoc rubble revetment with a soil/fill embankment forming the crest. Private industrial land is located beyond the structure crest. A steel fence is present along the structure crest.

The rubble that forms the revetment has become dislodged and is strewn across the toe. There is also a large erosion scarp behind the structure indicating inundation during periods of elevated water levels.

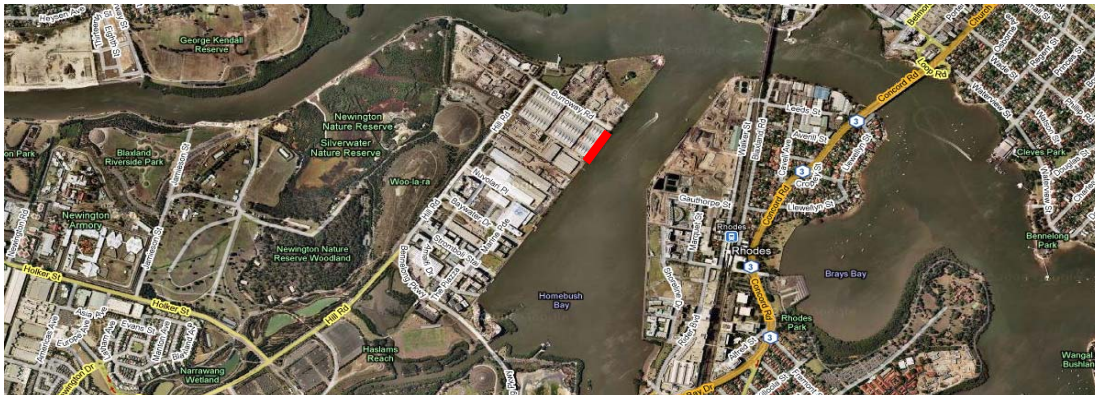
The concrete capping has cracked and failed along the lower section of the wall. The older blocks that forms the revetment are slumping.

Cracked and failed concrete capping with older sandstone block revetment visible.

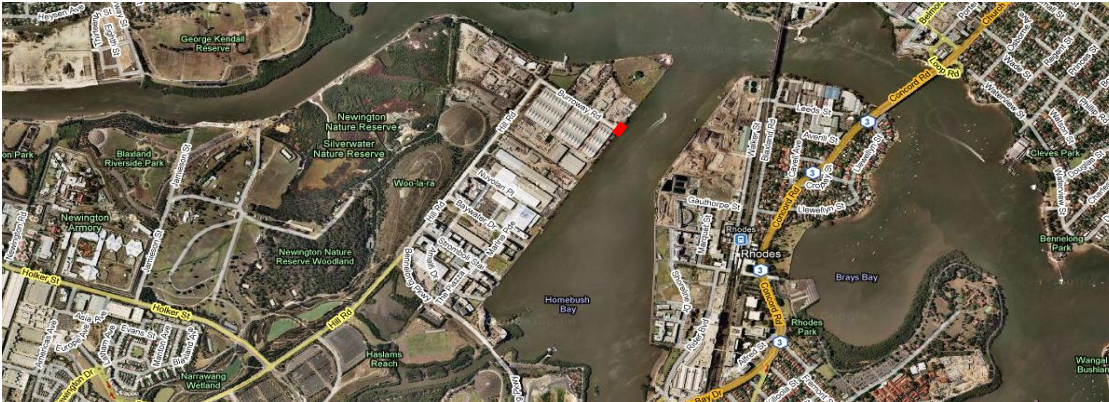
The sloping concrete crest has cracked and failed in places with large voids observed. The blocks that form the toe of the structure are slumping.

Public access is available and the structure forms the end of Burroway Road. If the structure is allowed to continue to deteriorate OH&S and asset issues may arise.

Cracked and failed concrete crest with voids present and slumping of concrete blocks.

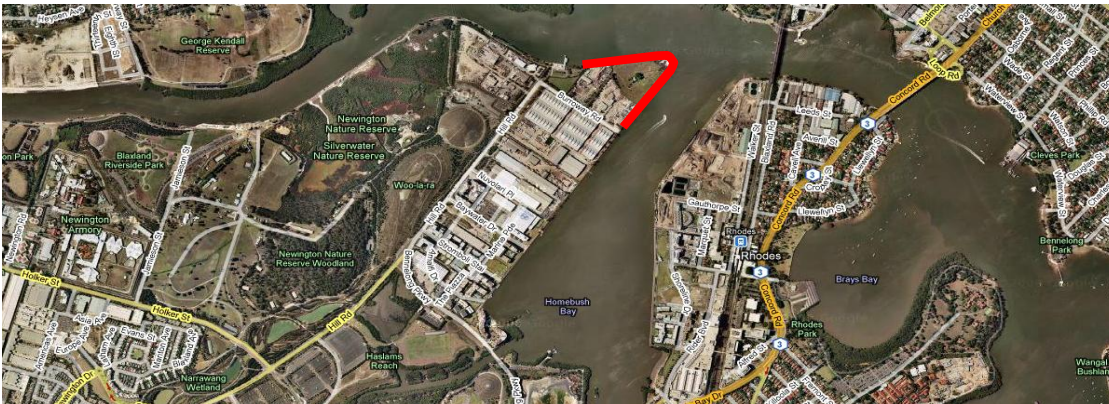
The revetment has failed with material lost from the crest and strewn across the muddy flat in front. A large erosion scarp is present at the crest which increases on the Parramatta River side where it is exposed to ferry wash.

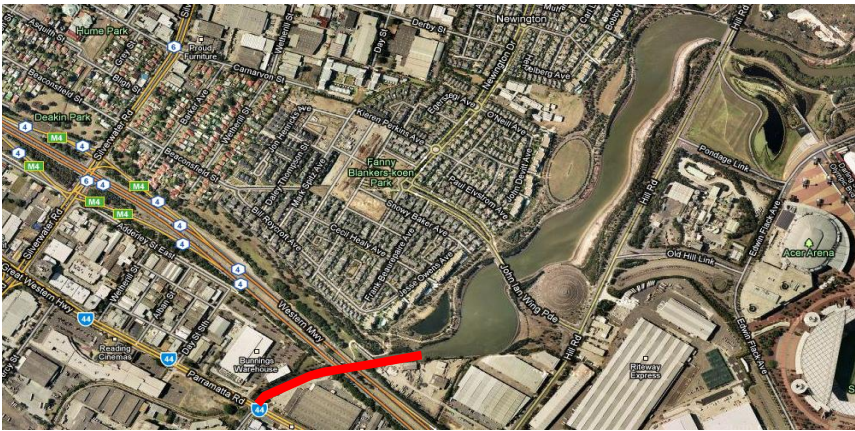
Minor cracking and weathering of concrete observed. Cracks are particularly evident between concrete panels.

The wall is cracking beneath the eastern abutment of Parramatta Road.

The bank supports abutments for two road bridges and is cracking beneath one.

Cracking between concrete panels.

Cracks beneath eastern abutment of Parramatta Road.

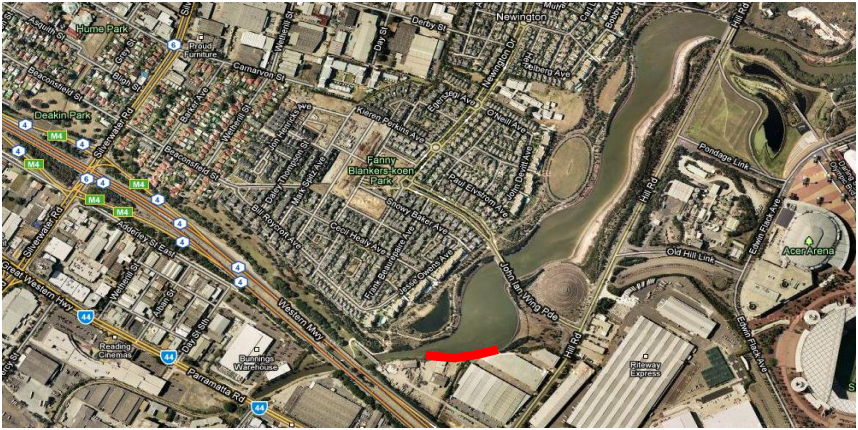
Condition Assessment:	Excellent
Minor cracking and weathering of concrete observed. Cracks are particularly evident between concrete panels.	Good
	Poor
	Failed

Photo 2
Cracks between concrete panels that form canal bank.

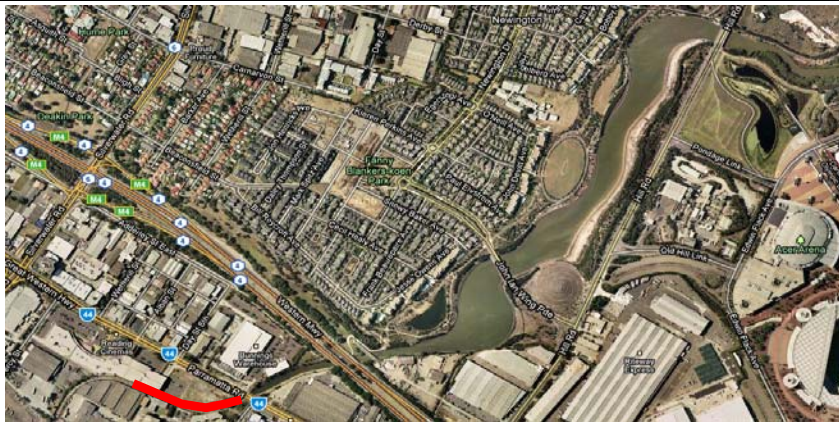
Minor cracking and weathering of concrete observed. Cracks are particularly evident between concrete panels.
Condition worsens to the south.

Minor cracking and weathering of vertical concrete wall.

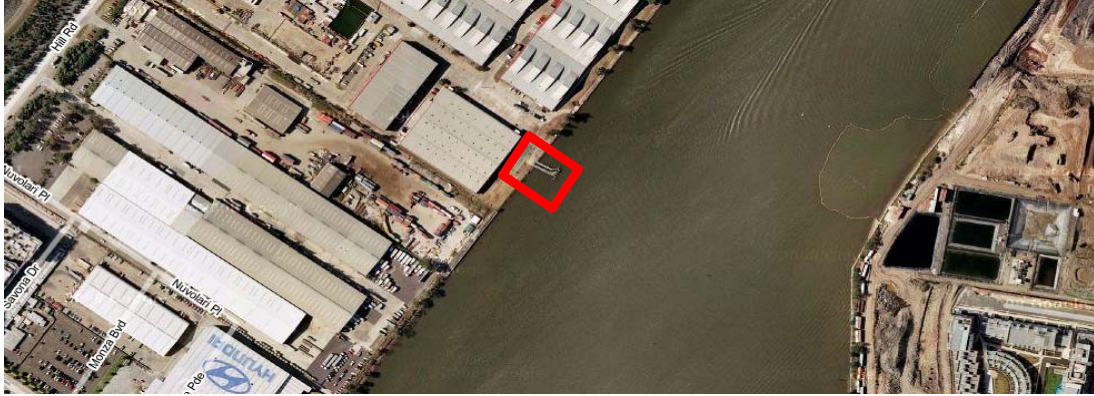
A number of the timber piles have failed at the water line. All other components are showing signs of deterioration.

The piles have failed and the structure may collapse if no action is taken.

Failed timber piles.

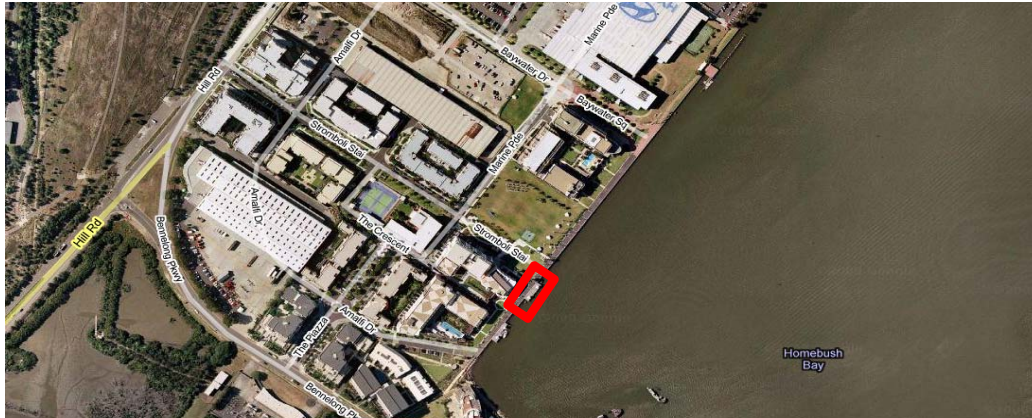
Timber landing supported by timber piles and the adjacent seawall, AUB_S05. A low timber rail is present around the perimeter of the structure. The southern most pile has been replaced recently. Large umbrellas for shade have been installed on the structure.

Apart from the new pile at the southern end of the structure, all timber piles have failed at the water line. Other timber components are showing signs of deterioration.

The piles have failed and the structure may collapse if no action is taken. Umbrellas and adjacent residential development mean structure is well utilised by the public. The structure edge is well defined by timber rail.

Failure of timber piles at the water line.

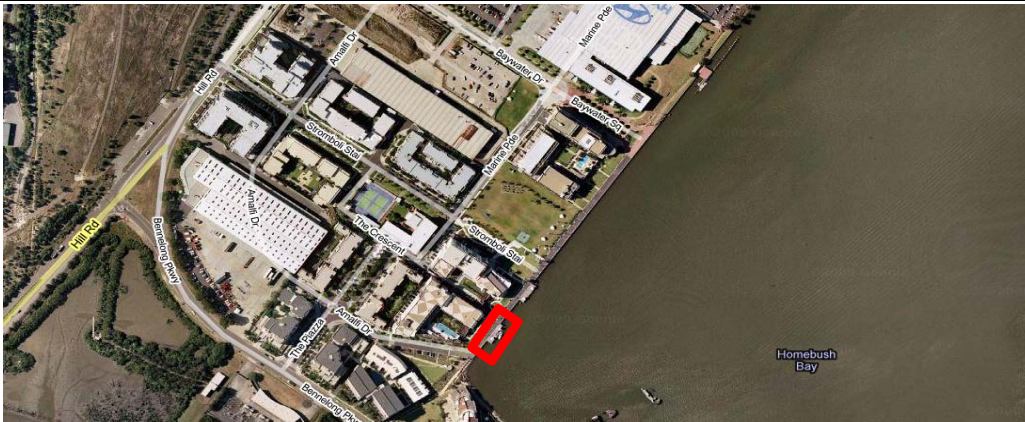
Timber piles are severely deteriorated at the water line. Other timber components are showing signs of deterioration. A number of timber stairs have been replaced.

The piles are in poor condition and may fail if not replaced. Access to structure from the water is difficult at low tide. Umbrellas and adjacent residential development mean structure is well utilised by the public. The structure edge is well defined by timber rail.

Severe deterioration of timber piles at the water line.

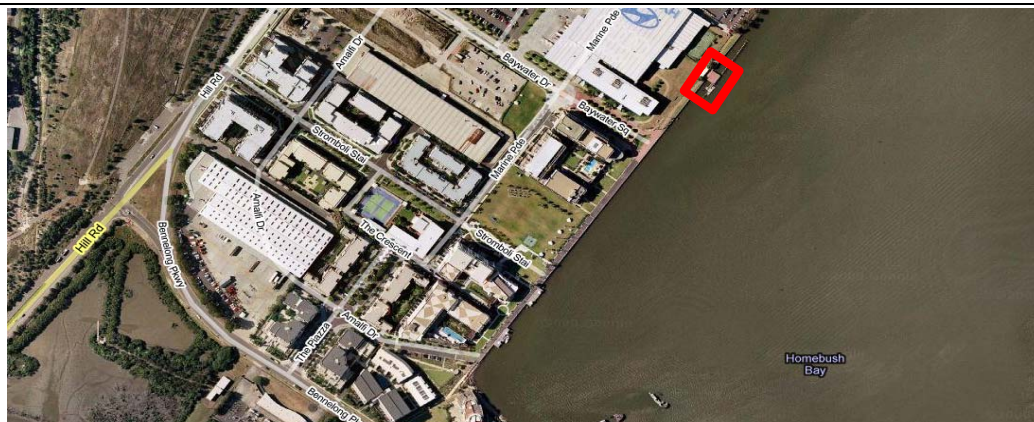
Timber piles and other components are showing signs of deterioration.

Although not as urgent as the two other facilities at this location (AUB_F03 & AUB_F04), the piles are in poor condition and may fail if not replaced. Umbrellas and adjacent residential development mean structure is well utilised by the public. The structure edge is not defined.
