Seawall Inspection Record - HUN_S01

Date	<u>5/08/09</u>	Locality	<u>Clarkes Point, River North</u>	Level	<u>0.80m</u>	LGA	<u>Hunters Hill</u>
Time	<u>14:35</u>			Tide	<u>Low-Mid</u>

Seawall Inspection Record - HUN_S02

Facility Inspection Record

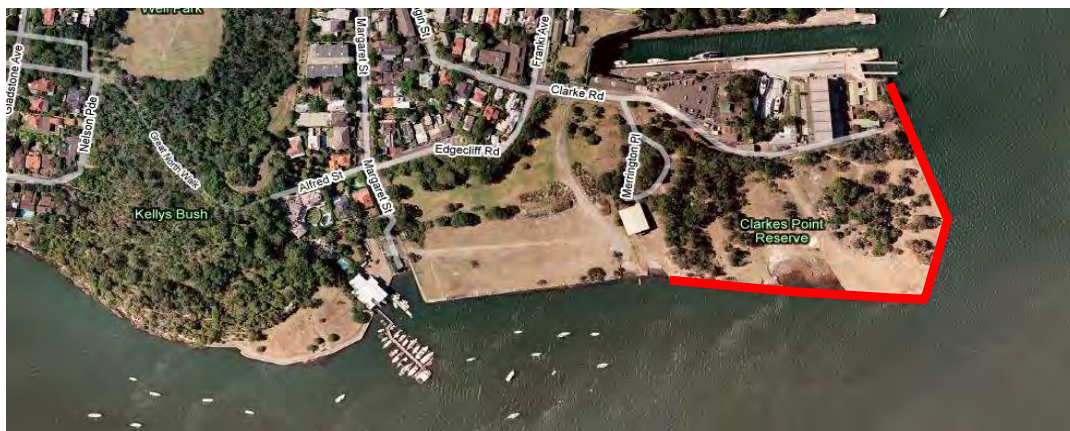
Numerous block failures of the crest were observed with blocks fallen into water below. Surface weathering of the sandstone blocks and sinkholes behind structure crest were also observed.

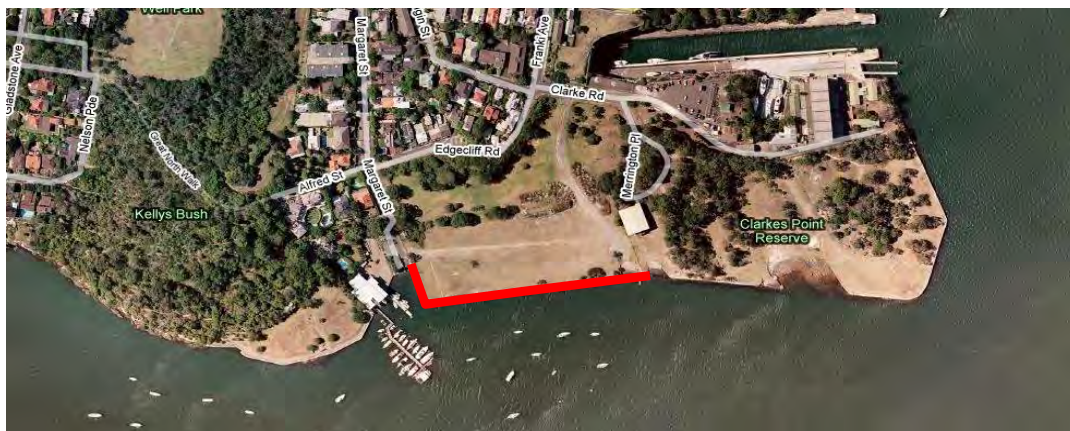
Numerous block failures of the crest were observed with blocks fallen into water below.
Surface weathering of the sandstone blocks and sinkholes behind structure crest were also observed. Western section is in better condition.

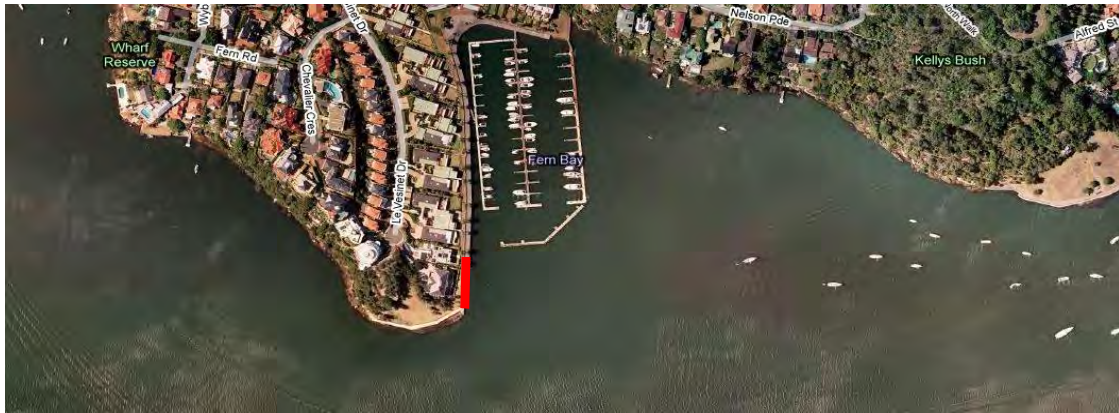
Grout is missing from the lower blocks with extensive slumping and cavities observed. A number of localised block failures at the seawall toe were also observed. The newer, top layer is in good condition with grouting present.

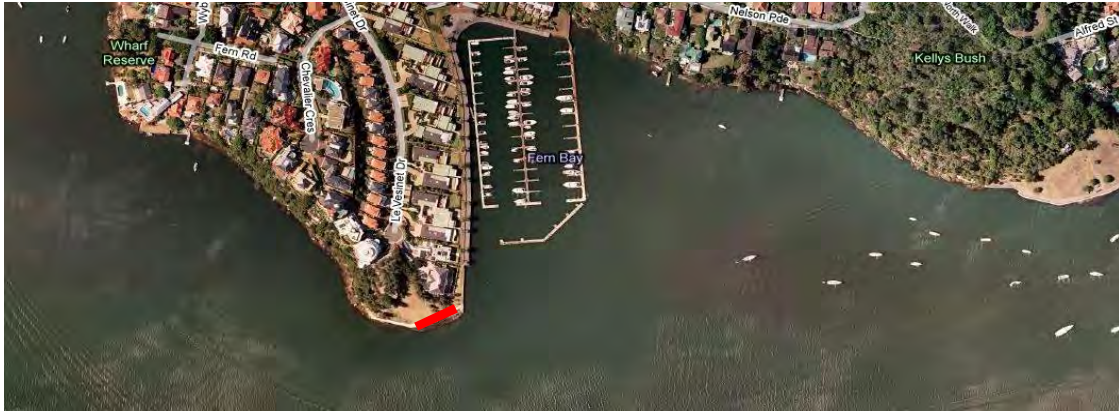
A number of gabion units that make up the toe have failed and have lost fill material. The vertical face component of the structure is in good condition. If the toe continues to deteriorate, the structural integrity of the entire gabion wall may be threatened.

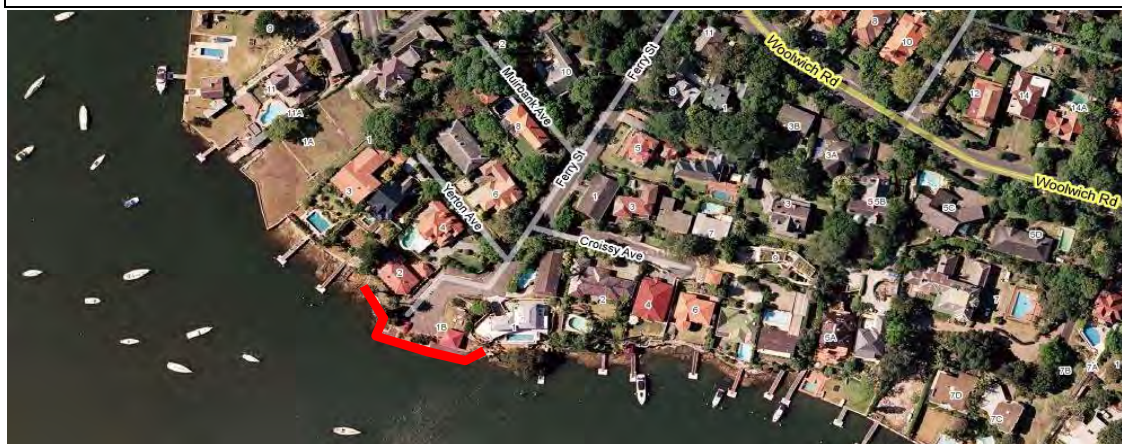
Sandstone blocks are missing grout and are showing severe signs of surface weathering and slumping. Localised block failures were also observed. Surface weathering and cracking of the concrete section of the structure was observed. The sea stairs have lost grout material and are severely weathered.

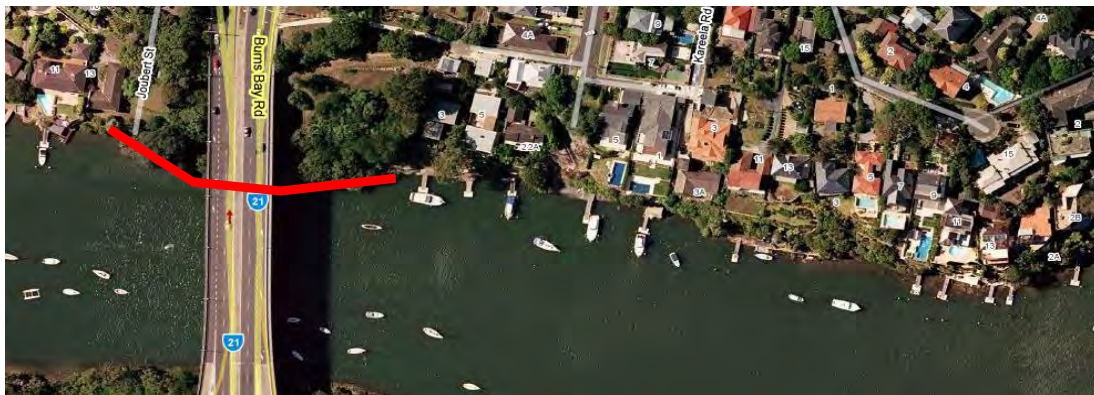
Older sections of the seawall are missing grout and are showing signs of weathering and slumping. Localised block failures were also noted. The new section of wall is in very good condition.

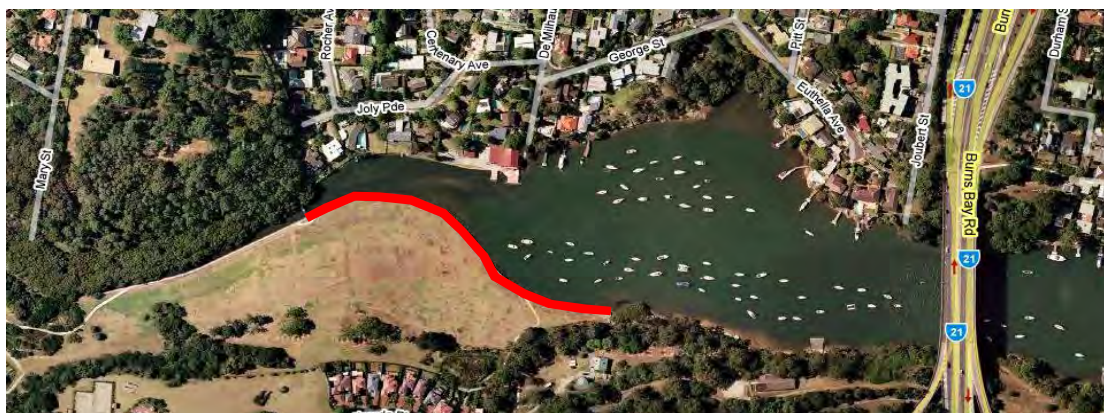
Majority of grout material has been lost from the structure leading to loss of fines from behind and slumping of both the vertical face of the wall and the concrete footpath beyond. Significant weathering of the sandstone blocks was also observed.

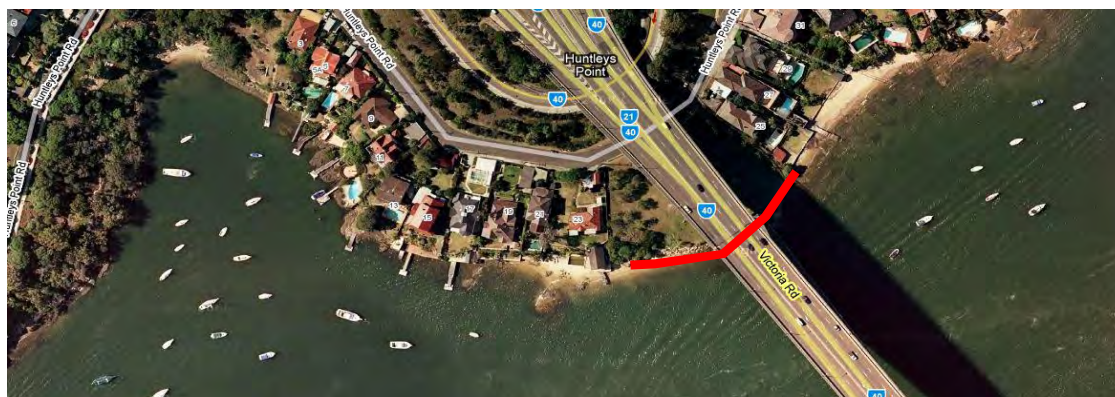
The sandstone block revetment and gabion baskets on the eastern side of the bridge are in a good condition. The sandstone boulder revetment on western side has failed with material from original structure strewn on the sandy beach in front.

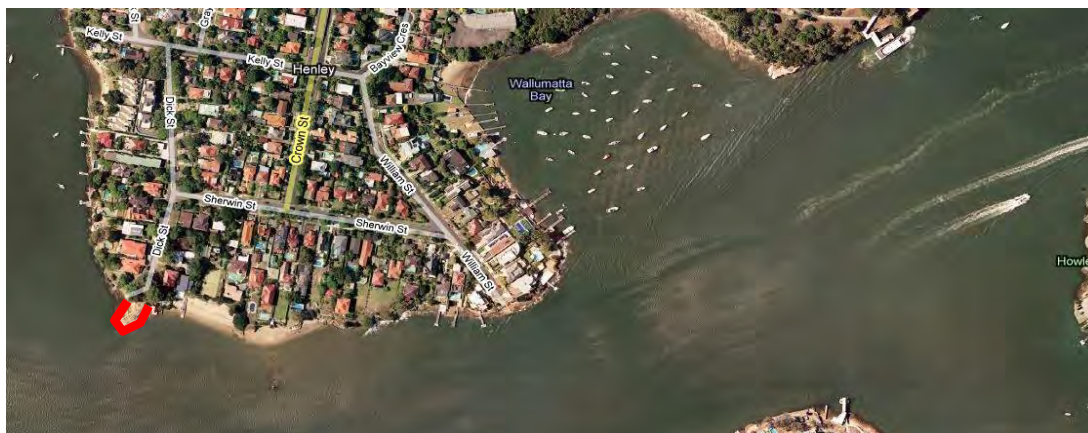
Vertical sandstone block wall that forms front face of structure is missing grout material, a number of block failures were also observed. The revetments on each side of the structure are slumping due to a loss of fine material from behind. Large sinkholes and cracking of concrete capping at crest further confirm the loss of fine material.
