Seawall Inspection Record - RYD_S23

Date	<u>19/08/09</u>	Locality	<u>Meadowbank, River North</u>	Level	<u>0.30m</u>	LGA	<u>Ryde</u>
Time	<u>12:33</u>			Tide	<u>Low</u>

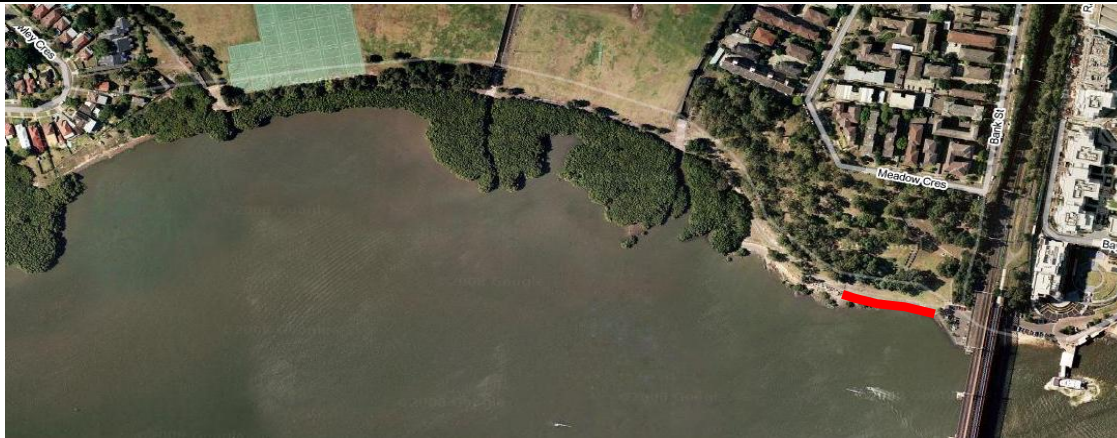
variable size sandstone block seawall with concrete slab along crest along entire structure and face at western end. Structure is founded on
bedrock and there is rubble material along the toe. Mangroves are present in front of the structure at western end. A public footpath and
cycleway runs along the length of the structure 1-2m from the crest. Structure also supports new solar powered light poles.

Grout not present, voids and localised block failures were observed. Concrete capping on crest and
face has cracked and failed.

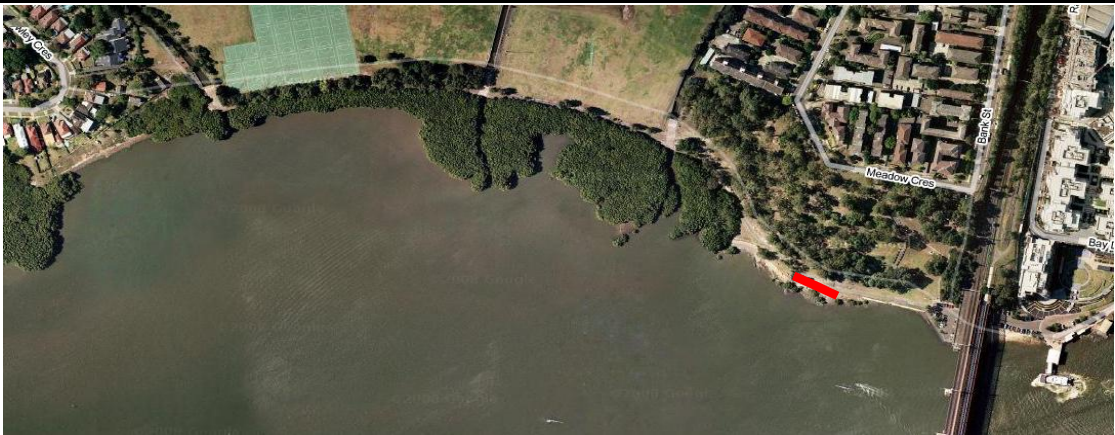
Condition Assessment (Slope, Crest, Toe, Backfill):
Significant slumping, block failures at the crest and weathering of sandstone blocks was observed along the length of the structure. Vegetation is also growing out of the wall.

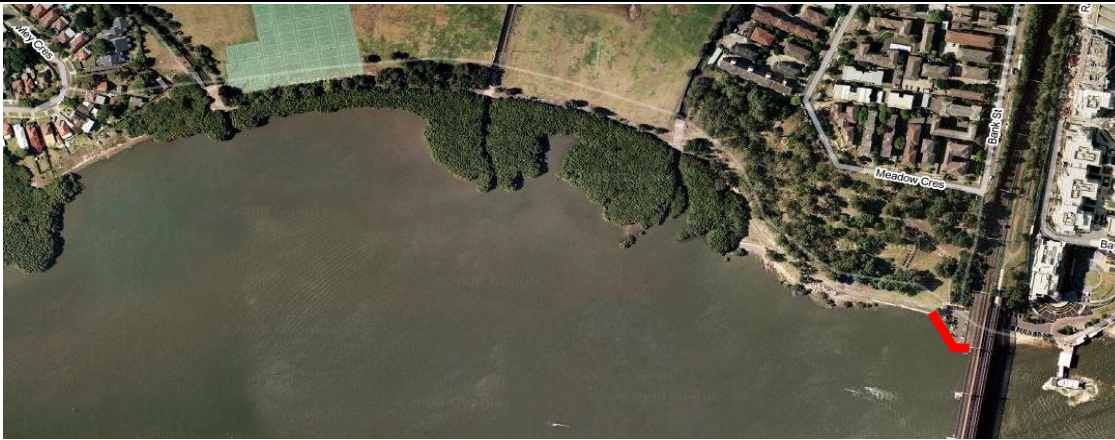
The section adjacent to the bridge abutment has failed and all material has been lost from the baskets. The rest of the structure is slumping.

The structure supports a public carpark and walkway which has been undermined by the failure adjacent to the bridge abutment.

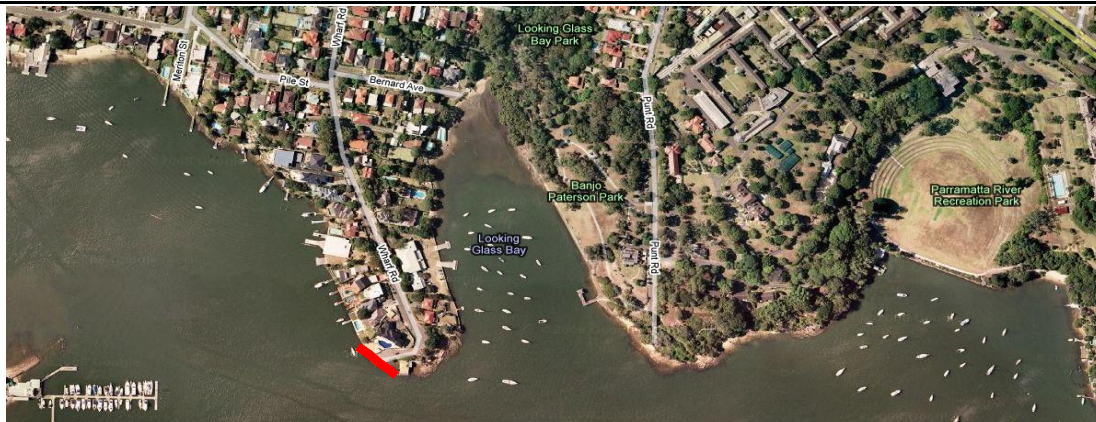
A number of block failures were observed along the length of the wall. Additionally, no grout is present between the blocks, sinkholes are present at the crest and surface weathering of the blocks has taken place.

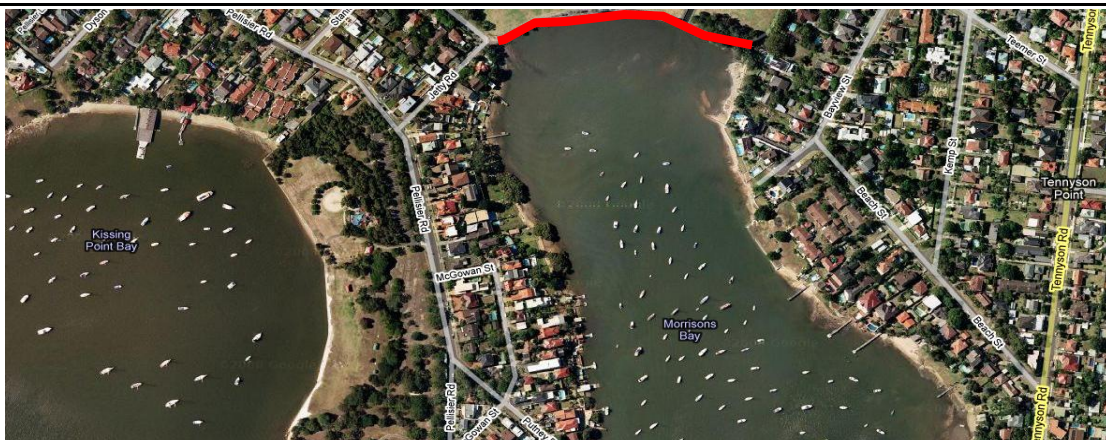
Severe weathering, slumping and loss of grout from between sandstone blocks was observed. A number of sinkholes are present behind the crest indicating a loss of fine material.

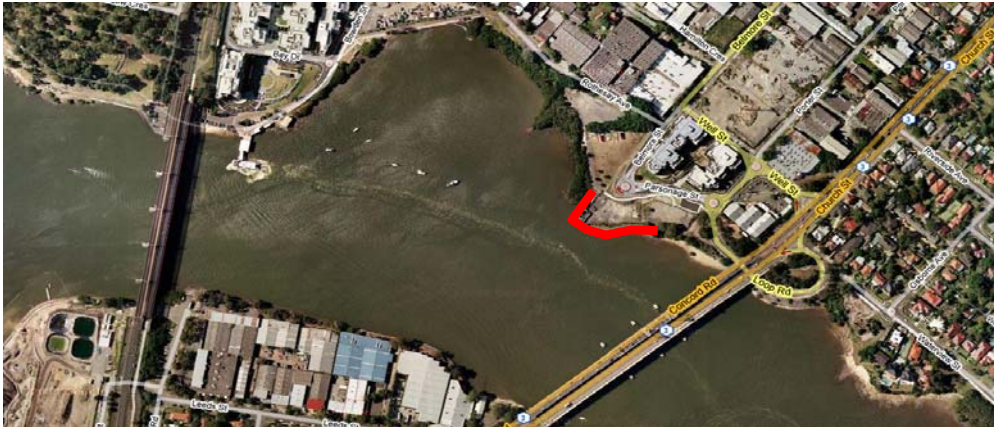
Single block failures were observed along the older, lower section of the wall. The lower section is also slumping and grout material is missing from between the blocks. The newer blocks that form the crest are in excellent condition.

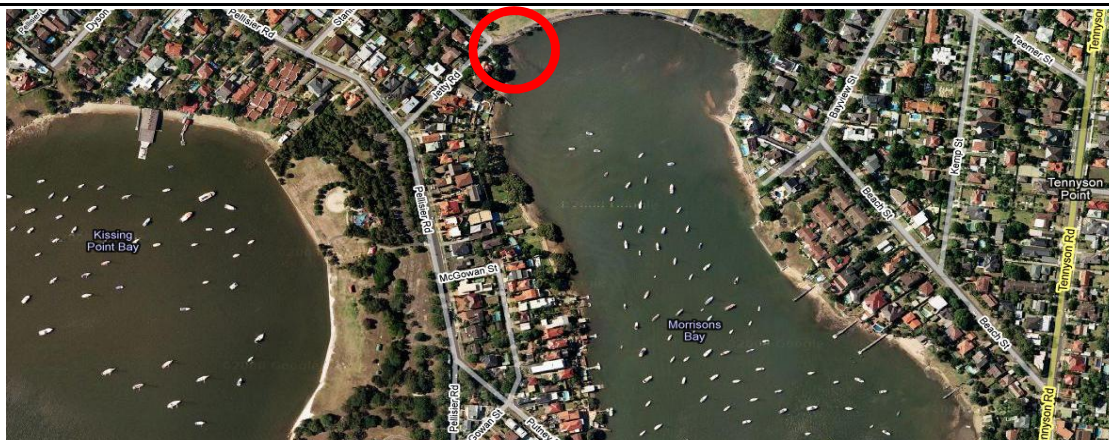
The boat ramp is not constructed to typical engineering standards. The toe has been undermined and the sides of the ramp are failing with aggregate material strewn along adjacent sandy shoreline. There is no formal structure for dingy storage.

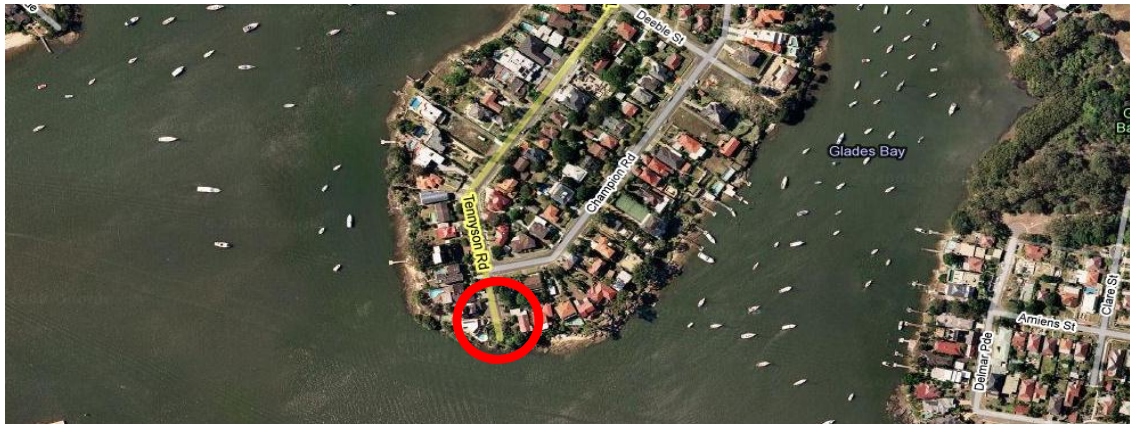
The concrete stairs are in a poor conditions with cracks present and undermining at the lowest point.

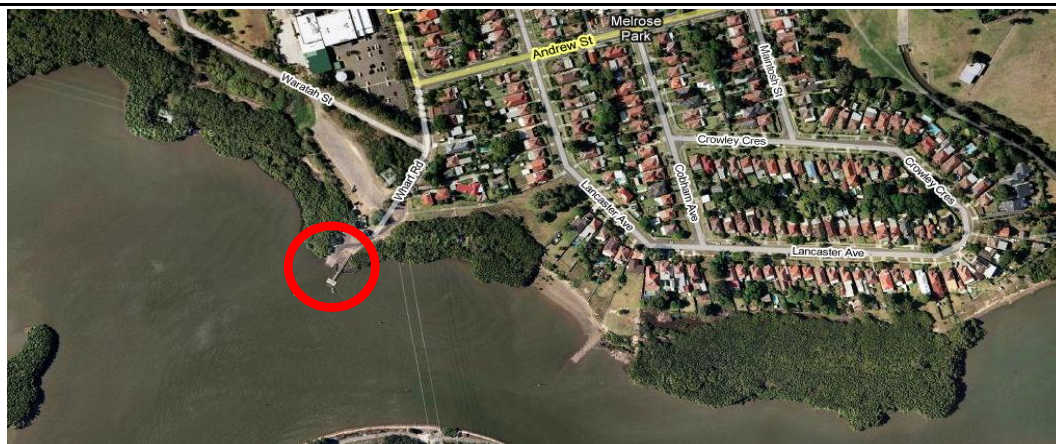
The timber slats on the jetty are loose and deteriorating as is the timber rail. The timber slats on the gangway are also loose and deteriorating. The edges of the concrete that makes up the floating pontoon are severely corroded with reinforcement visible.

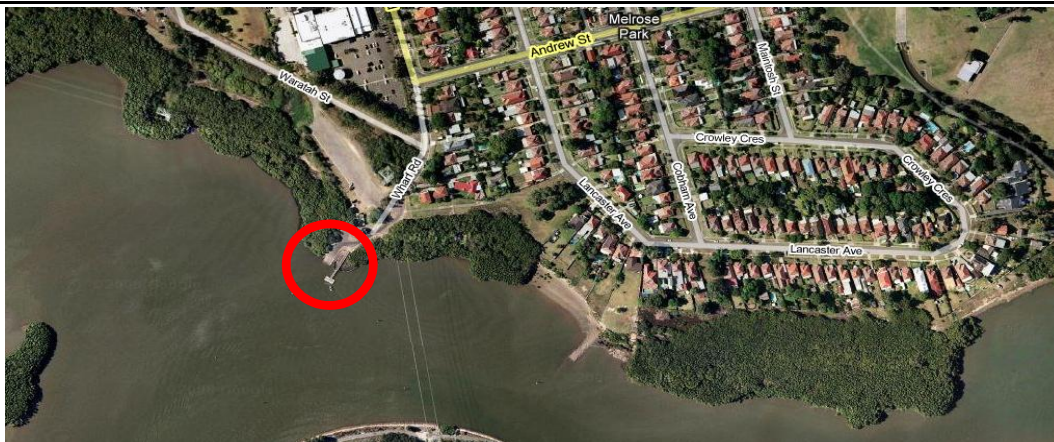
The concrete ramp is cracking and aggregate is exposed. The western side of the structure has been undermined.

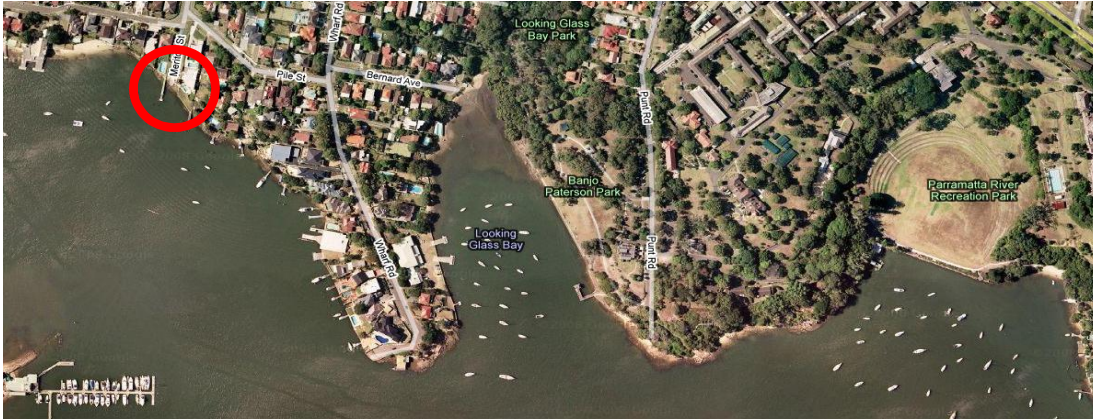
No formal facility. Steel safety rail associated with Sydney Water pumping station is showing signs of corrosion and the concrete slab it sits upon has been undermined.

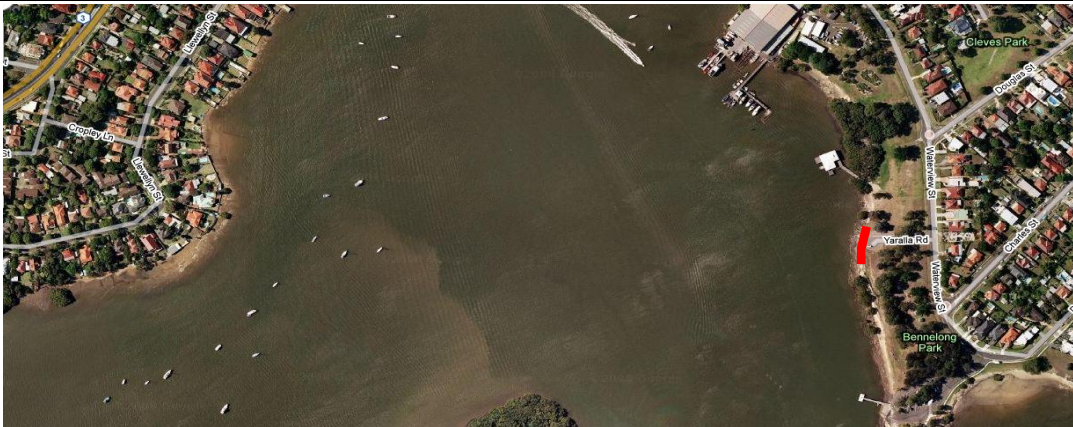
A large, approx. 500mm erosion scarp is present for 50m encompassing the end of Yaralla Road. The section is fenced off from the public and council workers were on site during the inspection and were placing large sandstone boulders along the scarp which don't appear to be designed to typical engineering detail with no filter layer observed.
