# Seawall Inspection Record - PAR\_S16

Date 21/08/09 Level 0.21m LGA Parramatta  
 Time 14:32 Locality East of Macarthur Street Bridge, River South People Low

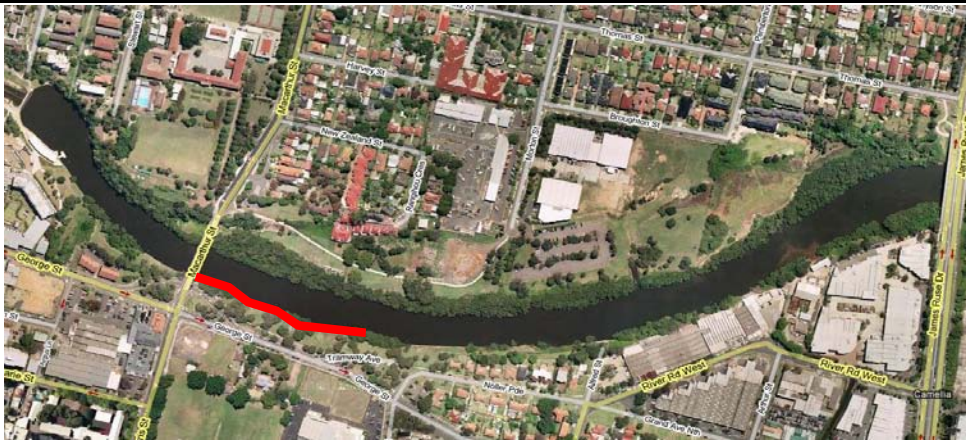
Grouted in places, small/medium sized sandstone block seawall. Concrete slabs are located at the toe at discrete locations as are intermittent mangrove stands. A footpath and public reserve are present beyond the crest which was 2-3m above water level. The foreshore is exposed to vessel wash.

Localised wall failures at the toe and crest were observed. In general, grout is absent from blocks which are slumping. Some section of the wall have been repaired with grout installed between sandstone blocks.

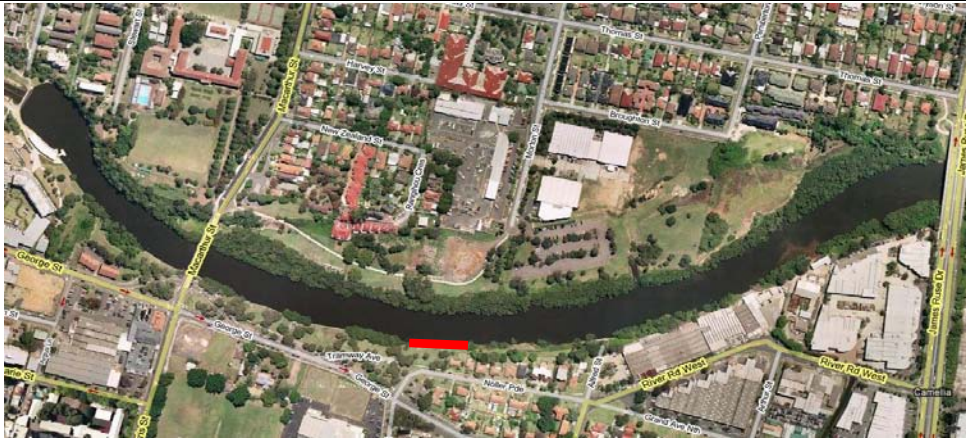
Small/medium sized sandstone block seawall. An informal footpath and public reserve are present beyond the crest which was approx.

Localised wall failures at the toe and crest were observed. The blocks are also slumping and weathered.

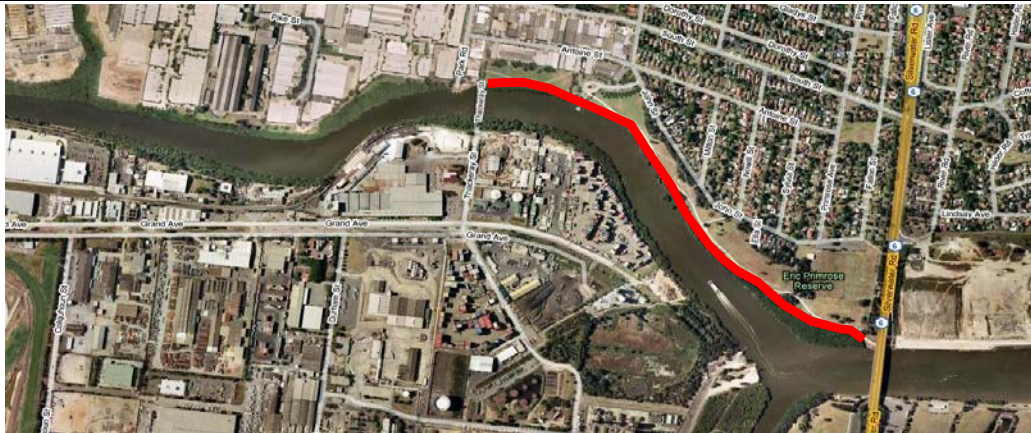
The revetment is failing at discrete locations which correspond to the absence of mangroves exposing the structure to vessel wash. In general, the structure is ungrouted, slumping and the sandstone blocks are weathered. Mangroves that are present in front of the revetment have been undermined leading to failure.

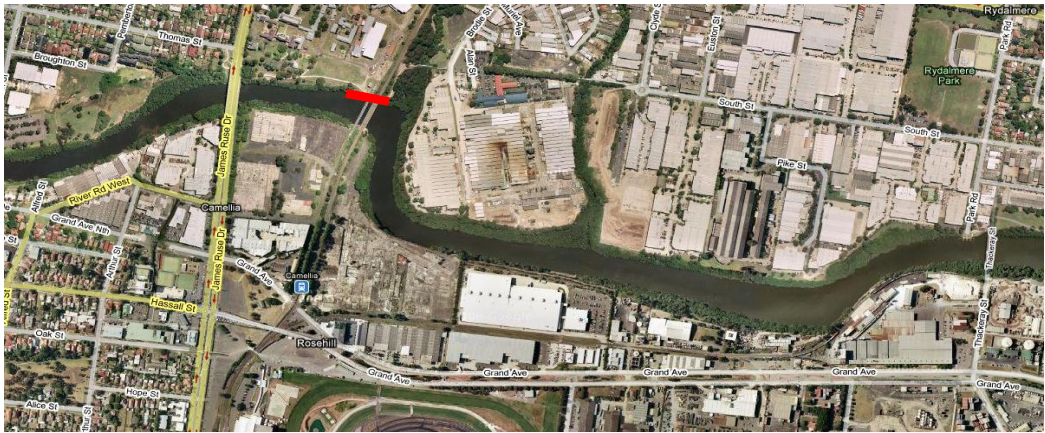
Seawall Details (Slope, Material, Const. Method, Type):  
Large sandstone boulder revetment beneath and adjacent to the Rydalmere rail bridge within the University of Western Sydney Parramatta Campus. A large storm water outlet is located at the western extent of the foreshore which is constructed from gabions baskets that slope to the water line. An informal walkway is present along the crest.

Condition Assessment (Slope, Crest, Toe, Backfill):  
The revetment has not been constructed to typical engineering standards with no underlayers evident. The structure crest level is inadequate with an erosion scarp present beyond due to vessel wash exposure. A number of the gabion baskets that form the storm water outlet structure at the western extent have failed with all material lost.

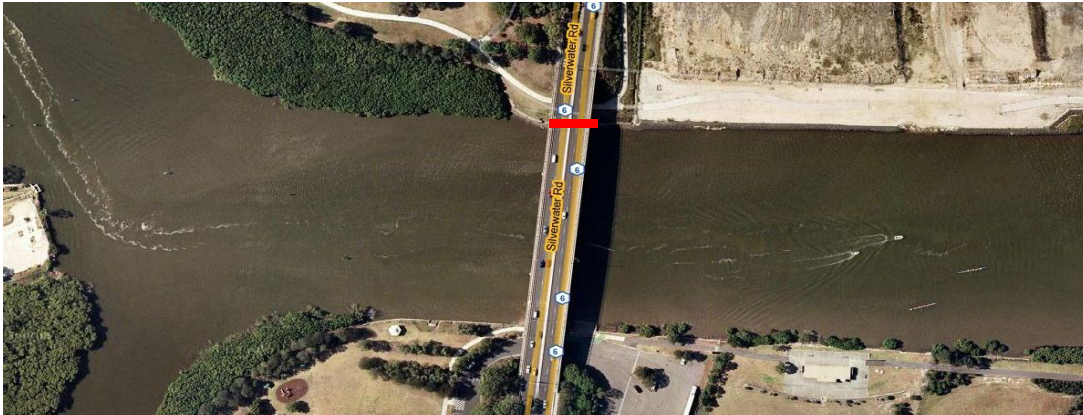
The structure has failed with a large section of sandstone blocks missing. The concrete crest has collapsed onto the sandy bank below. Gabions baskets are present to the east (PAR\_S03) and west (PAR\_S05) and have probably been installed to replace other section of failed wall.

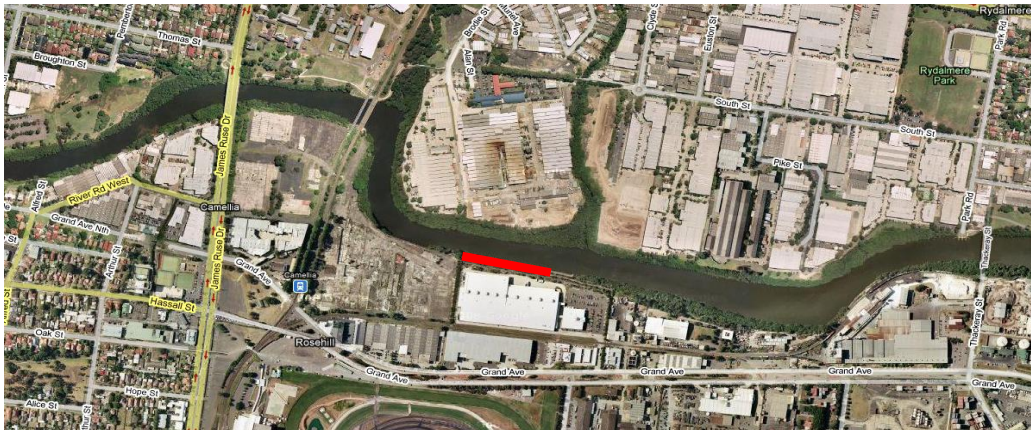
Medium sized sandstone blocks seawall. The western extent of the structure has been replaced with a new, grouted brick seawall.

The majority of the wall has failed due to undermining. The new section of wall at the western extent has also

failed. Mangroves that are in front of the wall have been undermined and have collapsed into the water.

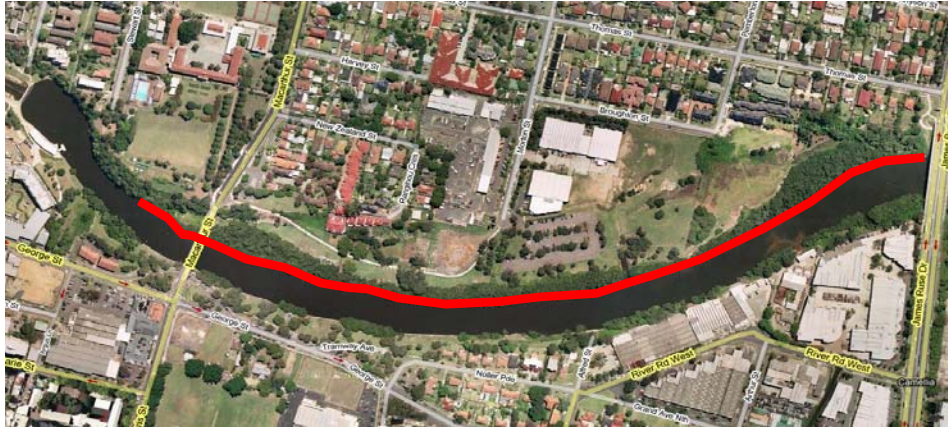
Erosion observed with undermining and loss of fine material from pneumatophores due to exposure to vessel wash.  
A number of mangroves have collapsed into the water. The A-Jacks units are in good condition with no displacement observed.

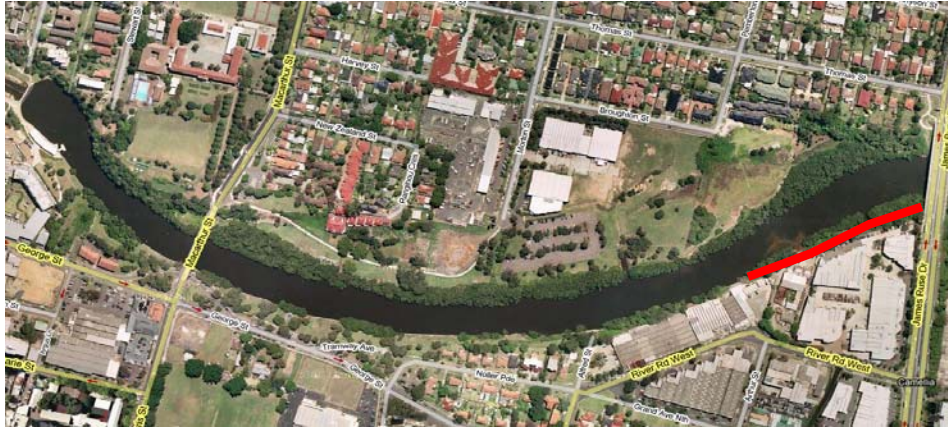
Loss of fine material from pneumatophores due to exposure to vessel wash observed. A section without mangroves has collapsed with a large, >2m, erosion scarp present. Fill material has been dumped to the side of the failure in an attempt to impede erosion.

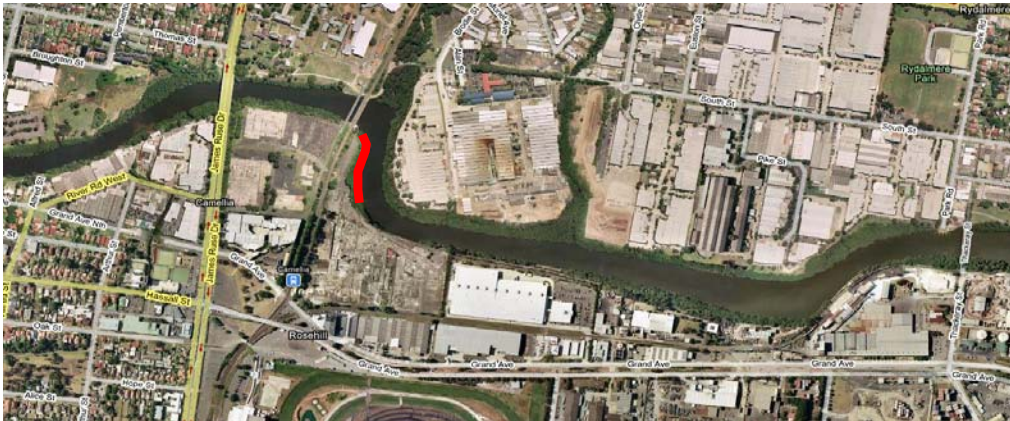
Erosion observed with undermining and loss of fine material from pneumatophores due to exposure to vessel wash.  
 The steel fence has failed and the surrounding earthen bank is severely eroded.

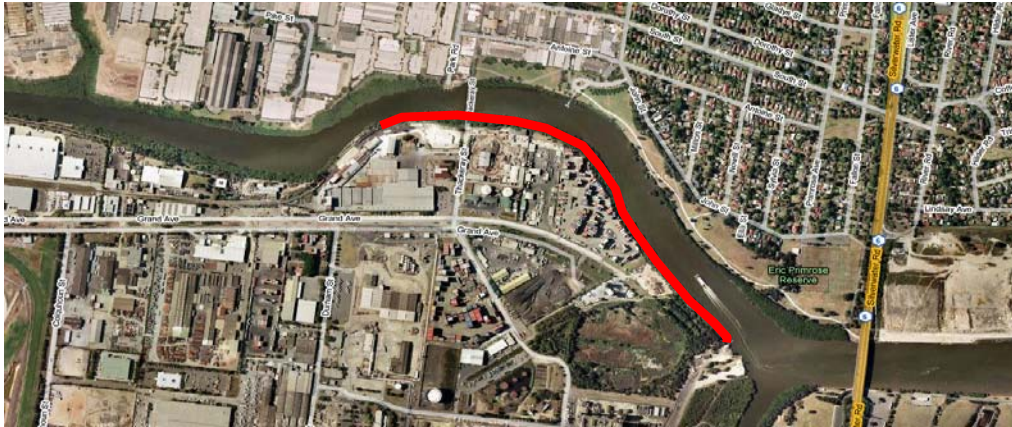
Erosion observed with undermining and loss of fine material from pneumatophores due to exposure to vessel wash. The abandoned timber pile wharves and concrete stack have been undermined.

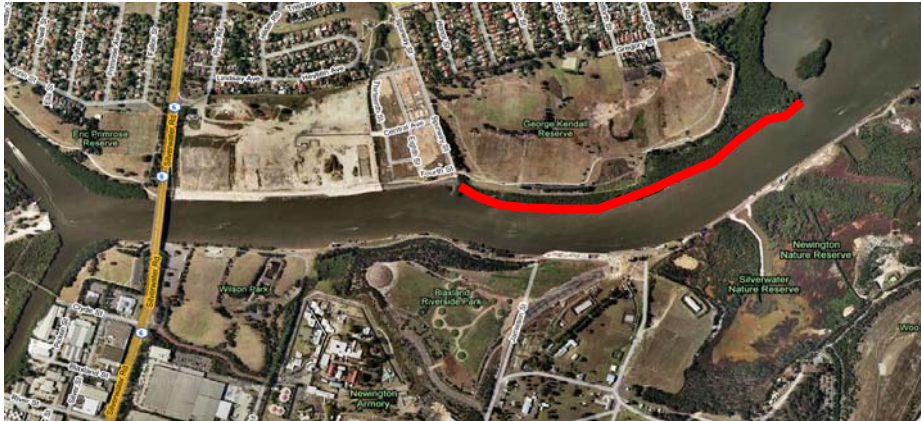
Erosion observed with undermining and loss of fine material from pneumatophores due to exposure to vessel wash.  
A number of mangroves have collapsed into the water.

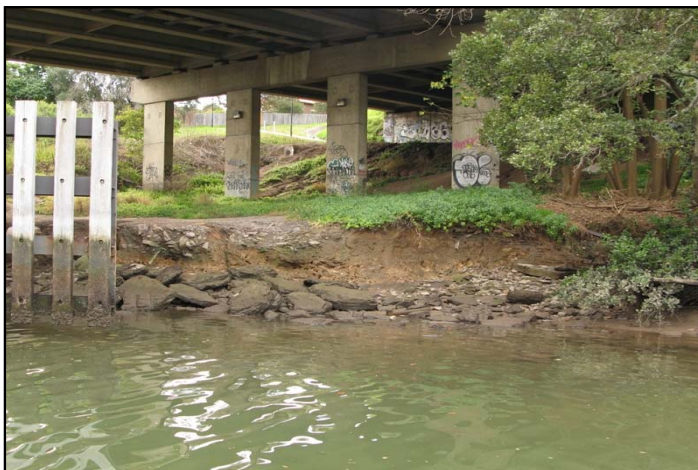
## Photo 2

Erosion scarp behind timber fenders directly under James Ruse Drive.

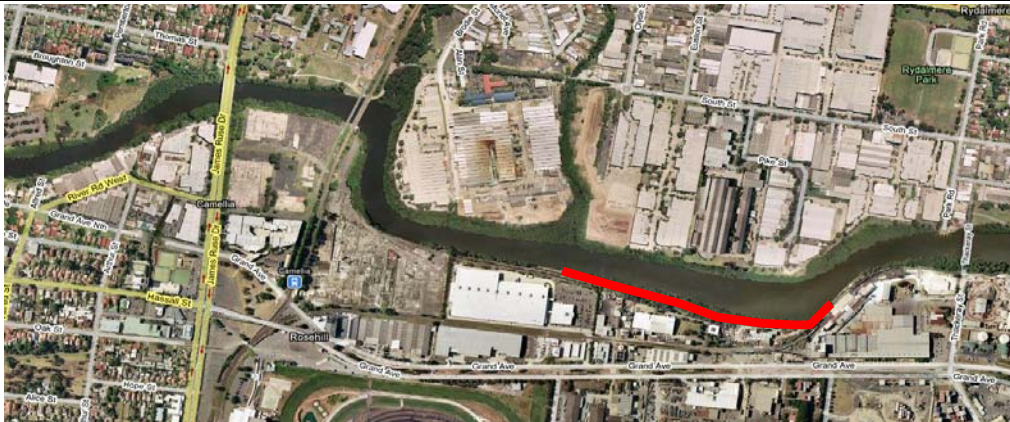
Erosion observed with undermining and loss of fine material from pneumatophores due to exposure to vessel wash.  
A section of bank with no mangroves, adjacent to seawall PAR\_S23 has also failed.

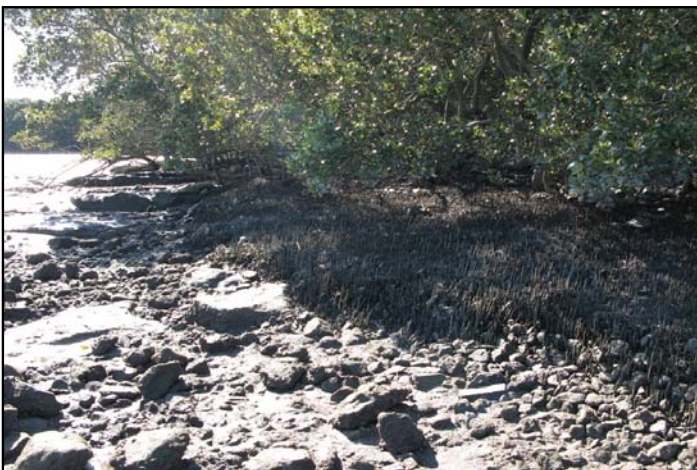
## Photo 2

Loss of fine material from pneumatophores.
