Parramatta LGA

9.10 Parramatta LGA

Seawall Inspection Record - PAR_S16

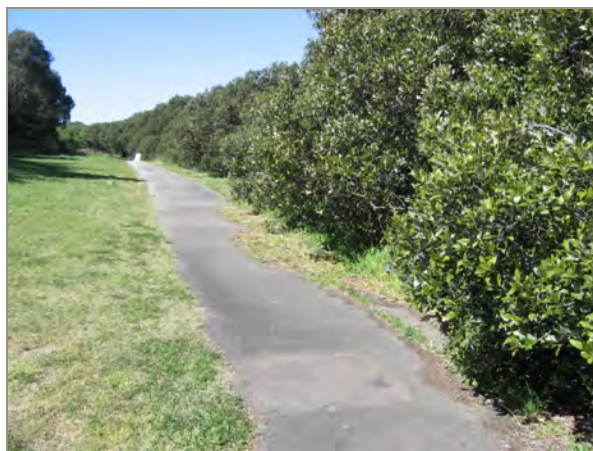
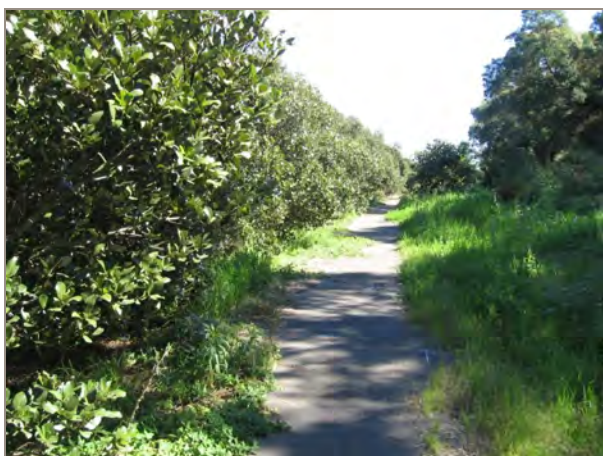
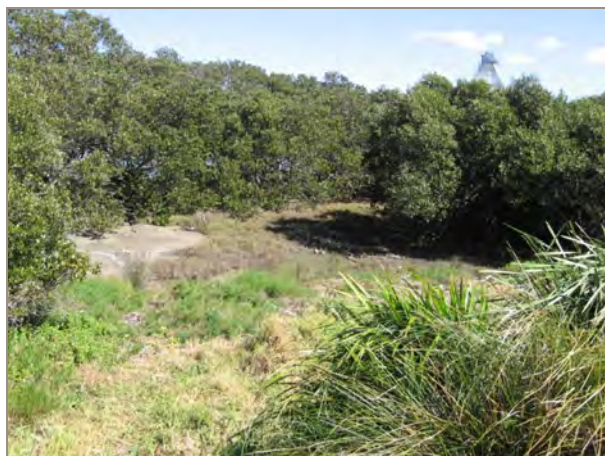
- Stormwater management and weed control at stormwater outlets between Archer Park and George Kendall Riverside Park (River_North_093-095);
- Reserve upslope land for migration of mangroves and colonisation of saltmarsh vegetation in the future (*photo top right*);
- Weed control (including *Juncus acutus*), ongoing monitoring for regrowth and seed germination of *J.acutus*;
- Potential to salinise non-salt tolerant introduced species (*photos bottom left and right*).

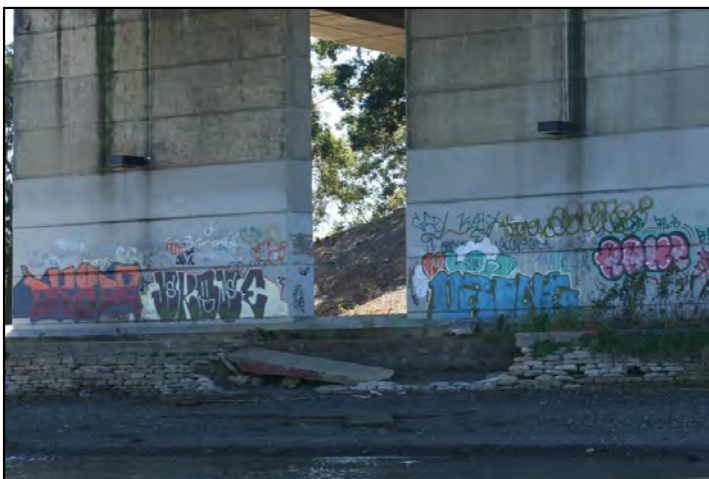
Photo 2

The structure has failed with a large section of sandstone blocks missing. The concrete crest has collapsed onto the sandy bank below. Gabions baskets are present to the east (PAR_S03) and west (PAR_S05) and have probably been installed to replace other section of failed wall.

Failed section of wall.

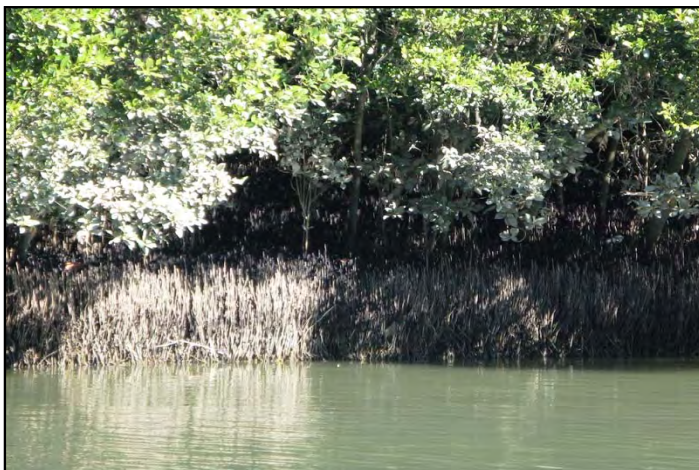
Photo 2

Collapse of exposed bank in front of private industrial building.

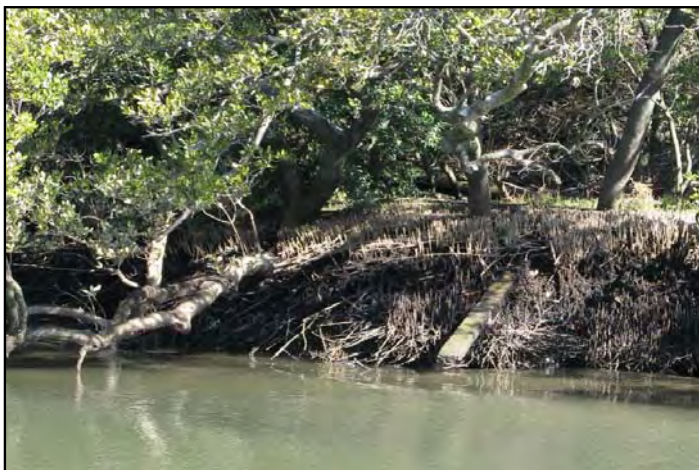
Photo 2

Undermining of pneumatophores.

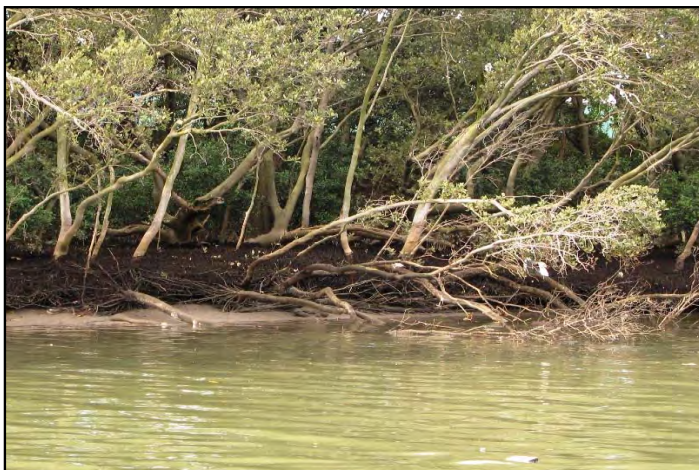
Photo 2

Undermining of pneumatophores.

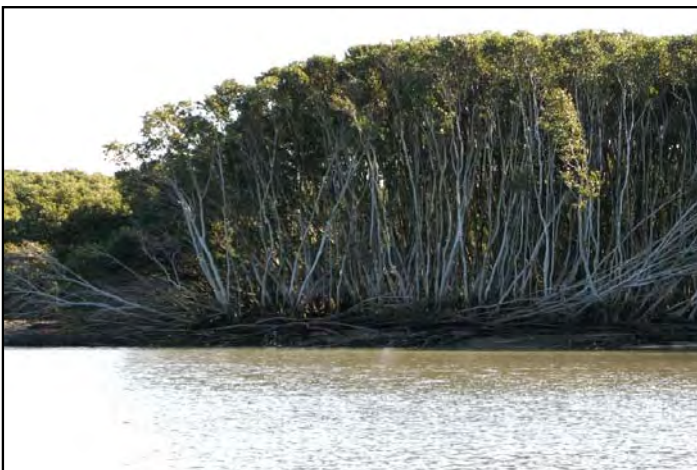
Photo 2

Undermining and loss of fine material from pneumatophores.

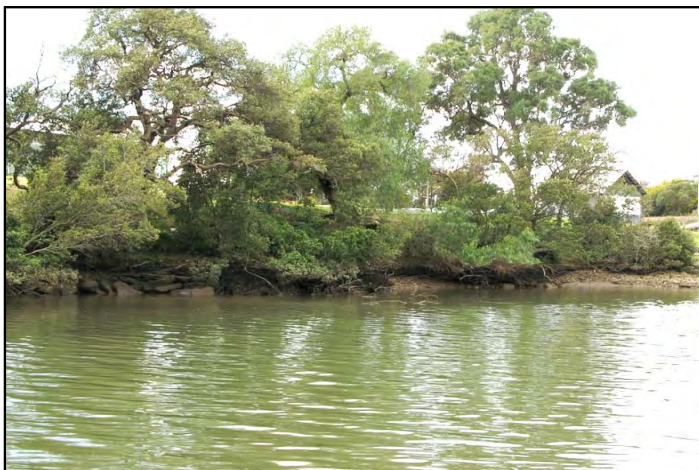
Photo 2

Undermining of pneumatophores.

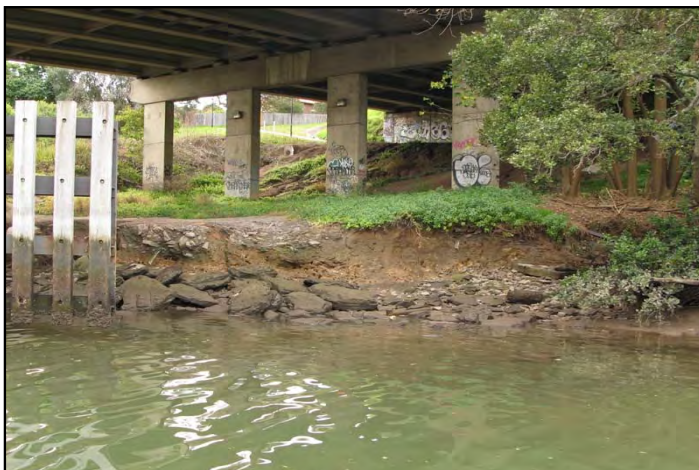
Photo 2

Erosion scarp behind timber fenders directly under James Ruse Drive.

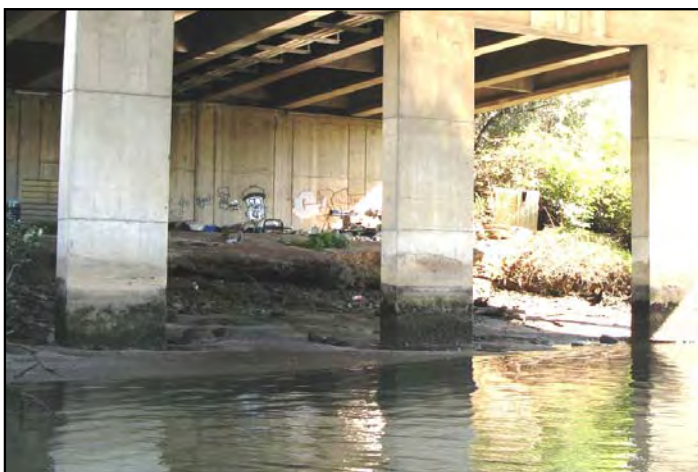
Photo 2

The large erosion scarp at the foreshore.

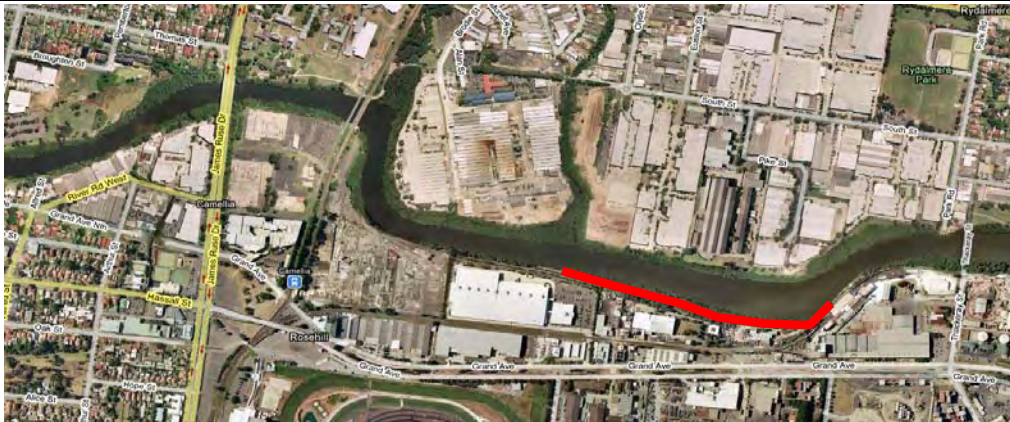
- PAR_NS16

Erosion observed with undermining and loss of fine material from pneumatophores due to exposure to vessel wash.
A section of bank with no mangroves, adjacent to seawall PAR_S23 has also failed.

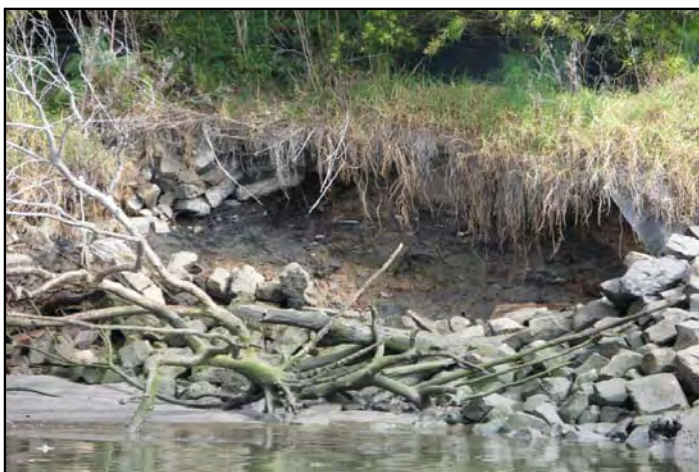
Photo 2

Loss of fine material and undermining of mangroves.

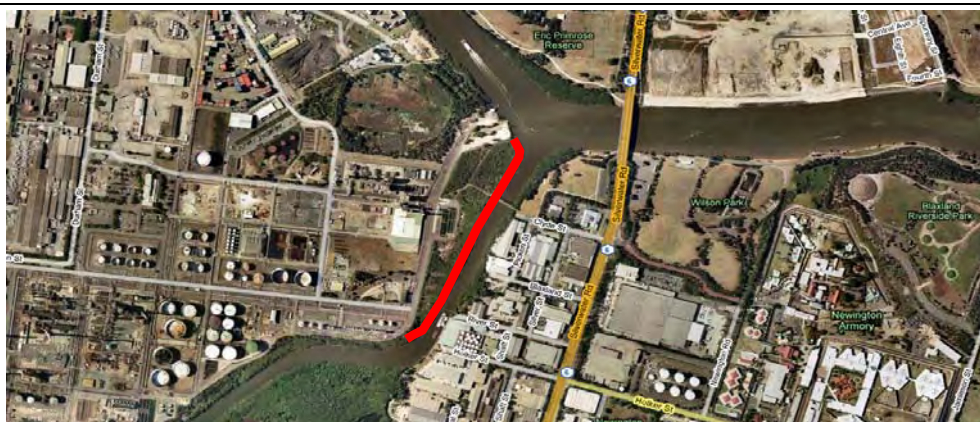
- PAR_NS18

Erosion observed with undermining and loss of fine material from pneumatophores due to exposure to vessel wash. The condition of the shoreline improves upstream of the confluence in the Duck River.

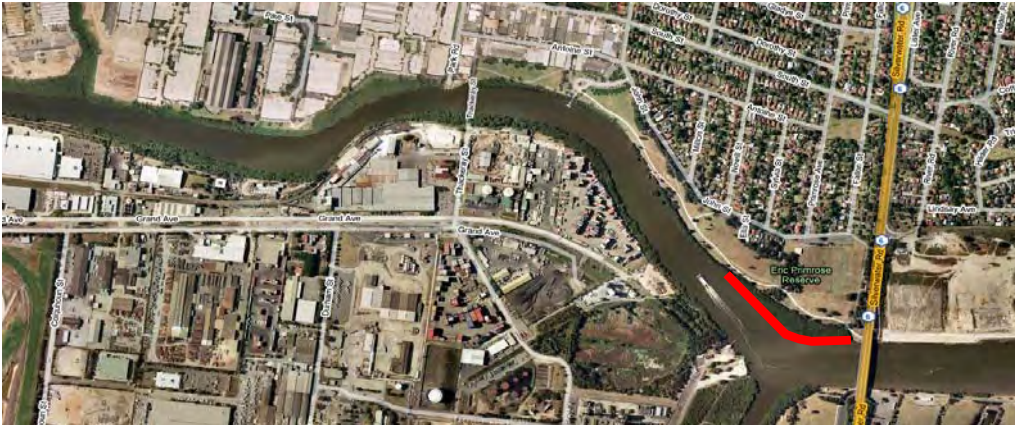
Erosion observed with undermining and loss of fine material from pneumatophores due to exposure to vessel wash.
A number of mangroves have collapsed into the water.

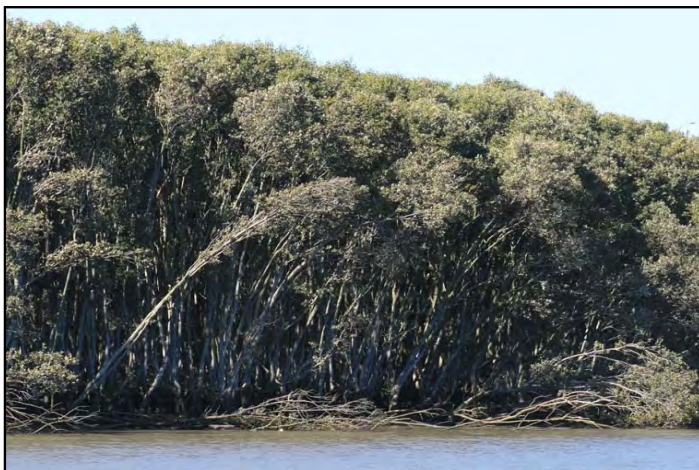
Photo 2

Vessel wash at foreshore.

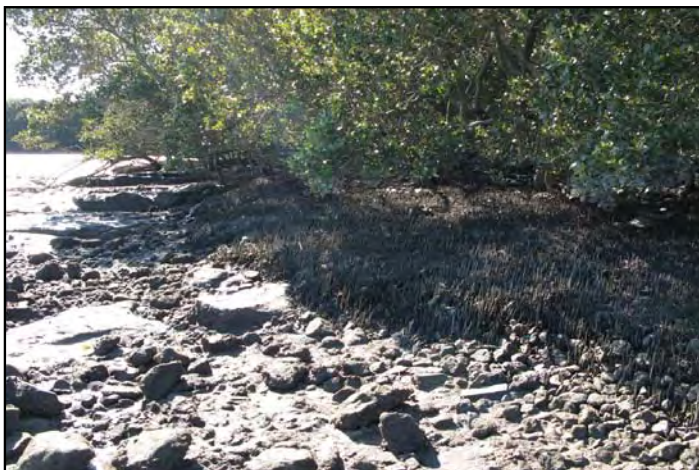
Photo 2

Loss of fine material from pneumatophores.
